**The Performance of Defected Spent LWR Fuel Rods in  
Inert Gas and Dry Air Storage Atmospheres**

**January 1985**

NUREG/CR-4074  
EGG-2364  
Distribution Category: RJ

**THE PERFORMANCE OF DEFECTED SPENT LWR FUEL  
RODS IN INERT GAS AND DRY AIR STORAGE  
ATMOSPHERES**

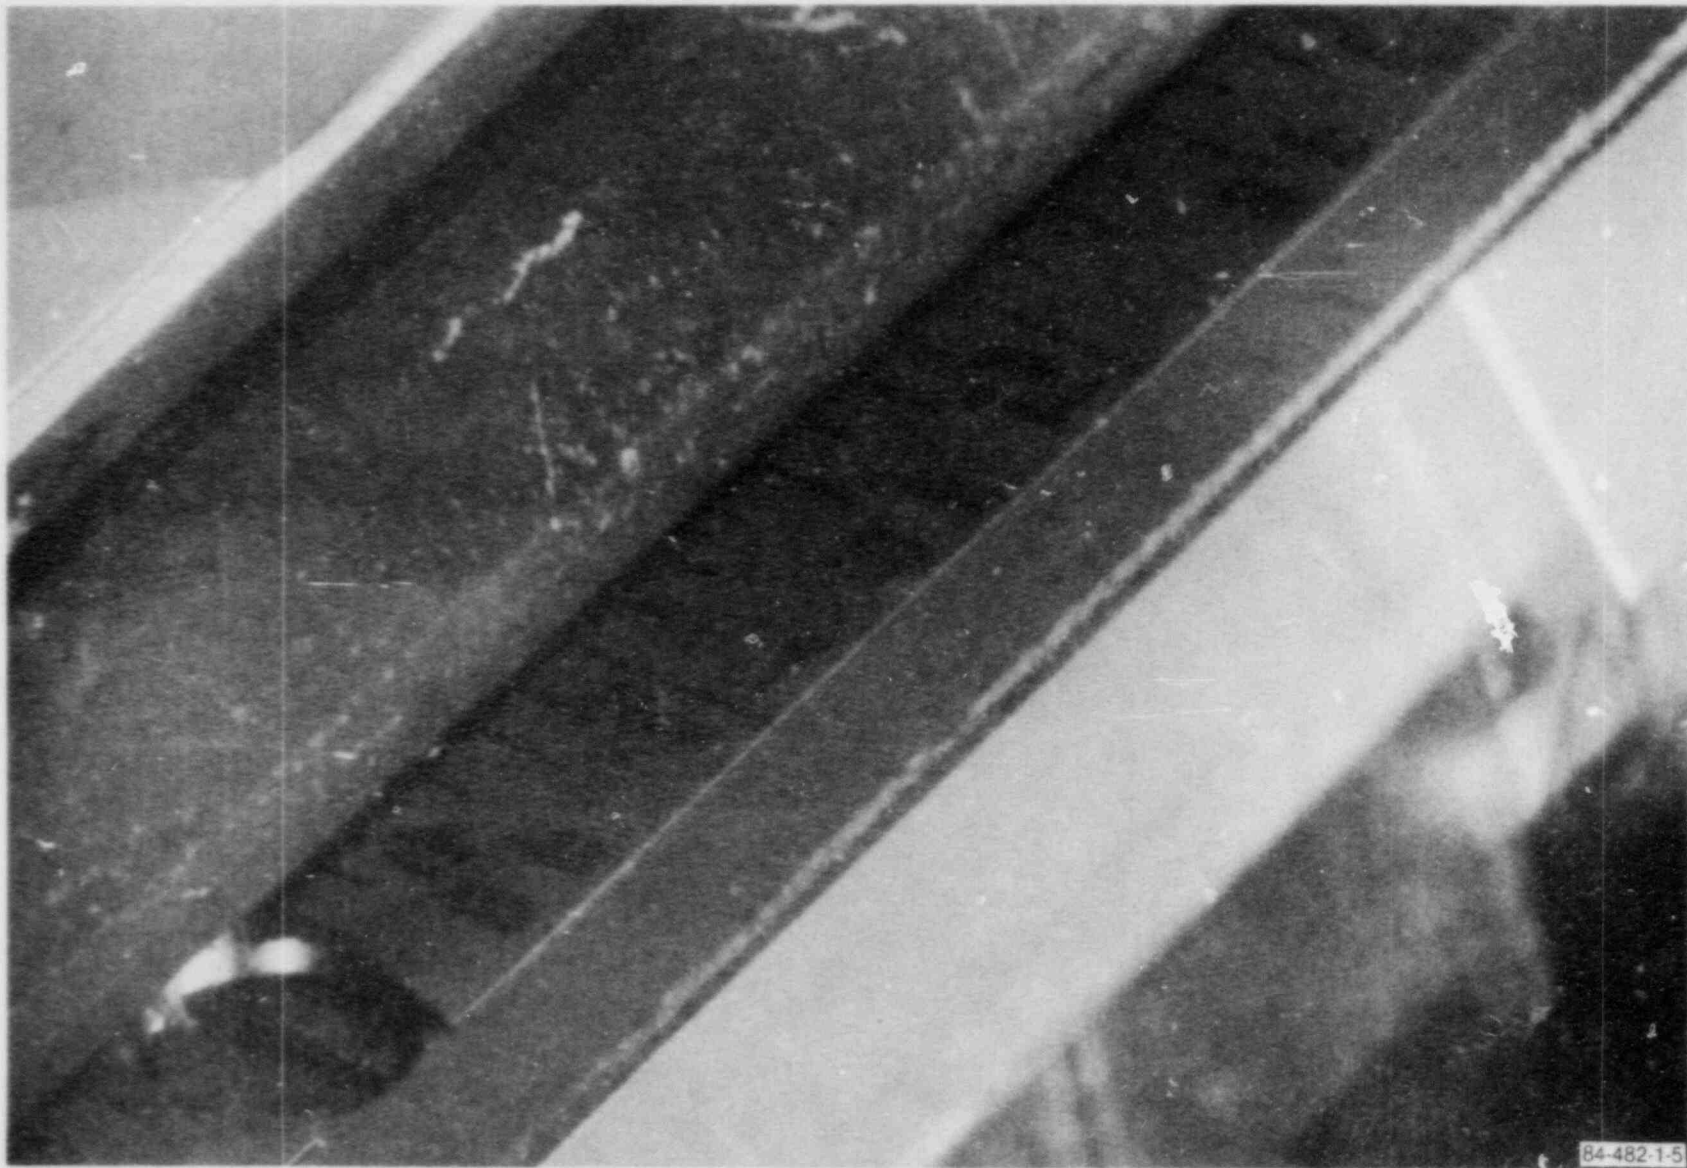
The general surface appearance of the four BWR fuel rods also appeared to have not changed. The artificial defect at the top of rod PH462-C5 did not appear to be fully open. When this hole was drilled into the cladding, indications were that the drill bit had penetrated through the wall. The defect located at the bottom showed significant enlargement and developed an axial crack emanating from both sides of the original hole (Figure 6). Also the top defect in rod PH462-D6 did not appear to be fully open to the atmosphere.

Figure A-6. Defect at 66 cm location in PH462-C5.

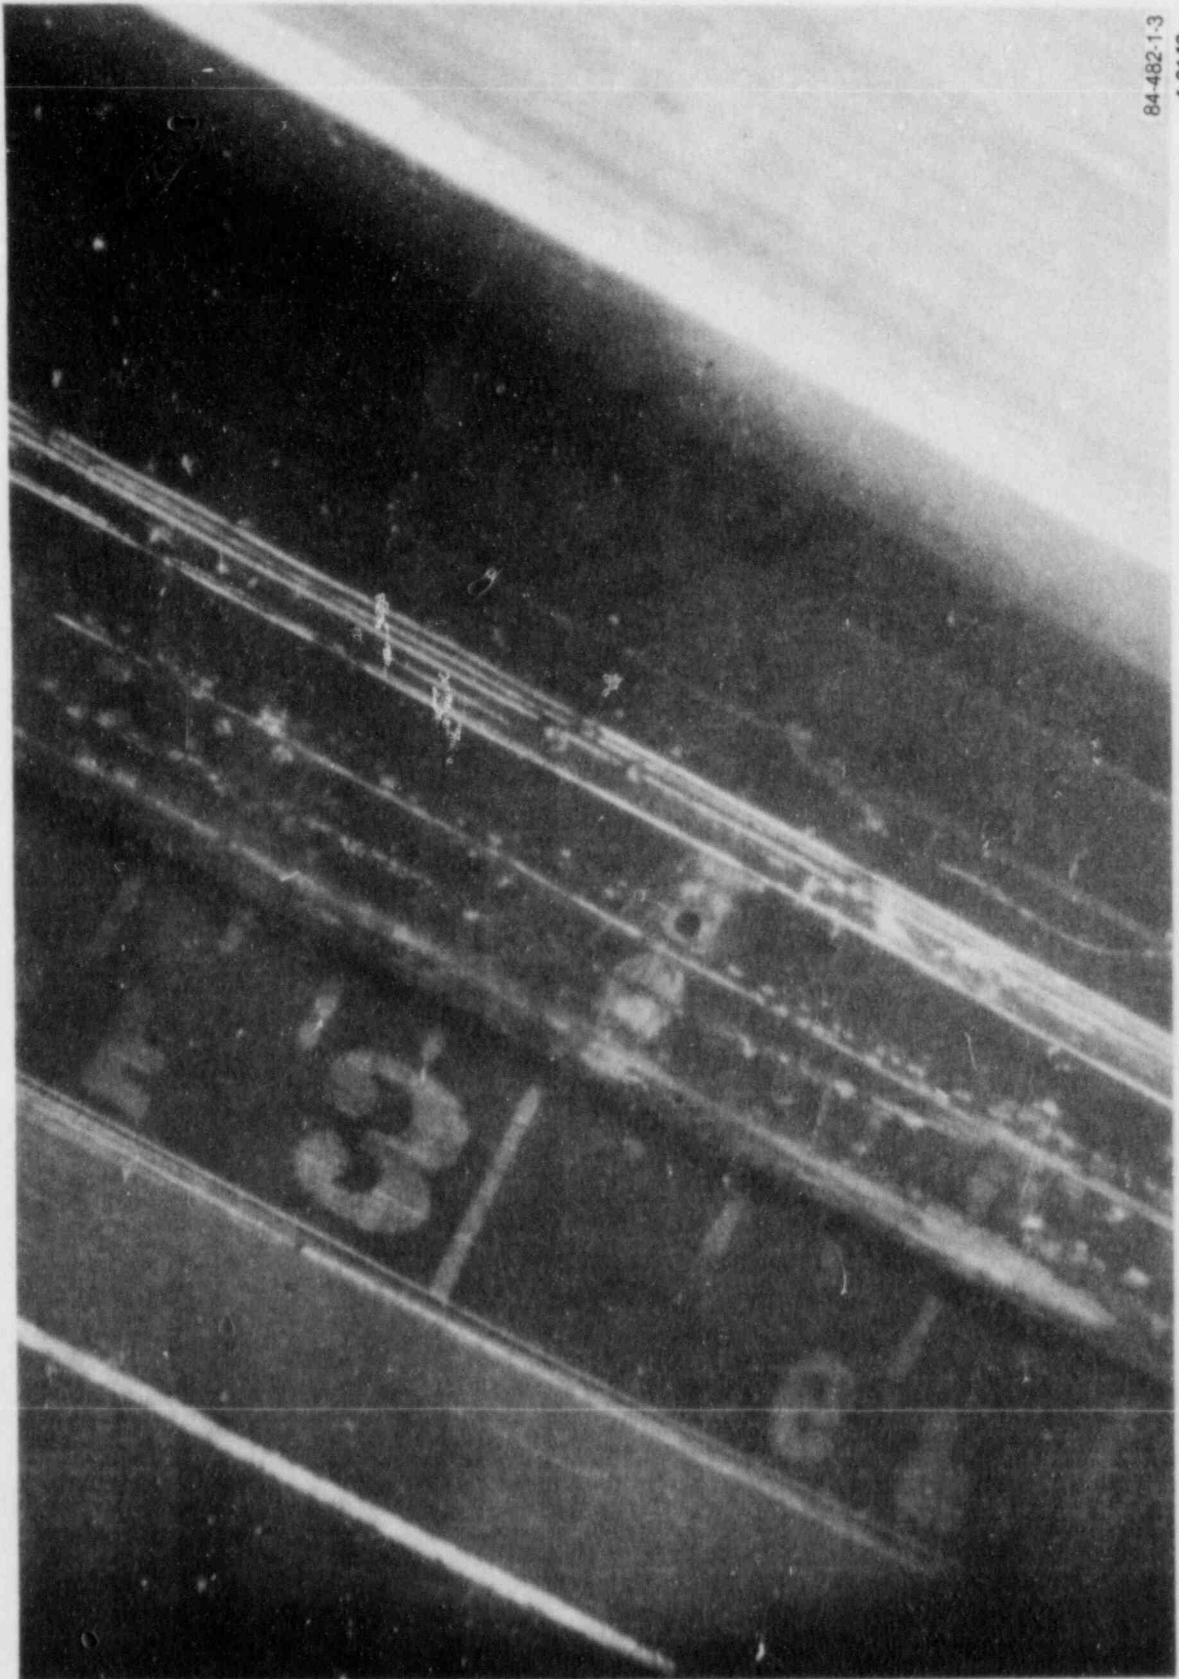
Figure A-7. Defect at 236 cm location in PH462-C5.

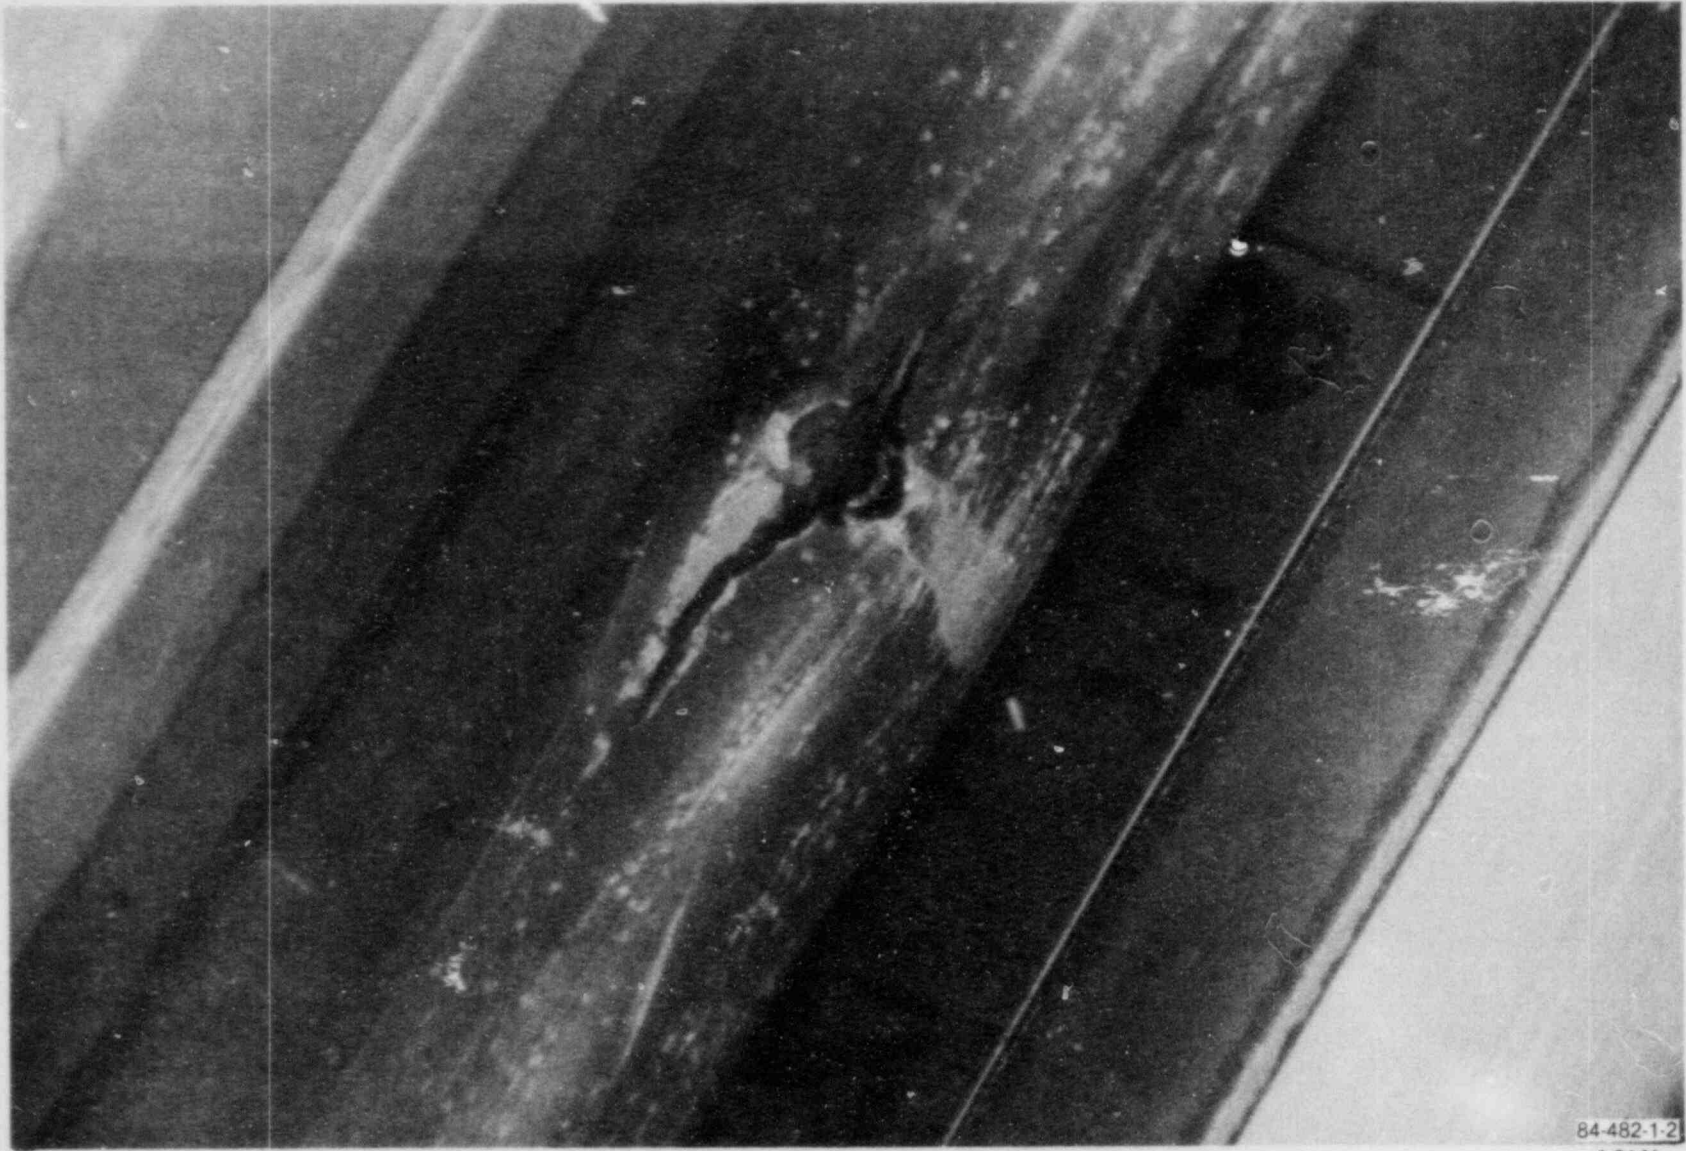
The fuel rod diameter measurements are listed in Table 3, and the defect sizes are listed in Table 4. Significant fuel rod strain was measured in the BWR PH462-C5 fuel rod. The crack size in PH462-C5 was asymmetrical, extending 8.6 mm up the rod and 10.2 mm down the rod from the defect. Its width at the widest point was 1.3 mm. The original defect, which was 0.76 mm, increased by 0.25 mm neglecting the initial crack opening. The fuel rod expanded 17% at 90 degrees from the crack and 7% at 30 degrees almost parallel to the crack. The deformation of the failed BWR fuel rods was apparently constrained by the fuel rod capsule. The maximum deformation of the fuel rod is 1.73 cm, compared with 1.75 cm inside diameter of the capsule. The fuel rod was stuck inside the capsule when the capsule was being unloaded. There is no apparent fuel rod strain in the other three BWR fuel rods, based on the fuel rod diameter measurements.

Figure A-8. Crack from bottom defect of PH462-C5.

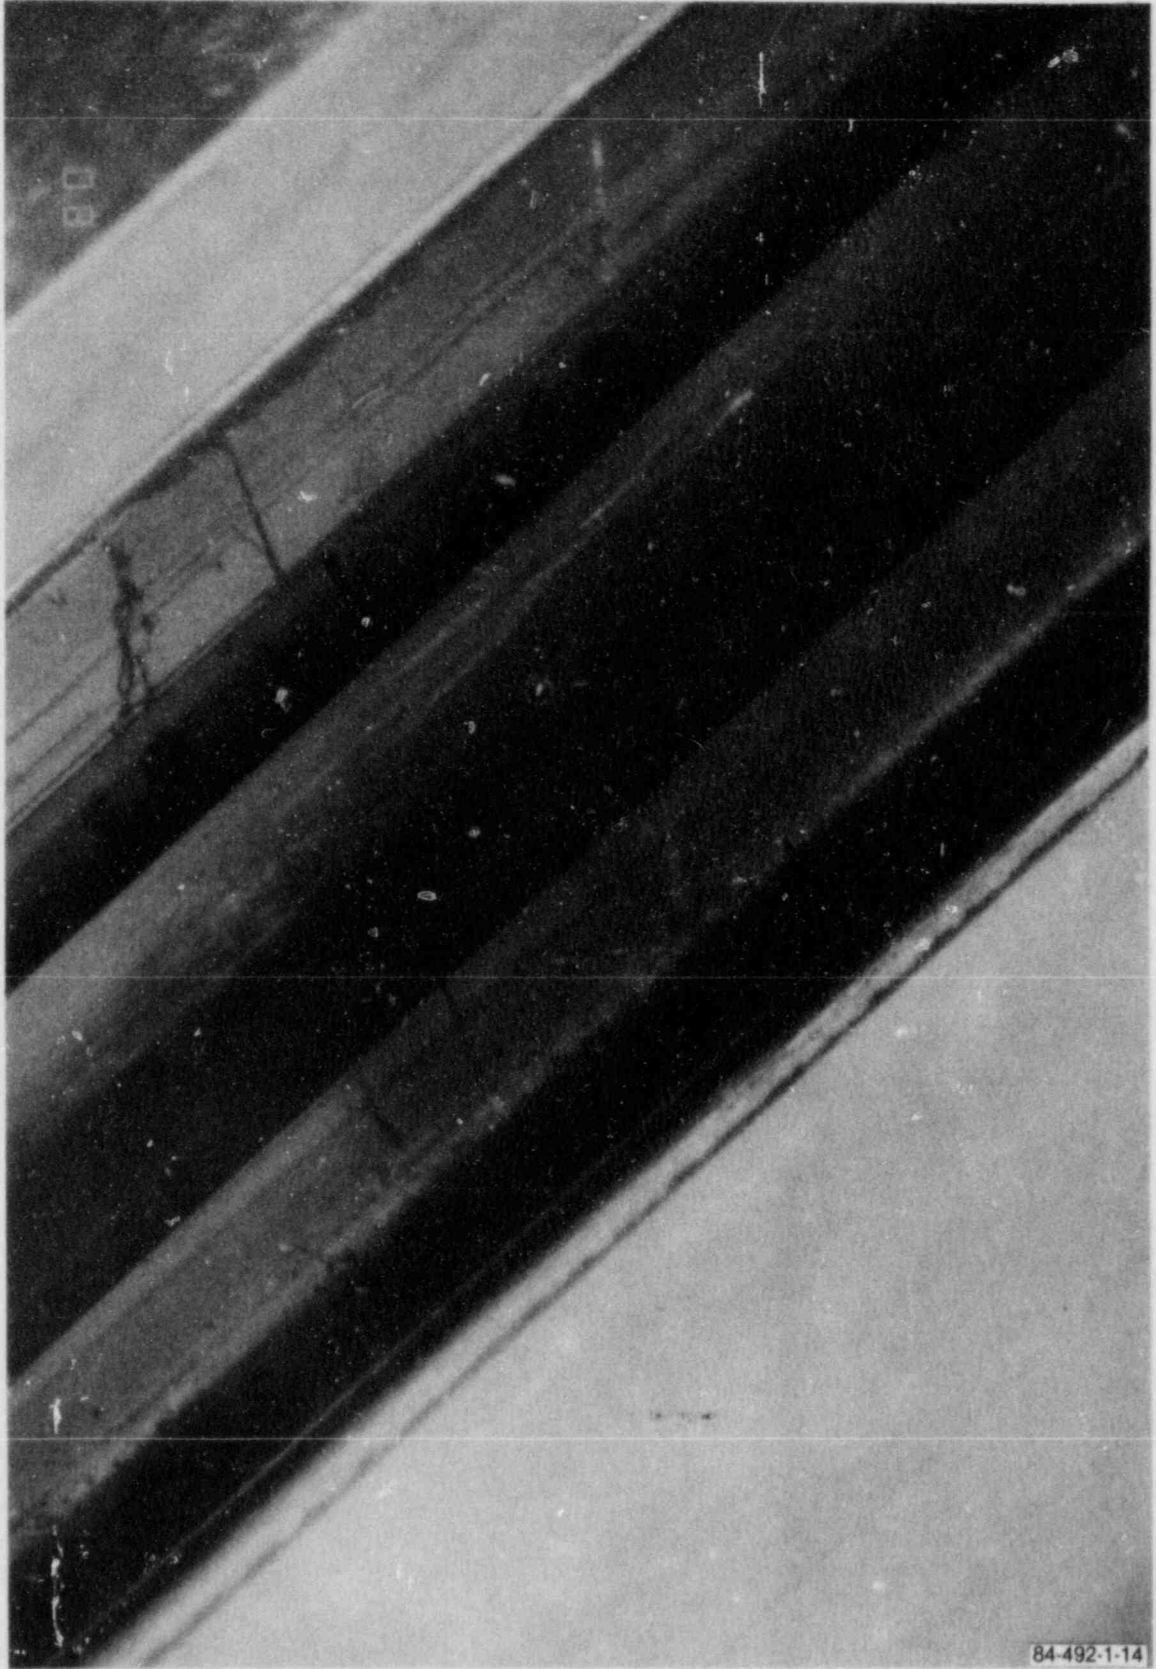
Figure A-9. Defect at 28 cm in BO5-G7.
