Subject: Oyster Creek Station  
Docket No. 50-219  
Addendum to Abnormal Occurrence  
No. 50-219/74/28

## ADDENDUM

### Abnormal Occurrence Report No. 50-219/74/28

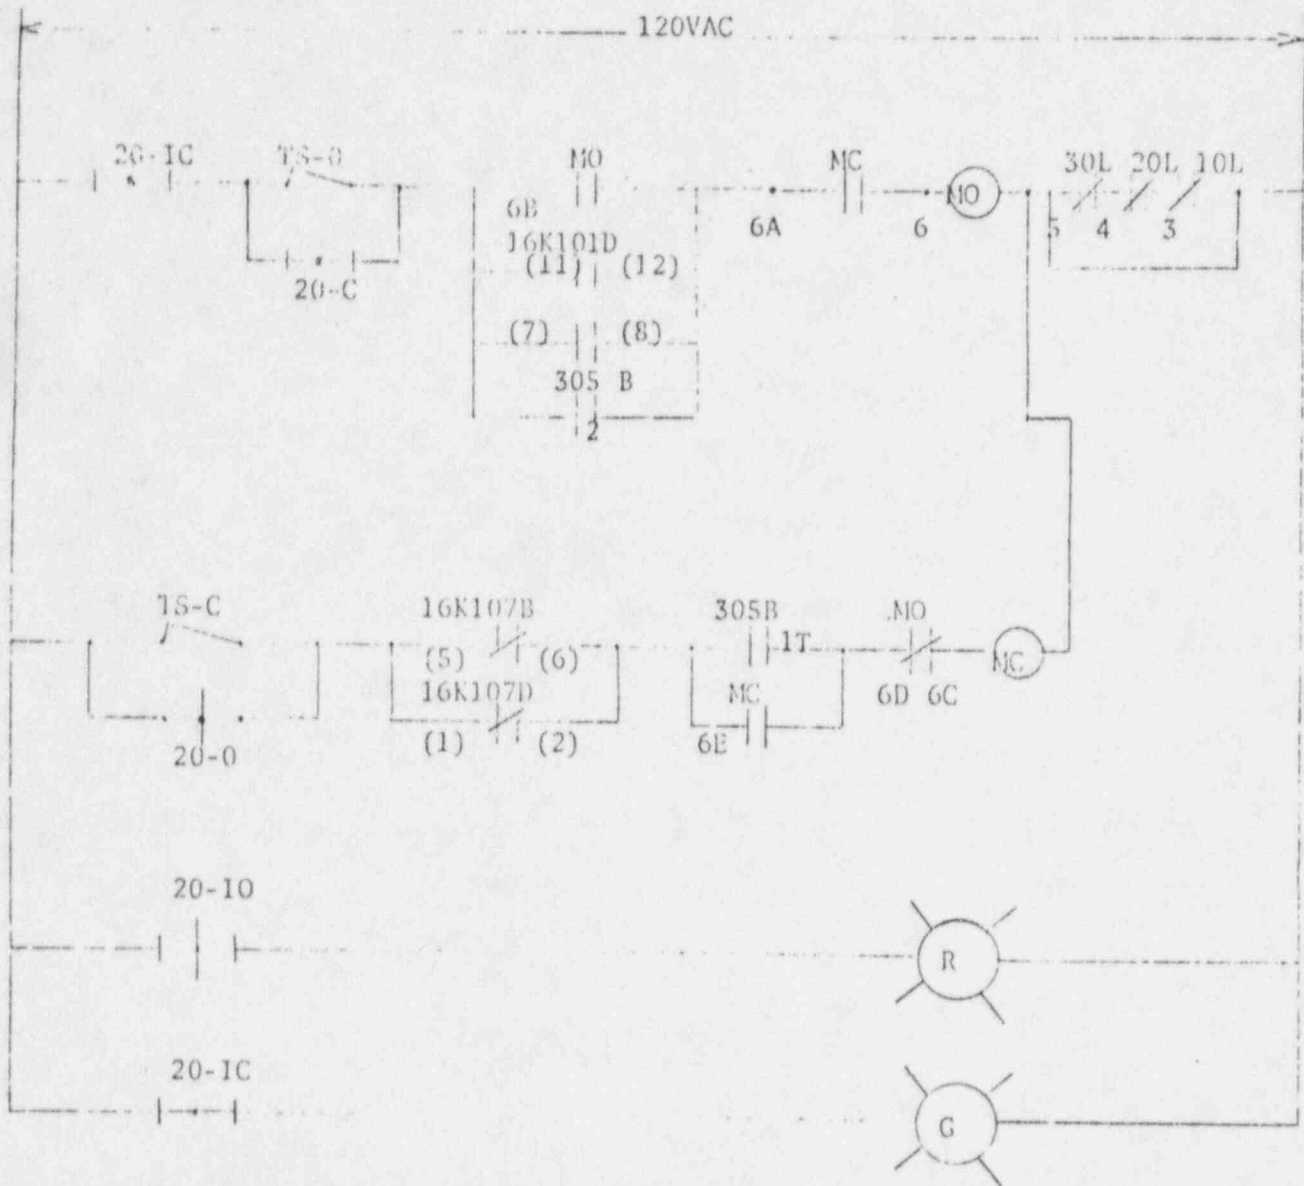
Figure 1

Refer to the attached schematic diagram of the opening and closing control circuitry for V-20-4 (Figure 1). Torque switch TS-0 is provided to interrupt the control circuitry if a mechanical overload occurs during the opening cycle. Position switch 20-C is provided to override the function of TS-0 during the initial stages of the opening cycle. This position switch (20-C) is normally adjusted to open at approximately 10% of valve travel. Investigation of the control circuitry after the abnormal occurrence revealed that 20-C was opening prematurely at 6% to 7% of valve travel. It has, therefore, been concluded that 20-C opened before torque switch TS-0 closed, thereby preventing V-20-4 from opening.

Opening And Closing Control Circuitry For V-20-4

Position switch 20-C was readjusted to open at approximately 10% of valve travel.
