Section I

Enforcement Action:

The reactor remained in the start - up mode for approximately one day with only one isolation condenser operable, in violation of paragraph 3.8.D of the Technical Specifications. (Paragraph 5)

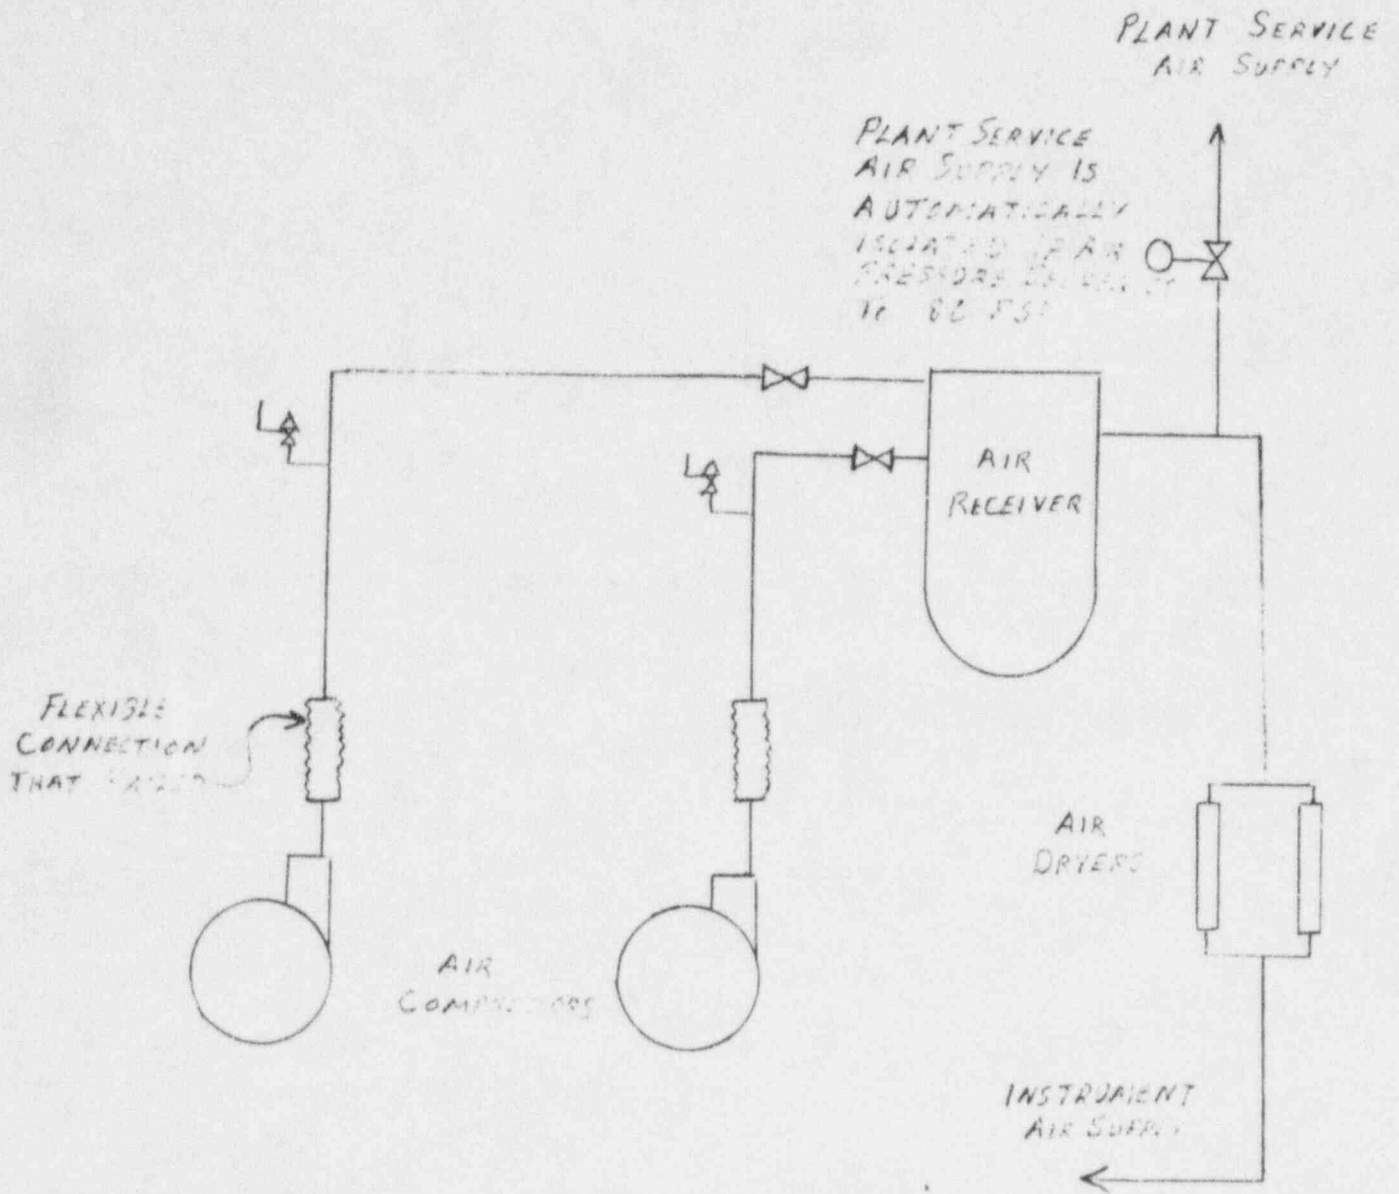
Plant Air Supply

Records show the plant was shutdown by a manual scram on November 16, 1971 due to the loss of instrument air. The investigation showed that a 6" flexible connection on the discharge of the compressor ruptured catastrophically. (See sketch) The line between the compressor and the air receiver does not have a check valve. As a result, the standby compressor started, but could not supply enough air to maintain system air pressure and eventually tripped out. Plant service air was automatically isolated from the air receiver (the service air isolation valve is set to close at 80 psi). Instrument air pressure dropped to essentially "0" pressure. After the leak was isolated by closing the manual valve in the discharge line, the standby compressor was restarted. The operations supervisor stated that air pressure was below 50 psi for a period of 20 - 25 minutes (50 psi is the pressure at which the control operator is required to initiate a manual scram). Air pressure is indicated on a gage in the control room.

Jersey Central's evaluation of the cause of the failure was that the weld points in the connection are where the flexible pipe is welded to the pipe flanges and that the flexible connection was originally installed with a strain, created by misalignment of the flanges. As a result of vibration, failure started at the weld and continued until the flexible connection was completely separated.

According to the maintenance supervisor, specifications for the failed flexible connection were obtained from the vendor of the air compressor and a new flexible connection was fabricated to the same specifications, except a double wire braid was specified for the replacement, instead of a single braid. (A piece of thin wall 6 inch flexible pipe was welded to two 150 psi pipe flanges. The flexible pipe was reinforced with a double wire braid in order to minimize the possibility of a sudden failure.) The replacement flexible connection was installed before the reactor was returned to power.

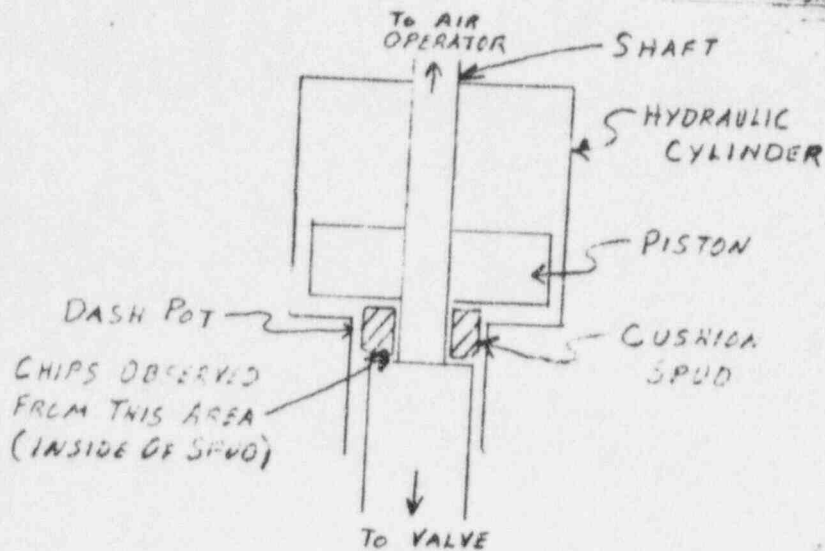
While timing the closing of the MSIVs prior to startup on November 17, 1971, NS03B which is located inside containment, failed to close. The containment was deaerated and the valve was disassembled to determine the cause of the failure. The inspection showed that the "cushion spud" in the hydraulic cylinder had fragmented and a segment of the "cushion spud" caused interference between the piston and the cylinder wall.

The cushion spud is "captured" between the piston and a larger shoulder of the shaft. In the above sketch the piston is shown with the valve in the closed position and the cushion spud in the dash pot. This cushion spud and dash pot decelerates the valve plug assembly just prior to seating.

The other 3 MSIVs were inspected for the same defect. (NS03A on the same line subsequently was reported to have a cracked cushion spud, but the fracture had not impaired the operation of the valve.)

According to Mr. Riggle, the manufacturer provided the specifications for the cushion spud and a replacement was machined to the manufacturer's specifications.

Mr. Carroll reported by phone November 21, 1971 that the valves had been reassembled and tested. The outside valves were set to close in eight seconds and the inside valve was set for six seconds.
