AEOD ENGINEERING EVALUATION REPORT*

UNIT: E.I. Hatch Units 1 and 2
DOCKET: 50-321; 50-366
LICENSEE: Georgia Power Company
NSSS/AE: General Electric/SCSI & Bechtel

EE REPORT No. AEOD/E422
DATE: August 27, 1984
EVALUATOR/CONTACT: T. Wolf

SUBJECT: HIGH PRESSURE COOLANT INJECTION SYSTEM PERFORMANCE AT E.I. HATCH
UNITS 1 and 2

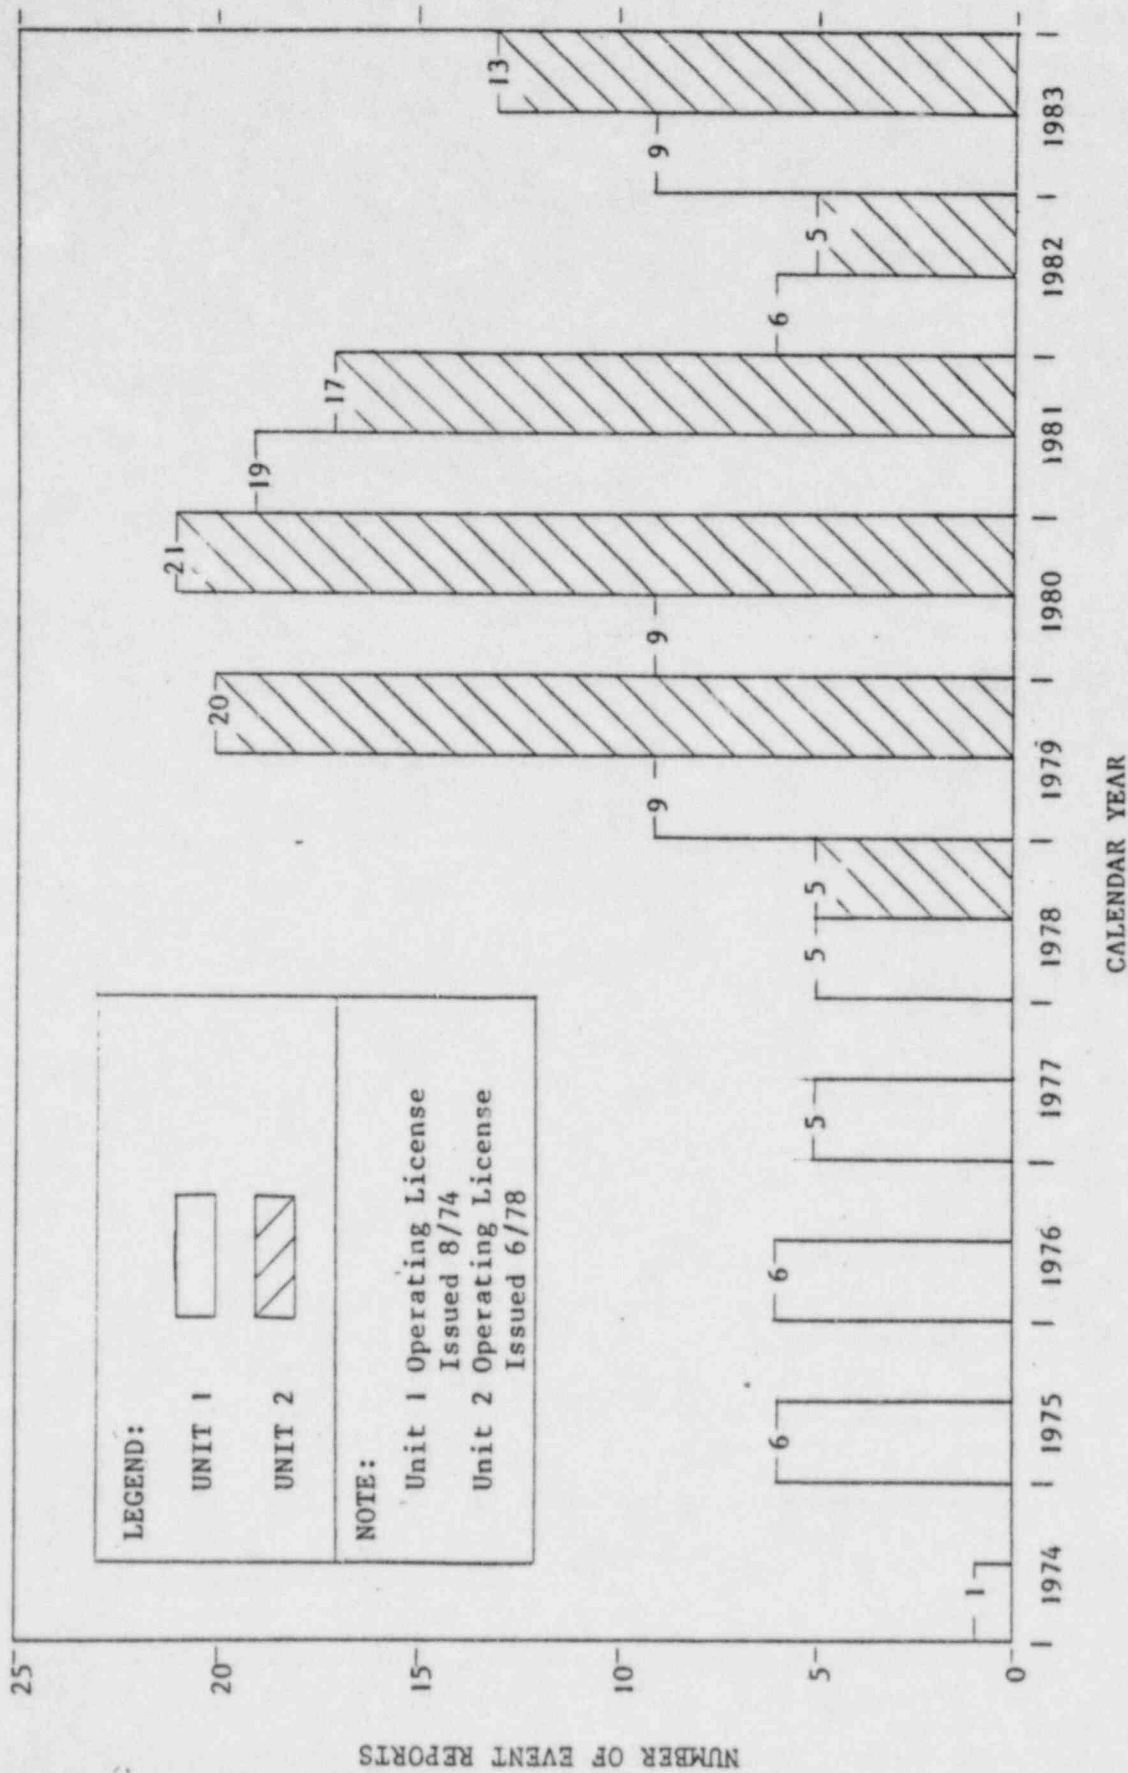
FIGURE 1: E. I. HATCH UNITS 1 & 2 - HPCI SYSTEM FAULT EVENT REPORTS YEARLY DISTRIBUTION

While the Unit 1 event reports covered about twice the Unit 2 time span, the overall number of event reports indicating HPCI faults was approximately equal (i.e., 75 for Unit 1 and 81 for Unit 2). The yearly distribution of these reports showed several characteristics.

The number of HPCI event reports for Unit 1 rose sharply during the first three years of full operation of Unit 2, averaging two to four times the number of reports issued prior to the start of Unit 2. In 1982, the number of

reports for Unit 1 returned to the average number issued prior to Unit 2 operations but in 1983, the number rose again to the levels experienced in the first two years of Unit 2 operation. For Unit 2, the number of HPCI event reports was approximately four times the number issued for Unit 1 during similar four year startup operational periods. The number of event reports decreased markedly at Unit 2 in 1982 but then almost tripled in 1983 from the 1982 level. The 1983 event report level, however, shows a decrease from the previous worst years. Figure 1 illustrates the yearly distribution of these event reports for both units.

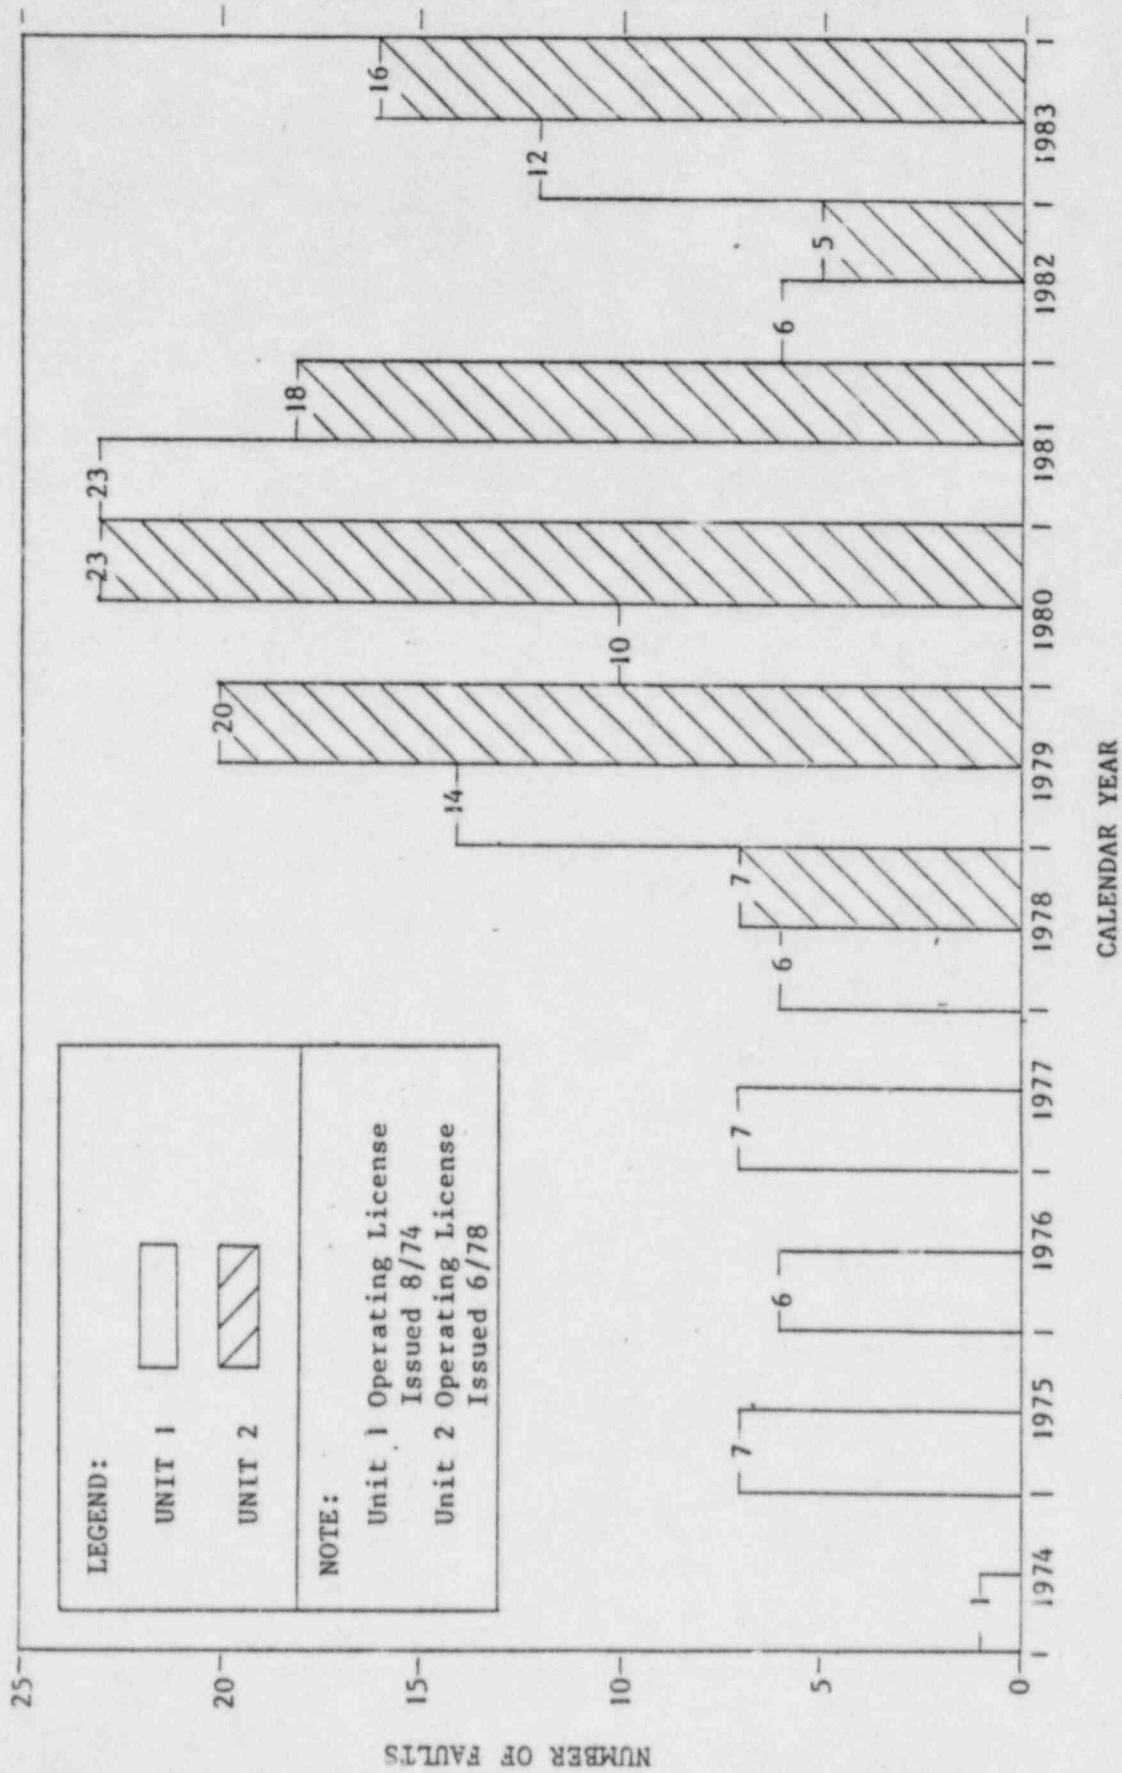
FIGURE 2: E. I. HATCH UNITS 1 & 2 - HPCI SYSTEM FAULT EVENTS YEARLY DISTRIBUTION

Like the number of event reports, the total number of faults recorded in these reports was similar (i.e., 92 for Unit 1 and 89 for Unit 2). The distribution of these faults also corresponded closely to the event report distribution. In general, the faults reported at each unit occurred in the same categories of (1) pressure instrumentation, (2) human factors, (3) valves, and (4) HPCI turbine trip and throttle system. Likewise, these basic fault categories were made up of very similar items. For example, the pressure instrumentation fault category consisted of faults attributable to instruments manufactured by the same companies. On a unit basis, the Unit 1 HPCI event reports were dominated by pressure instrumentation and human factor faults whereas Unit 2 reports were dominated by pressure instrumentation faults, with Unit 2 reporting one-third more pressure instrumentation faults than Unit 1. Additionally, the pressure instrumentation faults were primarily due to problems associated with instruments manufactured by either Barksdale or Barton, with the number of faults for the instruments manufactured by these two companies approximately equal within each unit. For both units, Table 2 lists the fault categories and associated items while the yearly fault distributions are given in Figure 2. Included in the table is a miscellaneous category with associated items which combines the few faults that did not fall into any of the other categories. Additionally, the table contains a listing of the number of reports and the number of faults recorded for each category and individual item. Note that the total number of reports listed (i.e., 81 for Unit 1 and 87 for Unit 2) exceeds the actual number of reports reviewed (i.e., 75 for Unit 1 and 81 for Unit 2) since some reports contained multiple faults such as a human factor fault and a valve fault.

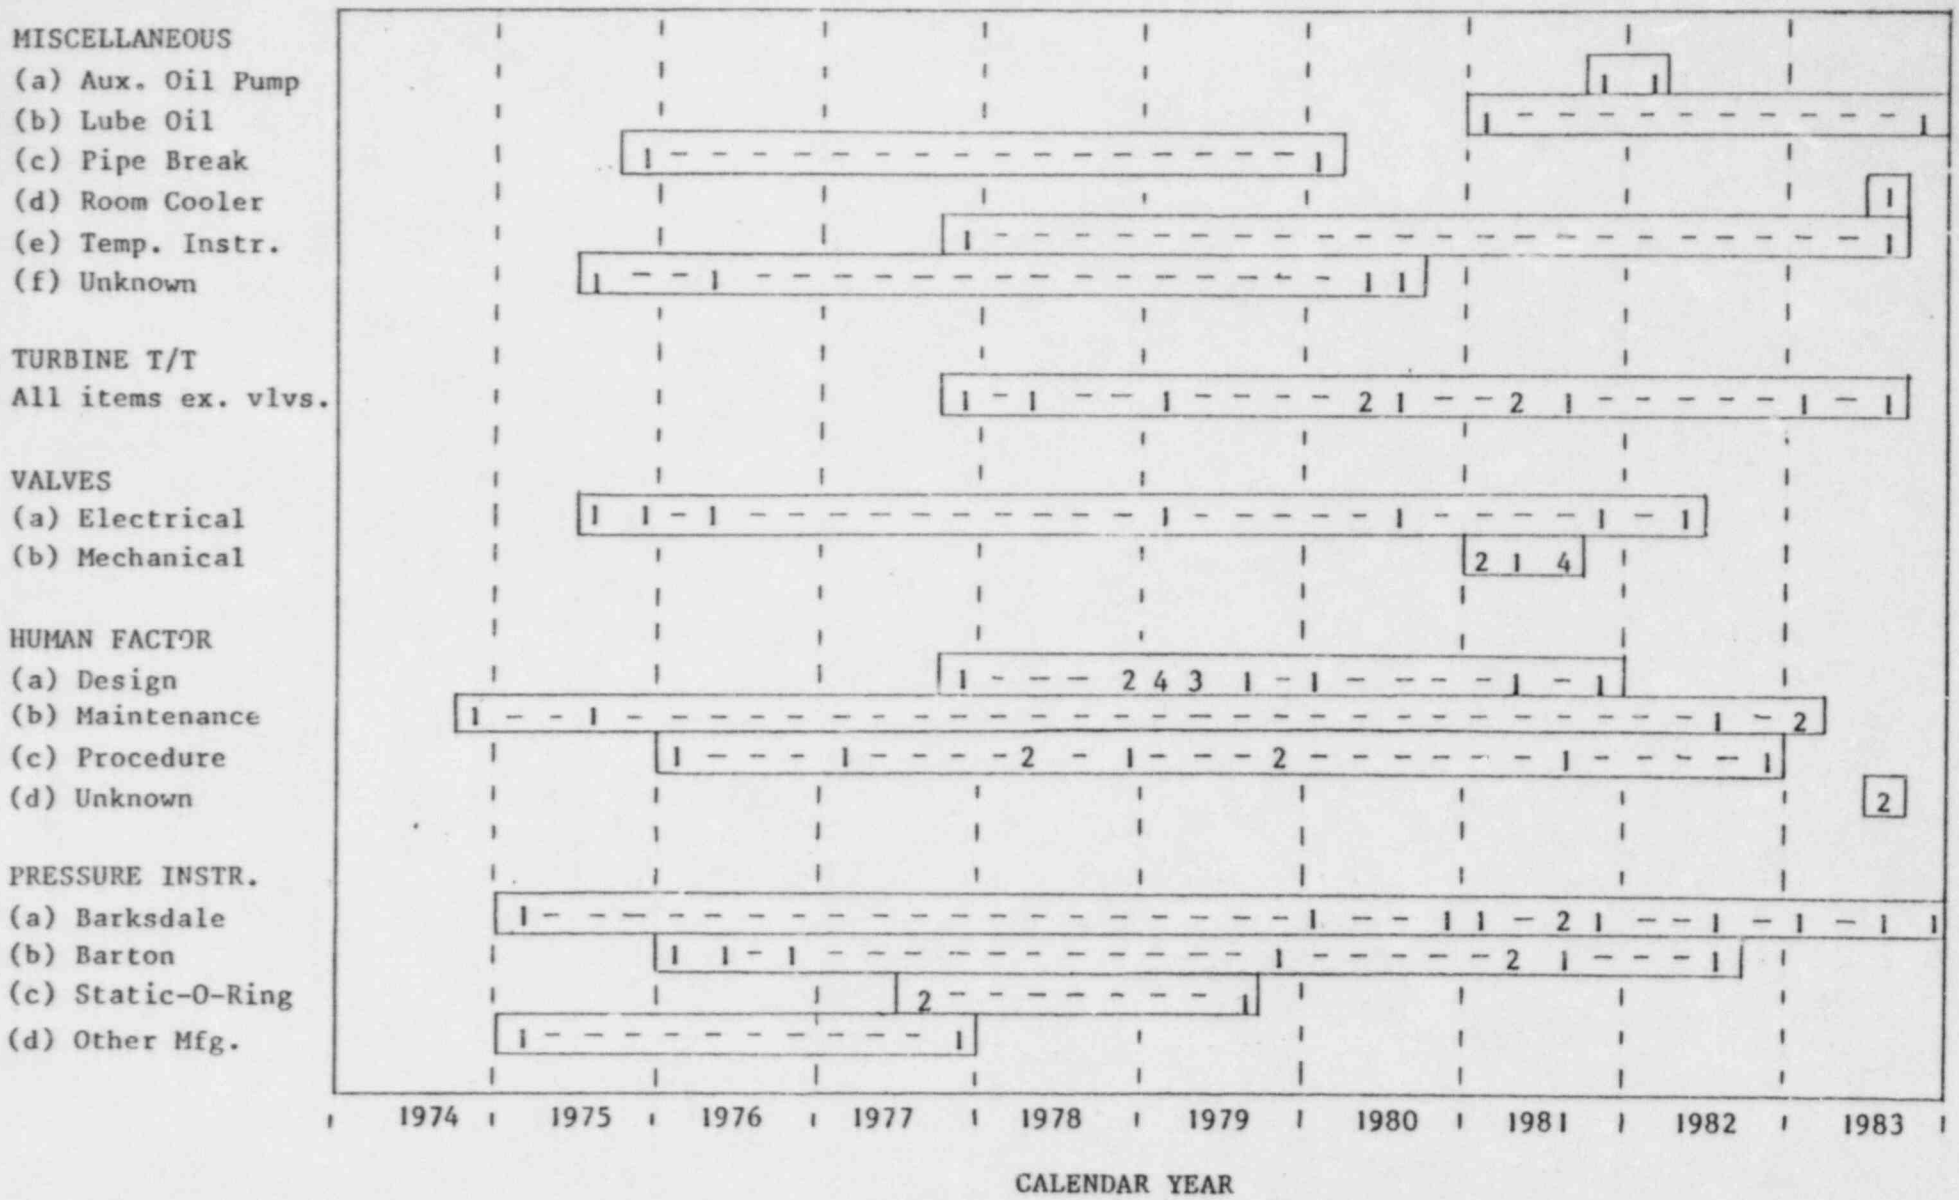
FIGURE 5: E. I. HATCH UNIT 1 - HPCI SYSTEM FAULT CATEGORY ITEMS CALENDAR QUARTER DISTRIBUTION

On a more detailed basis, pressure instrumentation faults in Unit 1 were uniform on a yearly basis except for a noticeable rise in 1981; however no distinctive quarterly pattern existed for these faults. At Unit 2, the yearly pressure instrumentation fault level was fairly constant for 1979 through 1981 with a dramatic decrease in 1982 and 1983. The majority of these faults occurred in the last three quarters of each year. Except for a sharp increase in 1978 and 1979, the human factor category faults were level at Unit 1 with design and procedure faults accounting for most of the faults. The 1978 and 1979 rise in human factor faults was dominated by design faults, primarily in the last quarter of 1978 and the first two quarters of 1979. Unit 2 showed no particular human factor fault area domination or uneven time distribution. The majority of the valve faults in Unit 1 occurred in 1981, with the overall Unit 1 valve faults being attributable to an equal number of electrical problems and mechanical problems. However, the mechanical problems occurred only in 1981, whereas the electrical problems were fairly evenly distributed throughout the study period. At Unit 2, valve faults were most prevalent in 1979, 1980 and 1983, with these faults attributable to almost twice as many electrical problems as mechanical problems. Additionally, the majority of all Unit 2 valve faults occurred in the last three quarters of 1979, 1980 and 1983. Unit 1 experienced three times the number of turbine trip and throttle system faults as Unit 2. The faults at Unit 1 started after the first two full years of unit operation, with the majority occurring in the second and third quarters of 1980 and 1981. The Unit 2 faults occurred in the third quarter of 1979 and the last two quarters of 1983. Miscellaneous faults for both units were dispersed throughout the operational report period of each unit with no one item dominant. Of the six fault items making up the Unit 1 miscellaneous category and the nine items in Unit 2, only problems concerning the auxiliary oil pump at each unit were common to both units. To illustrate these points, Table 2 lists the fault counts at each unit and Figures 3 through 6 show detailed time distributions. More specifically, Figures 3 and 4 illustrate the total yearly fault counts for Units 1 and 2, respectively. Included in these two figures are indications of the contributions to each yearly count by the fault categories. Figures 5 and 6 (for Units 1 and 2, respectively) show the quarterly distribution of the individual fault items which make up each fault category. Highlighted in these two figures are the enveloping fault

occurrence time spans for each fault item. Noted within each occurrence span are the number of faults recorded in each calendar quarter for each fault item.

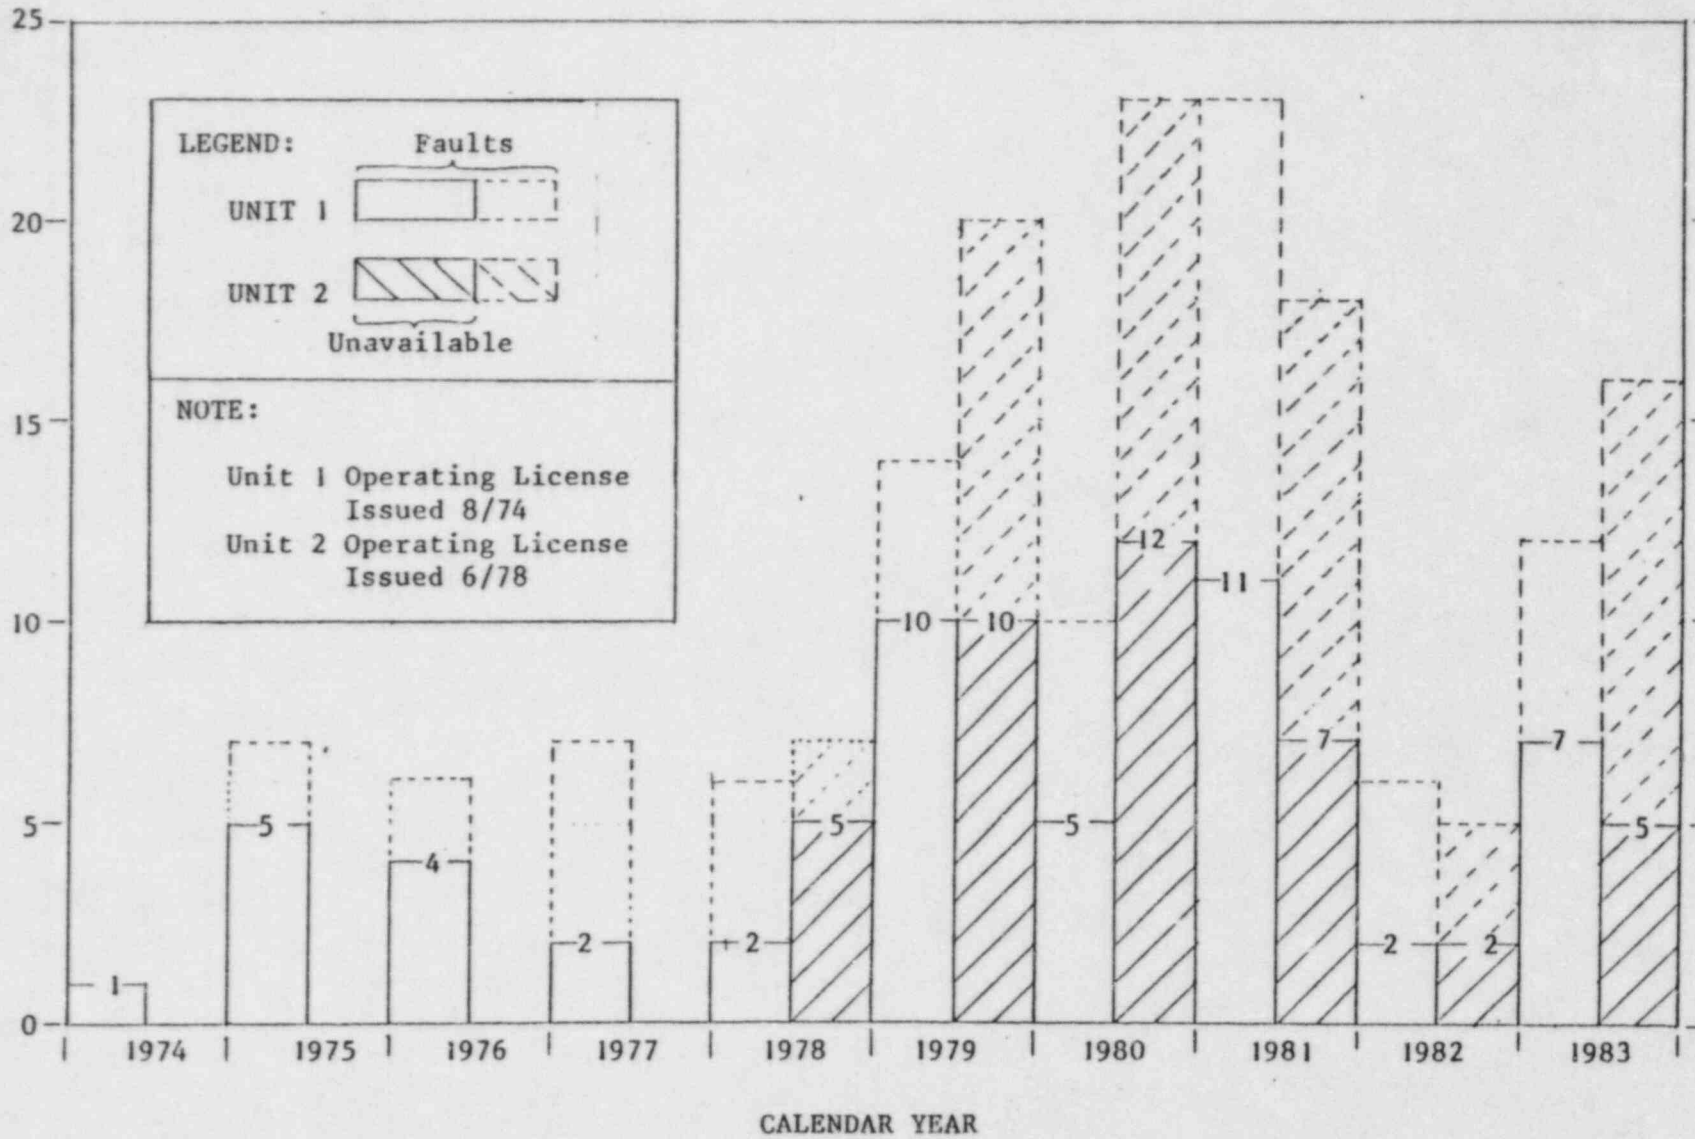
FIGURE 7: E. I. HATCH UNITS 1 & 2 - HPCI SYSTEM YEARLY SYSTEM UNAVAILABILITY DISTRIBUTION WITH ASSOCIATED FAULT DISTRIBUTION

With regard to the effect which each fault category and item had on the capability of the HPCI system to perform its safety function, several characteristics were displayed. Overall, approximately 50 percent of the HPCI system faults reported for either unit resulted in the systems being unavailable, with no particular unavailability fault time-dependent pattern evident in either unit. Of the fault categories, the problems in the pressure instrumentation had a minor effect on the overall functional availability of the HPCI system in either unit. Slightly over half of the human factor faults caused the HPCI system to be unavailable. The valve faults as well as the trip and throttle system faults almost always caused the safety function capability of the HPCI system to be lost. Likewise, the items making up the miscellaneous fault category at each unit normally caused the loss of the functional capability of the HPCI system. On a unit basis, the main contributors to the unavailability of the Unit 1 HPCI system were: (1) faults in pressure instrumentation manufactured by Barton; (2) human faults associated with design and maintenance activities; (3) electrical and mechanical problems in valves; (4) turbine trip and throttle system faults; and (5) all miscellaneous faults. For Unit 2, the primary unavailability contributors were: (1) faults in Barksdale pressure instrumentation; (2) human faults in maintenance and operations activities; (3) electrical and mechanical faults in valves; (4) turbine trip and throttle system faults; and (5) miscellaneous faults associated with pumps such as the auxiliary oil pump. Tables 2 and 3 and Figures 7 through 11 illustrate how the faults affected the HPCI system availability at E.I. Hatch. In particular, Figure 7 compliments Figure 2 and shows the calendar year HPCI system unavailability distribution for both units. Included in this figure for reference is the associated overall fault distribution as shown in Figure 2. Figures 8 and 9 (for Units 1 and 2, respectively) illustrate how each fault category item affected the overall availability of the HPCI system. Also shown are the number of times each item led to the HPCI system being either unavailable, available, or judged by the reviewer to probably be available to perform the system safety function. Figures 10 and 11 (which mimic Figures 5 and 6,
