**POWER
SYSTEMS**
COMBUSTION ENGINEERING, INC

DESTRUCTIVE EXAMINATION
OF TUBE L29R84 FROM THE
B STEAM GENERATOR AT
FORT CALHOUN

JUNE 1984

SUMMARY

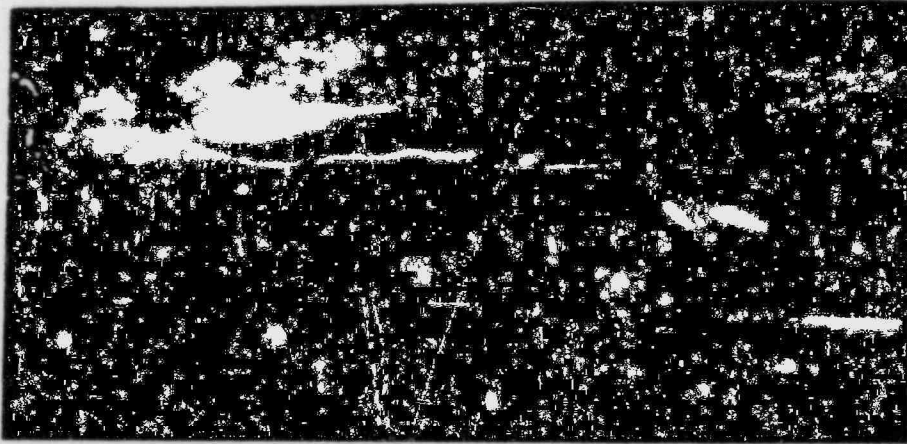
A major crack, approximately 1-1/4 inch long, was present at the six o'clock position of section 23B between the two scallop bar locations. Other areas of smaller cracks were present at either end of the major cracks. In one of these areas (Figure 2d), the cracks were oriented at an angle of 45° relative to the axis of the tube. Deposits at the scallop bar locations, which made location of the scallop bar positions possible, are shown in Figure 2d. Deposits, especially in areas near the major crack, were very thin and generally were orange to brown in color. At the scallop bar locations, there were some white deposits also present in addition to the orange-brown deposits.

(a) Overall View of the Major Crack
(Neg. #68014, 2X)

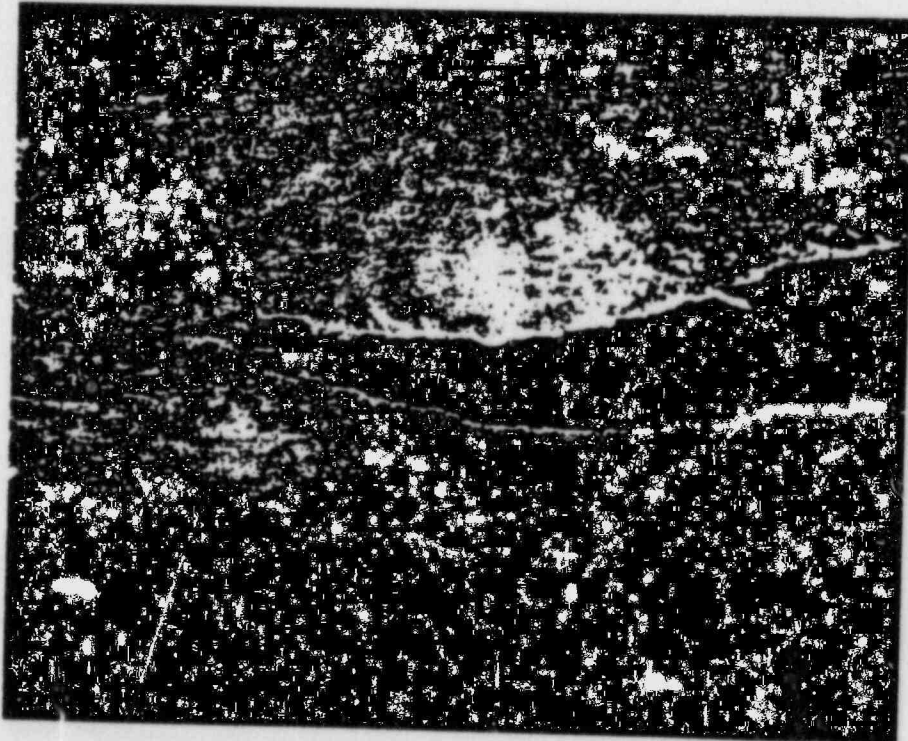
(b) Close-up View of One End of the Major Crack
(Neg. #68015, 8X)

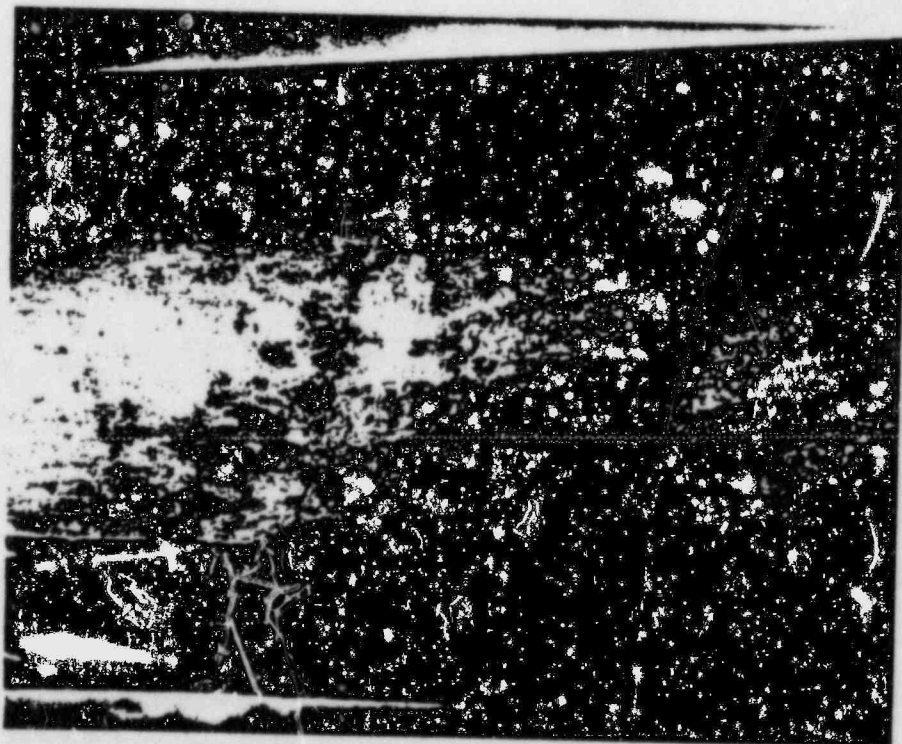
Approximately 1/4 inch from the hot leg end of the major defect, a second OD initiated indication was present. The location of this signal corresponded to the location of the second area of cracking. A mechanical kink in section 23B, induced during tube removal, distorted the signals from this smaller defect, rendering depth estimates impossible.

(d) Area of Smaller Cracks Oriented 45° to Tube Axis
(Neg. #68011, 5X)

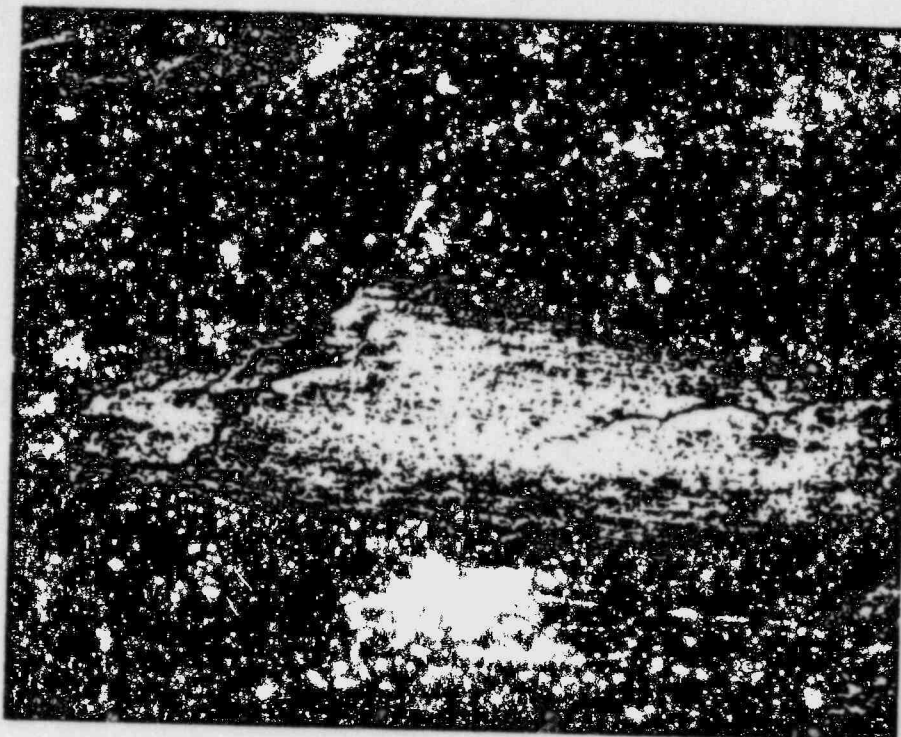
(e) Close-Up View of the Area of Smaller Cracks
(Neg. #68106, 20X)

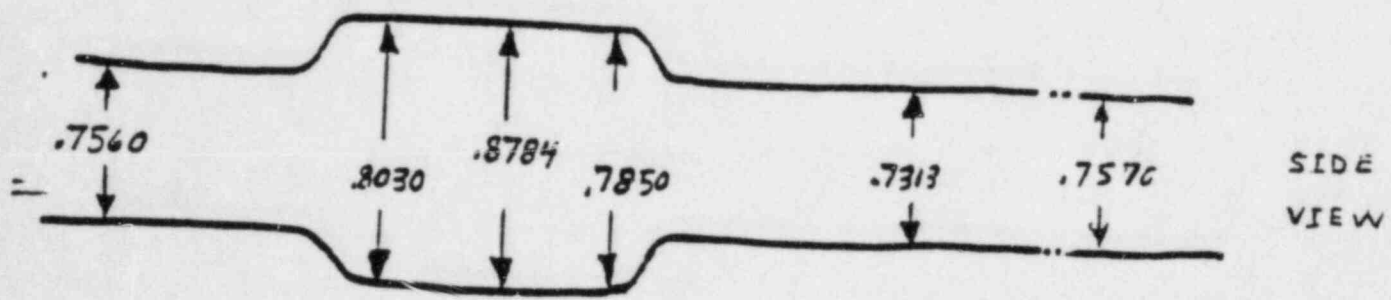
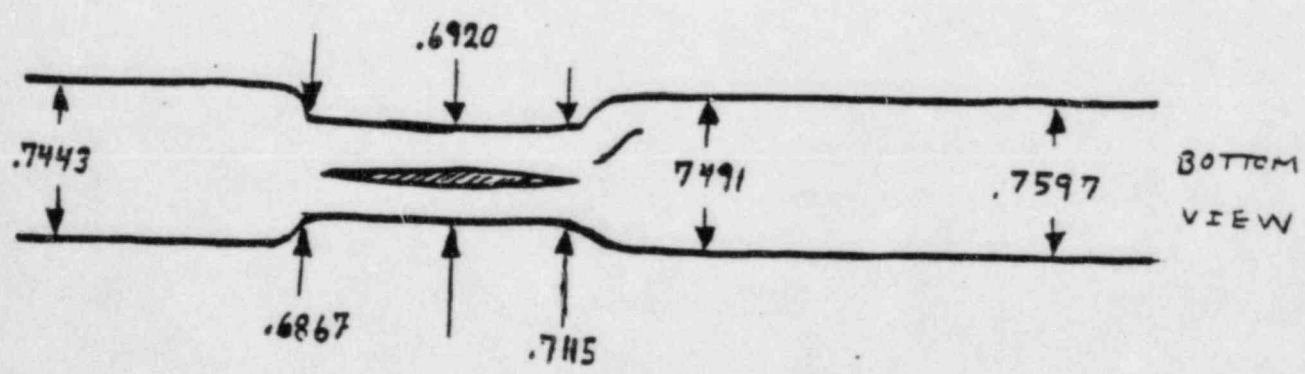
Figure 3. Dimensional Measurements of Section 23B.

Figure 3 gives results of dimensional measurements from the defect region. These measurements were taken before descaling, and as such include the thickness of residual deposits. The data indicate that the tube was ovalized with the major axis (6-12 o'clock) being elongated by 0.046-0.122 inch while the minor axis (3-9 o'clock) was compressed by 0.045-0.070 inch diametrically. Figure 4 illustrates qualitatively the degree of ovalization present in the area of the major defect in section 23B.

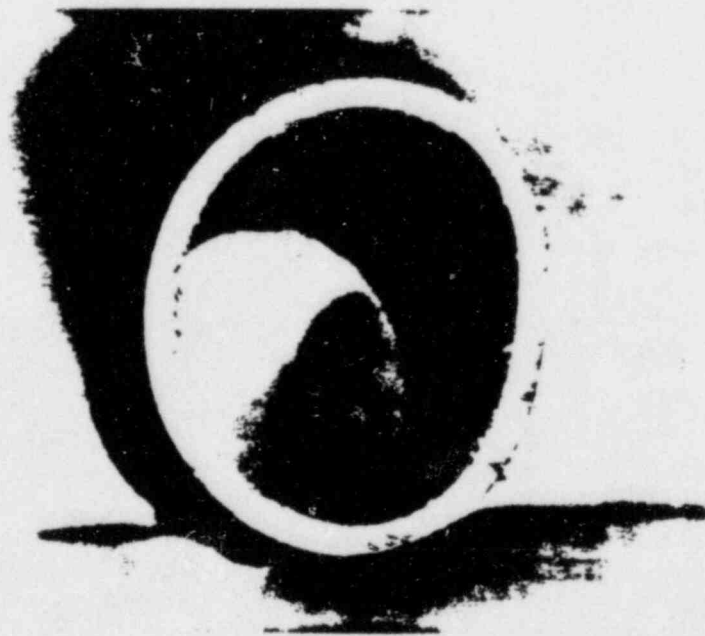
2. The major crack was located on the bottom of the tube between the scallop bars in the first (hot leg) vertical support strap.
3. The tube had been ovalized as a result of corrosion product build-up in the tube-to-support crevice.

Figure 4. Cross-Section View of Tube Section 23B Near the Major Crack
Showing Extent of Service Induced Ovalization.
(Neg. #68026, 3X)

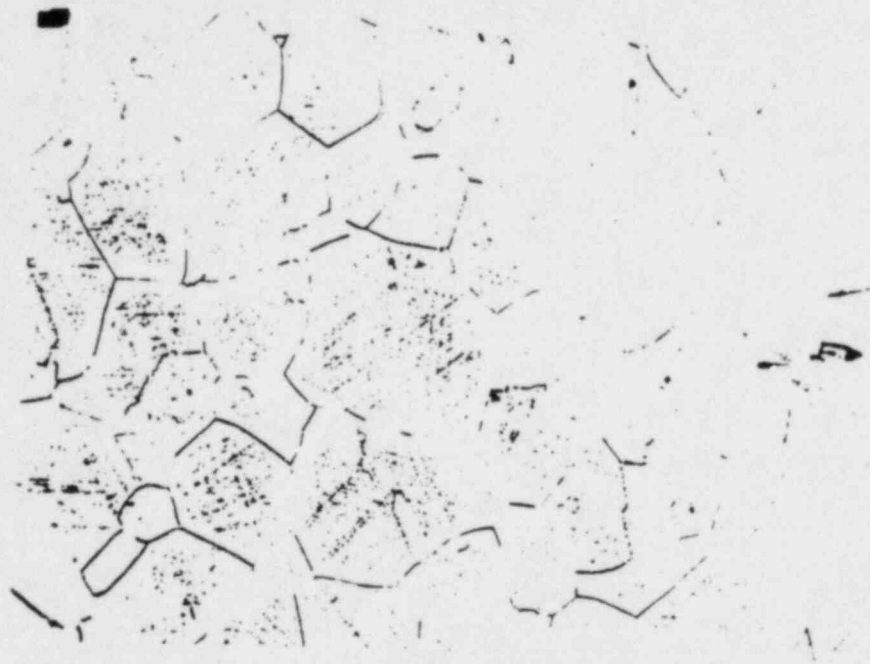
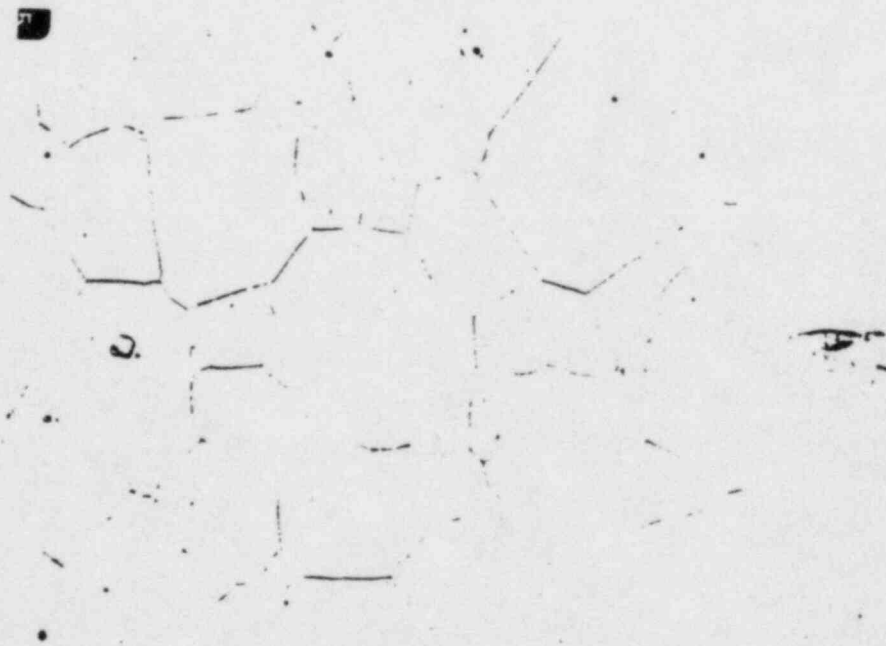
Figure 6. Microstructures of Tube L29R84 (Transverse View, Neg. #68020, 68021, 500X).

Figure 6 shows typical photomicrographs of the microstructure of tube L29R84 after the nital etch and the orthophosphoric etch. The microstructure of tube L29R84 consisted of medium size grains with some grain boundary carbides and very few intragranular carbides. The microstructure of tube L29R84 was nominal and a typical example of mill annealed Alloy 600 tubing.

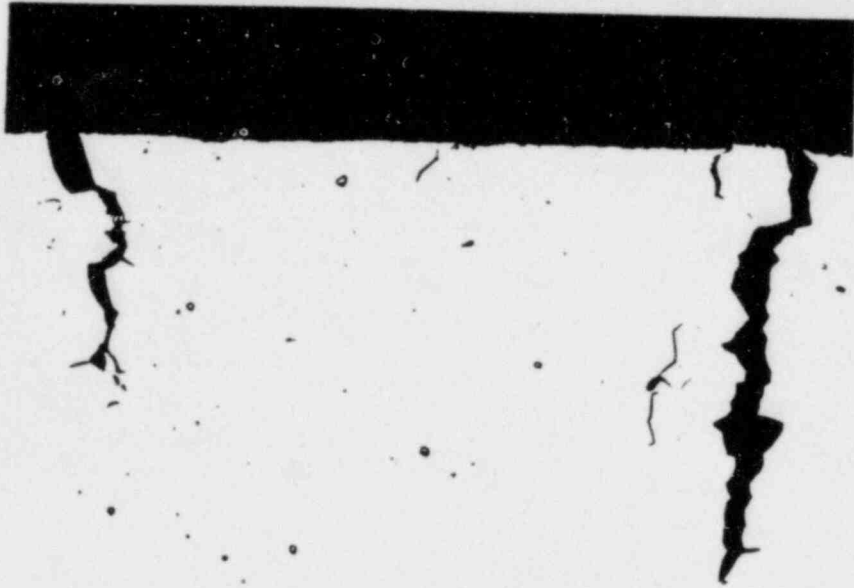
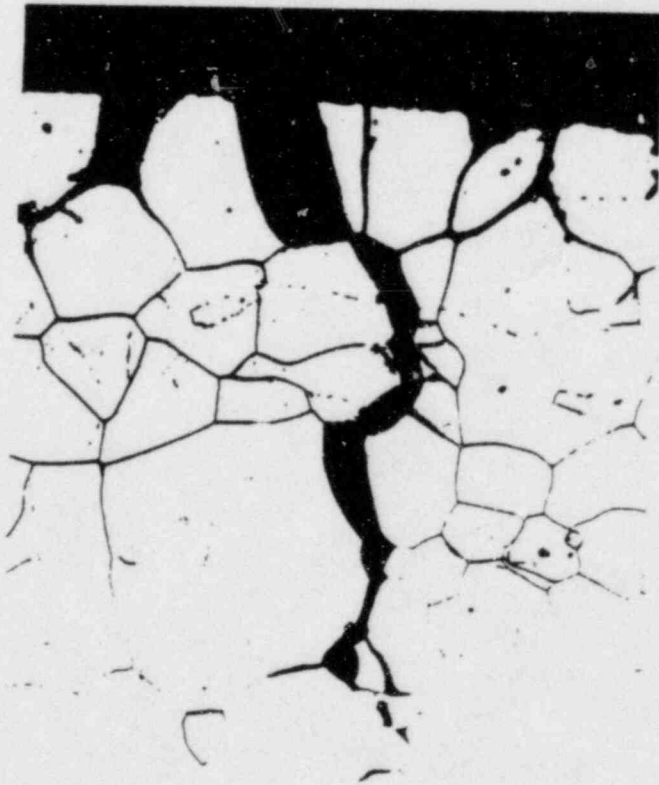
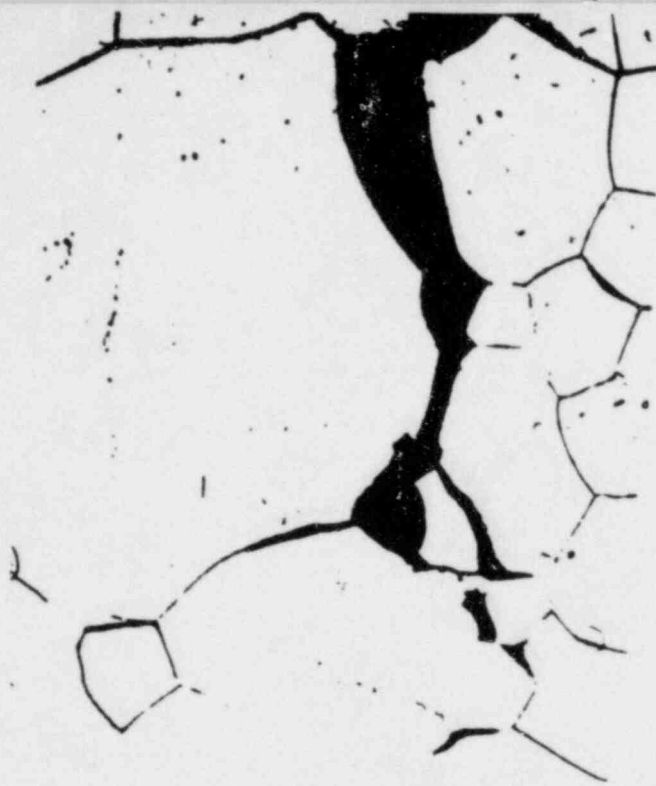
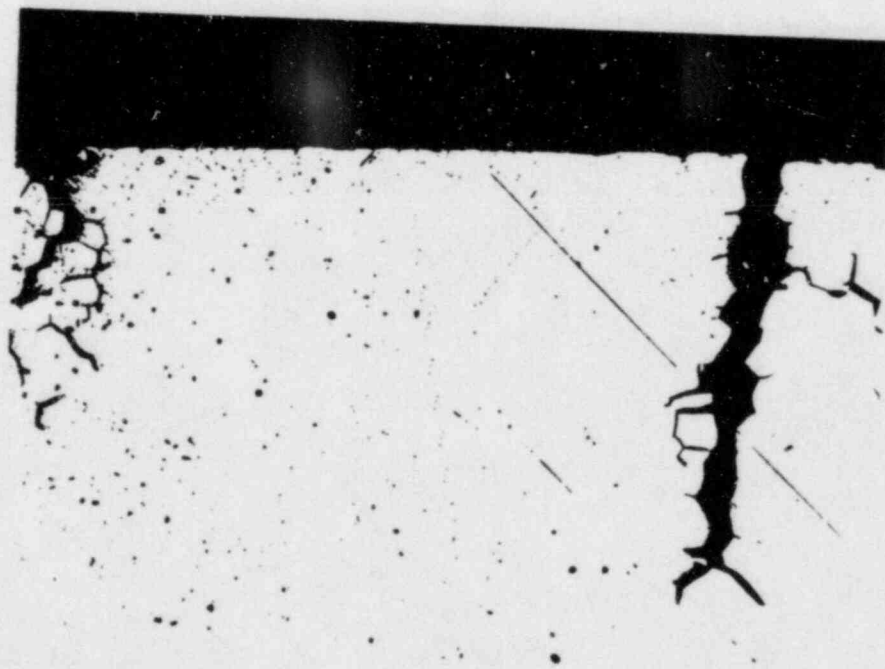
Figure 7. Transverse View of Cracks at the End of the Major Crack,
Mount 17B.

One end of the large throughwall crack was mounted, polished and examined to determine crack morphology. Figure 7 includes typical photomicrographs of cracks at the end of the major fracture. The intergranular nature of the cracks is evident in these photomicrographs. In the as-polished sections, there were no indications of intergranular attack (IGA) on the tube surface between the stress corrosion cracks. This was subsequently confirmed by etching the specimen with glyceregia, or an etchant which is particularly sensitive to IGA in nickel base alloys. Discrete intergranular stress corrosion cracks were present.

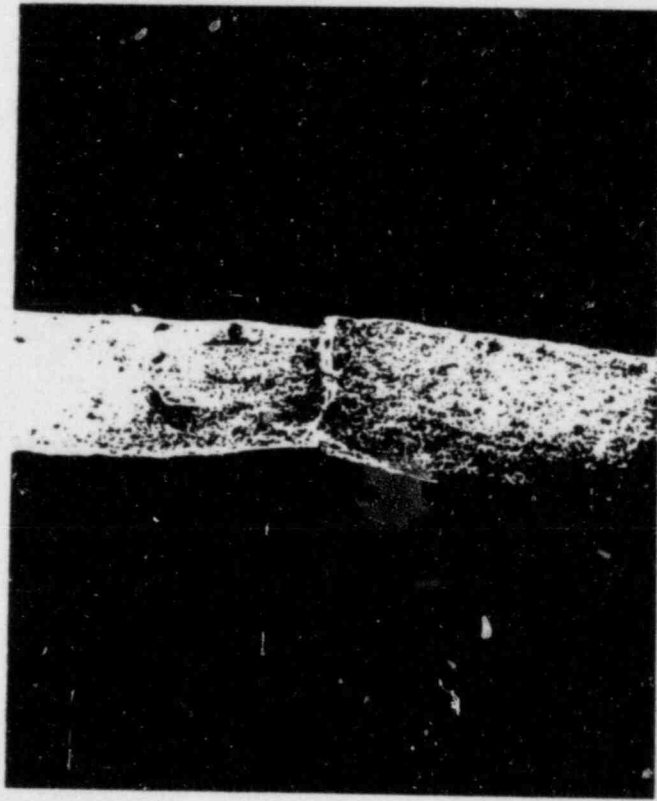
Figure 9 is a low power scanning electron micrograph showing a relatively flat crack surface with a central ductile tear ridge running from the O.D. to the I.D. surface of the tube. There were also other areas of ductile failure along the I.D. of the tube.

Figure 9. Low Power Scanning Electron Micrograph of the Fracture Surface.
(Neg. #68039, 10X)

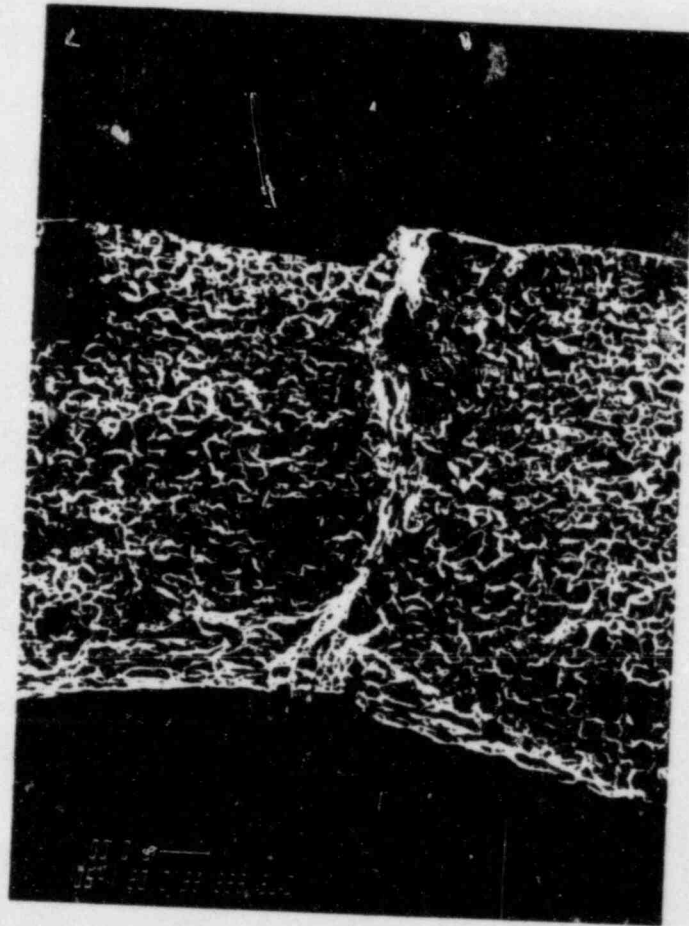
Figures 12-14 show that, although IGSCC covered most of the crack surface, there were small areas of ductile failure, as expected. Figure 12 shows a tear ridge extending from the O.D. to the I.D. surface. Figure 13 is a higher magnification scanning electron micrograph more clearly showing the transition from IGSCC to ductile failure near the I.D. surface.

Figure 12. Scanning Electron Micrograph Showing a Ductile Tear Ridge
Extending from O.D. to I.D. Surface.
(Neg. #68034, 60X)

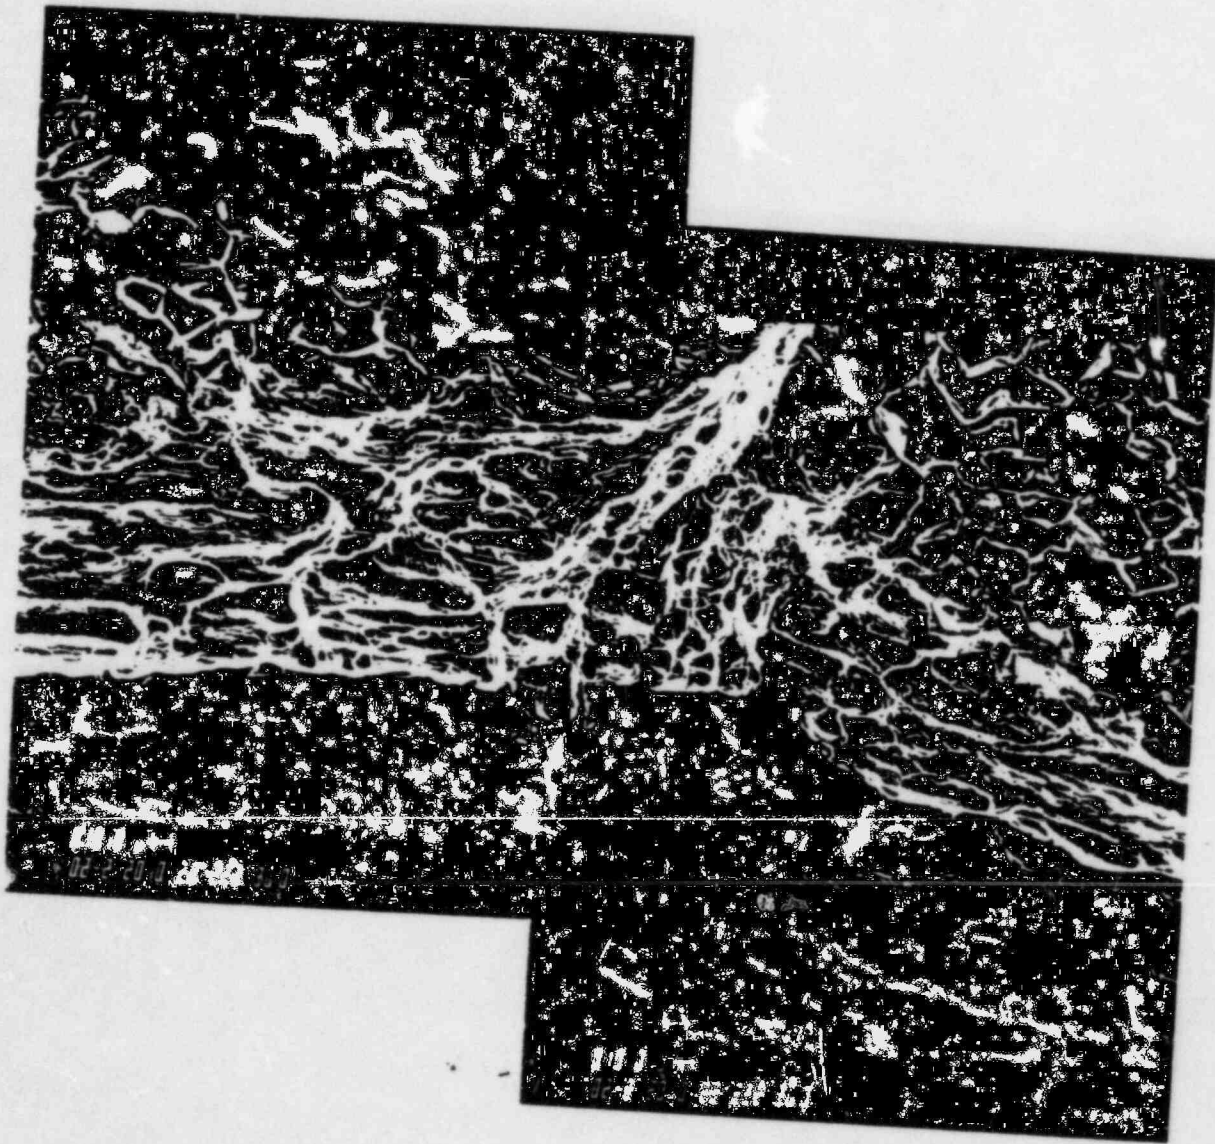
Figure 13. Scanning Electron Micrographs Showing Part of the Ductile Tear Ridge Shown in Figure 12. (Neg. #68033, 200X)

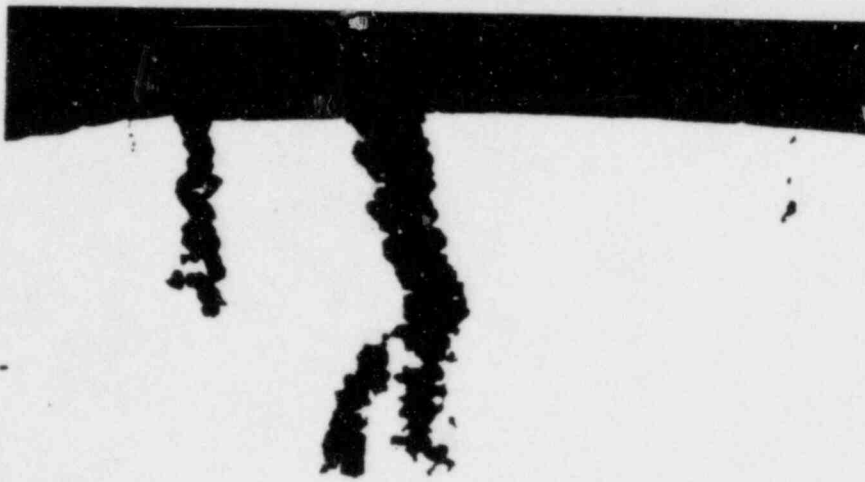
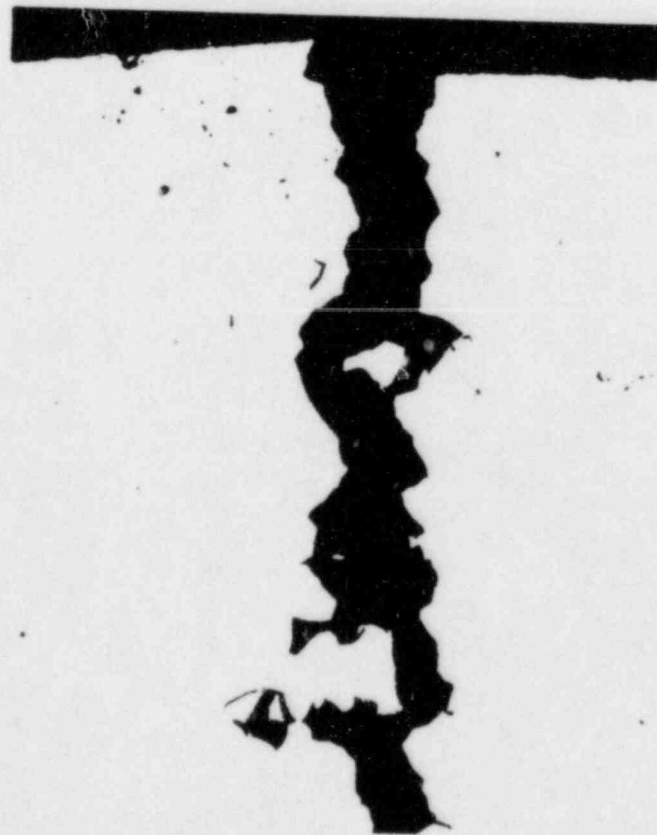
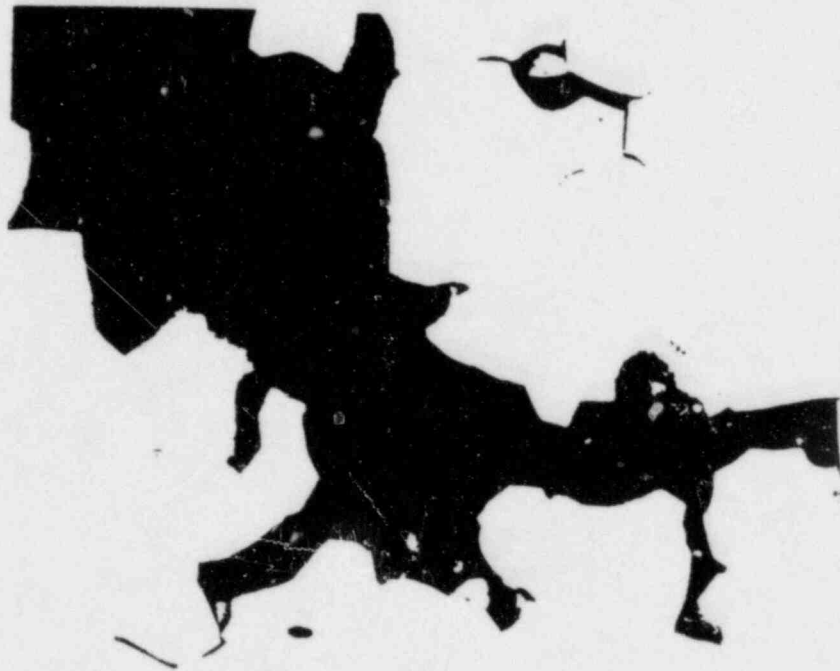
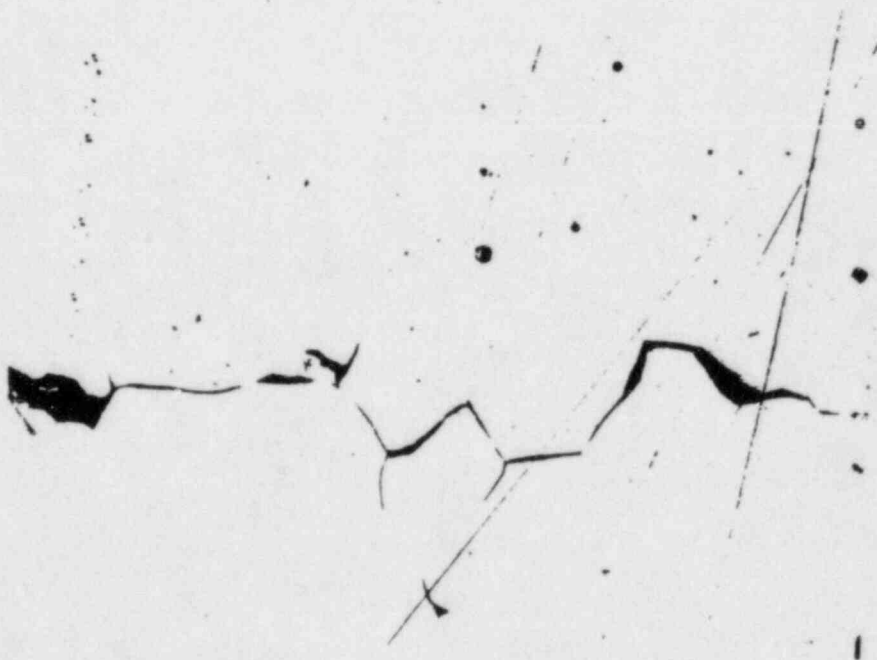
Figure 17. Transverse View of Individual Cracks in the Smaller Area of Cracking.

Typical photomicrographs of cracks in this area are shown in Figure 17. Several discrete cracks, with no indications of IGA were present in this section. The

intergranular nature of the cracks is readily apparent in these photomicrographs. There were no obvious deposits present in most of the cracked area. There was, however, significant amounts of metallographic mounting material present in the larger cracks.

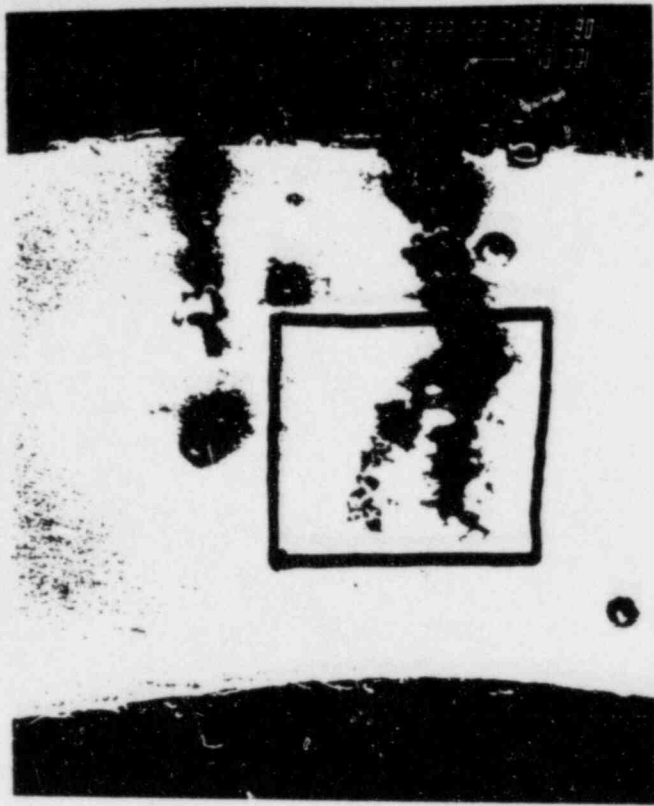
Figure 18. Scanning Electron Micrographs of the Specimen Shown in Figure 18.

Typical scanning electron micrographs and EDS analysis results of crack tip regions are shown in Figures 18-23. Elements identified by EDS analysis included Ni, Cr and Fe from the tube base metal; Si, probably from the grinding operations; and minor indications in one or more locations of Cl, S, Cu, K, Ca, Mg, Al and Ti. X-ray mapping of selected areas showed no major concentrations in the cracks of any of these elements. Thus, the EDS results provided no strong conclusions about possible aggressive species that may have promoted the IGSCC.

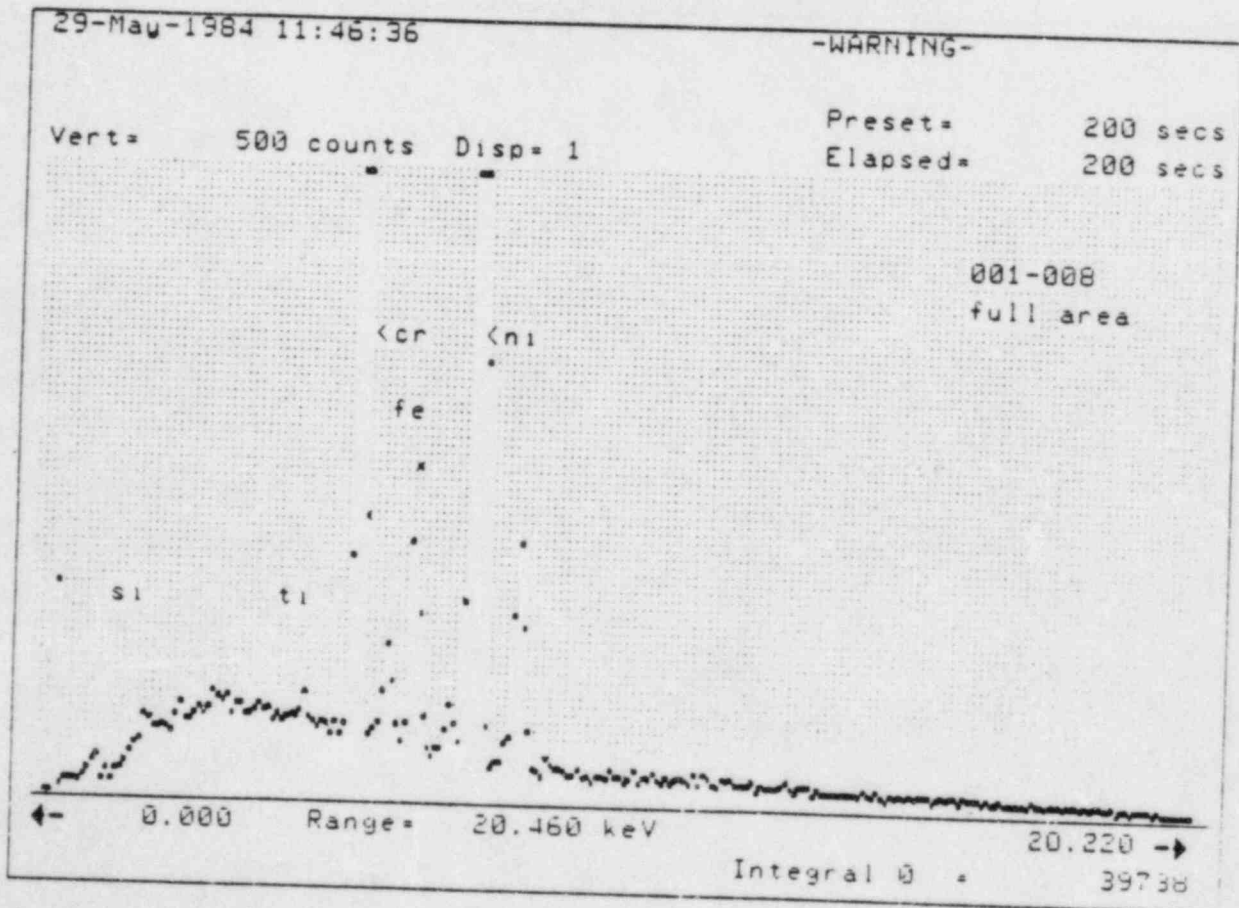
Figure 19. Scanning Electron Micrograph of Crack Tips and EDS Analysis Results from the Area Shown. (Neg. #67771, 260X)

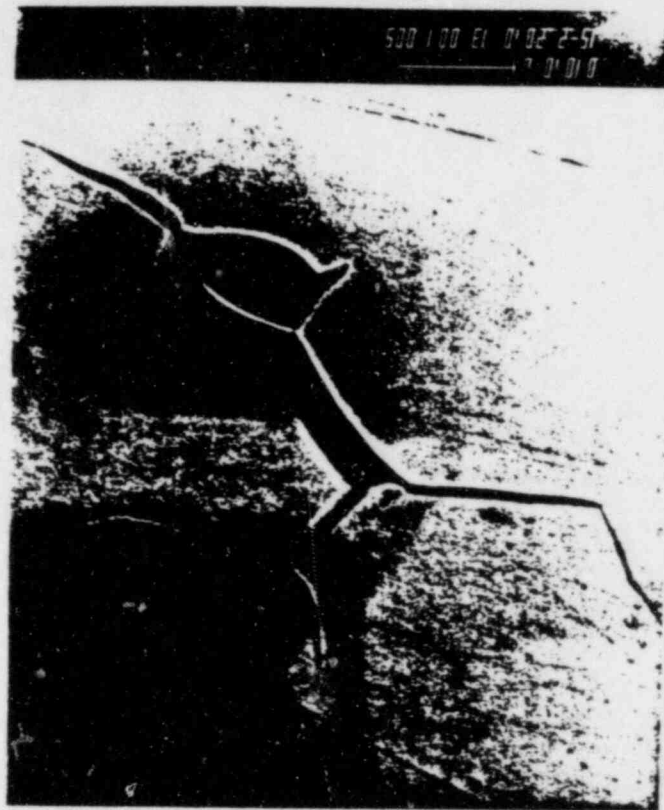
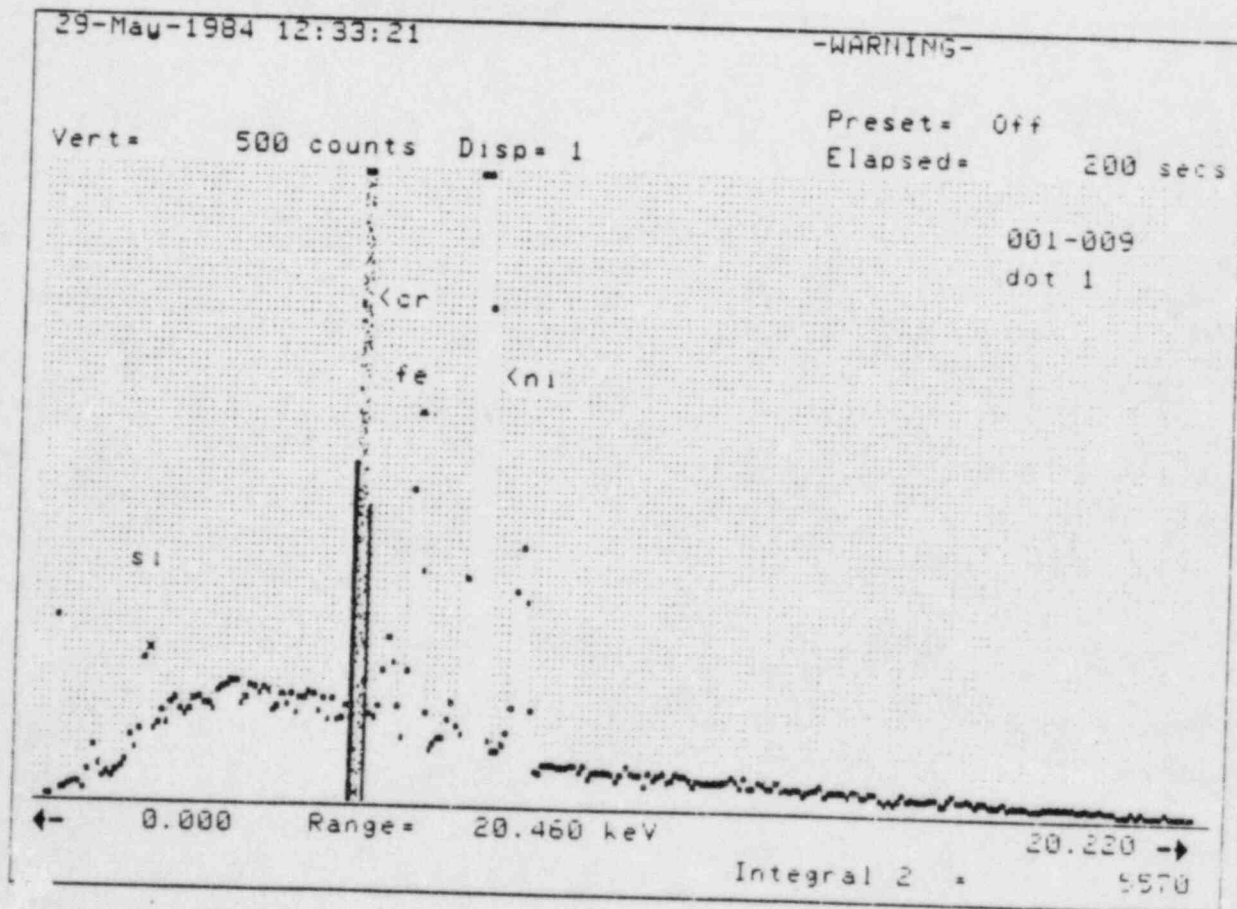
Figure 20. Scanning Electron Micrograph of Crack Tips and EDS Analysis Results from the Area Shown.
(Neg. #67772, 1500X)

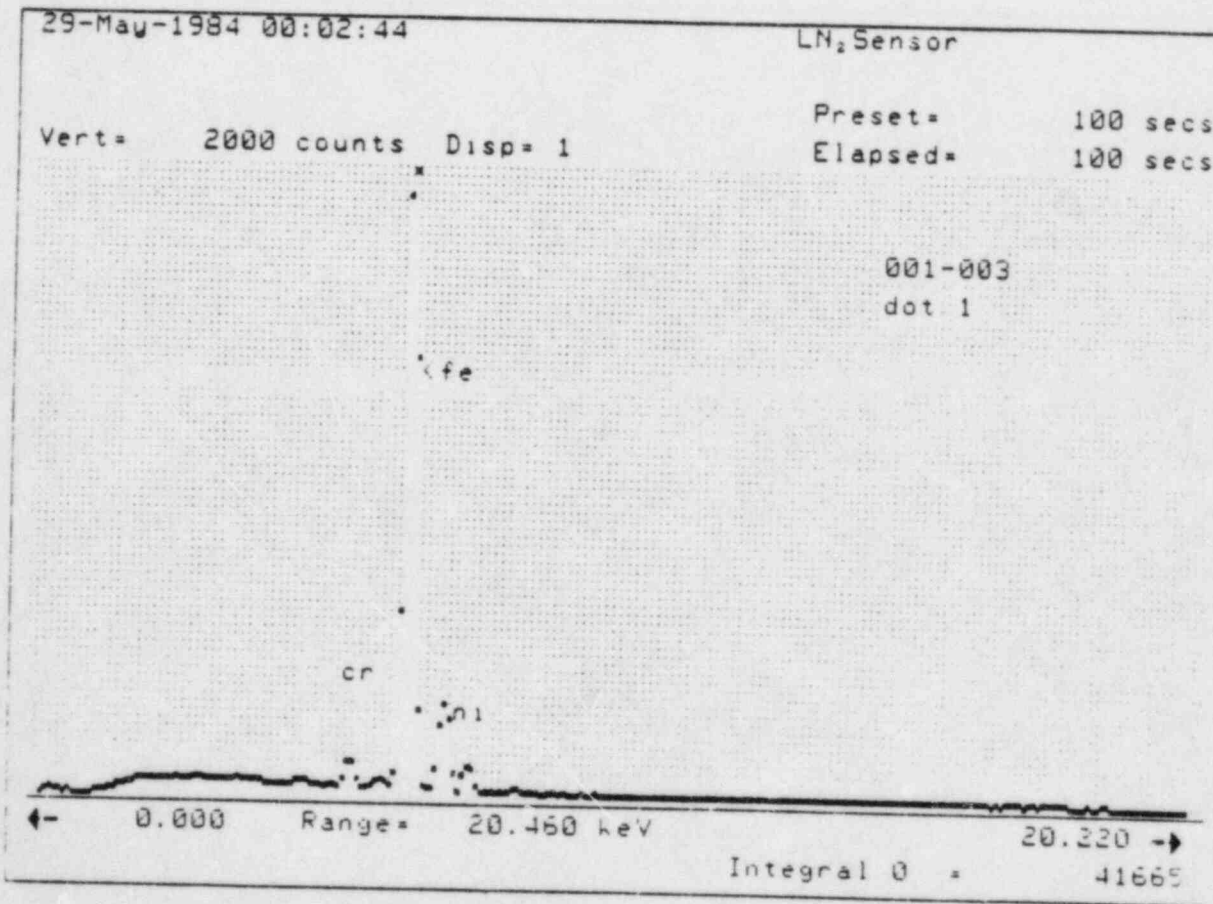
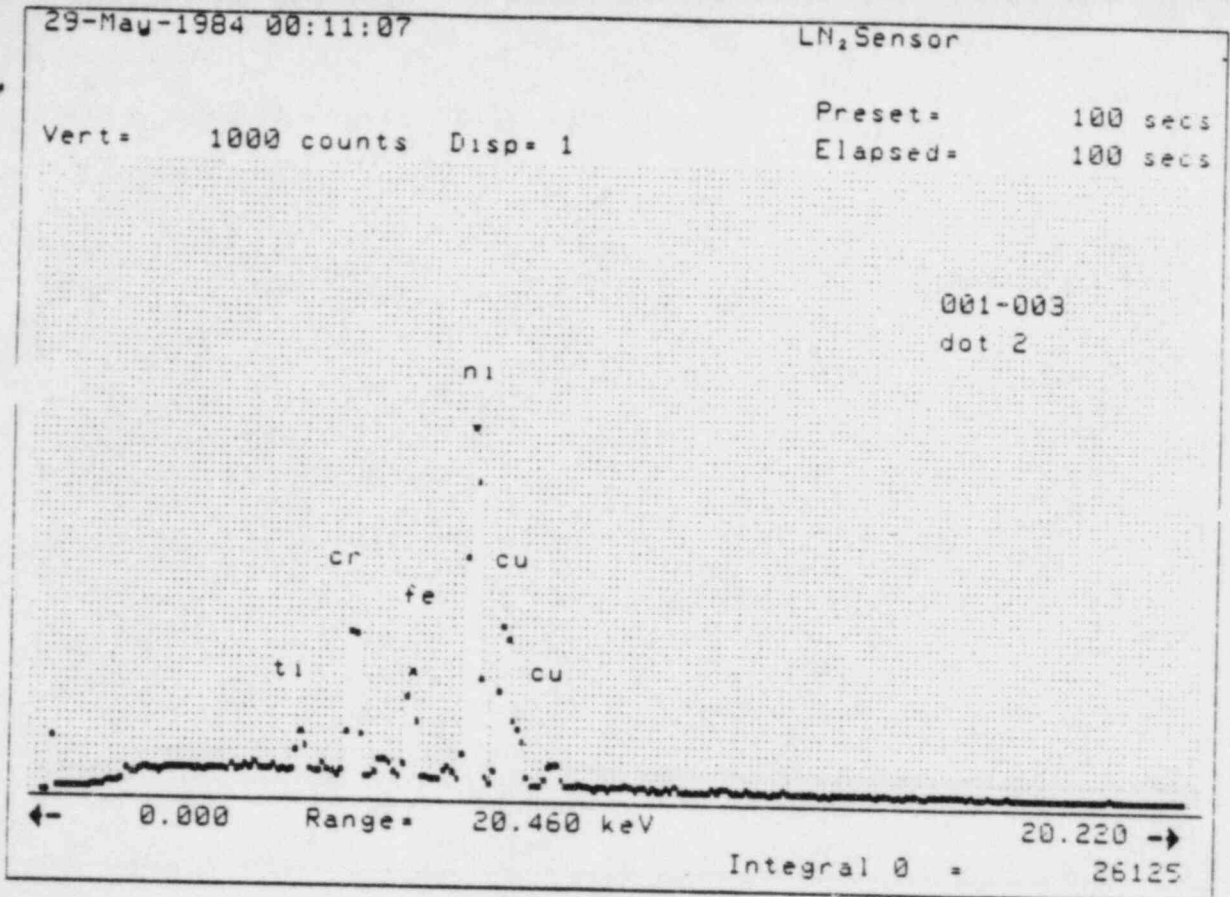
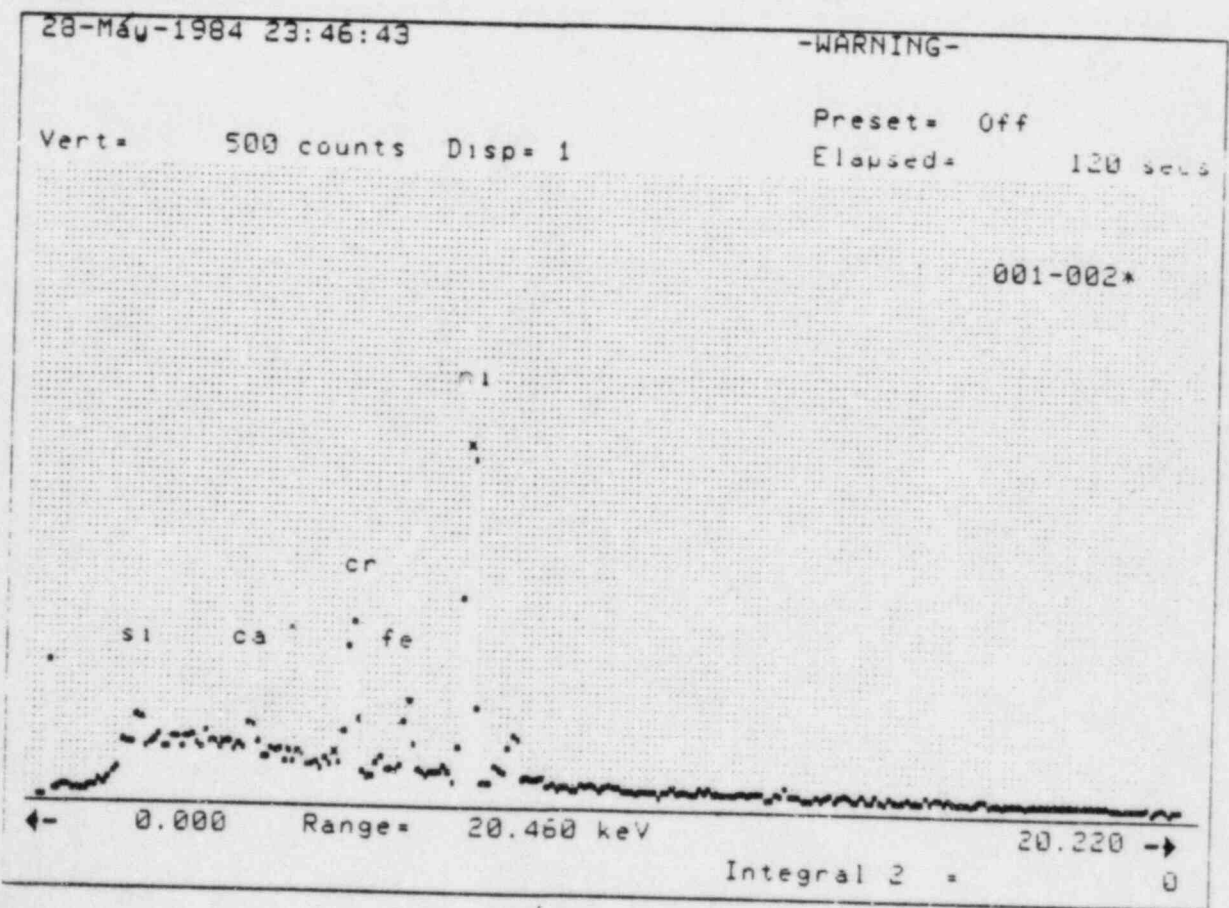
Figure 21. Scanning Electron Micrograph of Crack Tips and EUS Analysis Results from the Area Shown. (Neg. #67769, 1000X)

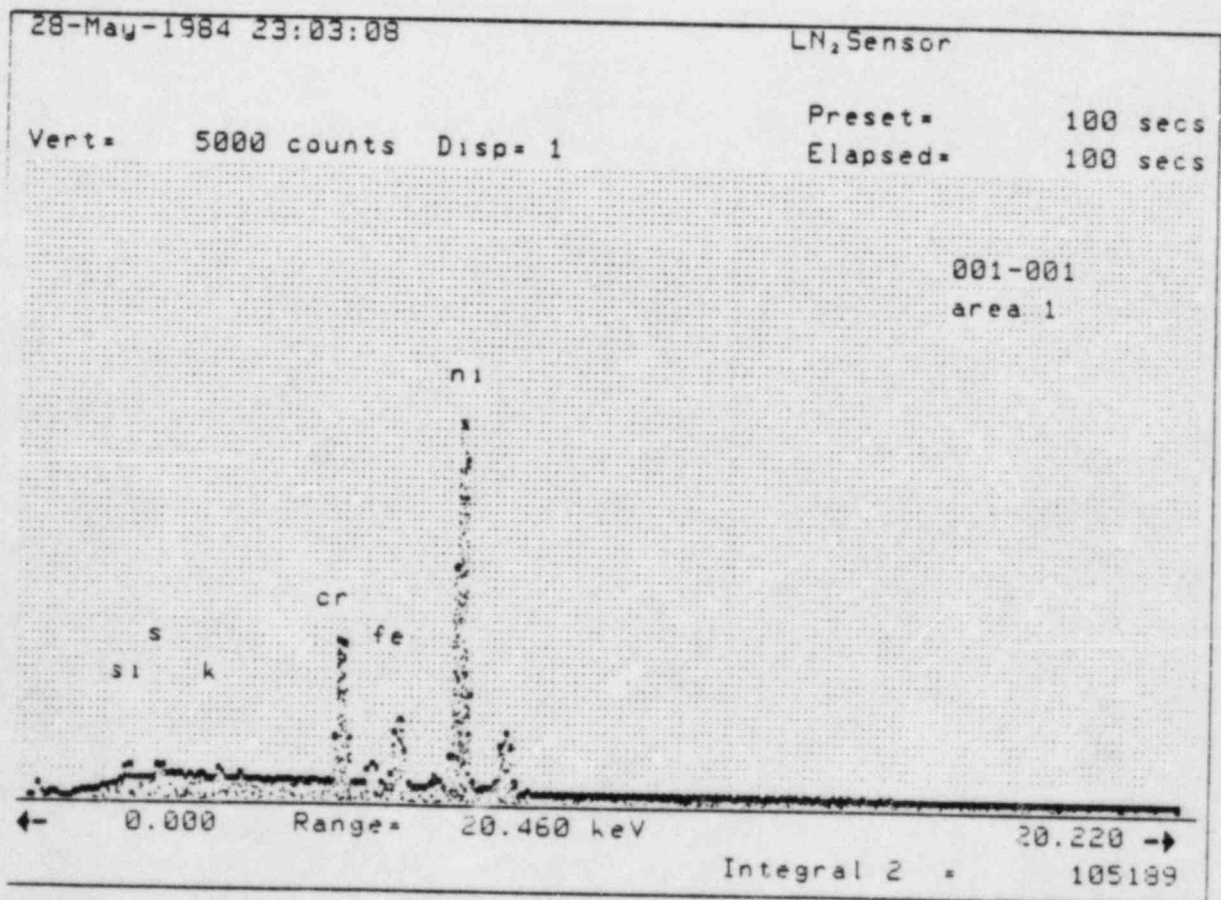
Figure 22. Scanning Electron Micrograph of a Crack Tip and EDS Analysis Results from the Area Shown. (Neg. #67767, 250X)

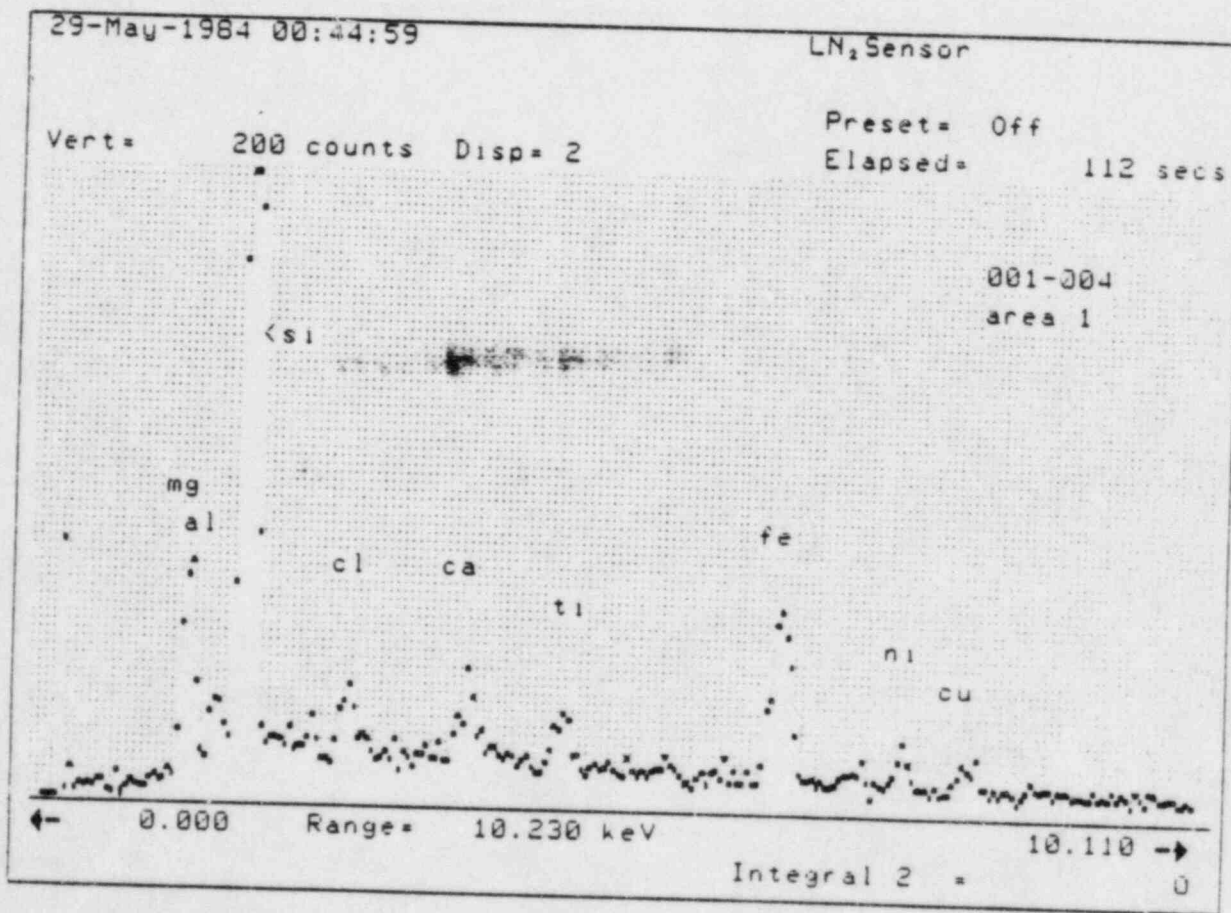
Figure 23. Scanning Electron Micrograph of a Crack Area and EDS Analysis Results of a Si Rich Particle. (Neg. #67770, 1000X)
