UNITED STATES
NUCLEAR REGULATORY COMMISSION
WASHINGTON, D. C. 20555

SAFETY EVALUATION BY THE
OFFICE OF NUCLEAR REACTOR REGULATION RELATED TO
INSPECTION AND REPAIRS OF HATCH UNIT 1
PRIMARY SYSTEM PIPING AND CORE SPRAY SPARGERS

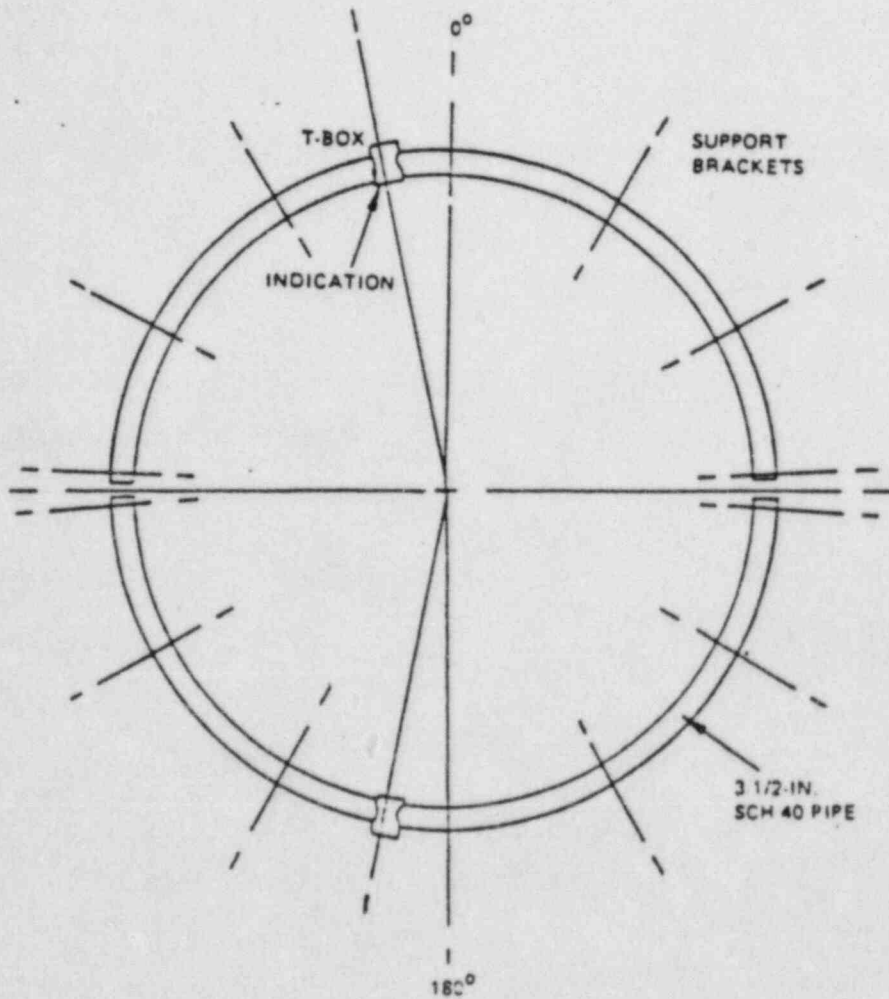
Figure 1-1a. Plan View of Cracked Core Spray Sparger

During this refueling/maintenance outage, the licensee also performed a visual examination of the core spray spargers in accordance with I&E Bulletin 80-13. The results of the visual examination revealed cracking of the lower sparger arm near the 350 degree T-box. The cracks were oriented in the circumferential direction and were located in the heat-affected zone of the sparger to T-box weld, approximately 1/8 inch from the weld. The cracks spanned at least 180 degrees of the pipe circumference with a maximum of 1.010 inch in width (Figure 1).

Evaluation of the cracking in the core spray spargers was performed by General Electric Company (GE) for the licensee and is contained in General Electric report, NEDO-30825, "Core Spray Sparger Crack Analysis for Edwin I Hatch Nuclear Power Station Unit 1." The cracking was suspected to be stress corrosion cracking resulting from cold work and sensitization during fabrication and installation of the spargers. GE's analysis concluded that the structural integrity of the cracked core spray spargers will be maintained for all conditions of operations even though the crack was assumed to be completely around the circumference and through wall. GE's loose parts analysis also concluded that a possible loose part from the cracked core spray spargers will have essentially a zero probability of causing any serious safety consequences. GE also performed LOCA analyses assuming one cracked core spray sparger. The results of the analysis showed that the current reload calculations are still valid because coolant injection to the upper plenum is maintained.

For added safety margin, the licensee elected to install a clamping device (C-clamp) which gripped the sparger with a pair of fingers on each side of the T-box to limit the relative movement of the two sections of the sparger. The clamp assembly was fabricated from type 304L austenitic stainless steel with a maximum carbon content of 0.02 weight percent.

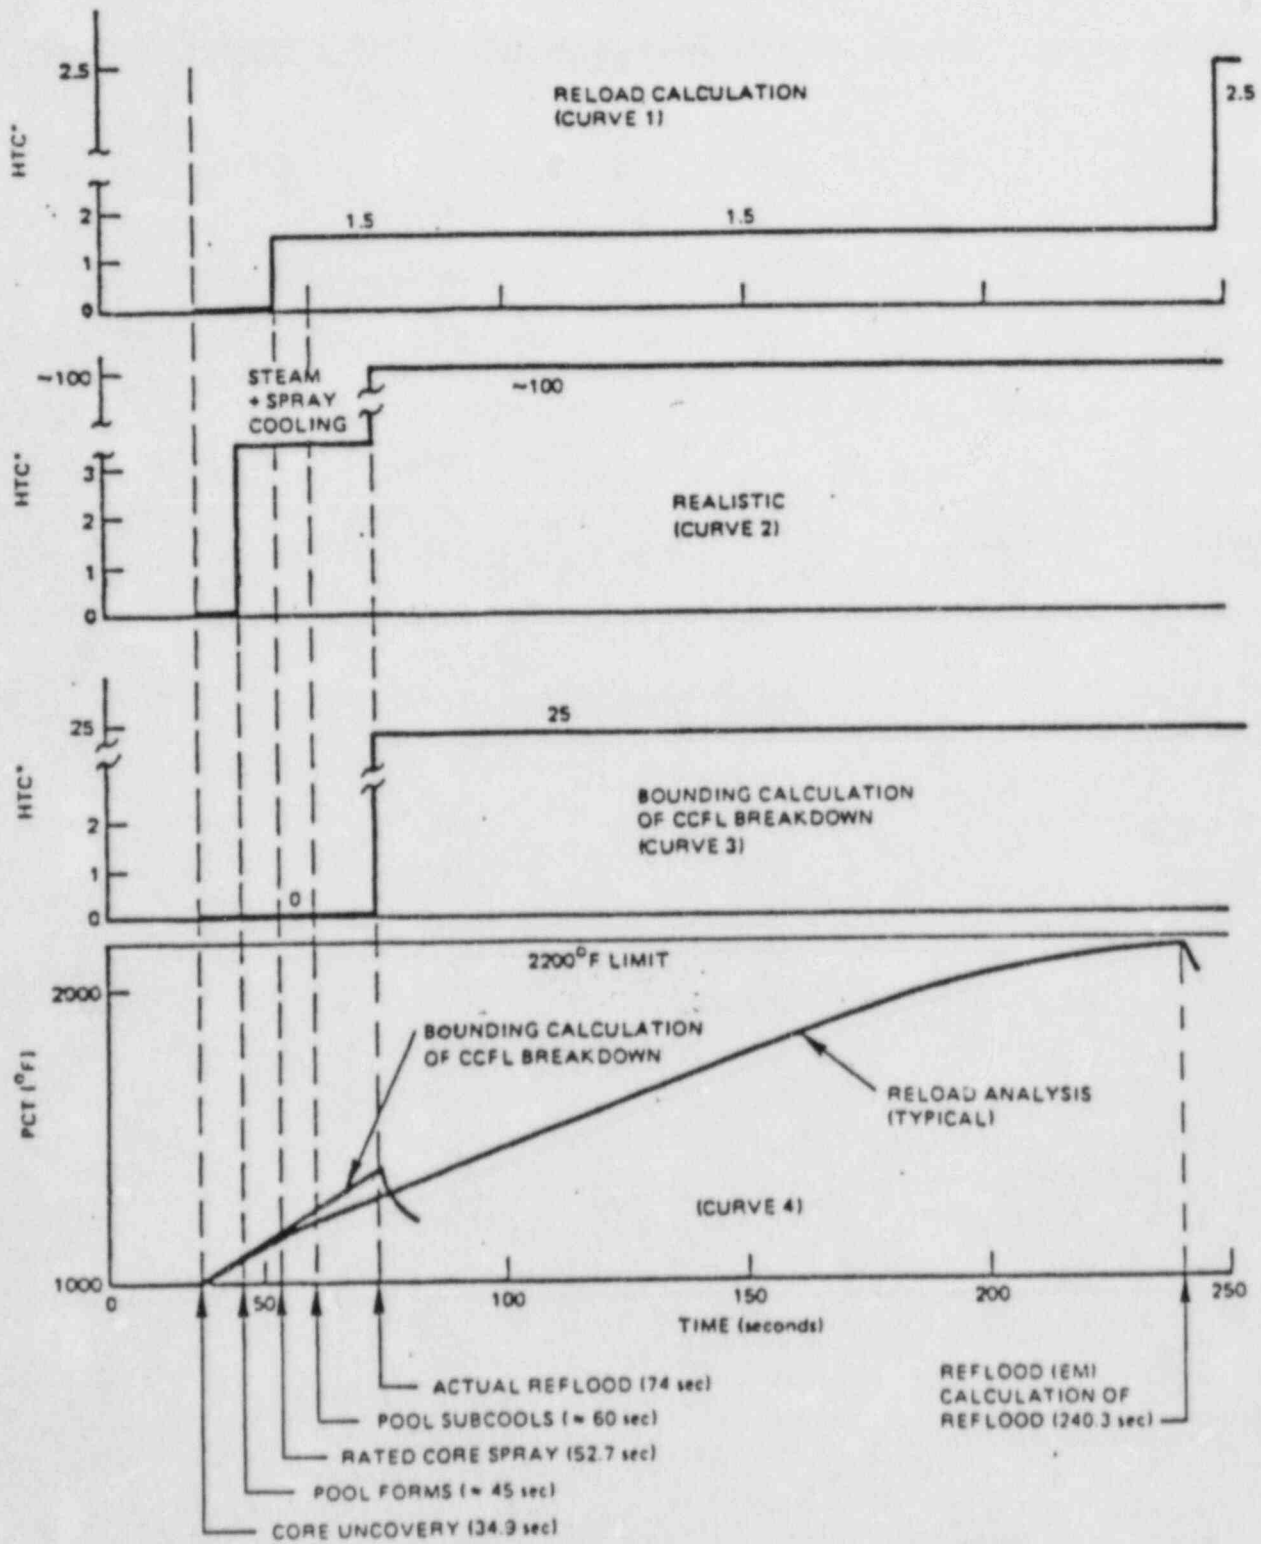
Figure 2 Hatch Unit 1 DBA (Limiting LOCA) Analysis

GE ECCS analysis indicates that for a core spray line break, there are always at least three low pressure ECCS pumps injecting water into the reactor vessel. It ensures that this break is not a limiting event. The plant specific LOCA analysis based on the SAFE and REFLOOD Codes indicates that a suction line break in the recirculation line with a LPCI injection valve failure is the most limiting break by a large margin. This limiting LOCA analysis was performed with the conservative modeling of counter current flow limits (CCFL) at the fuel assembly upper tie plates. The calculation limits the coolant delivery or downflow from the core spray systems to the fuel bundles. Further it delays core reflooding by neglecting the water held back in the upper plenum. The Peak Cladding Temperature (PCT) using this model did not exceed 10 CFR 50.46 temperature limit of 2200° F (Figure 2, curve 4).

GE Lynn facility large scale tests show that core spray flow injected into the upper plenum drains to peripheral bundles and increases the bottom reflood rate. GE performed a bounding calculation of the limiting LOCA case with CCFS breakdown input. No credit was taken for the spray cooling effect (i.e., the heat transfer coefficient for spray cooling is assumed to be zero). The calculated PCT is about 1380°F. This result demonstrates that the current reload analysis calculation of PCT is conservative (Figure 2, curve 4).
