# Duquesne Light

Reference: Beaver Valley Power Station, Unit No. 1  
Docket No. 50-334, License No. DPR-66  
IE Bulletin 84-U3

This letter is forwarded in response to IE Bulletin 84-03 "Refueling Cavity Water Seal" dated August 24, 1984.

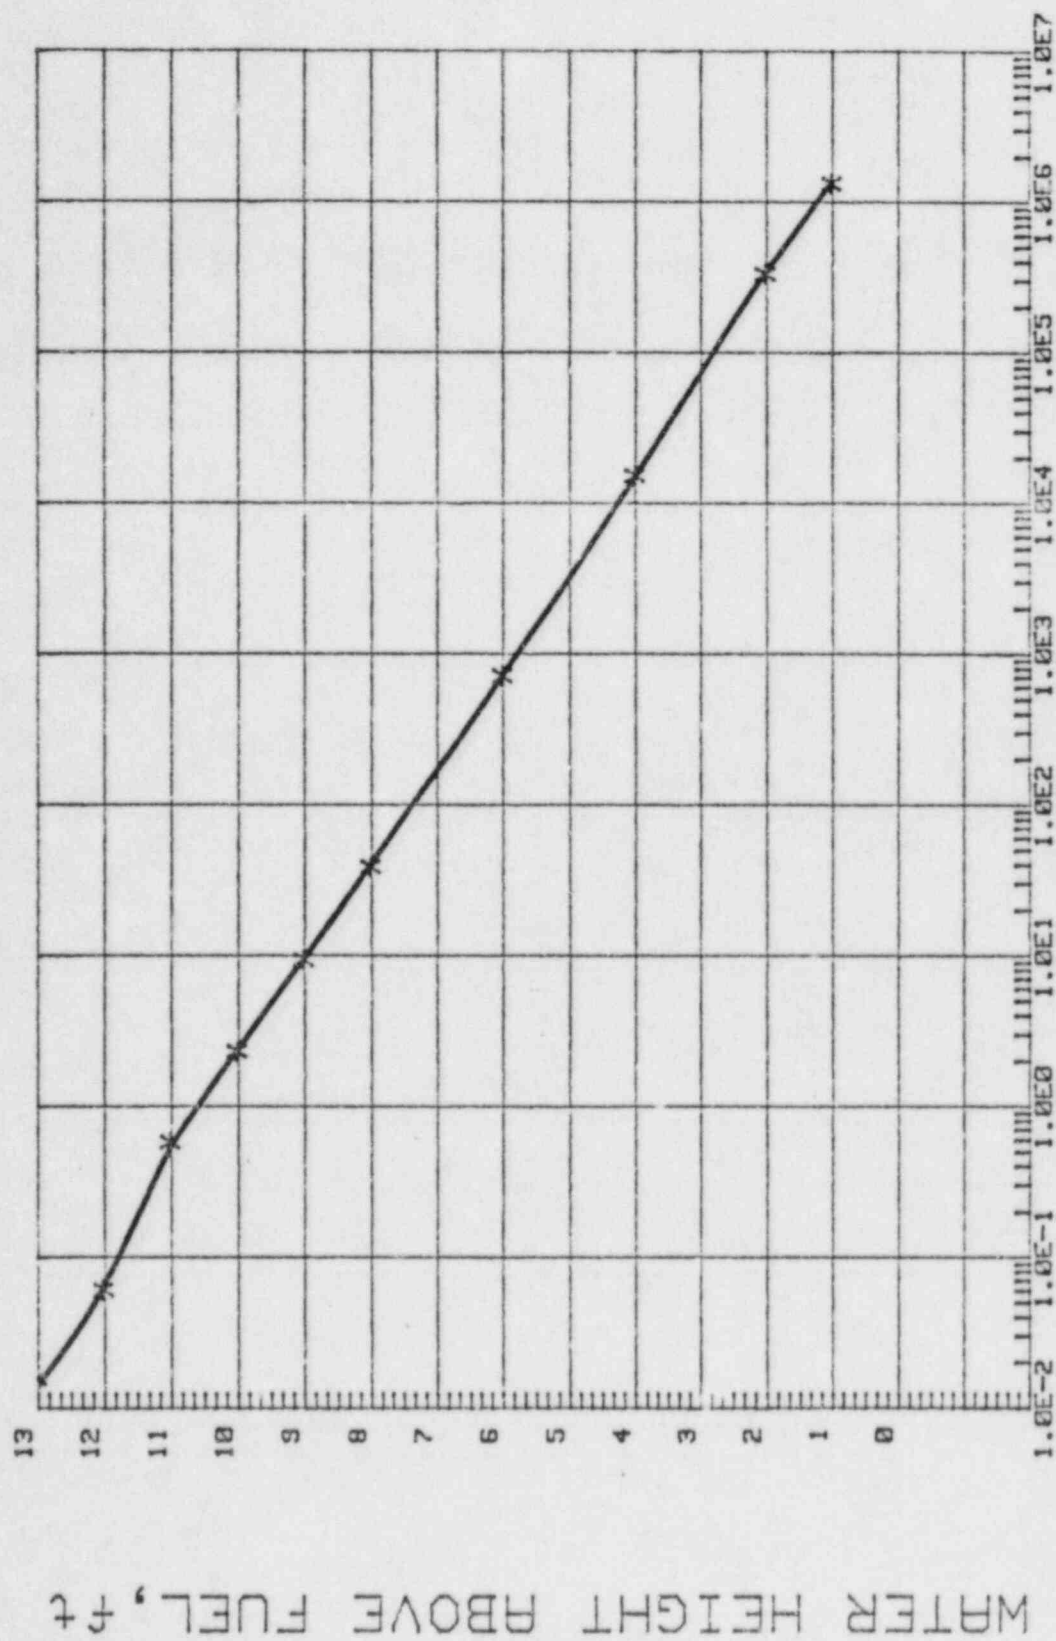
# DOSE RATE ON MANIPULATOR BRIDGE

Complete loss of an outer inflatable seal was evaluated in conjunction with a fuel handling accident. The evaluation assumed loss of water over a spent fuel assembly in the fuel building and a rupture of all fuel tubes in the assembly. It was found that resulting doses could exceed 10CFR100 criteria. This is primarily due to the loss of water over the spent fuel and the resultant increase (approx. 100 fold) in the iodine dose commitment due to the decrease in partitioning factors previously analyzed (Fuel Handling Accident) in accordance with Regulatory Guide 1.25 with 23' of water over the spent fuel. With conservative meteorological factors under this condition, the resultant dose commitment could reach approximately 3020 rem to the thyroid.

An attached Figure shows the dose rates on the manipulator bridge versus water height above the fuel. We do not consider this accident sequence credible (100% extrusion of the inflatable seal through the annulus gap) with the modifications already completed on this seal providing that the seal is properly designed, maintained and installed. Our review of the Haddam Neck event leads us to the conclusion that improper design margin was the principal contributor to the event.

We are taking the following additional actions to insure that uncovering of a spent fuel assembly will not occur and to maximize our ability to withstand high leakage rates regardless of the initiating event:

- monitoring seal leakage during and following fill of the Refueling Cavity
- prohibiting the use of the RCCA change fixture until a cofferdam is installed to insure complete fuel assembly submergence
- maintaining a LHSI pump available for injection to provide additional injection capability

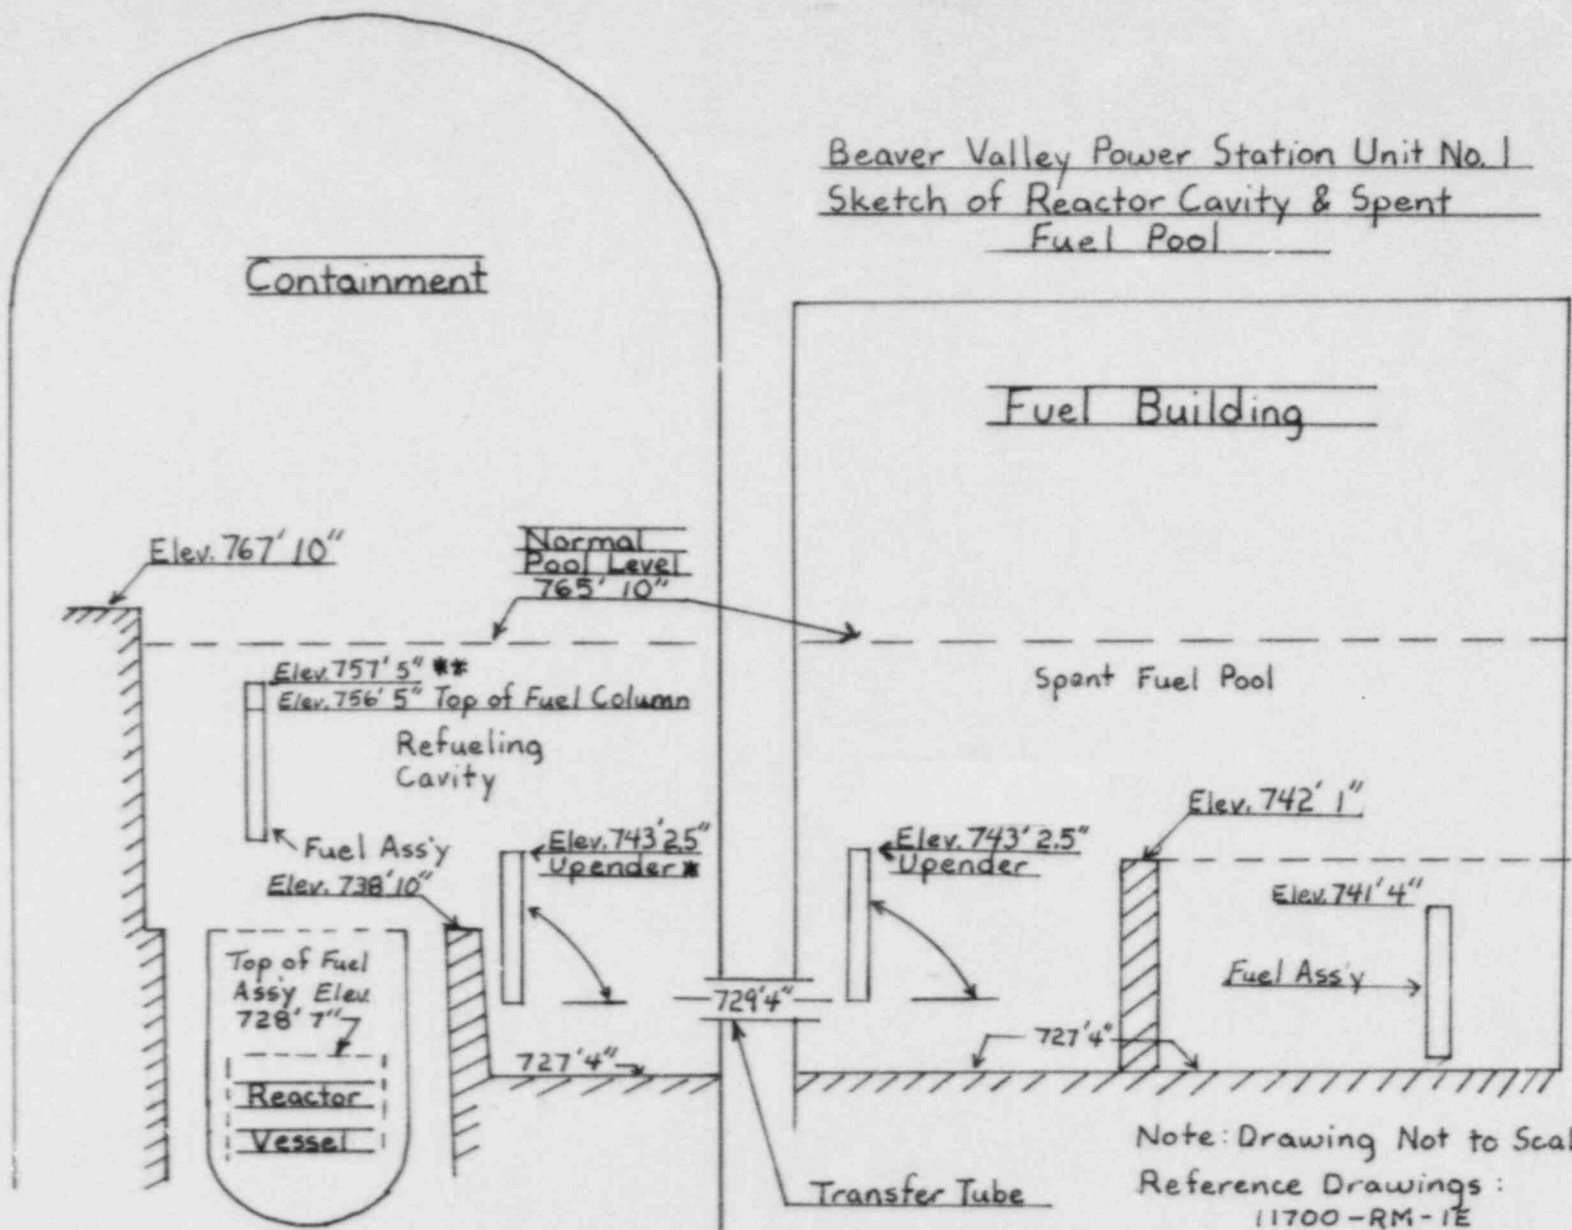
Beaver Valley Power Station Unit No. 1  
 Sketch of Reactor Cavity & Spent  
 Fuel Pool

In the event of reactor cavity seal failure, loss of water through the transfer tube would lower water levels in the spent fuel pool to elevation 742'1". The stored spent fuel assemblies would remain covered by approximately 9 inches of water. It has been calculated that it would take several hours for the water above the spent fuel to evaporate. This calculation assumed that the postulated accident occurs after cycle 12 with an initial pool temperature of 140° and that no makeup water was added. At this time, we have completed cycle 4 operation.

Please refer to the enclosed drawing showing the elevations of the spent fuel and cavity seal.

In the event of gross seal failure, resulting in leakrates greater than available makeup capacity, a fuel assembly in an upender (positioned vertically) or in the rod cluster control assembly (RCCA) change fixture would become partially exposed to air. Fuel in other parts of the transfer system, in the reactor vessel and in the spent fuel pool will remain submerged.

Before the water remaining above the stored fuel could evaporate completely, makeup water could be provided from the Refueling Water Storage Tank Recirculation Pumps, Primary Grade Water Pumps (no boron) or in extreme emergencies with the River Water or Fire Protection Systems' Pumps. Design of the fuel racks would prevent criticality in the spent fuel pool under all conditions. In addition, the ventilation drains from the cooling unit return to the spent fuel pool. Makeup to the RWST is available through the CVCS System with 2000 ppm of borated water. A drawing has been enclosed to show the piping arrangement of the Fuel Pool Cooling connections.

The RCCA change fixture will not be used during the current refueling outage and the fuel in the upender can be positioned horizontally to ensure cooling.
