LICENSEE EVENT REPORT (LER)

FACILITY NAME (1) Fort St. Vrain, Unit No. 1	DOCKET NUMBER (2) 0 5 0 0 0 2 6 7 1	PAGE (3) 1 OF 0 1 7
---	--	------------------------

TITLE (4)
Ultrasonic Detectors Inoperable Due To Instrument Drift

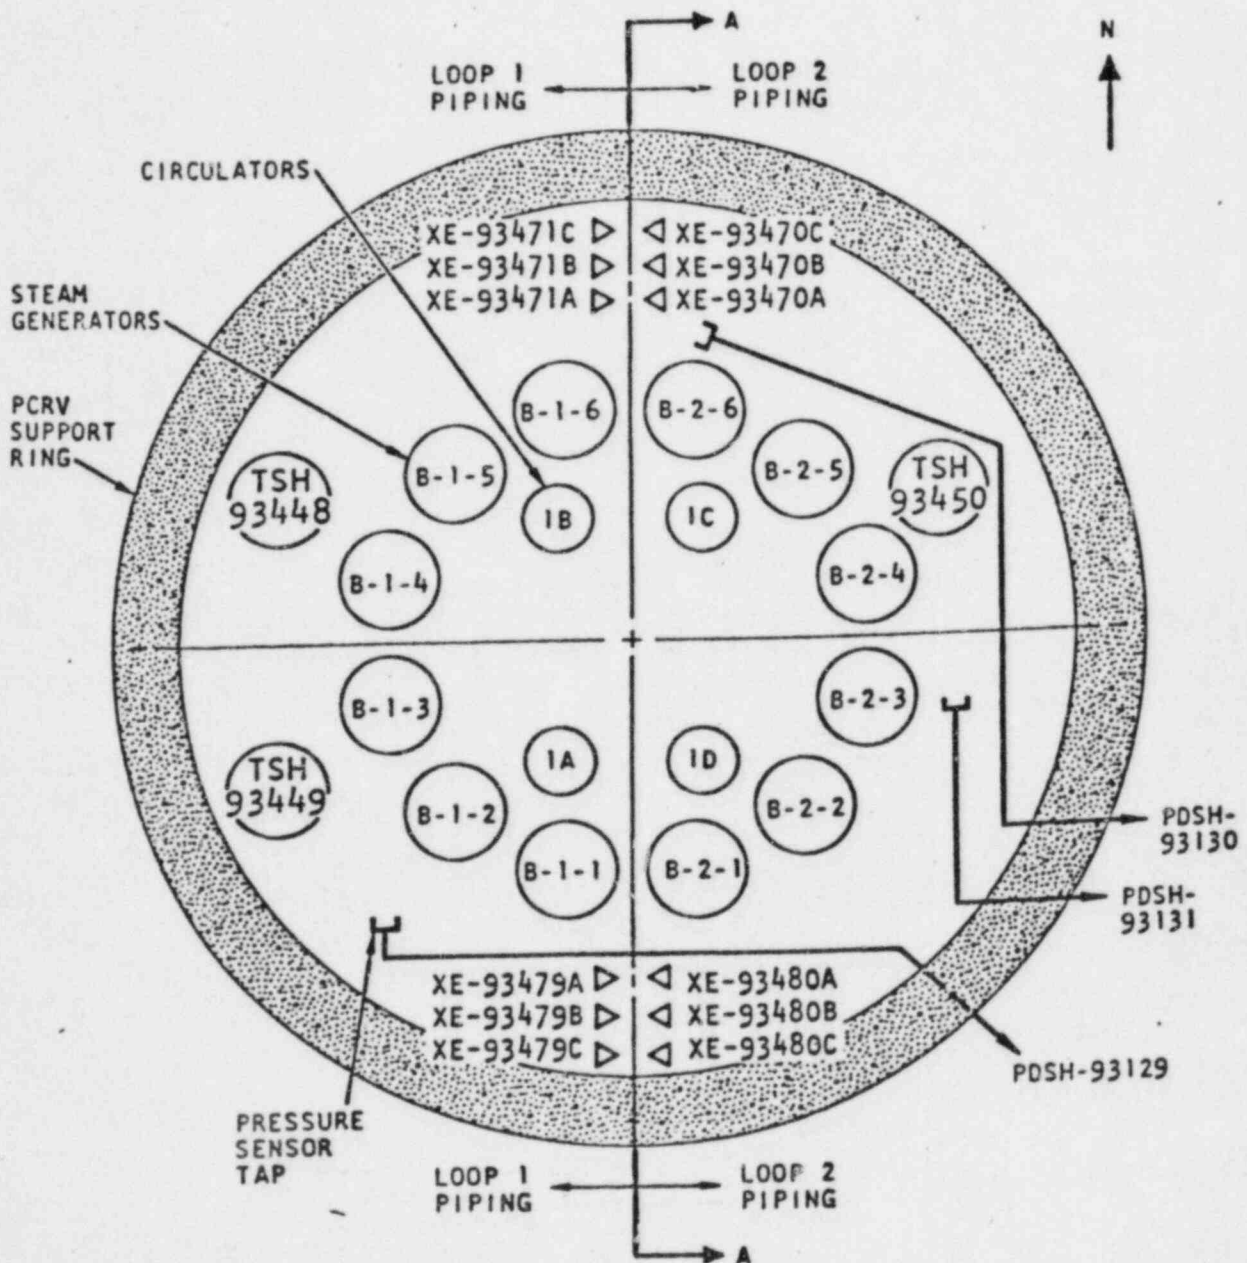
Pipe Rupture Detection System Below PCRV - Plan View

The steam pipe rupture detection system involves a combination of ultrasonic detectors, differential pressure switches, and temperature switches (Figures 1 and 2). The basic system utilizes the ultrasonic detectors to establish in which of two secondary coolant loops a steam leak exists and differential reactor building pressure or temperature switches to confirm that the magnitude of the leak is such that automatic action is necessary. The logic system requires two out of three ultrasonic detectors to trip in the same area plus either a high building pressure or temperature trip.
