HIGH GROUND-WATER LEVEL STUDY

GRAND GULF UNIT 1

MISSISSIPPI POWER AND LIGHT CO.

BECHTEL POWER CORPORATION

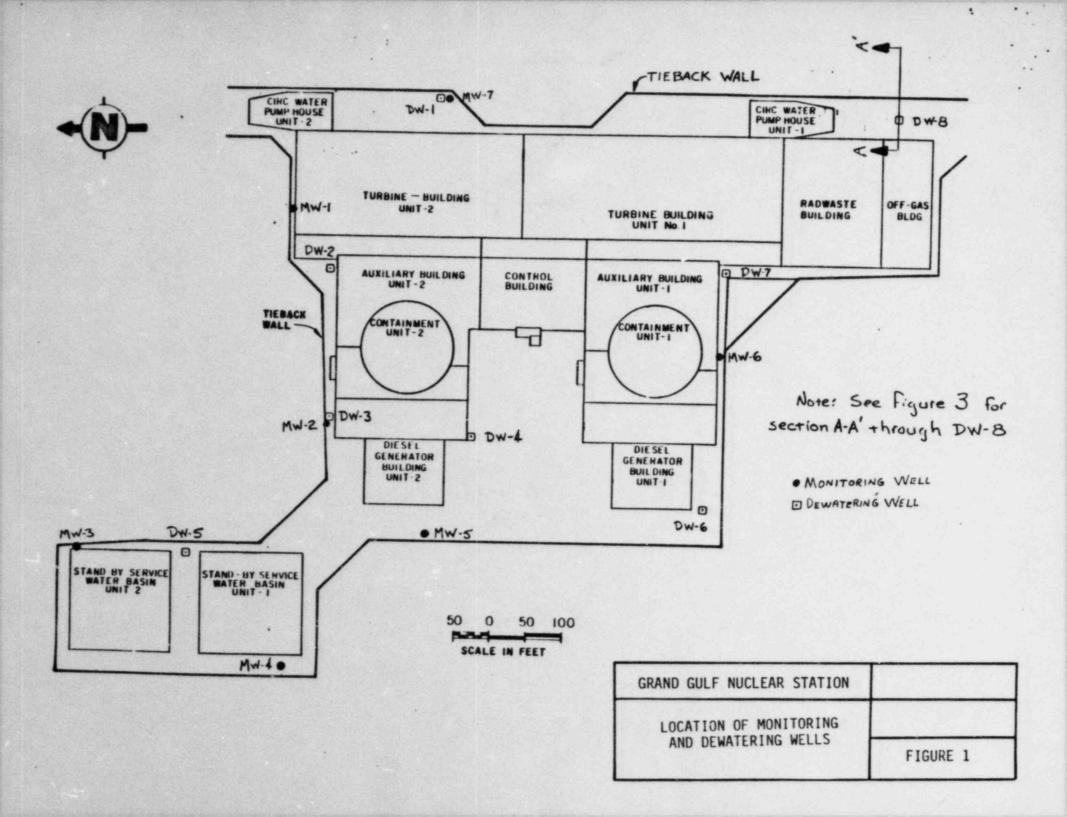
FIGURE 1: LOCATION OF MONITORING AND DEWATERING WELLS

Construction dewatering well DW-8 is located in the southeast corner of the area previously excavated for the plant structures (Figure 1). The screened interval is within the granular backfill which was placed between the Radwaste Building and the east tieback wall. Water levels in DW-8 have fluctuated between elevation 103.75 and 110.21 feet MSL during the period from the initial reading in July, 1980 to present. The lowest reading reflects the effects of pumping (prior to the spring of 1982) while the well was operational. During the period September, 1982 through October, 1983 the water level has fluctuated between elevation 106.51 feet to 110.21 feet MSL (Reference 2).

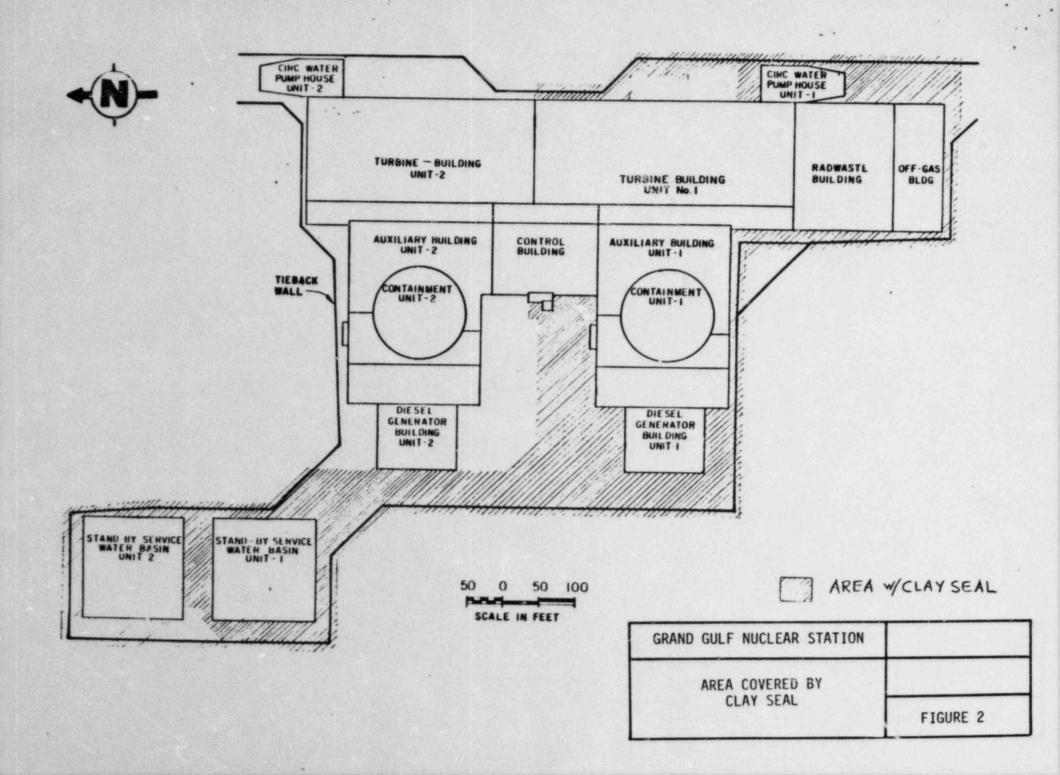
FIGURE 2: AREA COVERED BY CLAY SEAL

The review of construction records indicated that the clay seal was placed around the Unit 1 power block area and the essential service water basins. Installation was completed in April, 1982. The present extent of the clay seal is shown on Figure 2. The purpose of the clay seal is to prevent the in filtration of runoff into the highly permeable backfill between the structures and the tieback wall. This feature, along with the structures, extensive paved areas, and a grading plan which directs runoff away from the structures, is expected to provide a reduction in infiltration upon completion of the plant. The clay is to be covered with six inches of topsoil and sod to prevent dessication of the clay (Reference 1).

- A clay seal has been installed around the Unit 1 power block and stand-by service water basins.
- 5. A source of ground-water flow to DW-8 is from infiltration through the backfill in the circulating water line excavation which extends from the Unit 1 cooling tower to the pump house. The area outside of the boundaries of the tieback wall is not capped with a clay seal.

Control of the surface water flow south of the power block and extension of the clay seal over the circulating water lines will reduce the area available for infiltration of precipitation into the backfill. This will result in lower ground-water levels.

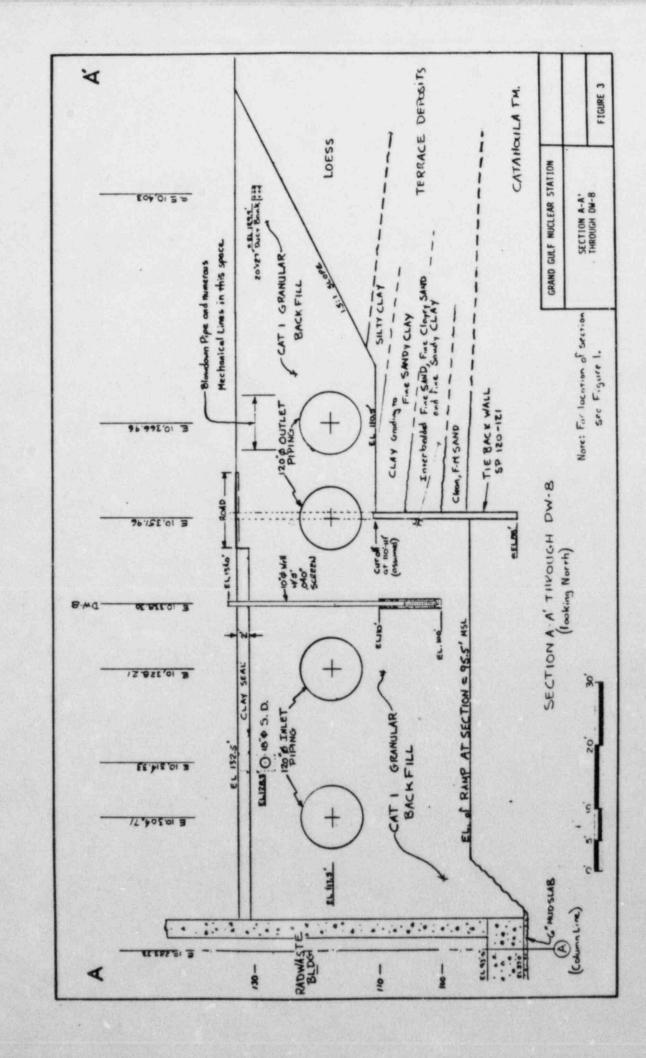
FIGURE 3: SECTION A-A' THROUGH DW-8

Figure 3 is a generalized cross-section showing the distribution of undisturbed and backfill materials around the Radwaste Building foundation, circulating water pipelines and the tieback wall. As shown, a portion of the tieback wall was removed and the excavation extended to the east for the installation of the outlet pipelines for Unit 1. Natural materials (Loess,

Terrace deposits, and Catahoula Formation) exist outside and beneath the excavation area. The top of the Terrace deposits is at about elevation 110 feet and the lower contact with the Catahoula Formation is at about elevation 97 feet. Mapping of the tieback wall face, performed by Bechtel in 1974, indicated that the Terrace deposits in this area consist primarily of fine to medium grained sand overlain by hard, light gray clay and brown, silty clay. The exposure of the Catahoula Formation consists of hard, gray, weathered clay about 1-2 feet thick overlying green, silty clay.

A granular backfill compacted to 95 percent Modified Proctor was placed on top of the Terrace deposits, Catahoula Formation, and the circulating water pipelines between the east wall of the Radwaste Building and the eastern portion of the excavation. Various mechanical piping and a blowdown pipeline exist in the backfill on the eastern edge of the excavation.

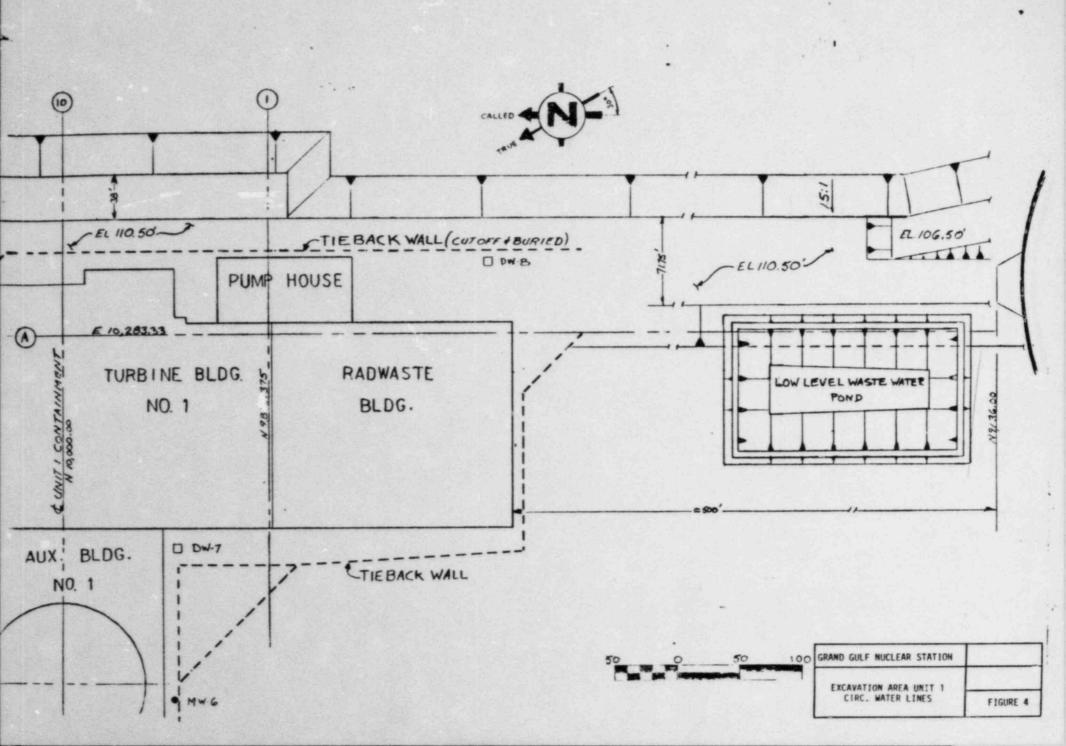
FIGURE 4: EXCAVATION AREA - UNIT 1 COOLING TOWER CIRCULATING WATER LINES

The yard area south and east of DW-8 has no permanent structures or clay seal. The area includes the excavation for the four 10 foot diameter circulating water pipelines between the Unit 1 pump house and the Unit 1 cooling tower. The excavation for the inlet and discharge lines extends about 70 feet eastward of the tieback wall. Backfill for the circulating water pipeline consists of a clean granular material compacted to 90 percent Modified Proctor. The clay seal only covers the portion of the excavation within the tieback wall (Figure 3). The excavation south of the Radwaste Building is about 500 feet long and 155 feet wide (Figure 4). Depth of the excavation is 22 feet below present grade or at elevation 110.5 feet (Figure 3).

The area east of the Radwaste Building and DW-8 is presently a laydown area with a gravel surface. The remainder of the area south of the Radwaste Building is sodded except where crossed by roadways. These areas south and east of the main power block excavation allow for the infiltration of precipitation and are the likely source of recharge to the granular backfill.

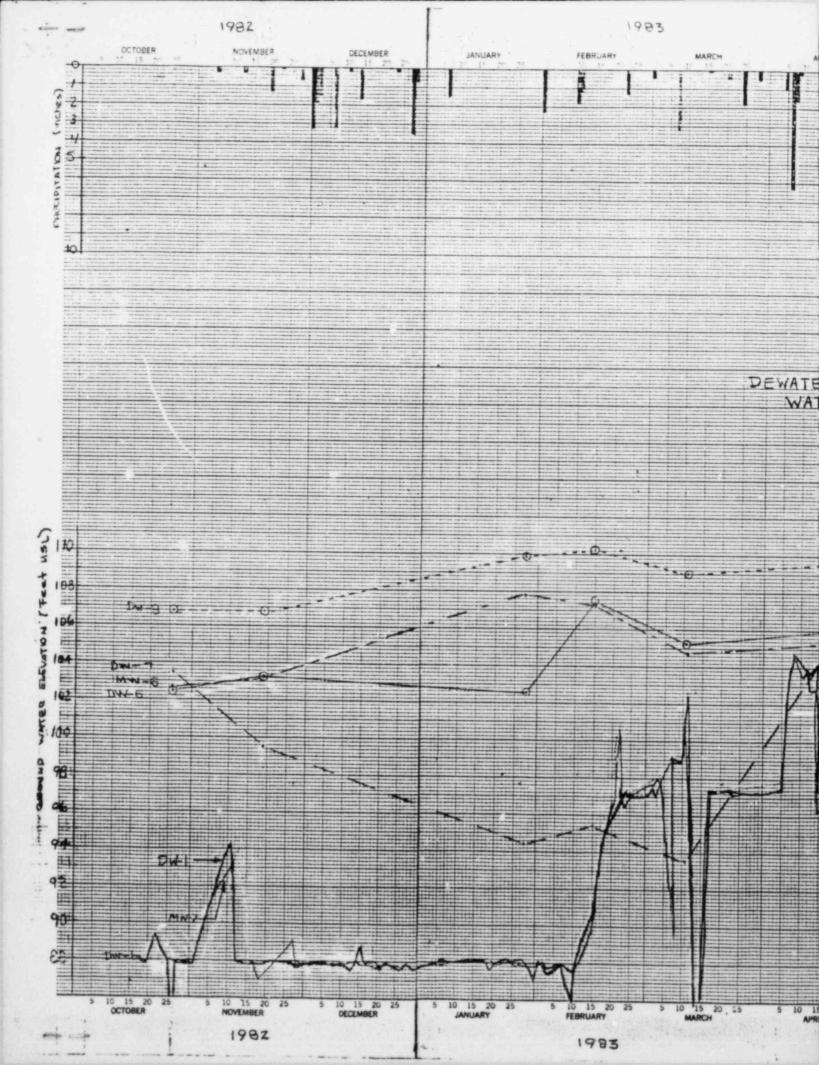
FIGURE 5: SELECTED WELL HYDROGRAPHS AND PRECIPITATION VARIATION

A review of the water level records for the plant site and vicinity reflect the increase in rainfall and resulting infiltration. An increase of four to five feet in water levels measured in wells on the Unit 1 side of the power block was common from January through June, 1983 (Figure 5). With two exceptions the rise is not reflected in Unit 2 observation wells. Levels in the Unit 2 area were controlled by operations of the dewatering wells in response to rising water levels. The exceptions are DW-1 and MW-7 which are located on the east side of the Unit 2 excavation. Due to operational problems with the pump in DW-1 it was pumped only on an intermittant basis from February through June, 1983. The water level elevation in DW-1 averaged about 88 feet prior to February 10, 1983. From February through the end of June, 1983, recorded levels reached as high as 104.8 feet, an increase of almost 17 feet. Since July, 1983, after modification of the pumping system, water levels in DW-1 have averaged between 97 and 98 feet. Hydrographs for several of the dewatering wells and monitoring wells are presented on Figure 5.

The water level rise of four feet in Unit 1 wells MW-6 and DW-7 during the same period as the rise in DW-8 is probably due to response to the abnormally high precipitation experienced during the seven month period. Recharge of the backfill in this area is from infiltration through the more permeable lenses in the Terrace deposits.

- 6. Water levels in adjacent dewatering and monitoring wells in the Unit 1 area increased four to five feet during the same period that the design ground-water level was exceeded in DW-8. This indicates that

the probable cause of higher than normal ground-water levels in DW-8 is increased infiltration from natural causes as opposed to seepage from buried pipelines or water impoundment facilities.
