Data Reference - Other Sources

# The Virginia Corporation of Richmond

Changes To: Final Report

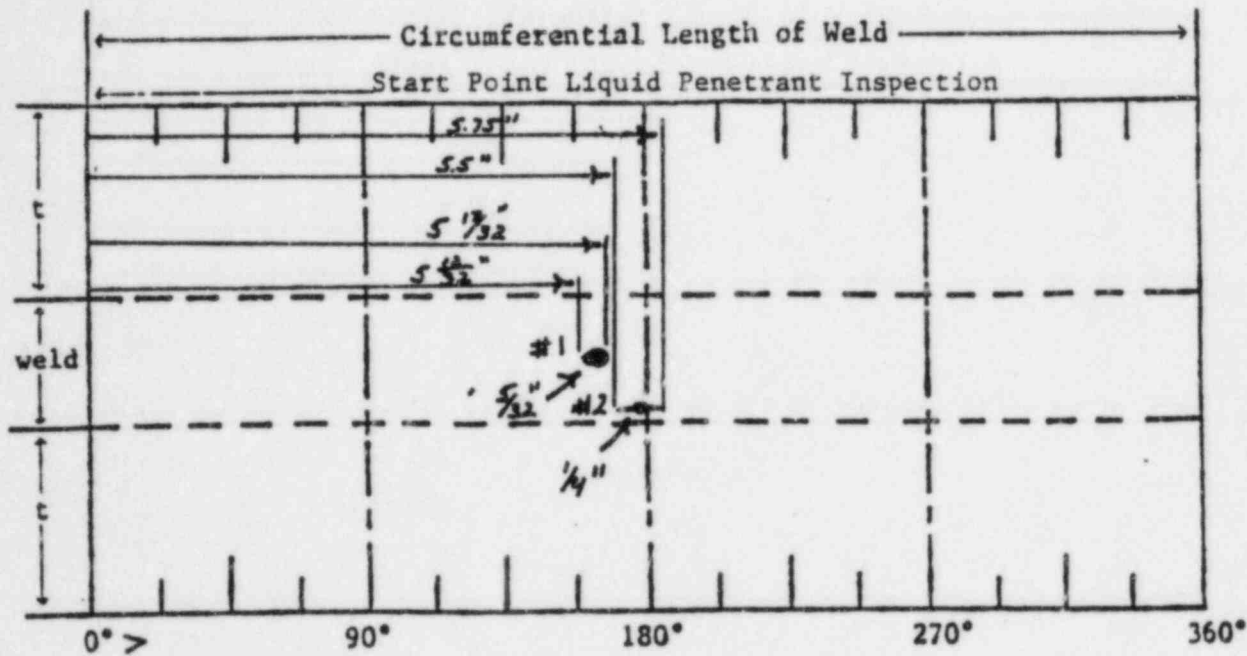
Description of Minor Nonconformance: LIQUID PENETRANT INDICATION RECORDS FOR WELDS 6-011 &amp; 24-015 WERE NOT FILLED OUT IN ACCORDANCE WITH NDE-PROCEDURE 151-1.2, PRESERVICE INSPECTION DOCUMENTATION, PARA. 5.7.3.

*Indication #1 is in center of weld 3/8" from top of weld*  
*Indication #2 is 1/32" off top of weld*

Disposition/Corrective Action: AREA OF REPORTABLE INDICATIONS WERE RE-EXAMINED AND NEW FORM PT-202 WERE COMPLETED WITH PROPER DATA.
