REPORT OF INCIDENT

SUBJECT: SALEM NUCLEAR GENERATING STATION UNIT 2/HEALTH PHYSICS
ALLEGATIONS RELATED TO CONTAMINATION INCIDENT

REPORT NUMBER: O-1-83-011

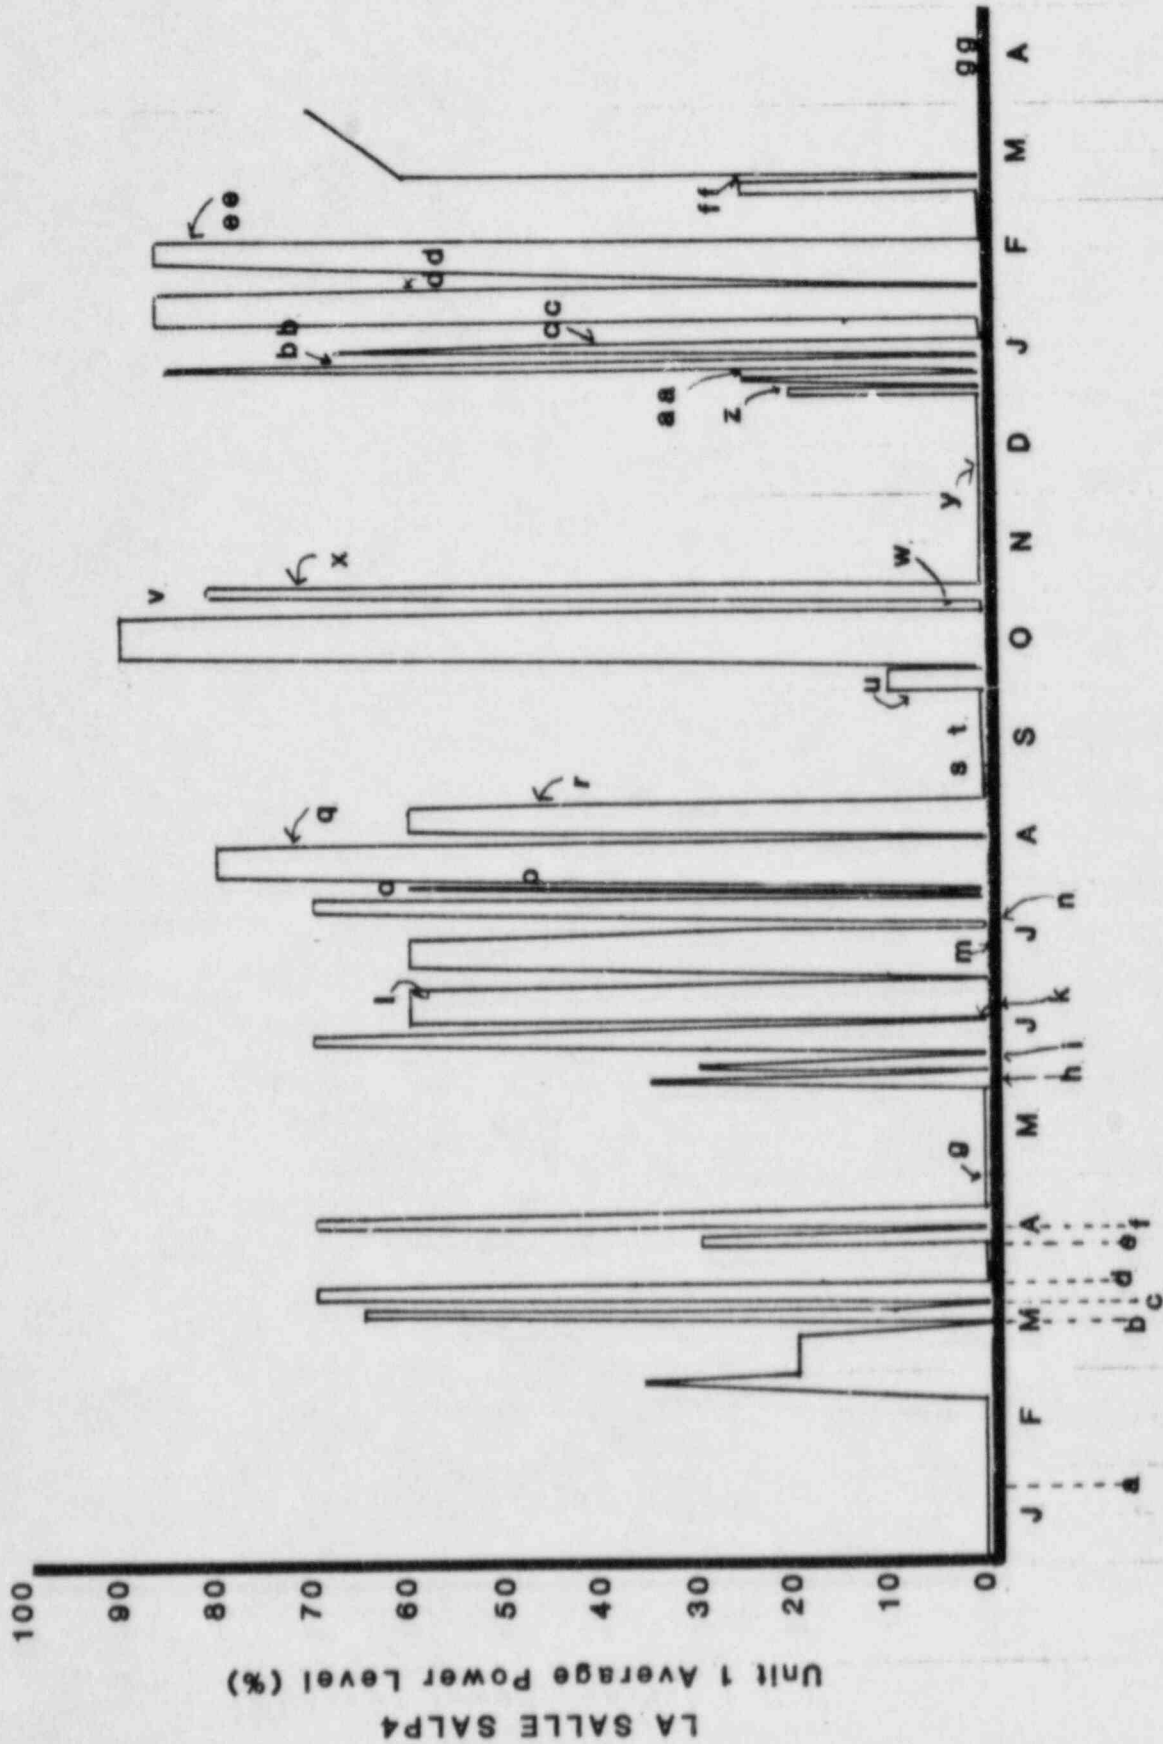
FIGURE 1

While the trend in the overall rate of LERs and personnel errors is encouraging, it should be noted that the rate of personnel errors in maintenance and surveillance activities has increased. In the case of maintenance, this increase is significant (one versus eight events). This is indicative of a need to focus additional attention on personnel performance in these areas and is supportive of a change in the rating category in the maintenance area.
