QUESTIONS ON WATERFORD 3 BASEMAT
3/26 MEETING IN BETHESDA

Allegations recently reported in a GAMBIT newspaper article and in staff investigations concerning the GAMBIT article have lead to the assignment of additional reviewers to evaluate the base mat adequacy. This transmittal is a composite set of Questions from the reviewers, and is intended to faciliate LP&L's preparation for the meeting on March 26, 1984 in Bethesda.

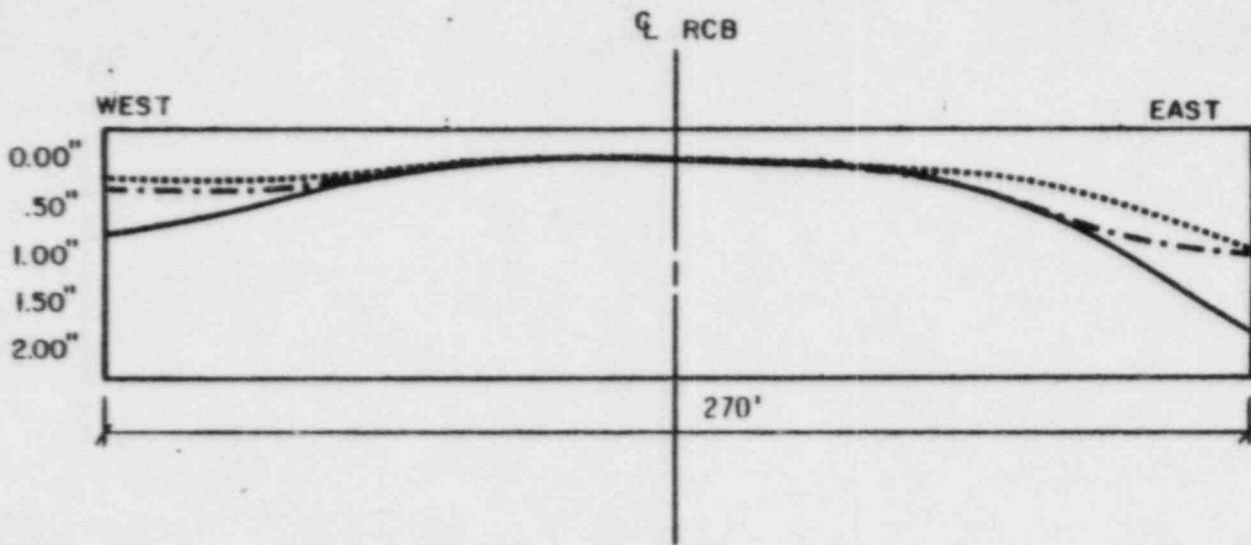
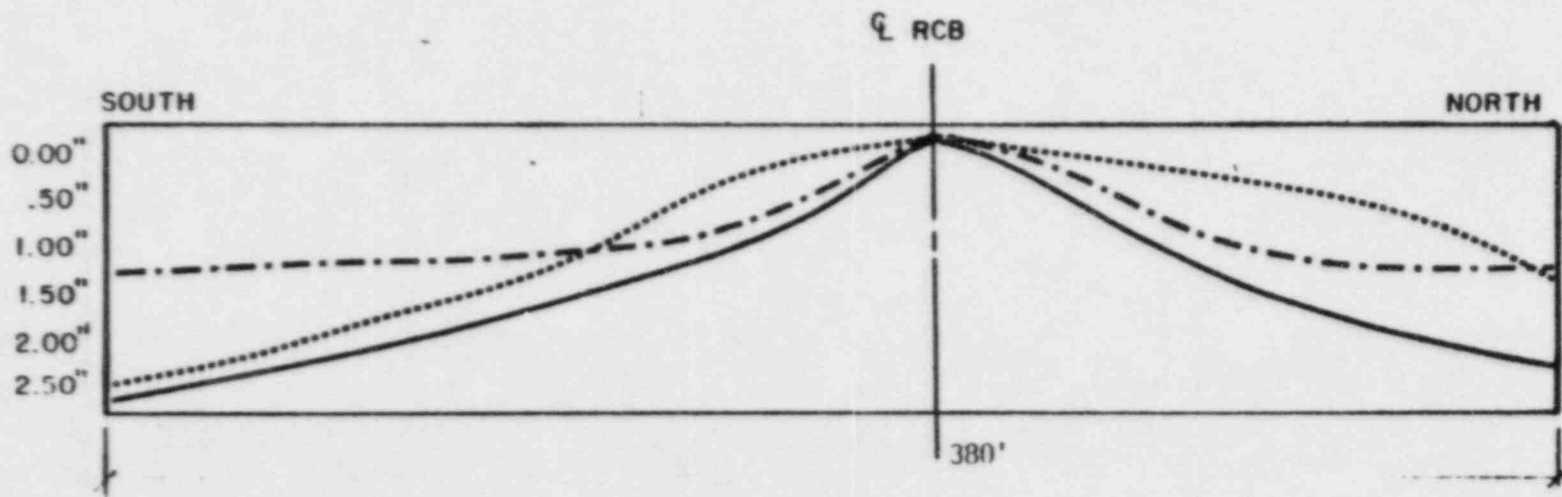
curvature of mat itself.

↑ this should help flexure argument.

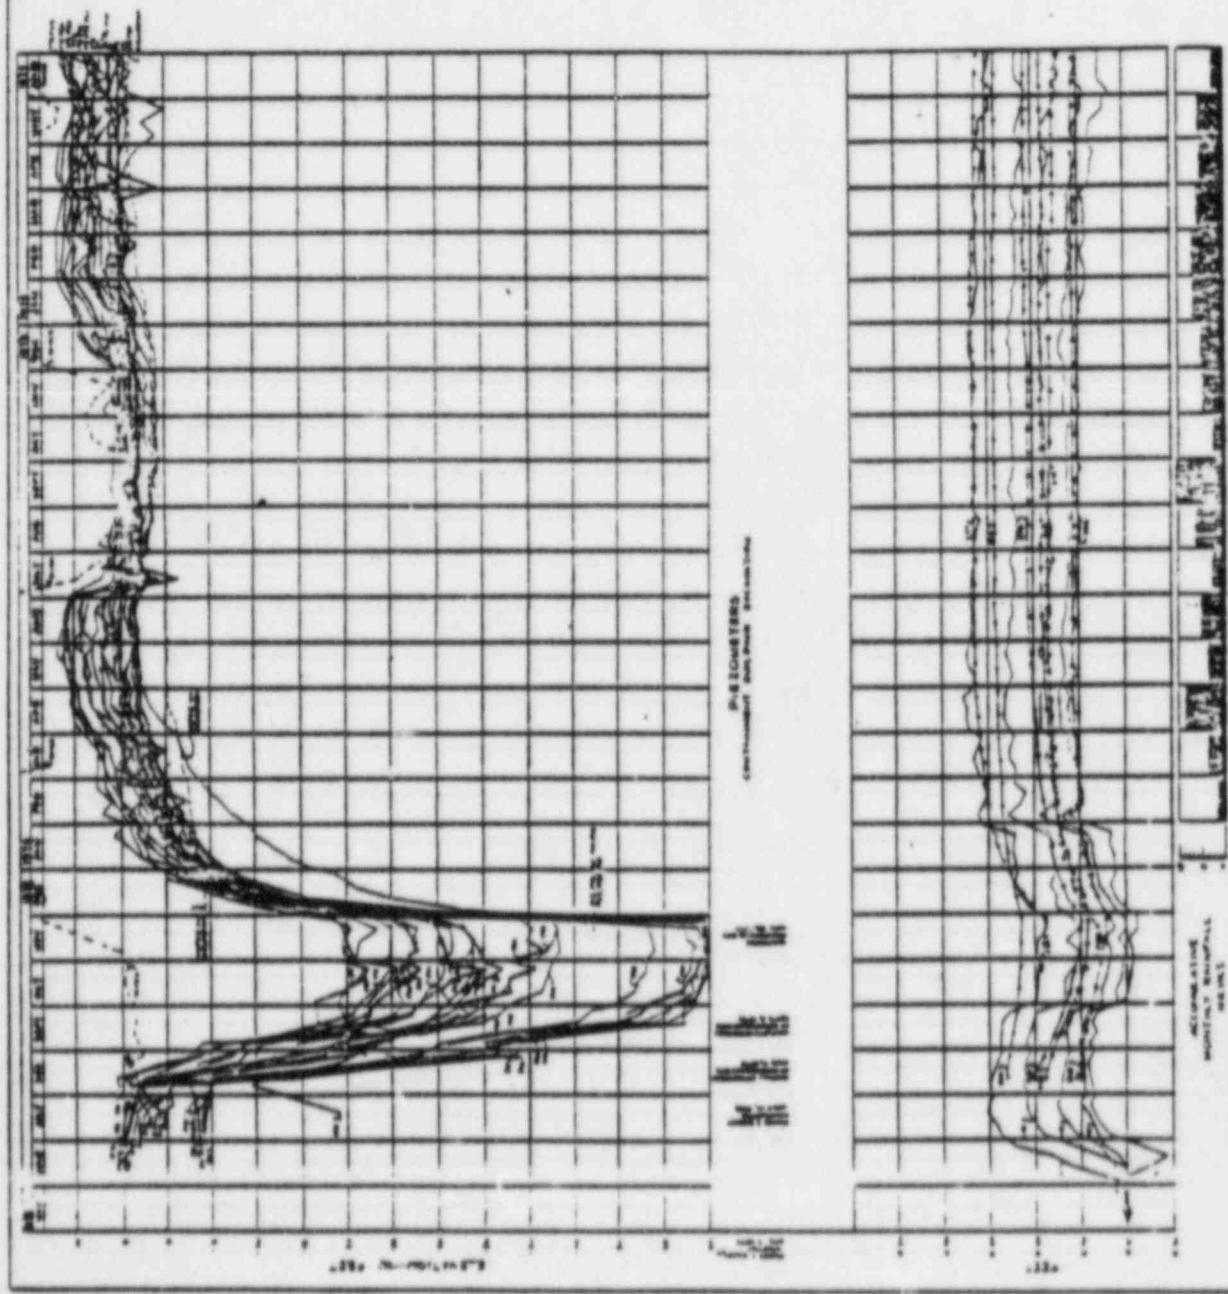
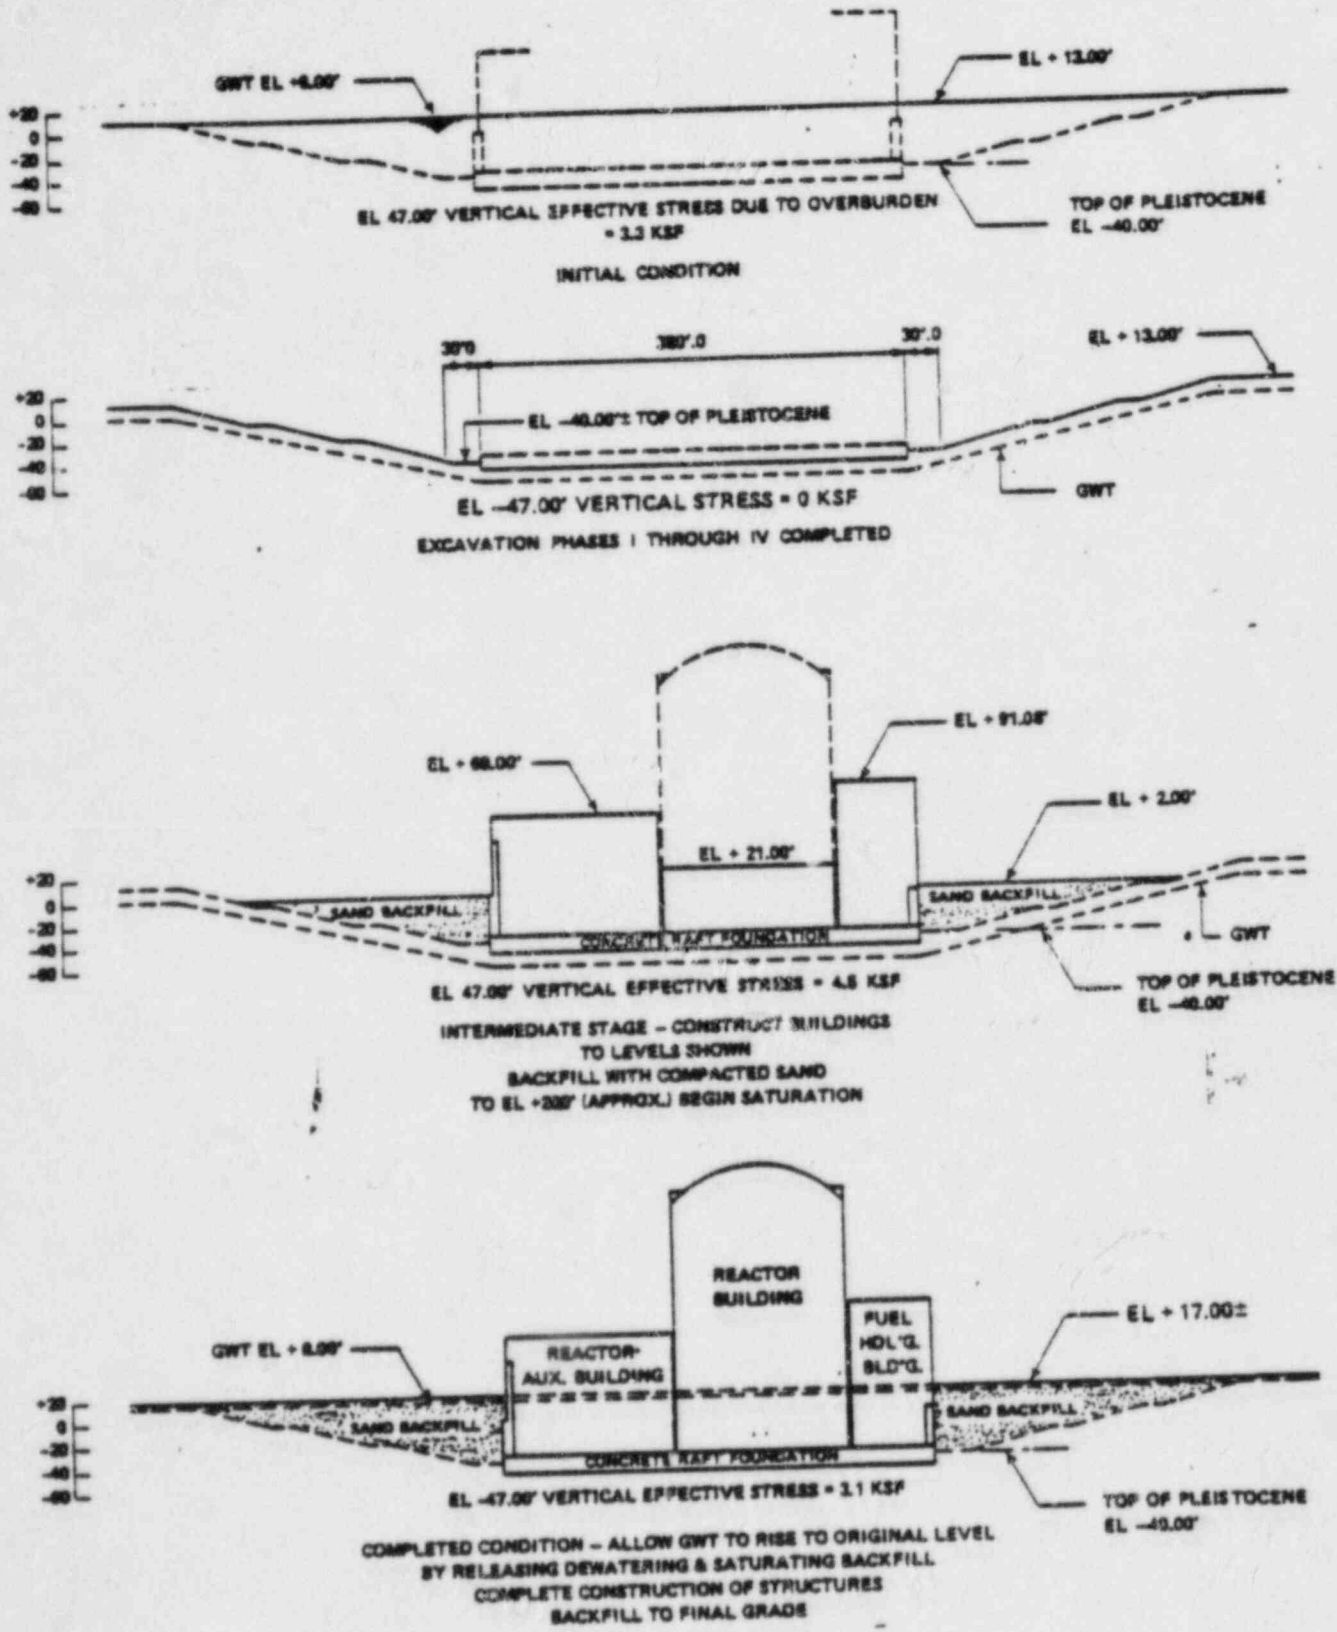
AMENDMENT NO. 22 1949
LOUISIANA POWER & LIGHT CO.
 Weirford Steam Electric Station
 PREDOMETER, HEAVE POINT AND
 EXTENSOMETER RESPONSES
 SHEET 1 OF 8
 FIGURE 25 113

Groundwater control and foundation heave from the start of dewatering until recent time are exhibited in FSAR Fig. 2.5-113 (sheets 1/5 to 5/5).

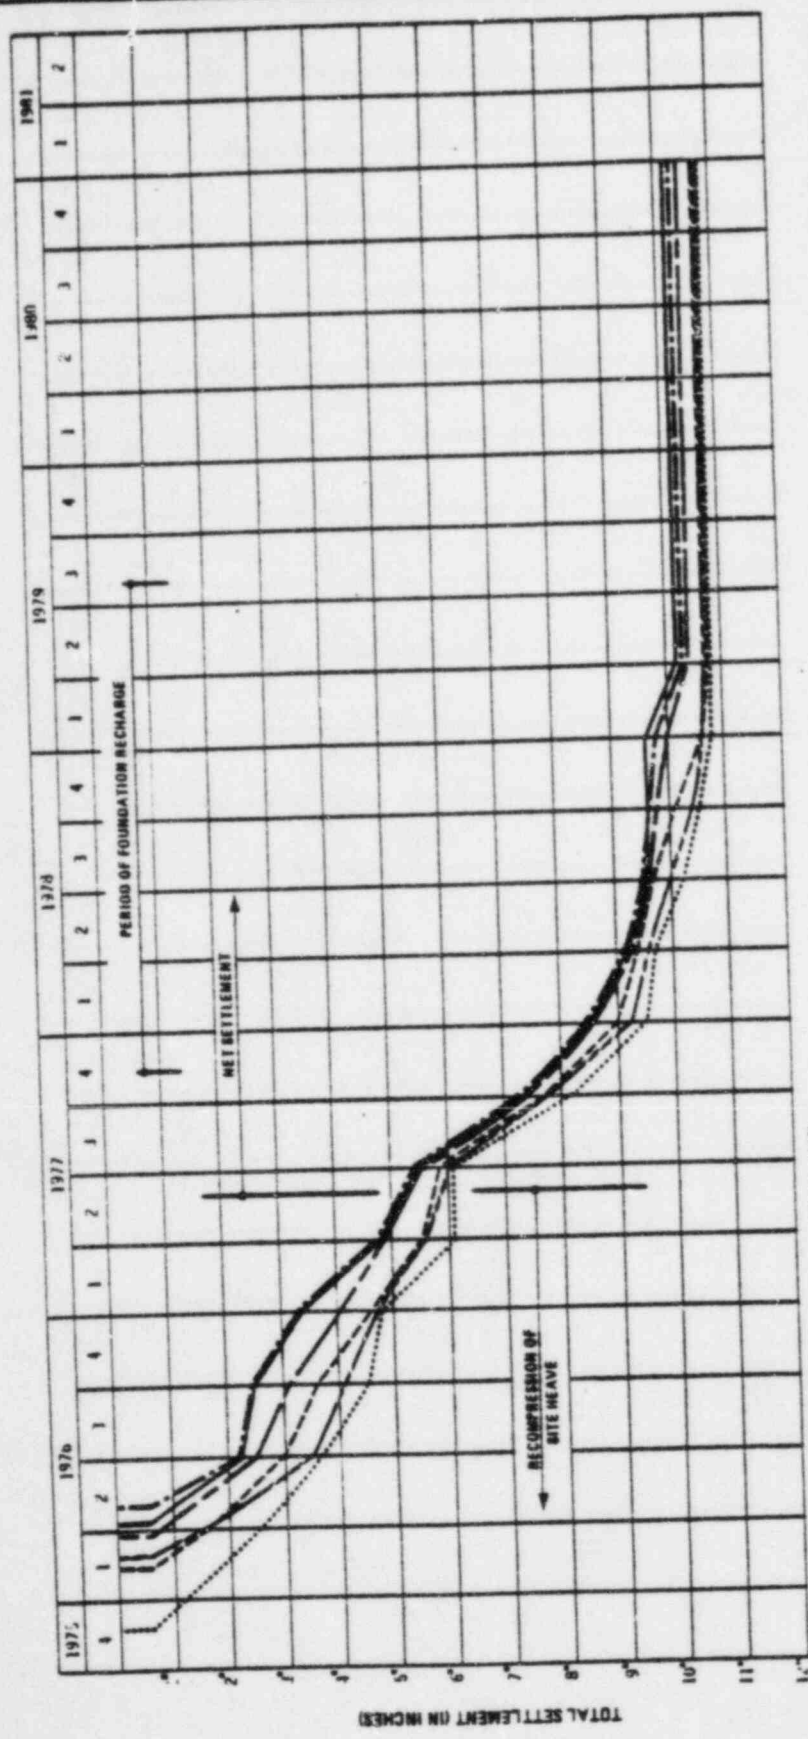
AMENDMENT NO. 34 11-80
LOUISIANA POWER & LIGHT CO.
 Waterford Steam Electric Station
 COMPOSITE FOUNDATION MAT
 SETTLEMENT
 SHEET 1 OF 3
 FIGURE 2-B-117

As can be noted on the Composite Foundation Mat Settlement (Figure 2.5-117 in the FSAR), recharging of the water table began in late 1977 and was gradually charged until completion in late 1979. Recharging commenced based on total stresses achieving the 4.5 KSF criteria. The initiation of recharging the mat was approximately week no. 85 of construction.

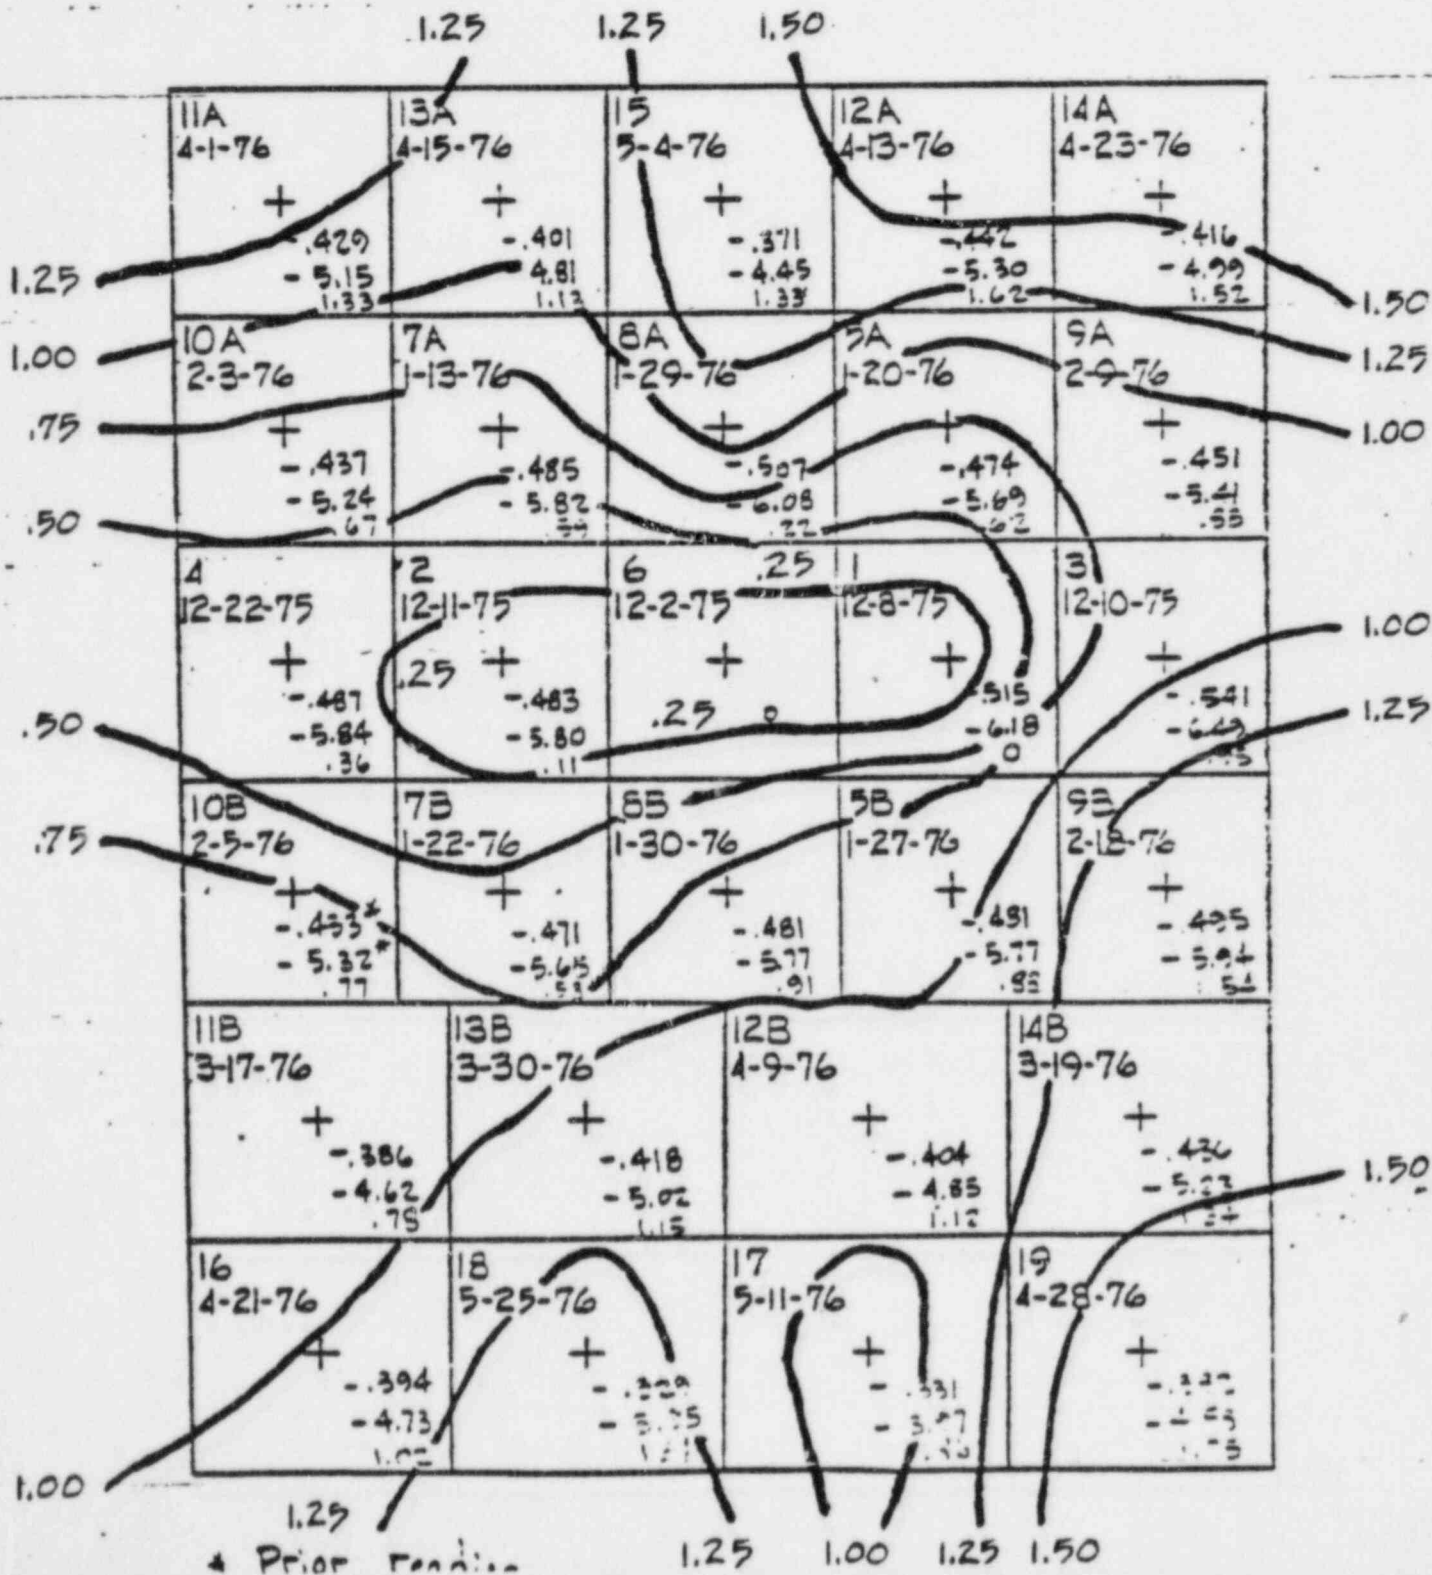
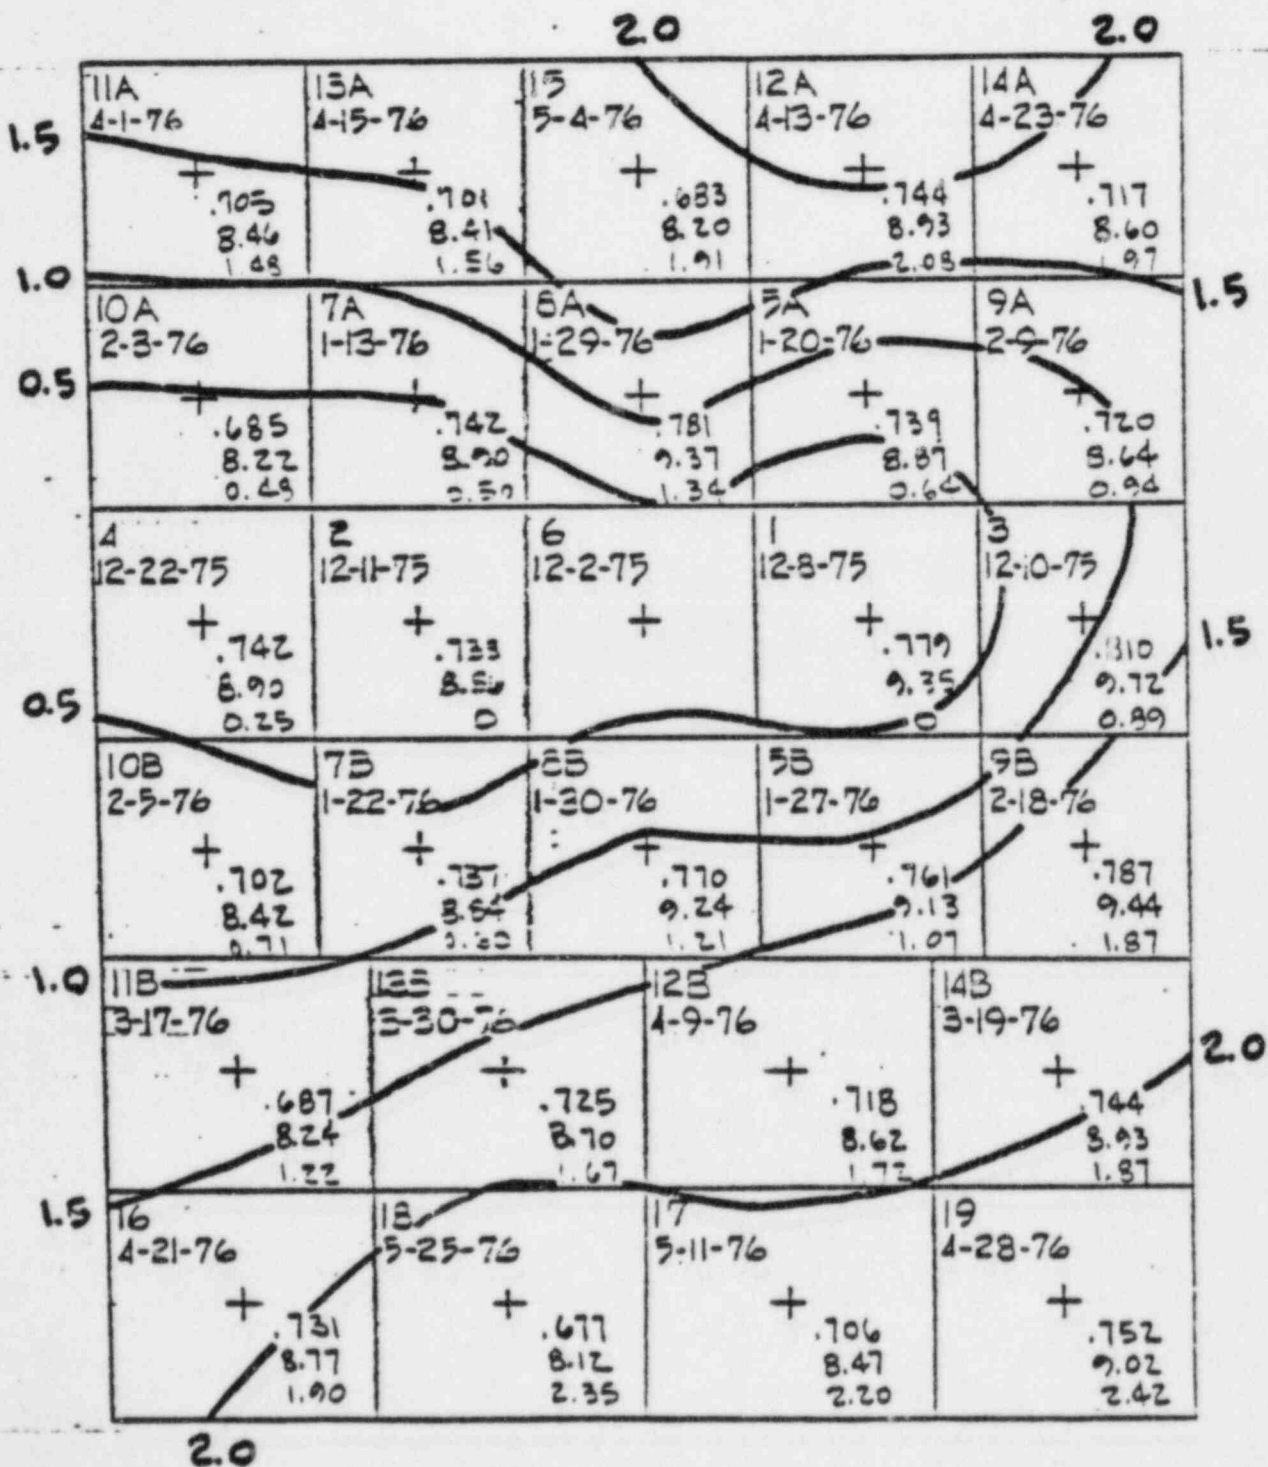
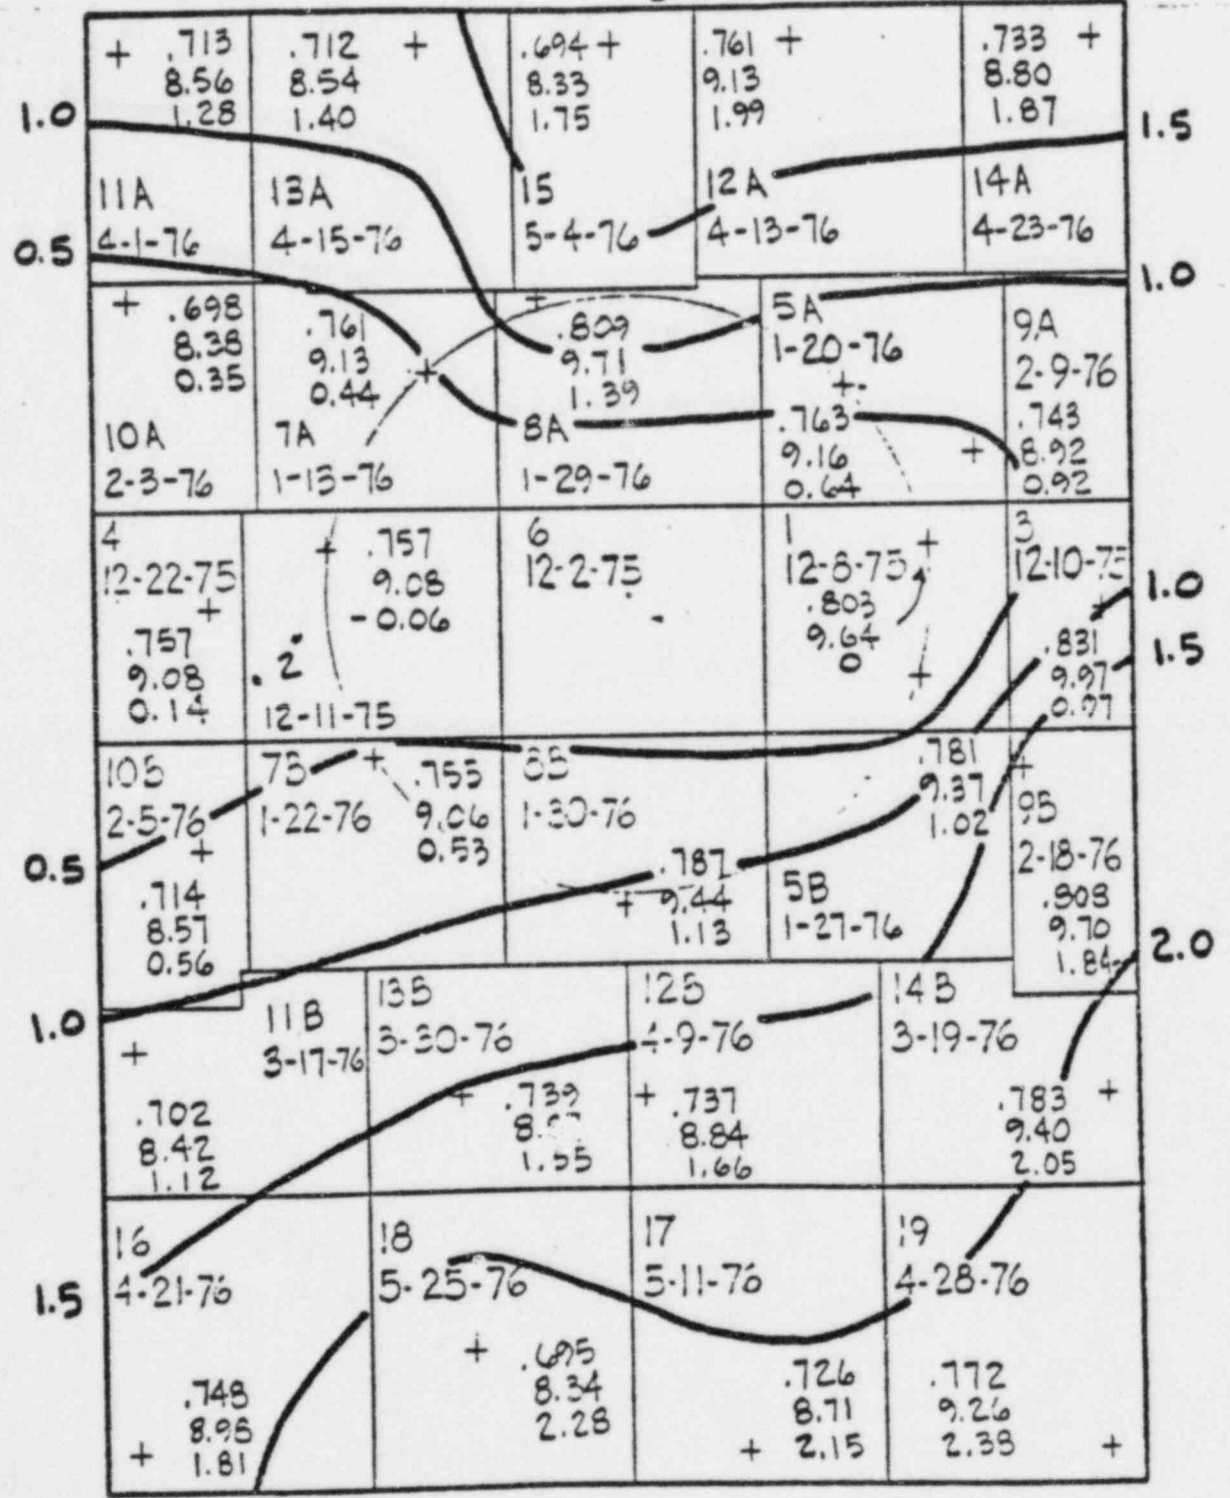
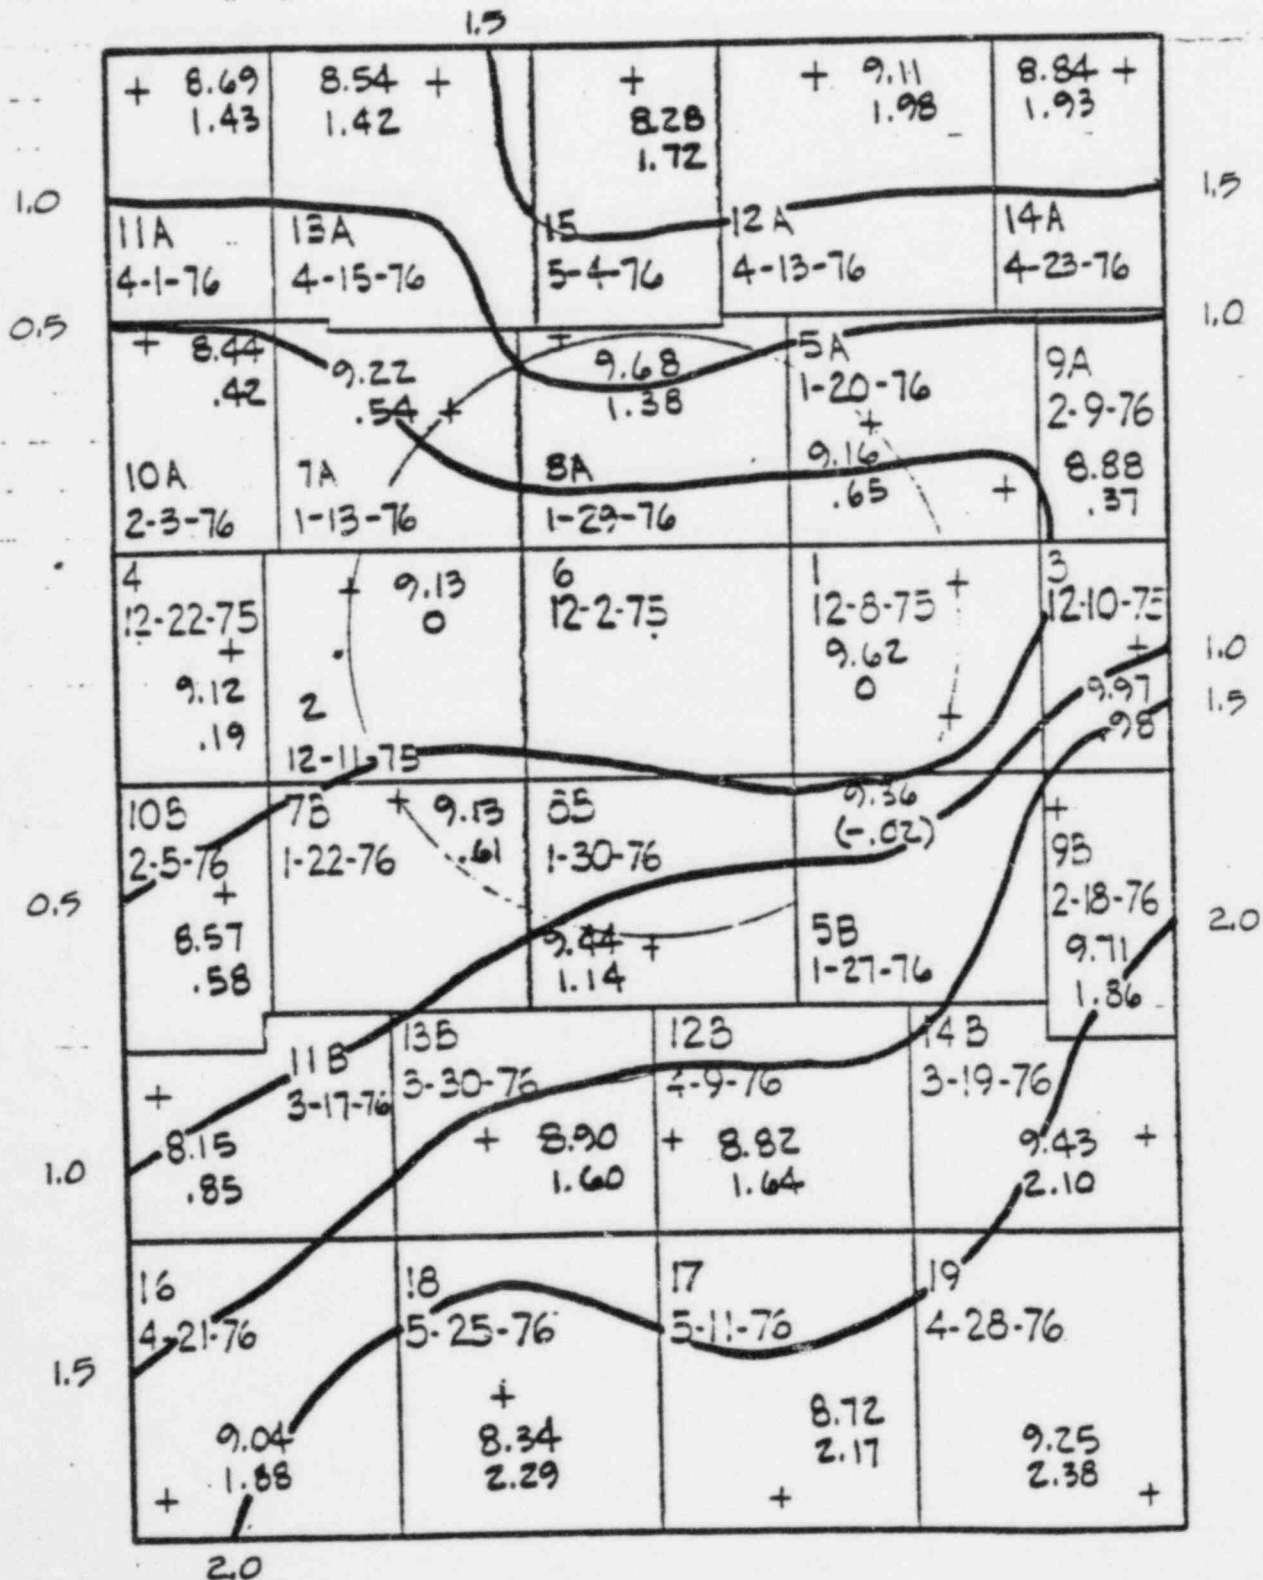
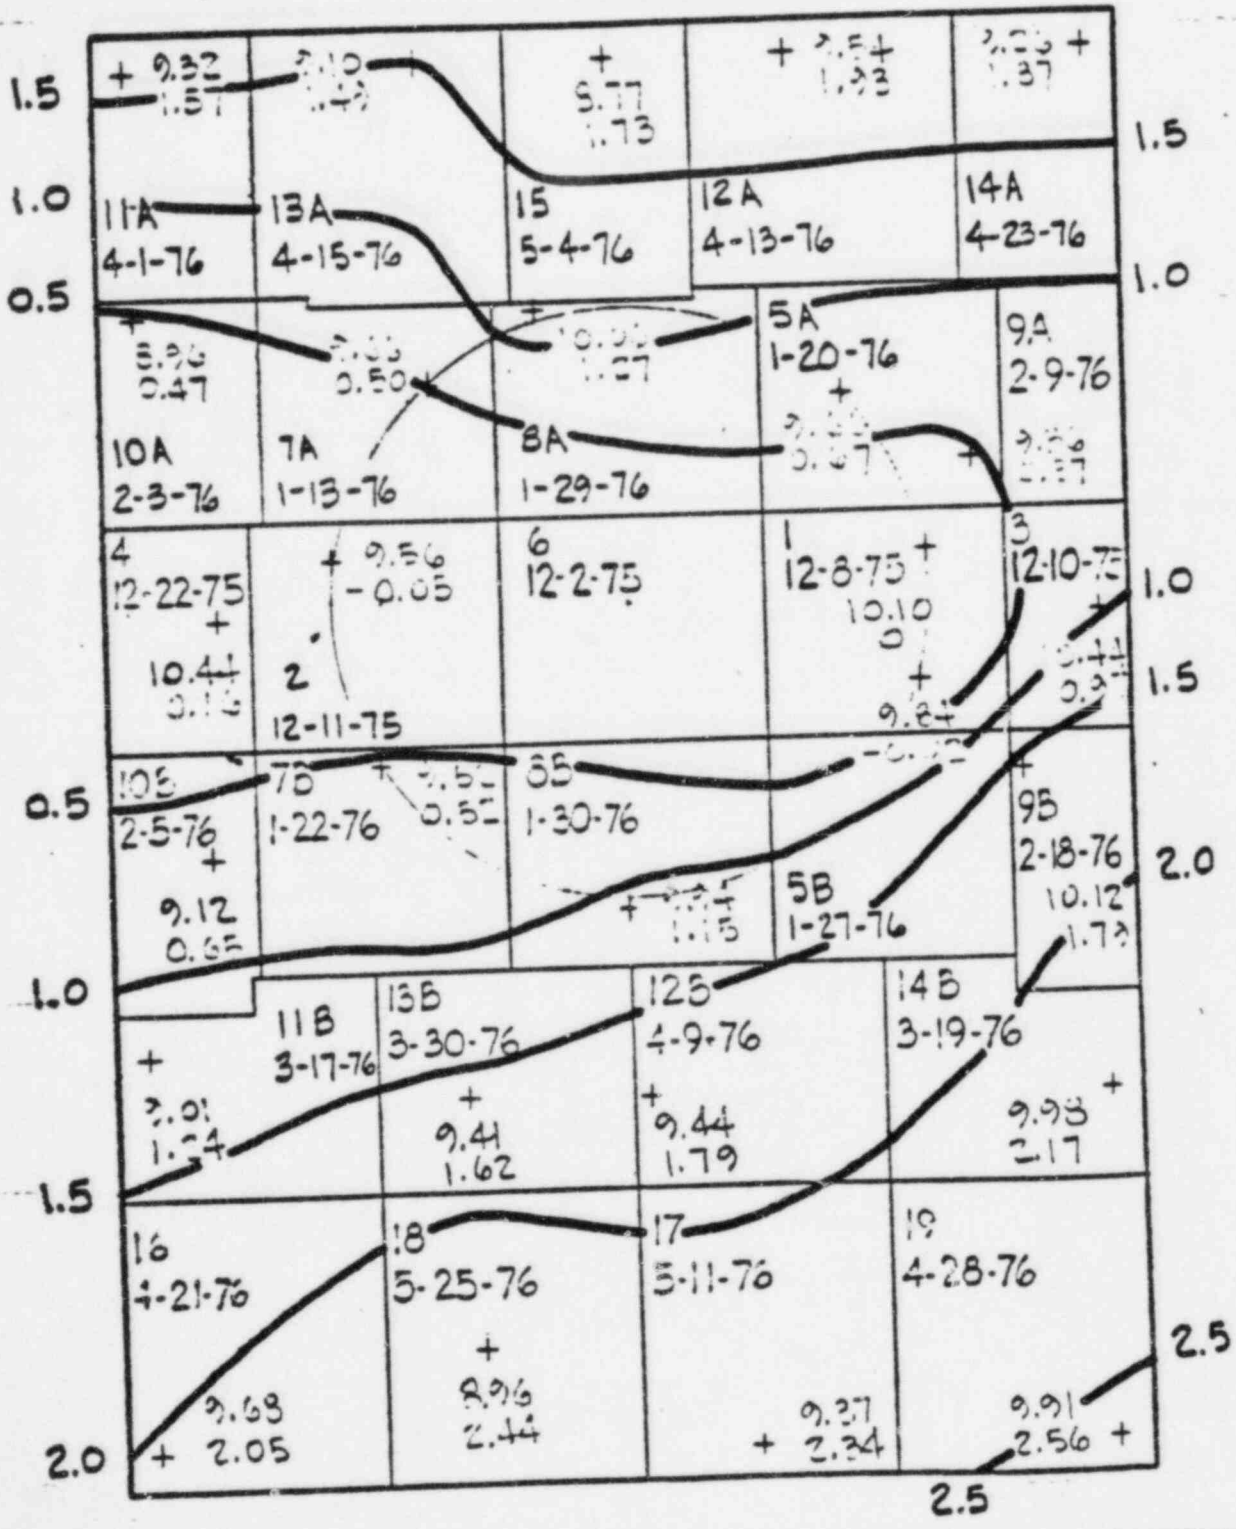
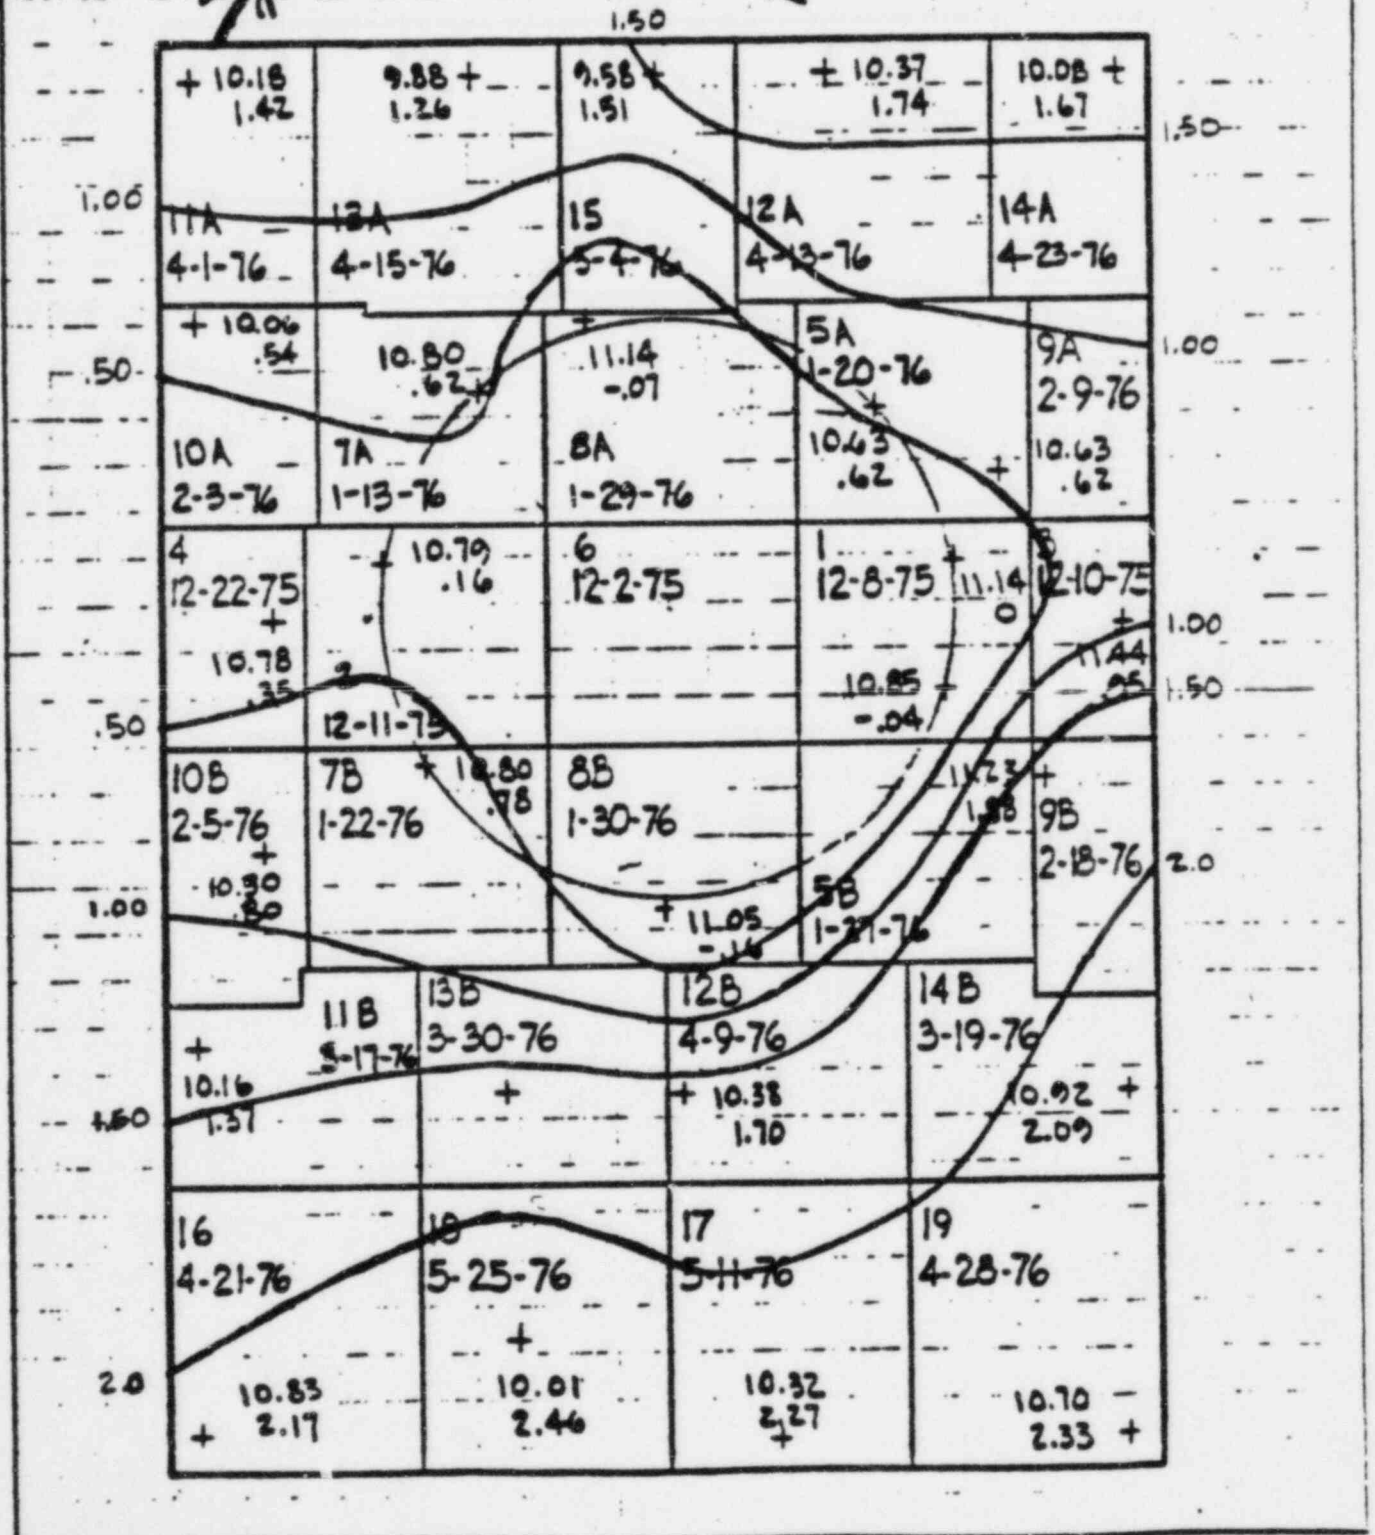
DIFFERENTIAL SETTLEMENT CONTOURS (IN)

18. According to the settlement contours shown in figure 2.5.118 the curvature is concave downward in both directions. This implies cracks on the top surface in both directions which would not penetrate all the way through.

In view of the above why did the water seep thru? Why doesn't the crack pattern match the given differential settlement?
