LOUISIANA POWER AND LIGHT COMPANY
WATERFORD STEAM ELECTRIC STATION
UNIT NO. 3

SUMMARY EVALUATION
STRUCTURAL SIGNIFICANCE OF BASEMAT
NONDESTRUCTIVE TESTING RESULTS

REVISION 1*

November 7, 1984
Ebasco Services Incorporated
Two World Trade Center
New York, NY 10048

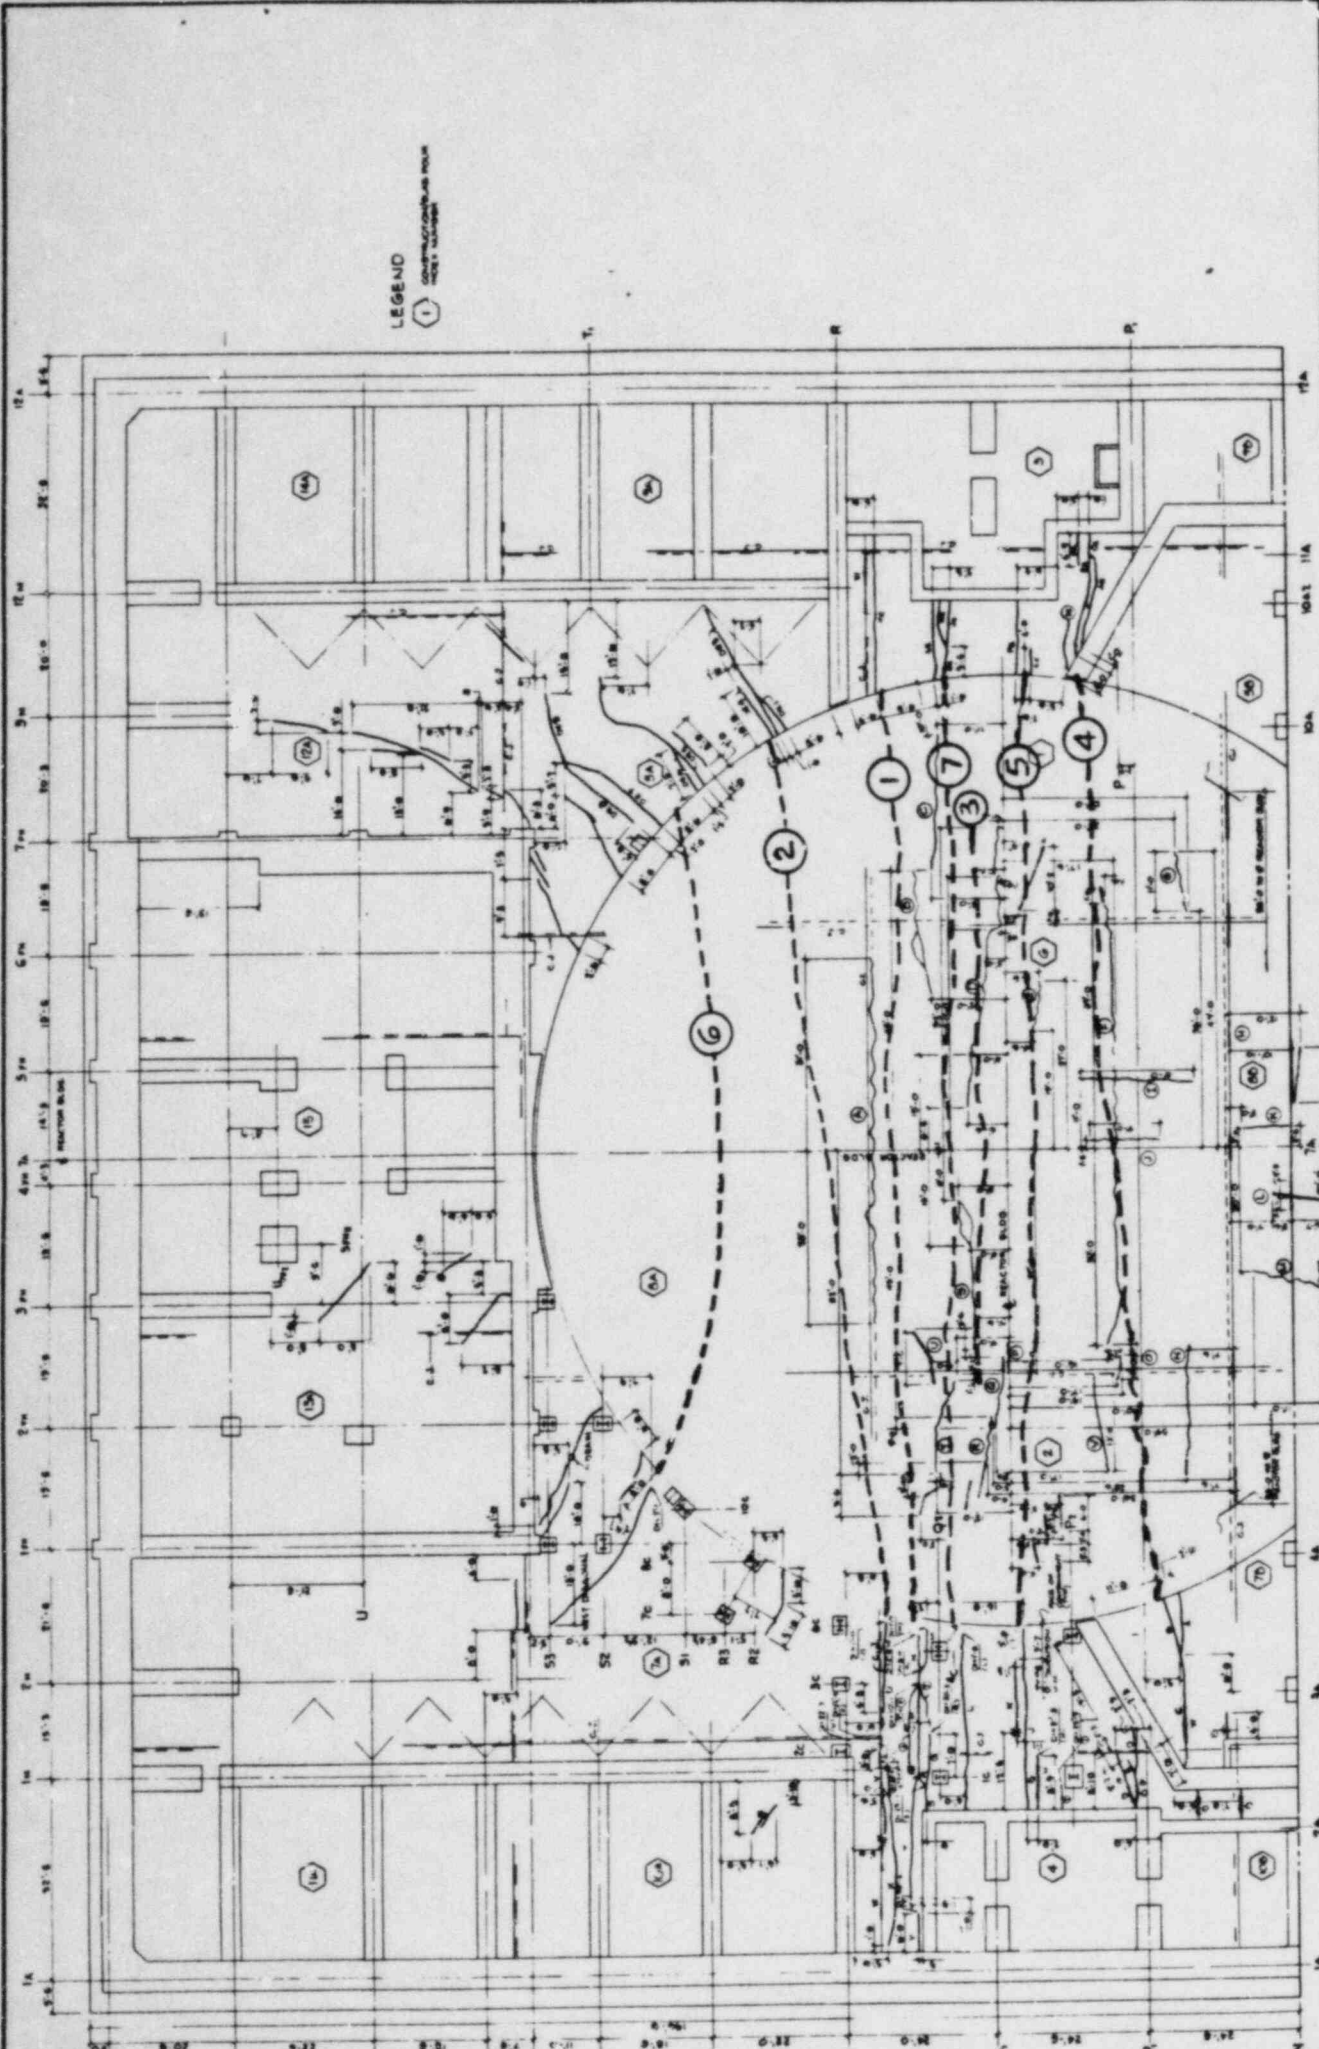
FIGURE 1

The majority of the hairline cracks are oriented in an east-west direction and located within a distance of thirty (30) feet from the east-west centerline of the RCB. Based on their appearance and nearness to each other they are grouped into 10 families:* 4 on the east side of the RCB and 6 on the west side of the RCB. Seven cracks beneath the RCB were also identified by NDT, four of these cracks (Numbers 1, 4, 5 and 7) appear to coincide with east-west cracks on either side of the RCB and probably are interconnected (Figure 1).

Other cracks are oriented in a northeast/southwest or northwest/southeast direction and they are grouped into a total of 7 families. Of these families, 4 of them were evaluated by NDT: 3 in the northeast and 1 in the northwest corners of the RCB. These cracks are also referred to as East or West Diagonal cracks in the Muenow and Associates, Inc. Report. Two of the cracks beneath the RCB (Numbers 2 and 6) appear to coincide with the East or West Diagonal cracks and probably are interconnected (Figure 1).

6. The crack pattern is predominantly in an east-west direction (Figure 1), localized in a band running east-west and centered near the RCB centerline. This band is within the region subjected to the most extreme convex curvature during the early stages of construction (Figure 2). This evidence indicates that the cracks resulted from early settlements of the basemat occurring during placement or shortly thereafter. The cracks lying in a northeasterly or northwesterly direction were influenced by the rigidity of the early placements of the RCB wall.

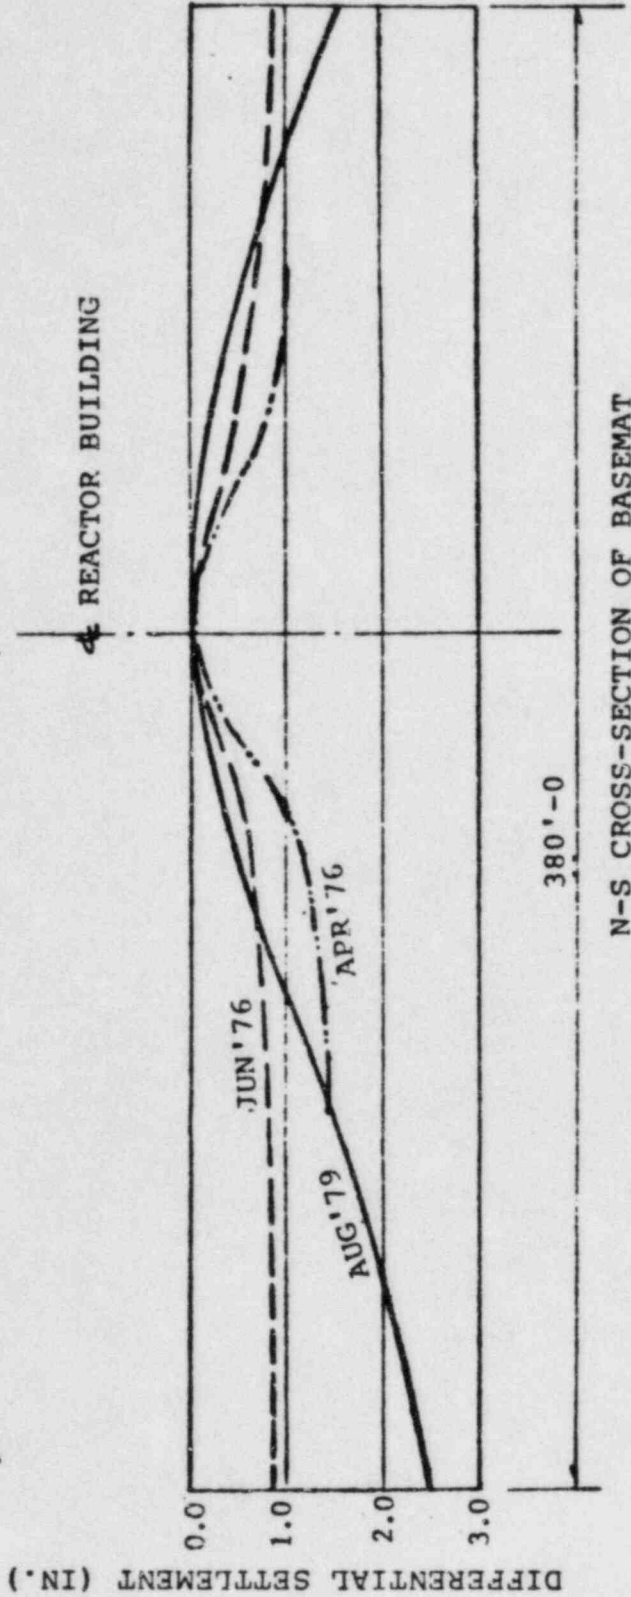
From the summary of NDT results, it is clear that the top cracks are greater in number than the bottom cracks. This reflects that the crack pattern generally followed the basemat flexure, which was found to be predominantly convex shape throughout the construction stages. The top cracks are located primarily in an east-west band centered on the RCB centerline. This matches closely the area of maximum convex flexure of the basemat in the early stages of construction as shown on Figure 2.
