WATERFORD 3 BASEMAT EVALUATION
STRUCTURAL & GEOTECHNICAL ENGINEERING BRANCH
DIVISION OF ENGINEERING

Geotechnical Engineering Evaluation of Concrete Cracking in the Basemat Waterford No. 3

Structural Engineering Evaluation
of Concrete Cracking in the Basemat
Waterford Unit No. 3
John Ma, Structural Engineer

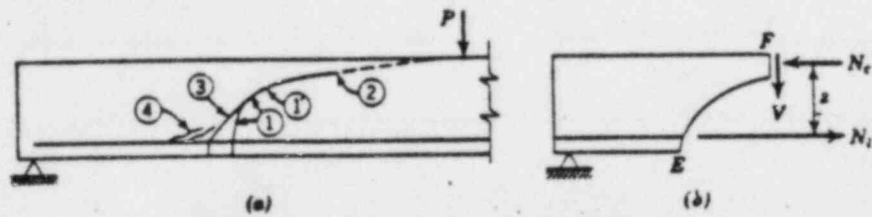
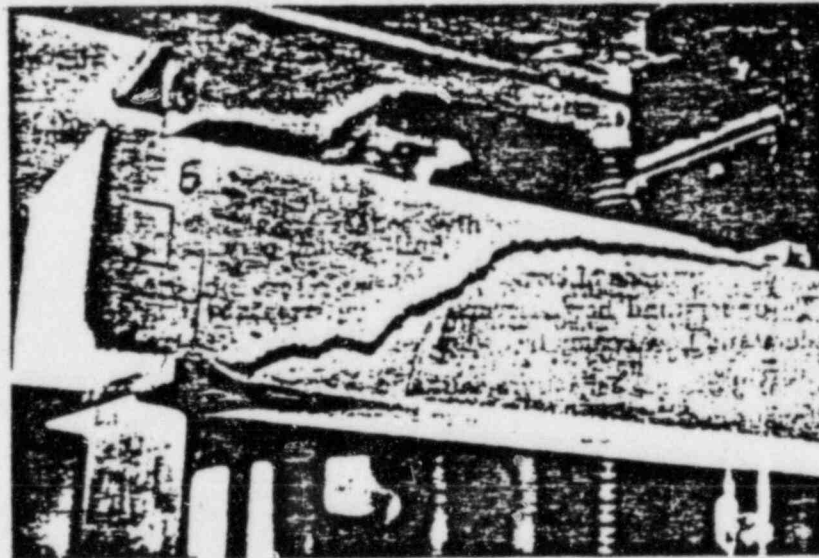
FIGURE 5.2 Development of a diagonal tension crack when loads and reactions are far apart. (a) Diagram showing sequence in crack formation. (b) Equilibrium sketch for portion of beam. (c) Failure of beam. The failure crack developed from the flexural crack faintly seen about one beam depth from the end. This crack turned gradually into the diagonal crack, as at 1 in the sketch. The final wide crack is comparable to 2-1-3-4 in (a) (The failure picture has been inverted to make this comparison easier).

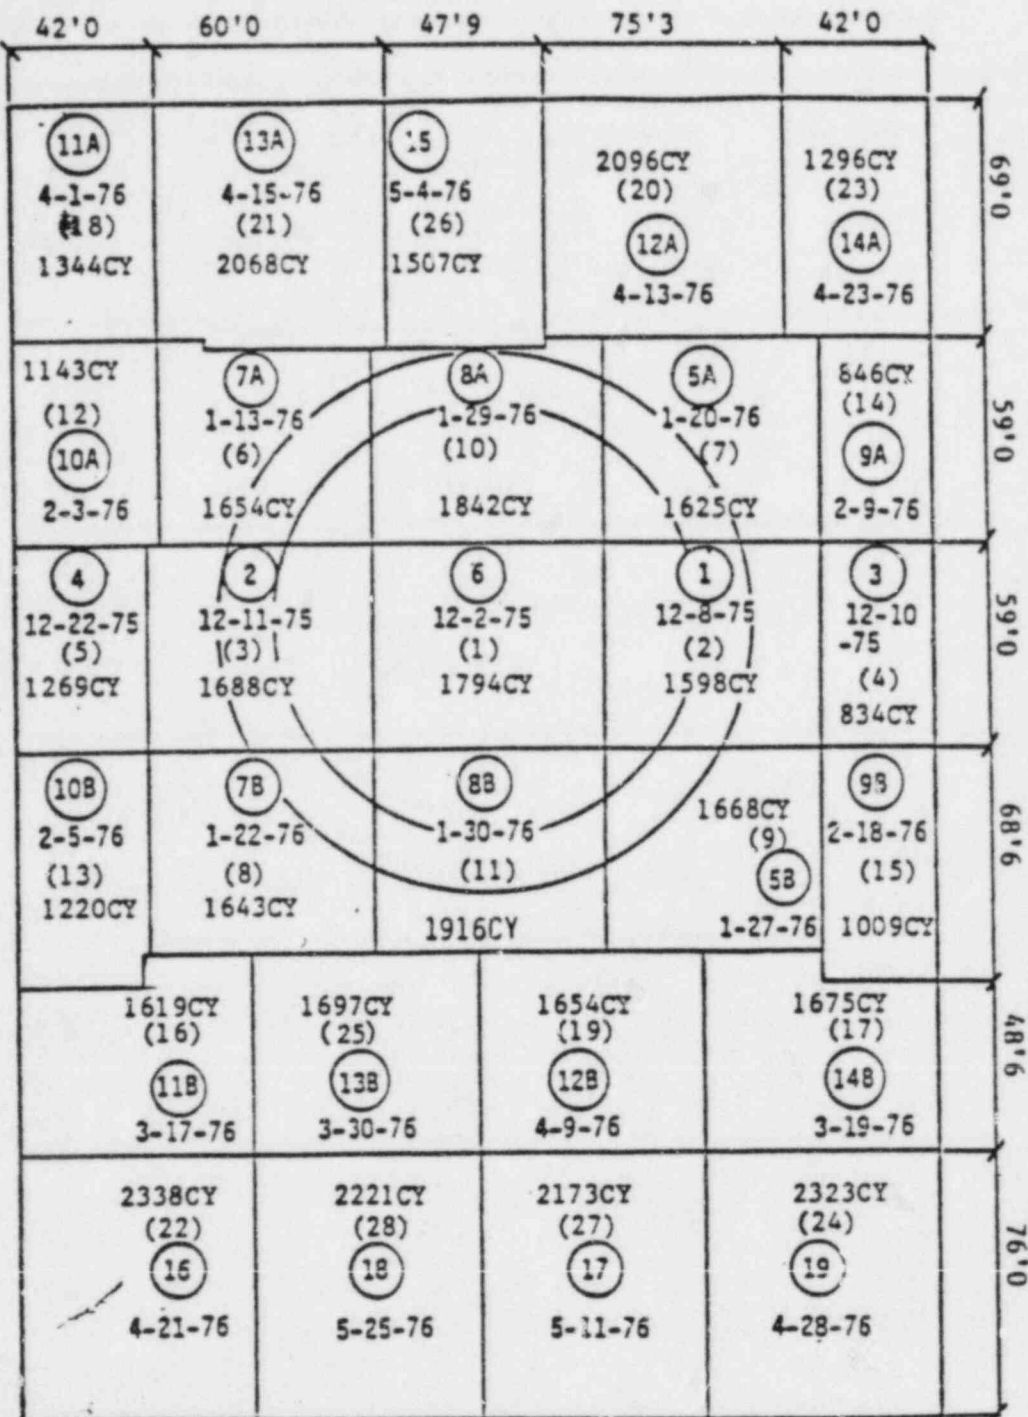
ENCLOSURE 3

Earthquake (SSE), while in Block 1 (see Enclosure 3) they are 52 k/ft for normal operating loads and 210 k/ft for loading combinations including SSE. It is also reported that the shear capacity was 274 k/ft for both blocks with shear reinforcing steel contributing 98 k/ft and concrete 176 k/ft. Based on the above numbers, it is shown that the diagonal tension capacity is substantially greater than the diagonal tensile stresses under normal operating loads. Under the DBE (SSE) condition, there is still some margin left between the shear stress generated under DBE and the ultimate shear (diagonal tension) capacity. The lack of physical information on the potential existence of diagonal tension cracks in the mat combined with a yet uncalculated diagonal tension stress due to uneven settlement of foundation soil and differential ground movements, as noted before, makes it difficult to draw conclusions on the adequacy of the above noted margin. Therefore, additional analysis, which accounts for the actual soil condition during concrete-placement, should be performed and non-destructive testing should also be used to detect and locate any major diagonal tension cracks. The information, thus obtained, should provide a high level of confidence in assessing the adequacy of the cracked mat.
