PROGRAM FOR THE NON DESTRUCTIVE EXAMINATION
OF CRACKS IN THE WATERFORD 3 BASEMAT

L.P&L WATERFORD No 3
COMPOSITE ISOMETRIC
WALL & MAT CRACKS

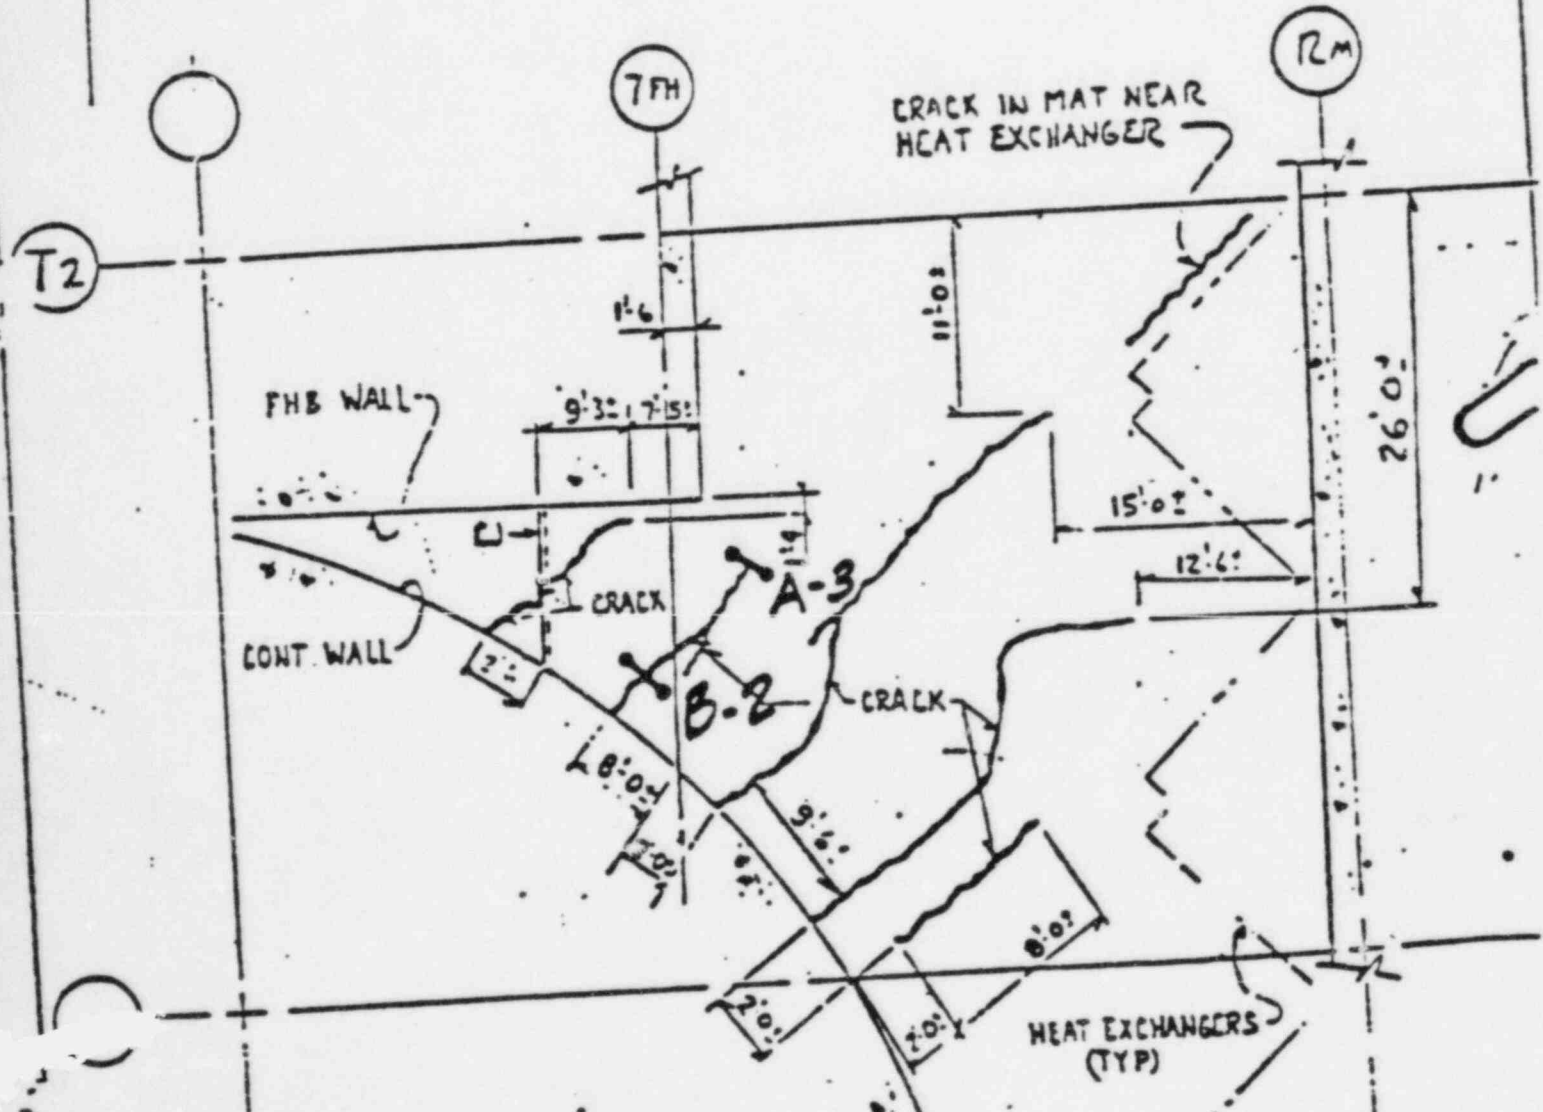
'PLAN AT EL - 34.75'

- 1 NO REPAIR.
- 2 NO FINISH
- 3 SOME EVIDENCE OF SEEPAGE
4. HAIRLINE CRACK

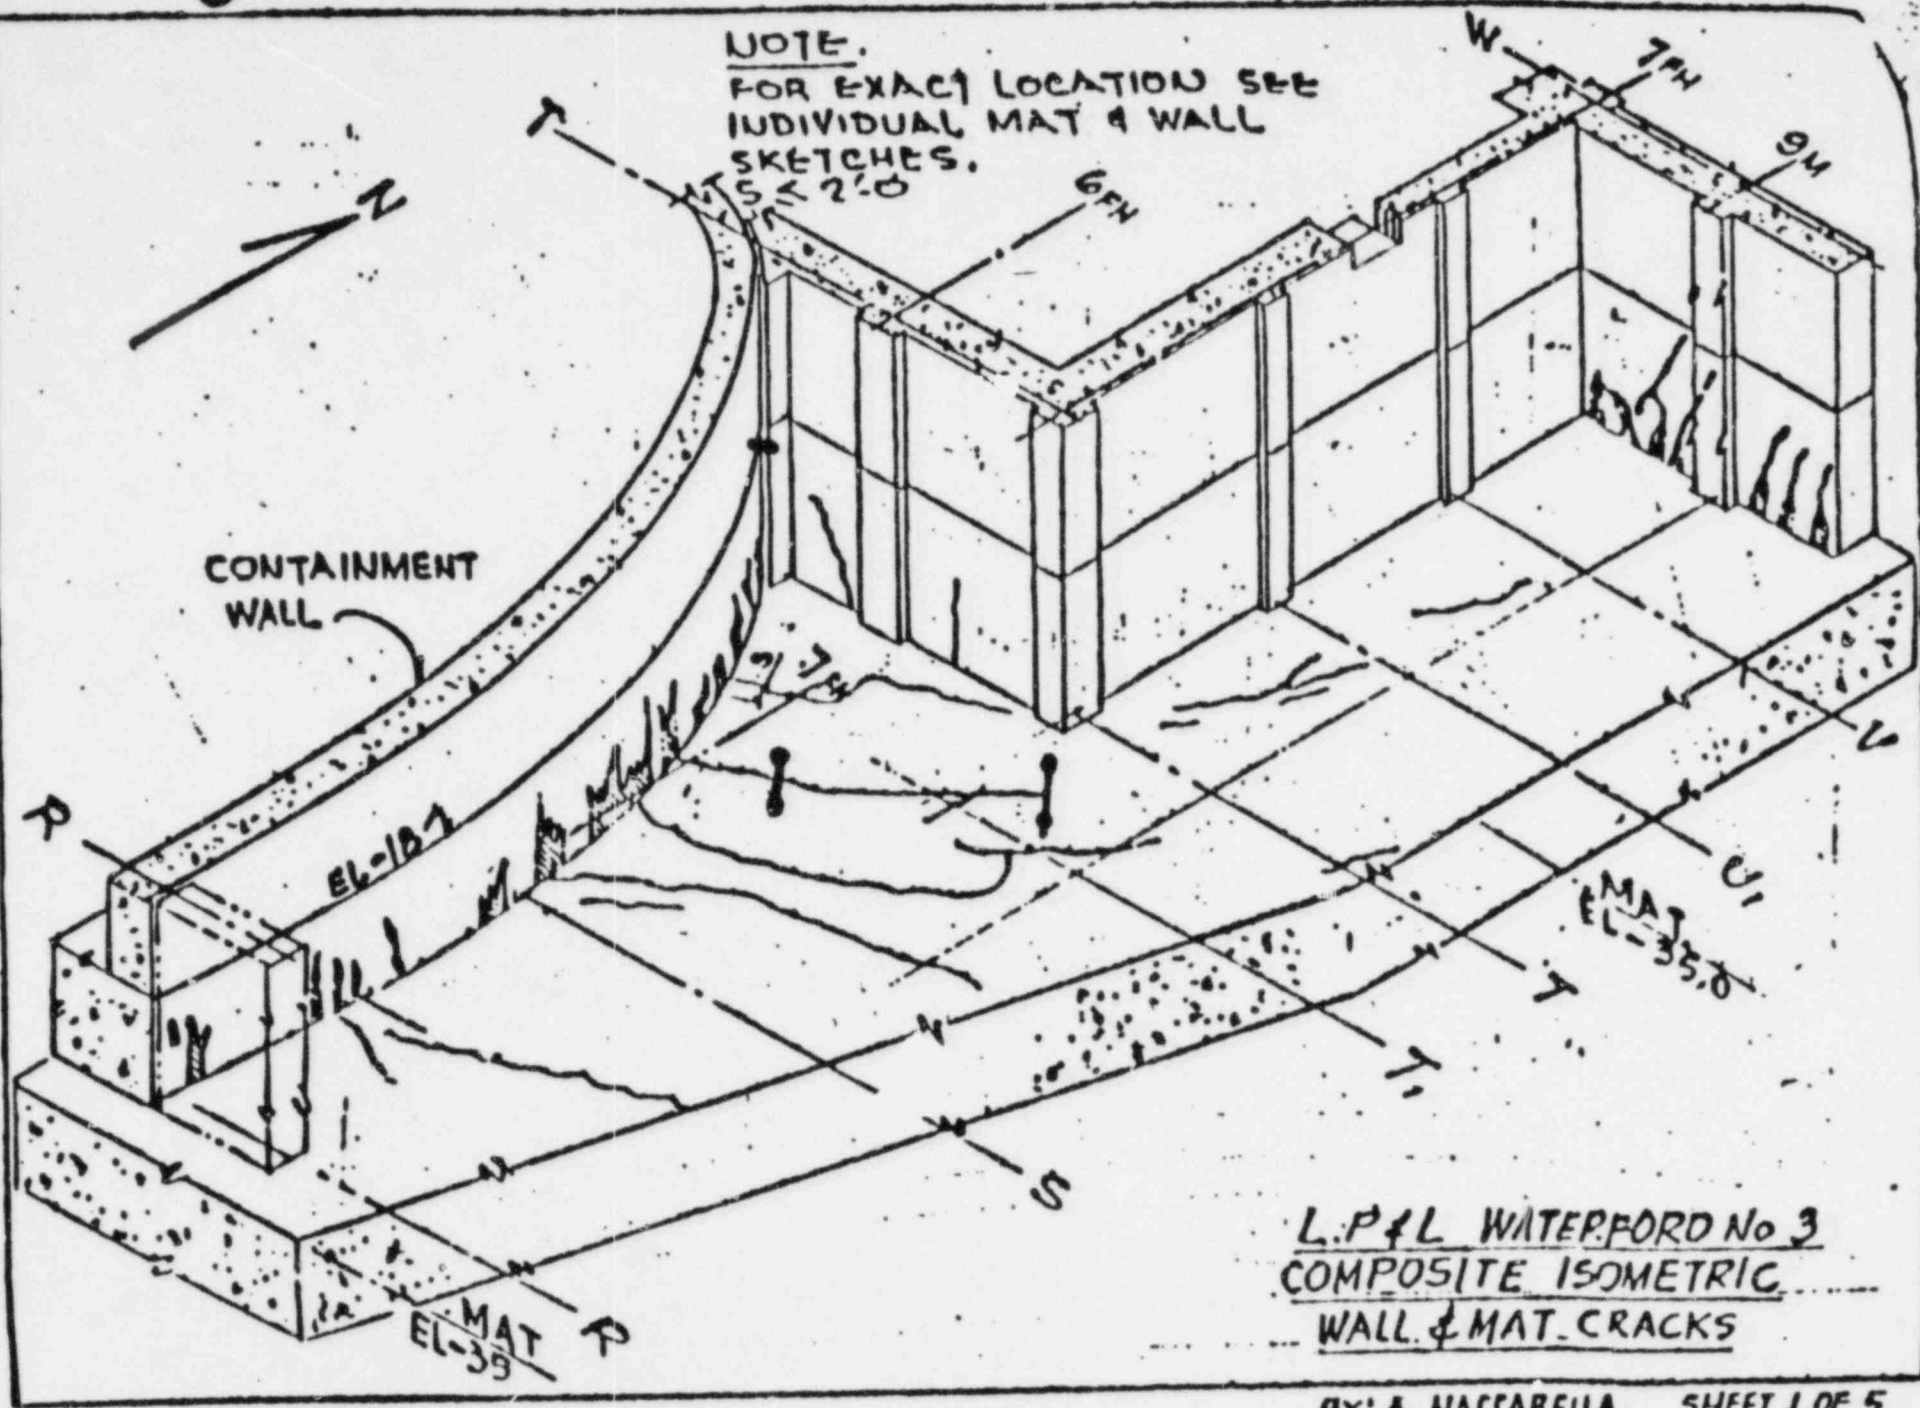
NOTE:
FOR EXACT LOCATION SEE
INDIVIDUAL MAT & WALL
SKETCHES.
S < 2'0

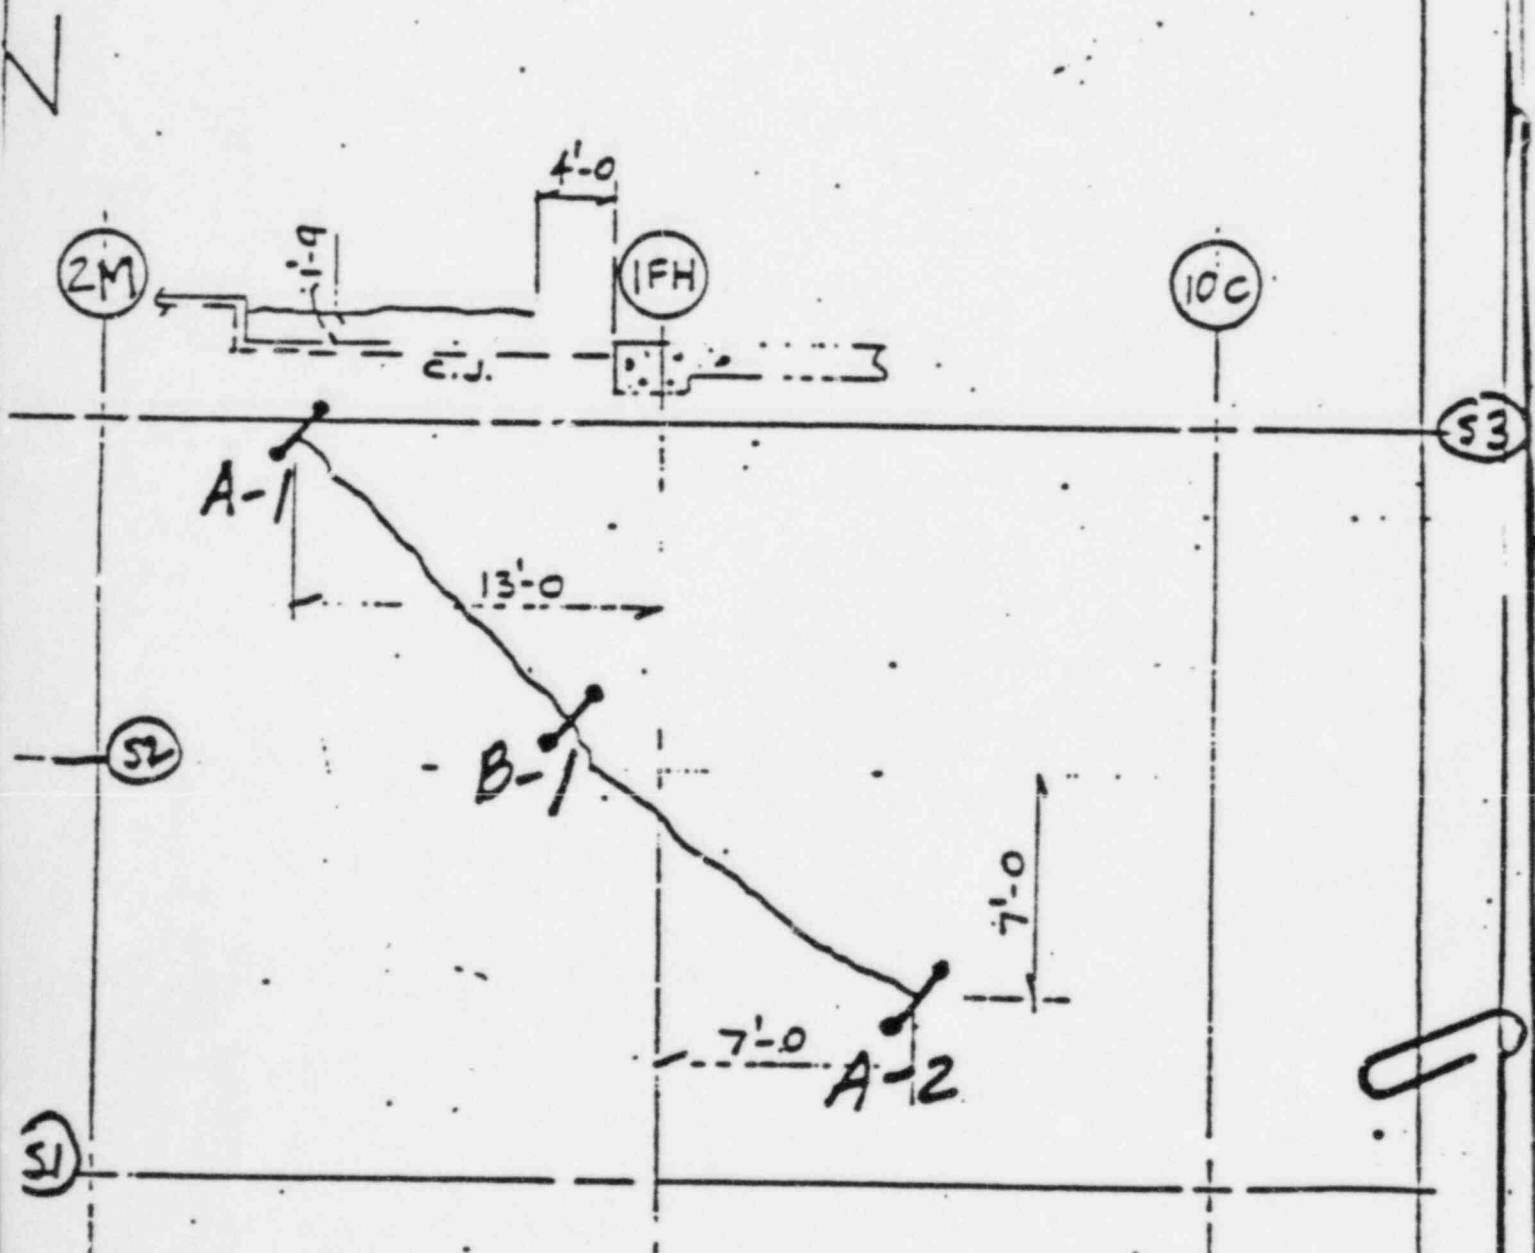
Attachment No 3 SHt 1 of 2

- NOTES:
1. NO REPAIR
 2. NO FLOOR FINISH
 3. NO EVIDENCE OF SECPAGE
 4. HAIRLINE CRACK

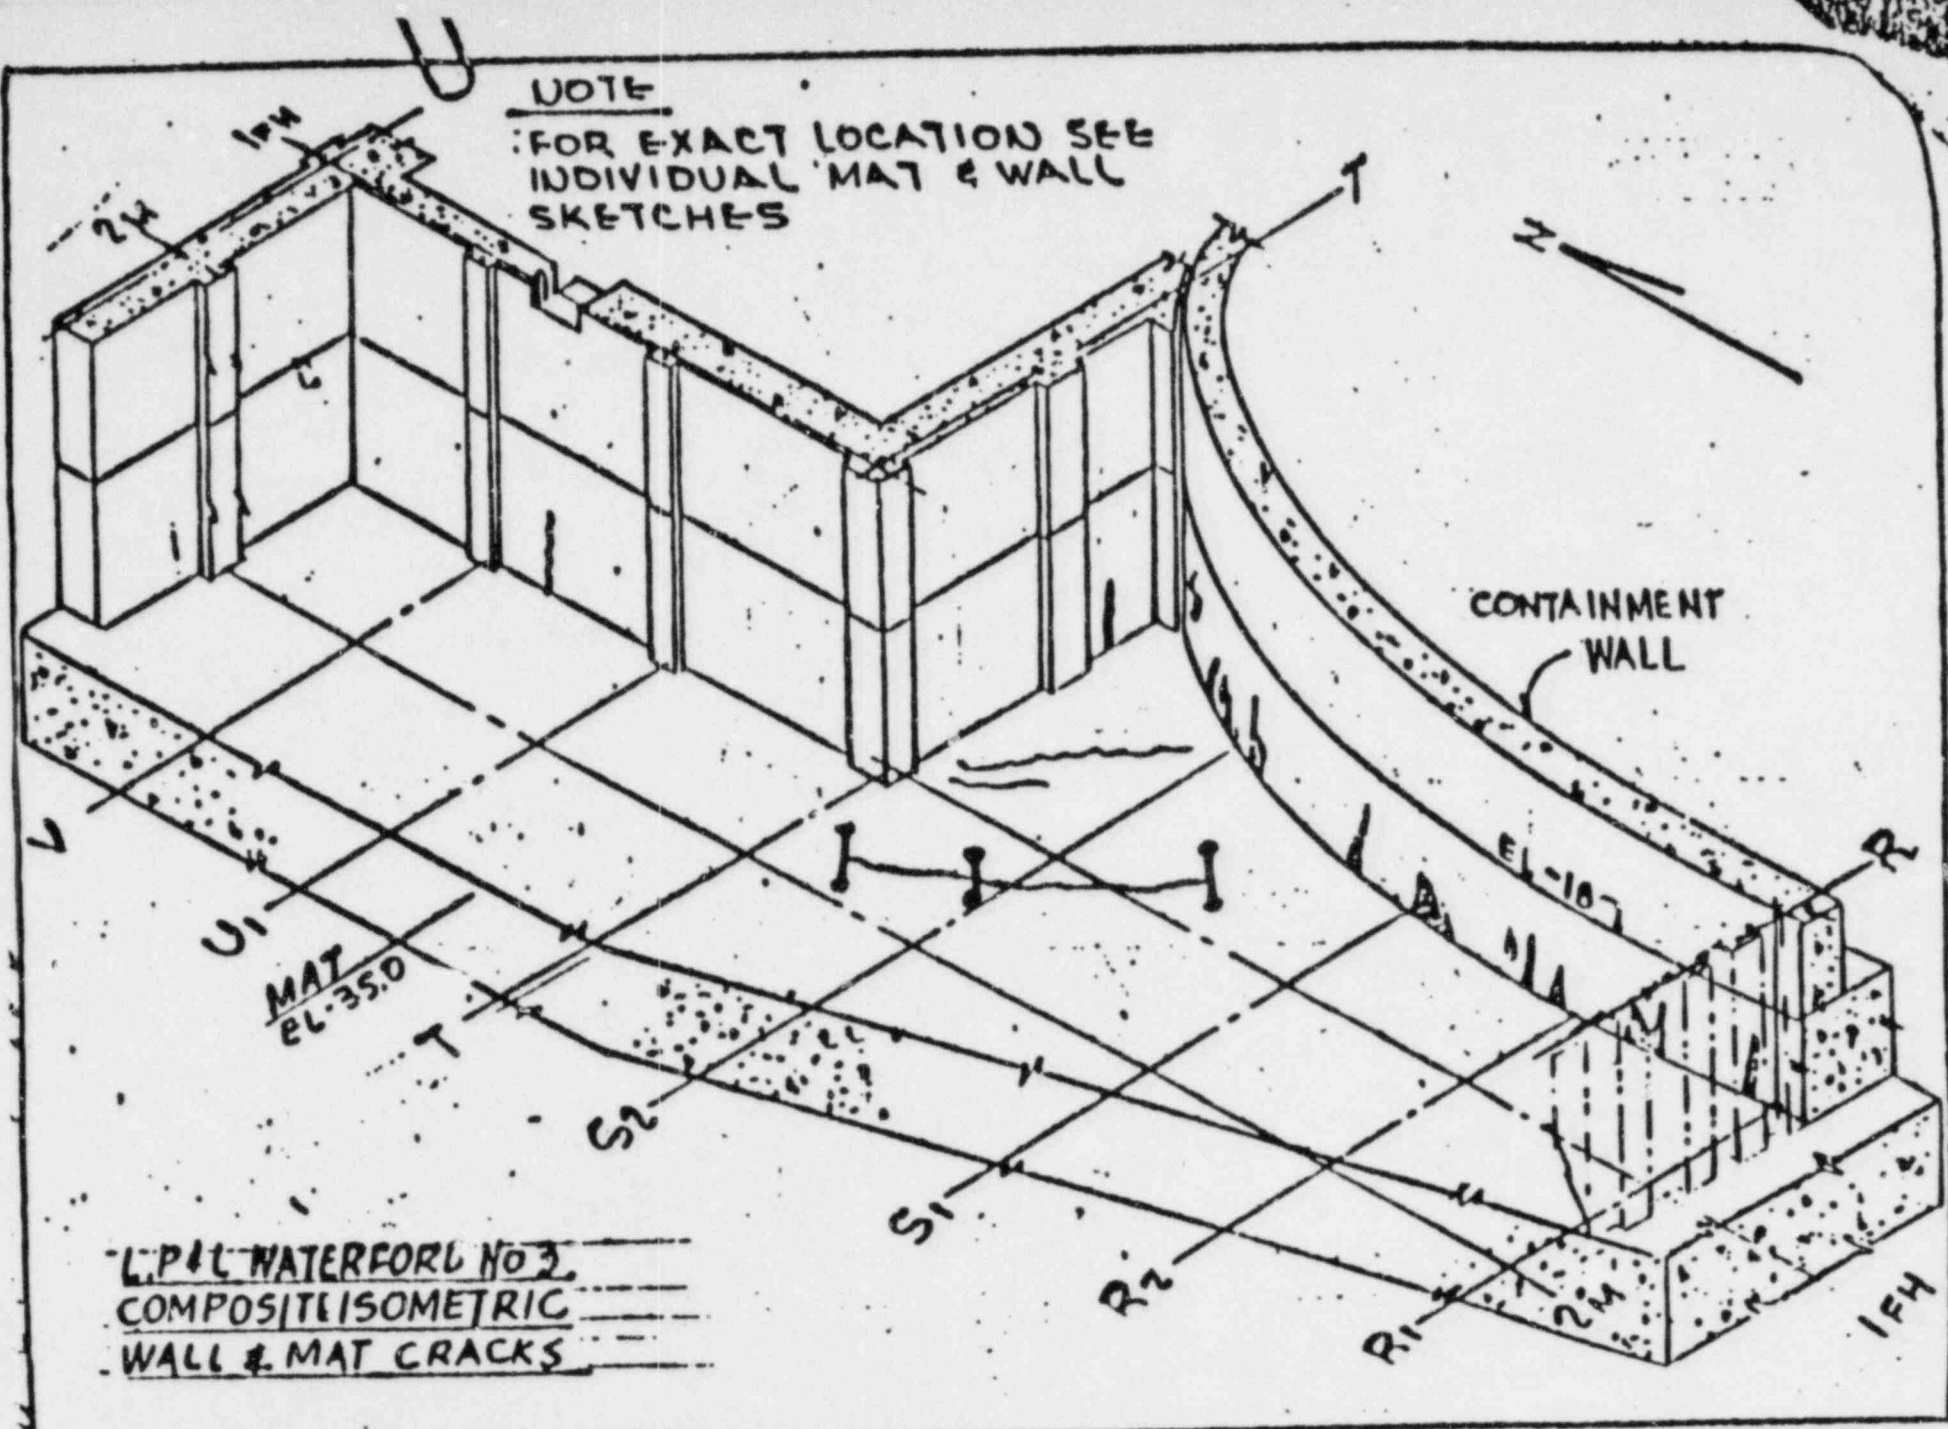
L.P.I.C. WATERFORD No 3
 COMPOSITE ISOMETRIC
 WALL & MAT CRACKS

NOTE
 FOR EXACT LOCATION SEE
 INDIVIDUAL MAT & WALL
 SKETCHES

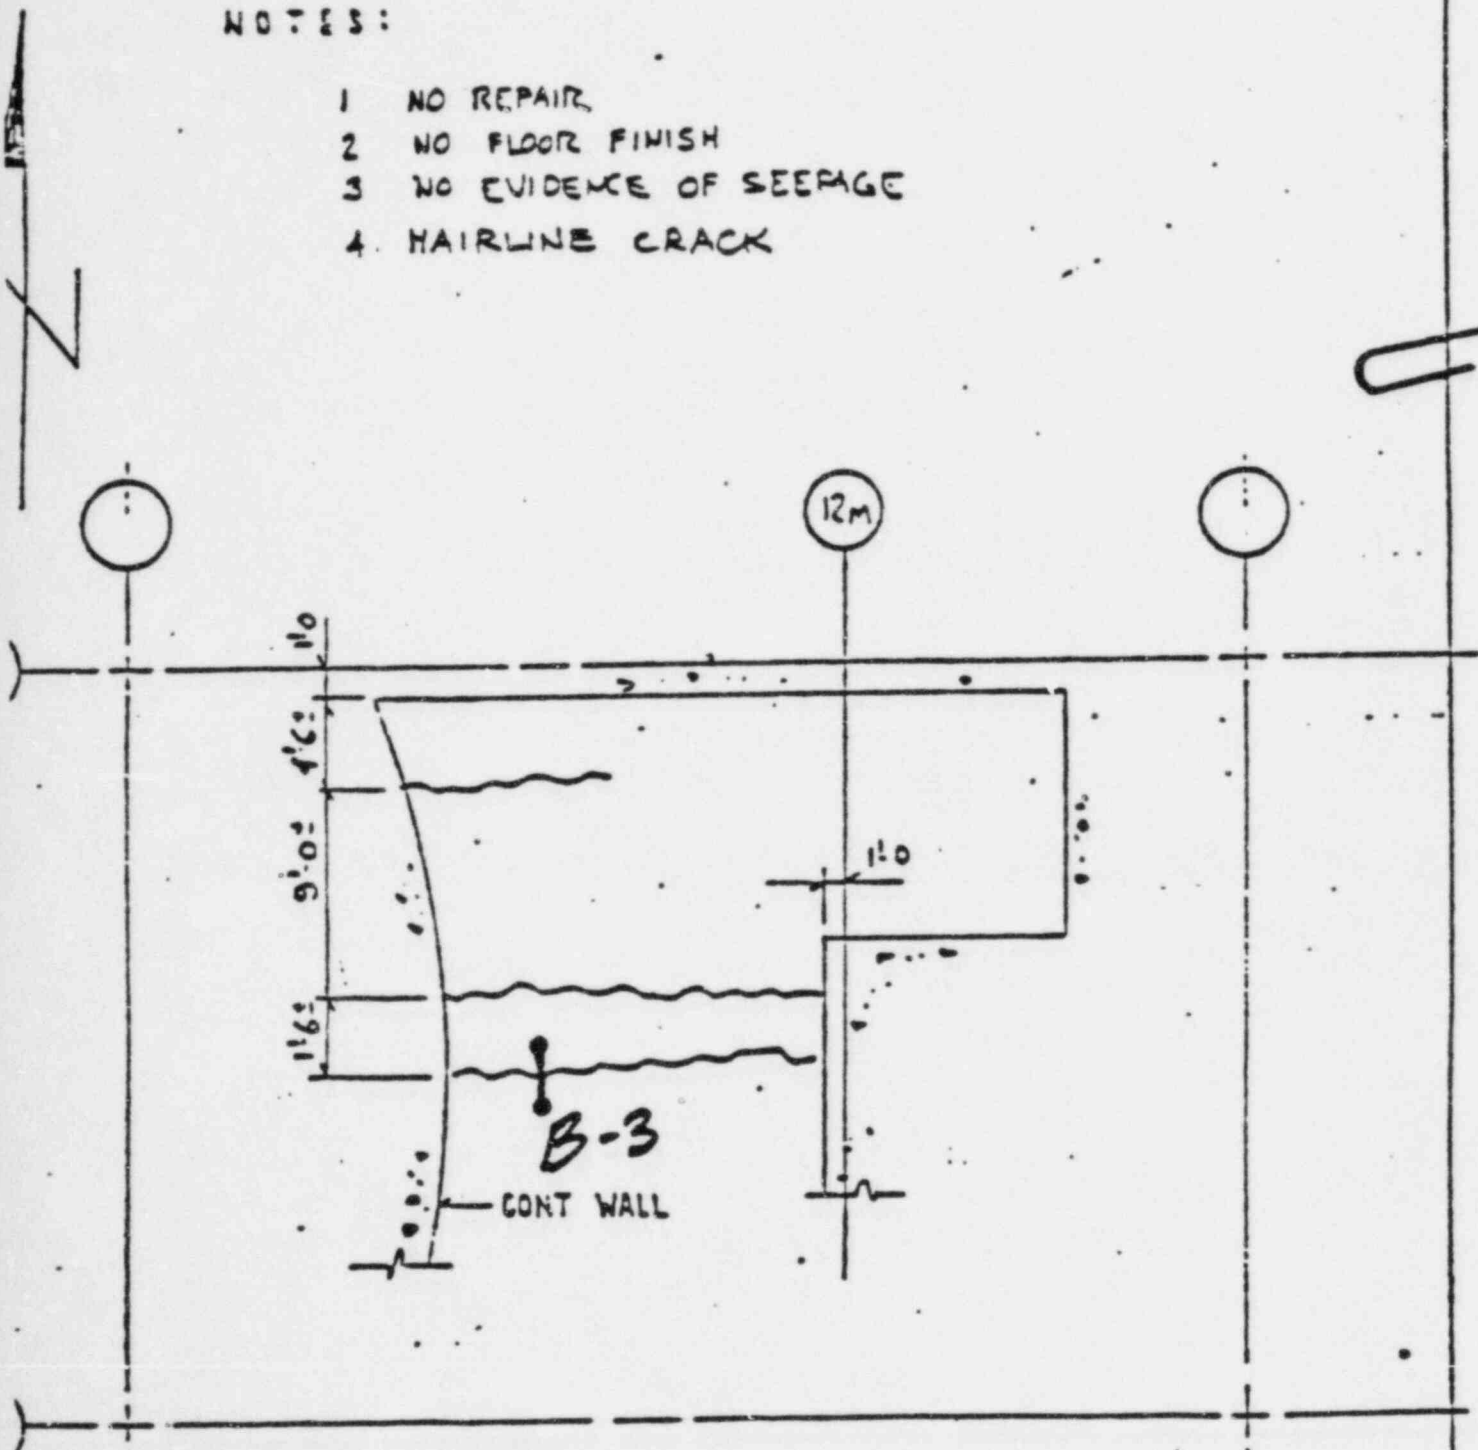
Attachment No. 4 Sht 1 of 2

1. NO REPAIR
2. NO FLOOR FINISH
3. NO EVIDENCE OF SEEPAGE
4. HAIRLINE CRACK

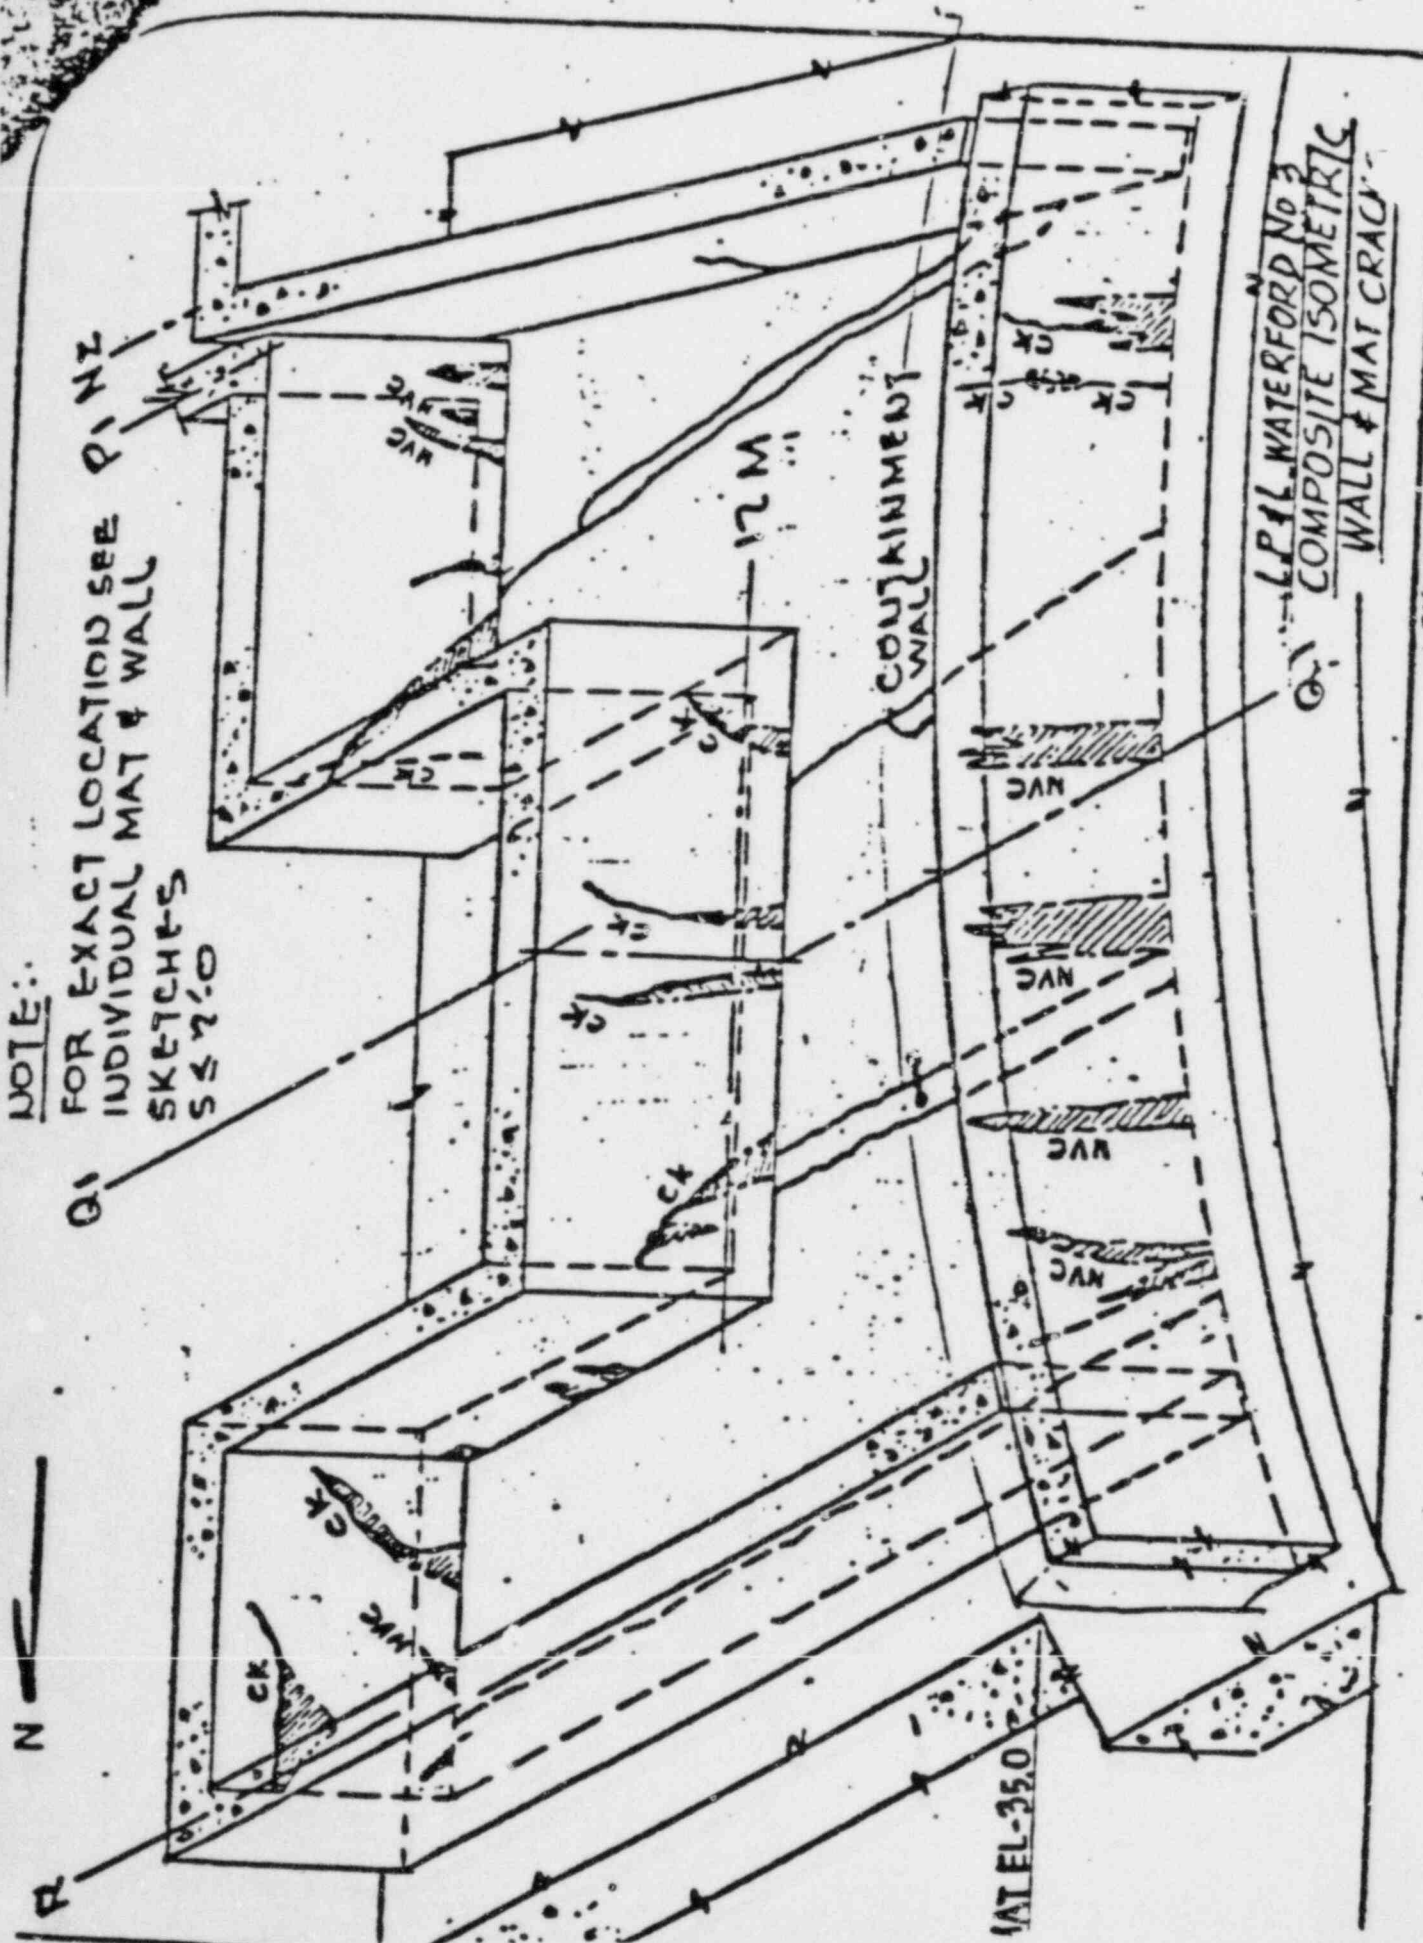
LP14 WATERFORD No 3
COMPOSITE ISOMETRIC
WALL & MAT CRACK

FOR EXACT LOCATION SEE P. 1 NZ
INDIVIDUAL MAT & WALL
SKETCHES
S 27'0
