EA-142 PROTOTYPE TEST

Supplement to
NUCLEAR PACKAGING, INC.
ENVIRALLOY
HIGH INTEGRITY CONTAINERS

February 1985

Enviralloy 190 Cubic Foot Prototype Drop Test

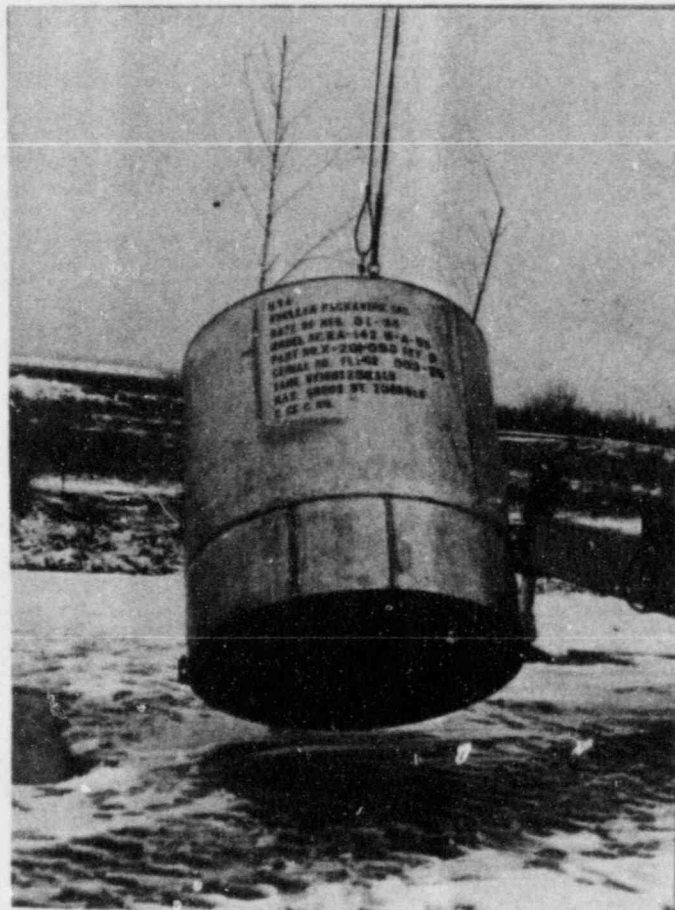
Figure 2 Lug Test

A successful lug load test was also performed on this container. Each lug was load tested to 300% of its rated capacity. All three lugs were used to lift the container by its full weight one lug at a time.

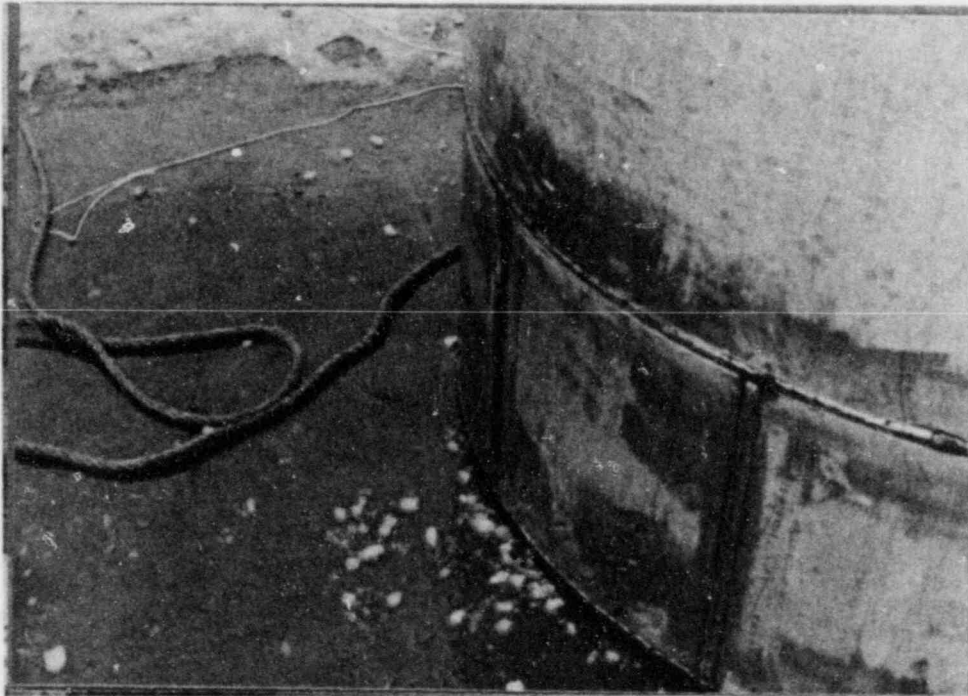
Figure 7 After Four Foot Bottom Corner Drop

The container did not sustain any significant damage from any of the drops. The only damage that was sustained by the container was a slightly dented lift lug on the top due to the four foot drop on the top straight down, and some damage on the corners due to the four foot drop. The lifting lug was not bent or deformed sufficiently to prevent its use. The container was slightly bowed due to the corner drop on the four foot drop. Also the ends, top and bottom were plastically deflected from the corner drop. None of these deformations were in the excess of 1/2 inch. The container did not sustain any loss of contents as a result of any of these drops. The container was not damaged either on the outside or on any of the inside supports, such that it would prevent its use. The container was cleaned up after the drop and all welds were magnetic particle tested to detect any damage to the welds. No damage was detected.

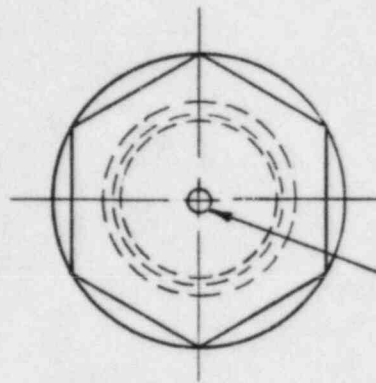
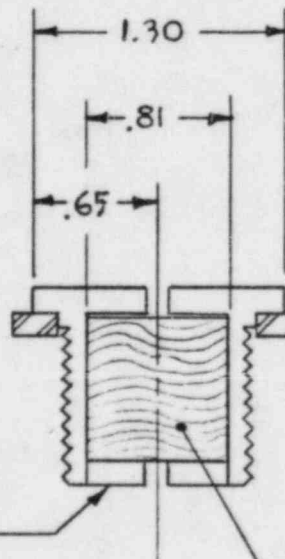
ATTACHMENT 1

The container was drop tested with the polyethylene and carbon optional seal as shown in Attachment 1. The seal was located in the center of the lid. The seal did not fail or cause any release of contents.
