Subject: LaSalle County Nuclear Power Station Unit 1
L1R07 Core Shroud Inspection Results
NRC Docket No. 50-373

Response to Generic Letter 94-03

ATTACHMENT 1
SHROUD SKETCHES

WELD H4 EXAMINATION SUMMARY SHEET

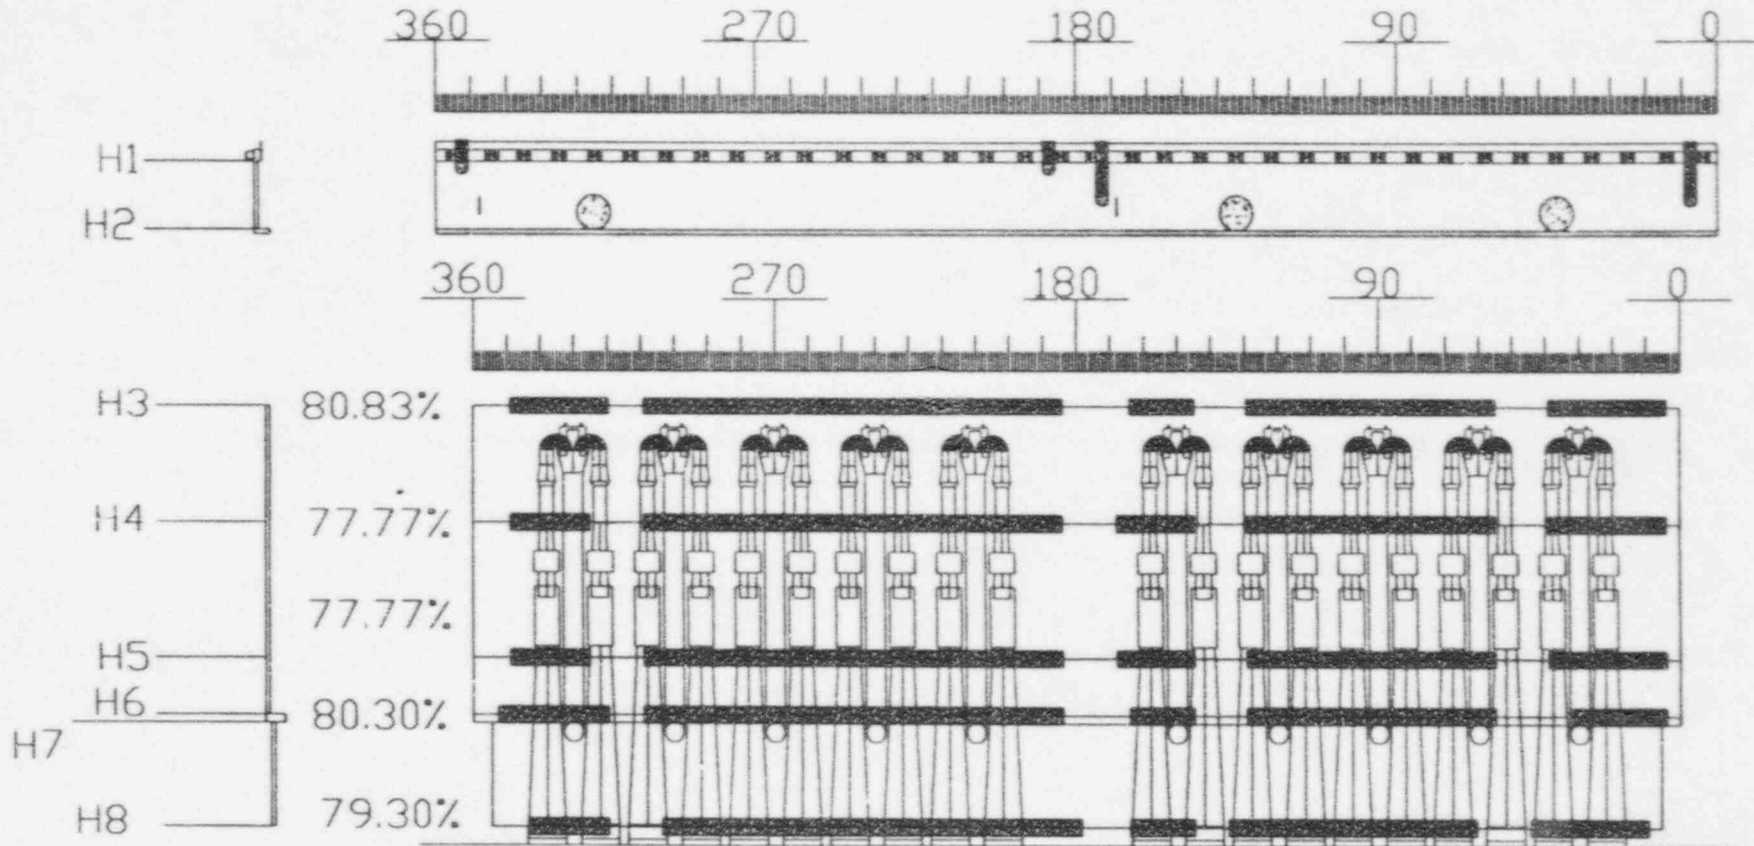
EFFECTIVE COVERAGE FOR
H3, H4, H5, H6 & H8

The ligaments into which each effective length was split are represented pictorially (in plan views and in a roll out) for each weld on the sketches of Attachment 1. A conversion factor of 1.81" per degree is applicable to welds H3, H4, H5, and H6 based on a 207.12" outside diameter for the Core Shroud at these elevations. A conversion factor of 1.75" per degree is applicable to weld H8 based on a 200.75" shroud outside diameter at the H8 elevation.

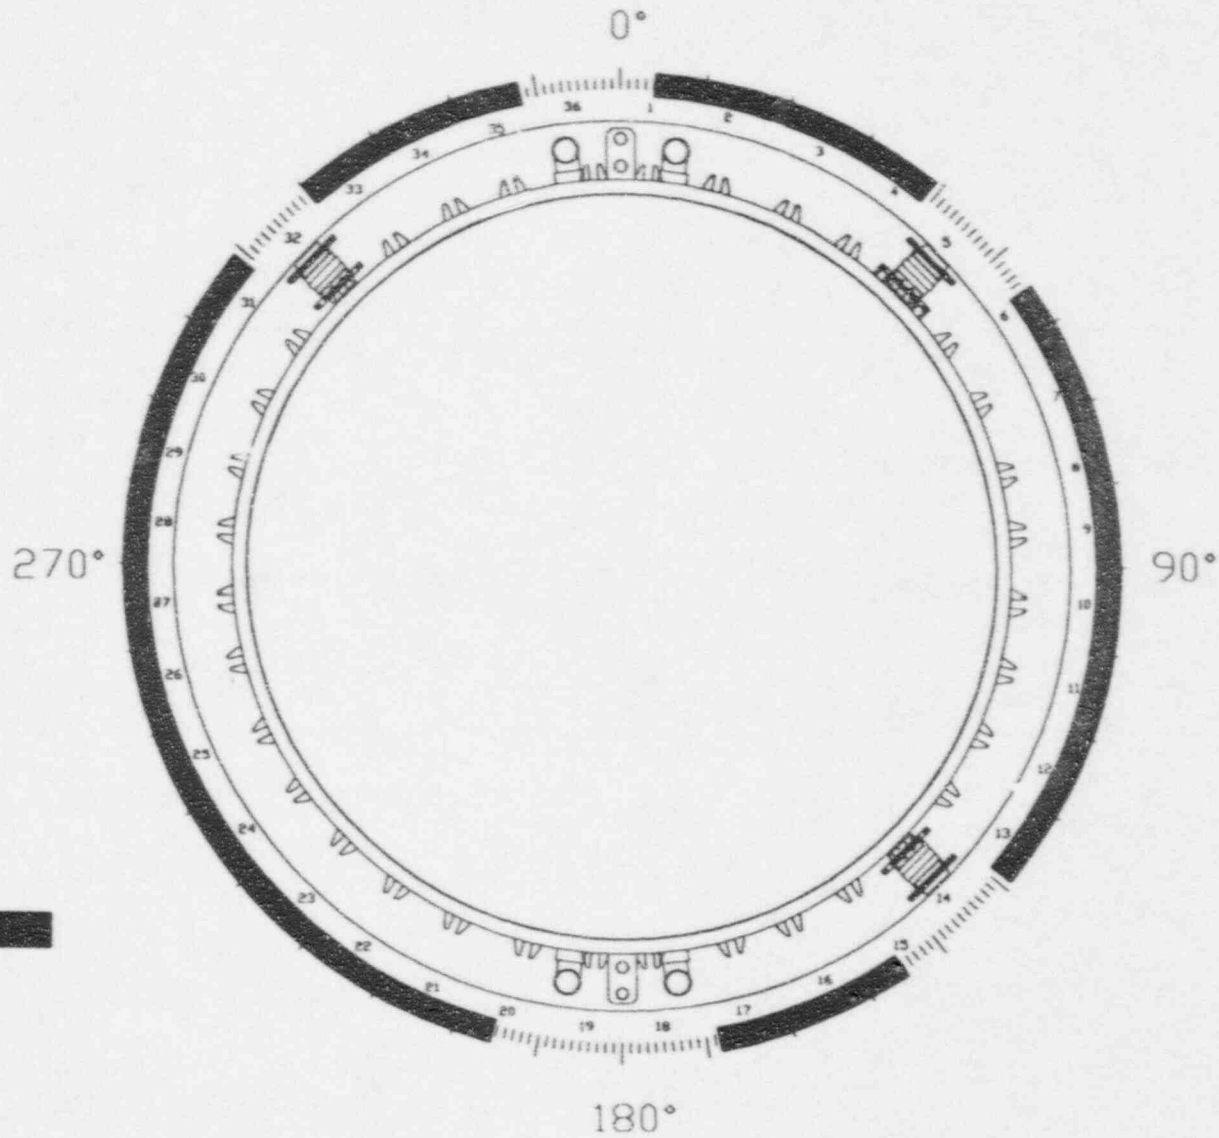
LASALLE UNIT I SHROUD INSPECTION H3 WELD COVERAGE MAP

Weld H3 - 526.7" examined representing 80.83% of the total weld length.

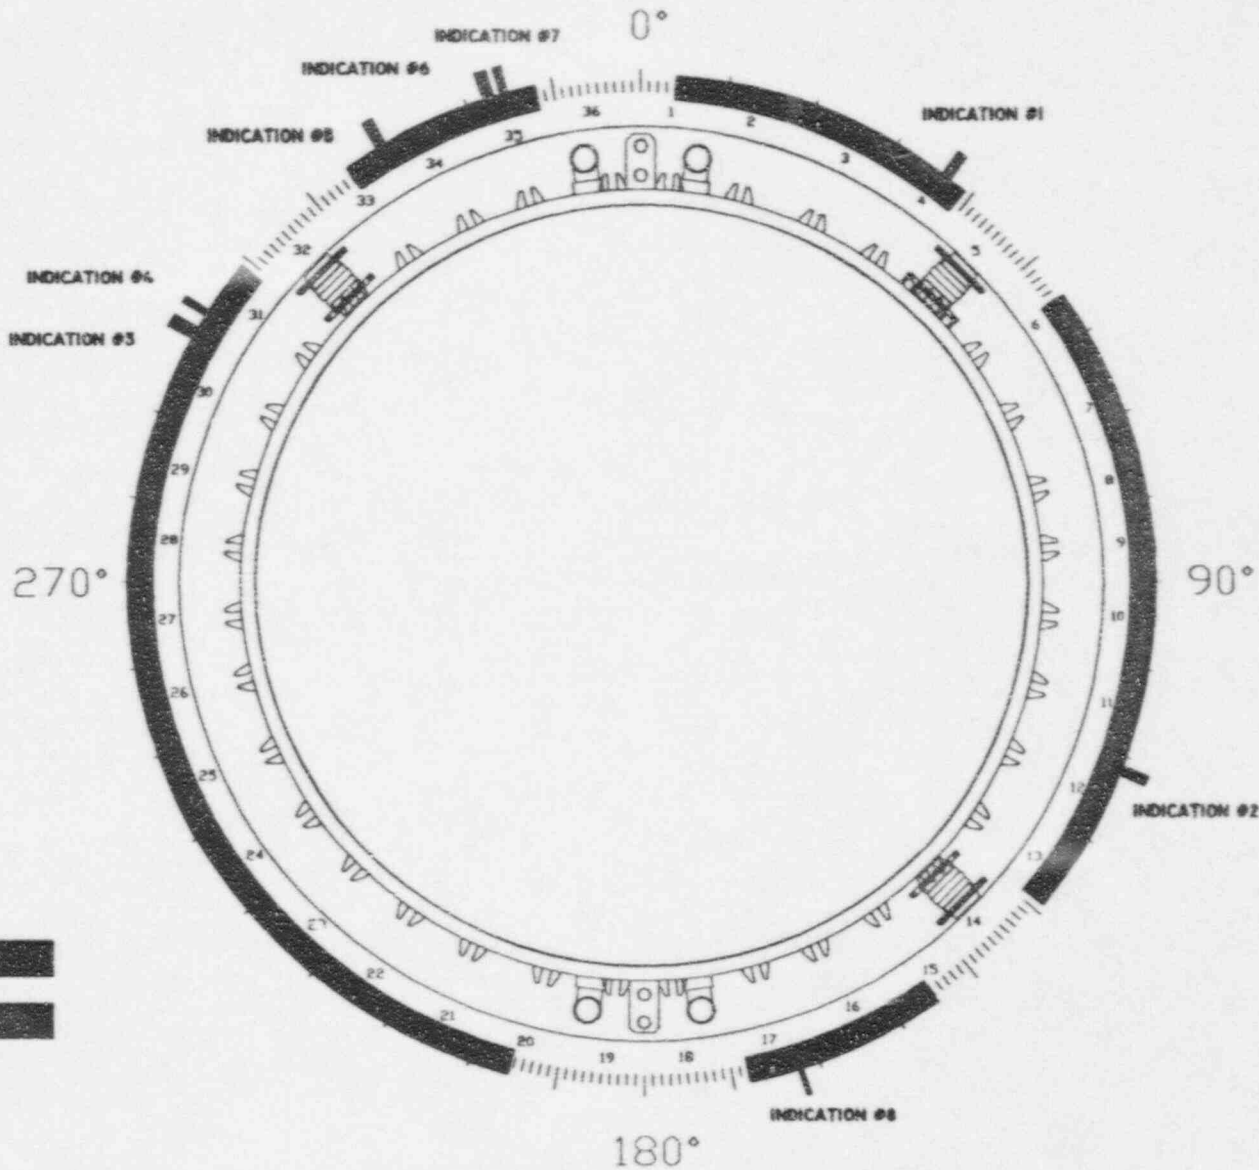
LASALLE UNIT I SHROUD INSPECTION H4 WELD FLAW & COVERAGE MAP

Weld H4 - 506.8" examined representing 77.77% of the total weld length.

Eight indications were detected by the 60 degree Refracted Longitudinal and/or the OD Creeping Waves during examination of the H4 circumferential weld. The total combined length of the eight indications is 15.2", representing 3% of the examined

length. The longest of the individual indications is 2.72" long. The depth of the indications does not exceed .60". Ultrasonic data shows that three of the eight indications are OD connected, none of the eight are ID connected. Visual examination of one indication confirmed that it was open to the OD of the Shroud. Attachment 2 (Examination Summary Sheet, Report No. RS-02) provides a detailed summary of the H4 weld examination and the locations and sizes of all of the indications.

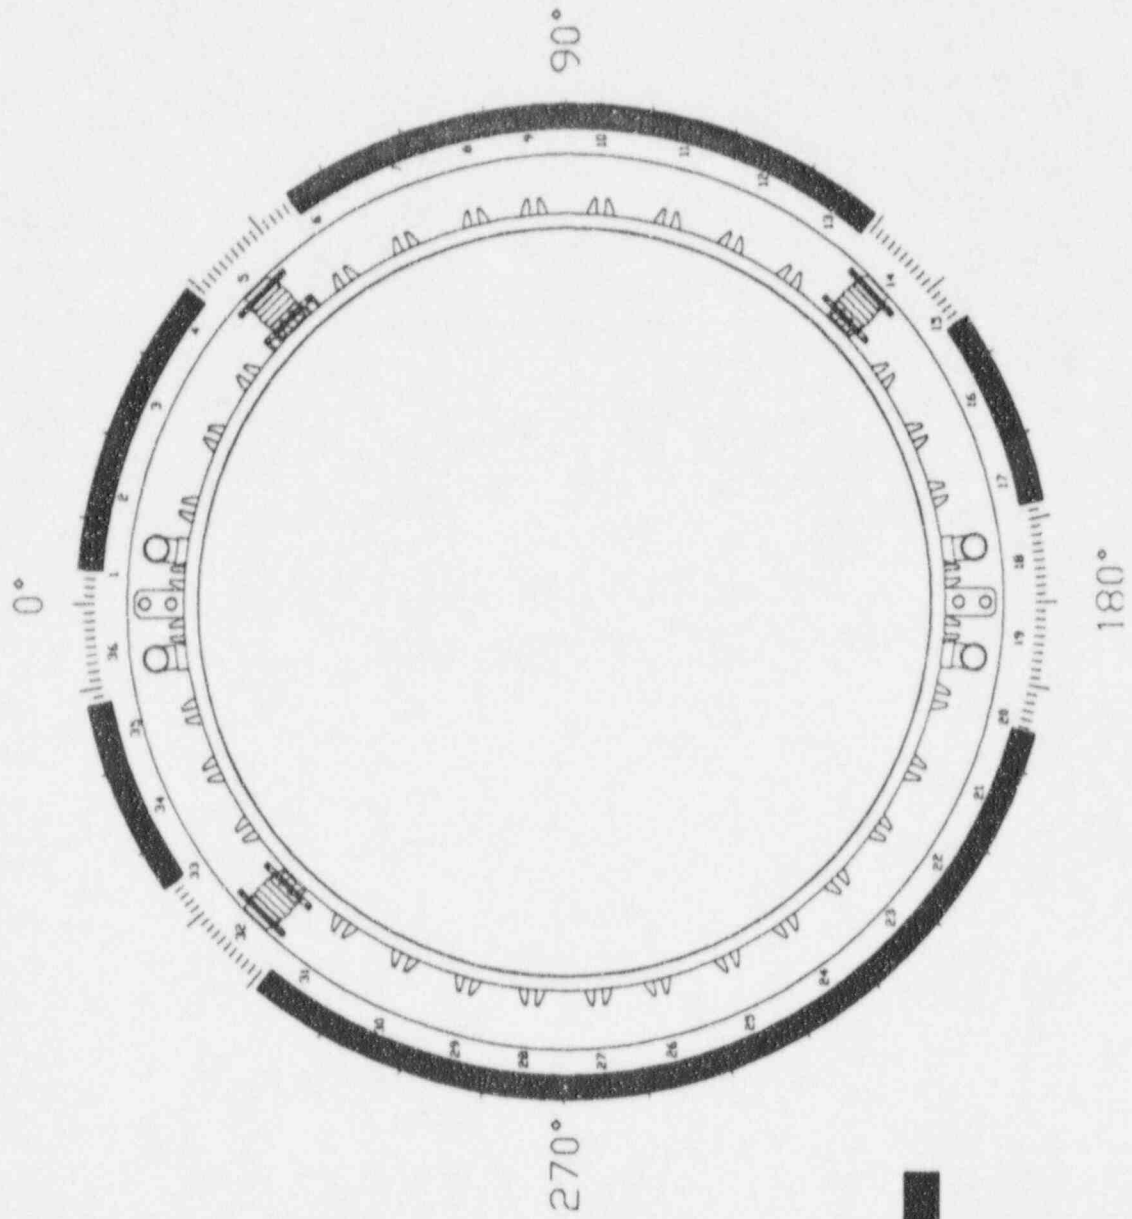
LASALLE UNIT 1 SHROUD INSPECTION H5 WELD COVERAGE MAP

Weld H5 - 506.8" examined representing 77.77% of the total weld length.

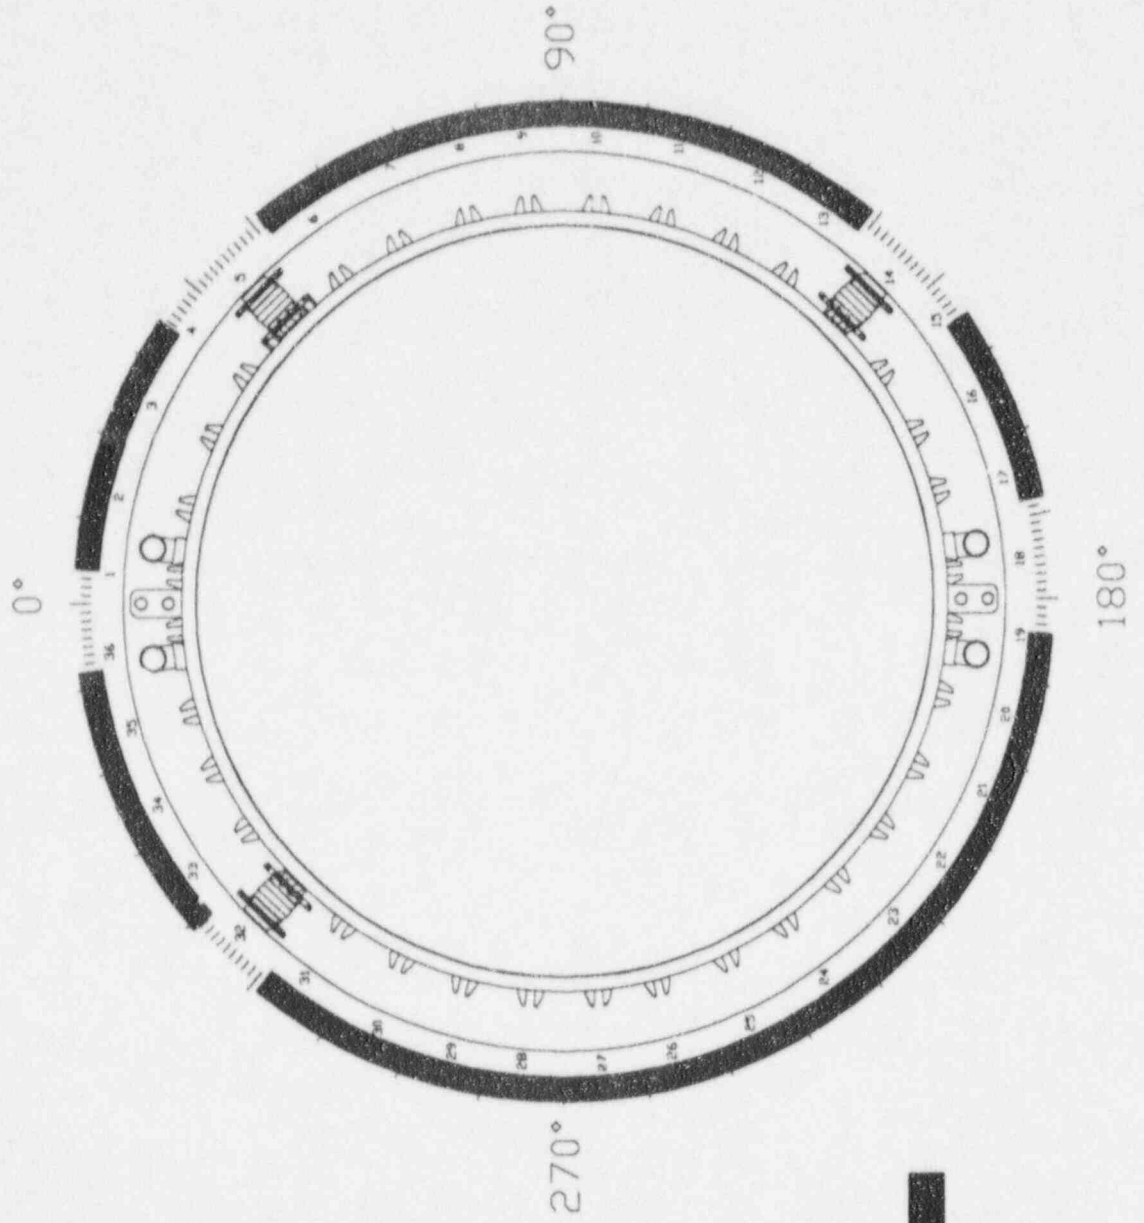
LASALLE UNIT 1 SHROUD INSPECTION
H6 WELD COVERAGE MAP

Weld H6 - 523.3" examined representing 80.30% of the total weld length.

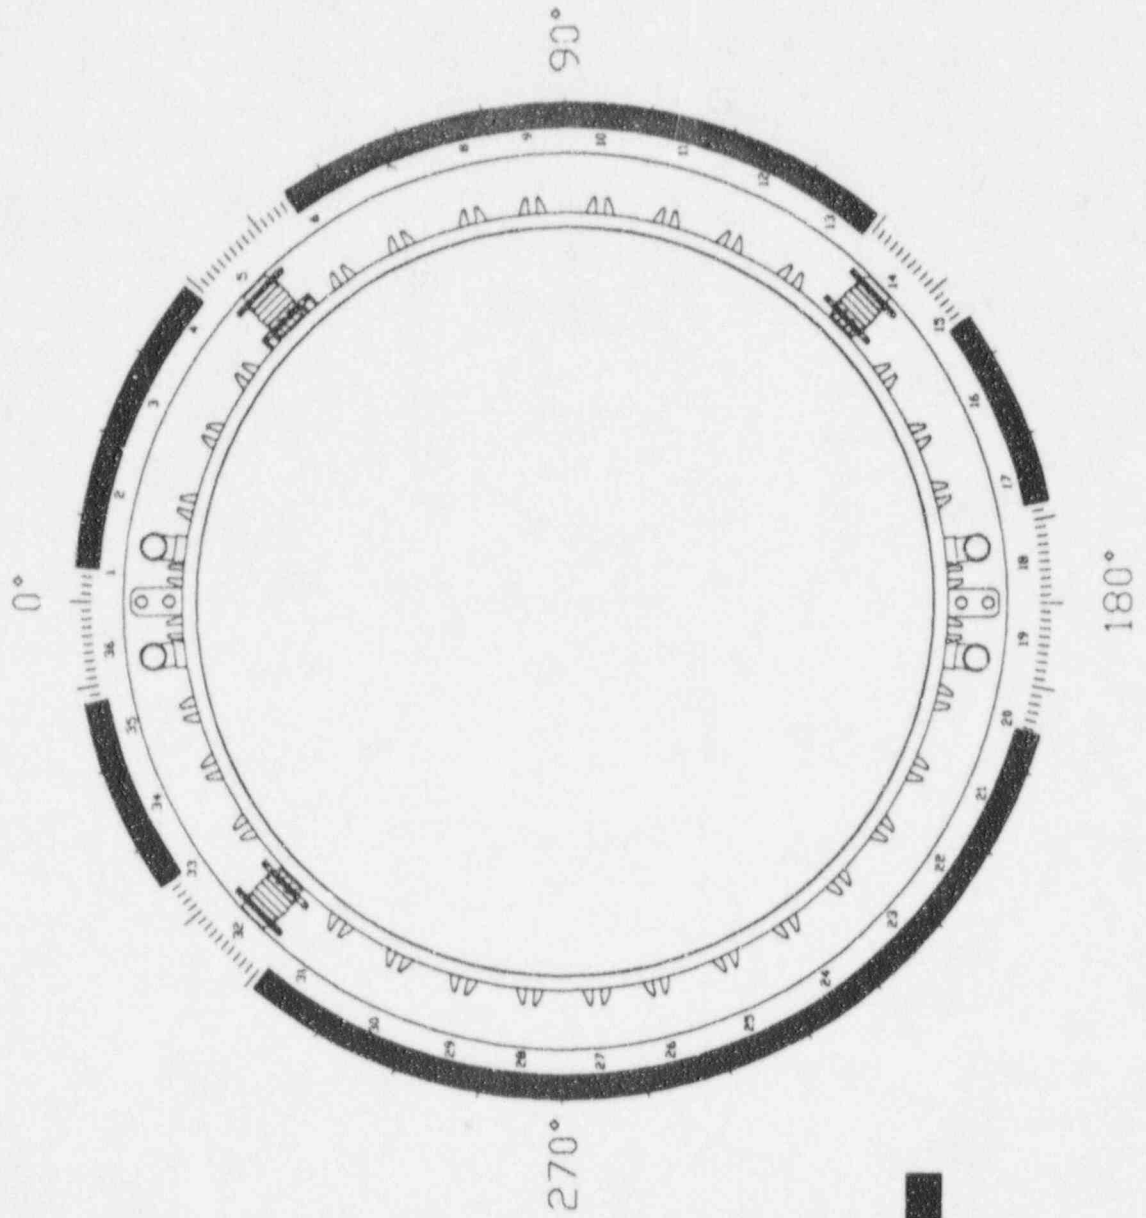
LASALLE UNIT 1 SHROUD INSPECTION H8 WELD COVERAGE MAP

Weld H8 - 499.6" examined representing 79.30% of the total weld length.

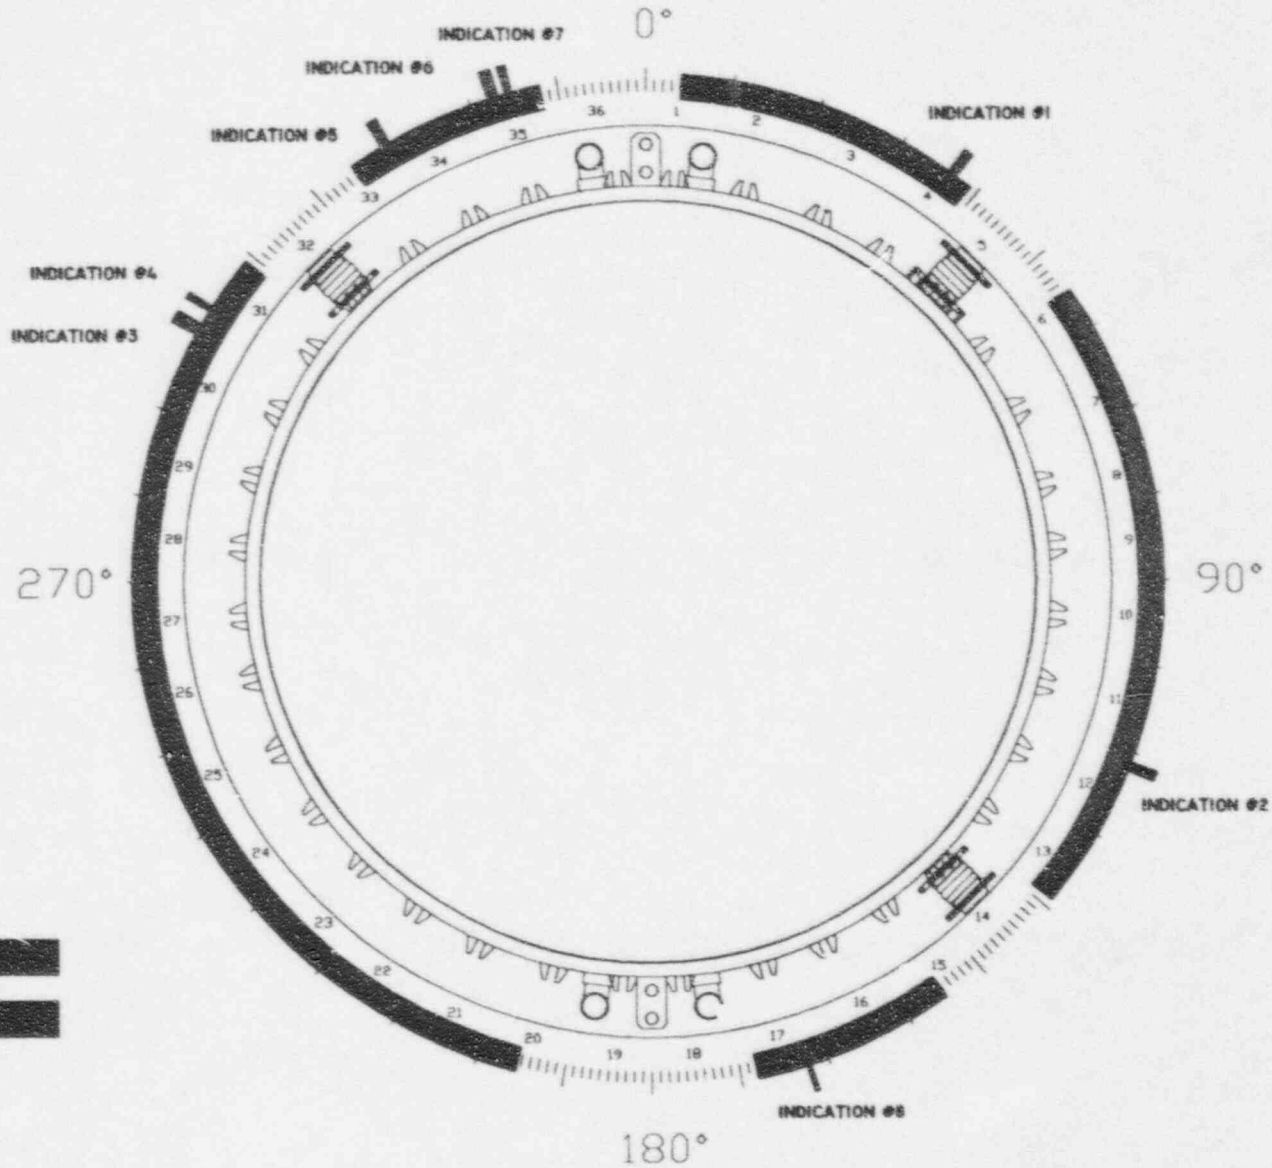
LASALLE UNIT I SHROUD INSPECTION H4 WELD FLAW & COVERAGE MAP

Indication Number	Distance from Vessel 'O'	Lug Set	Total Length	Flaw Depth	Distance from weld	Side of Weld	Surface Connection	Search Unit
1	35.79°- 36.89°	4	1.1"	*	2.8"	Lower	OD	60°/ODCR
2	110.47°-111.57°	12	1.1"	*	.50"	Lower	**	60°/ODCR
3	298.58°-300.08°	31	1.5"	*	1.1"	Lower	OD	60°/ODCR
4	302.06°-302.86°	31	.8"	*	.90"	Lower	OD	60°/ODCF
5	328.38°-329.58°	34	1.2"	*	.60"	Lower	**	60°/ODCh
6	341.76°- 343.06°	35	1.3"	*	.40"	Lower	**	60°
7	343.95°-344.85°	35	.9"	*	.50"	Lower	**	60°/ODCR
8	161.96°-162.46°	17	.5"	*	.80"	Lower	**	60°/ODCR

Total effective exam area was 284" or 506.8". This represents 77.77% of the weld length. Effective coverage is the area interrogated by all three beam angles. 100% of all accessible areas were examined. Access was limited due to the proximity of Guide Pins, Core Spray downcomers and LPCI bellows. This examination was performed from the lower shroud shell side only, due to Jet Pump riser brace interference.

Effective Exam Area: 4.1° to 39.1°, 55.1° to 129.1°, 145.1° to 168.1°, 184.1° to 309.1° and 325.1° to 348.1°

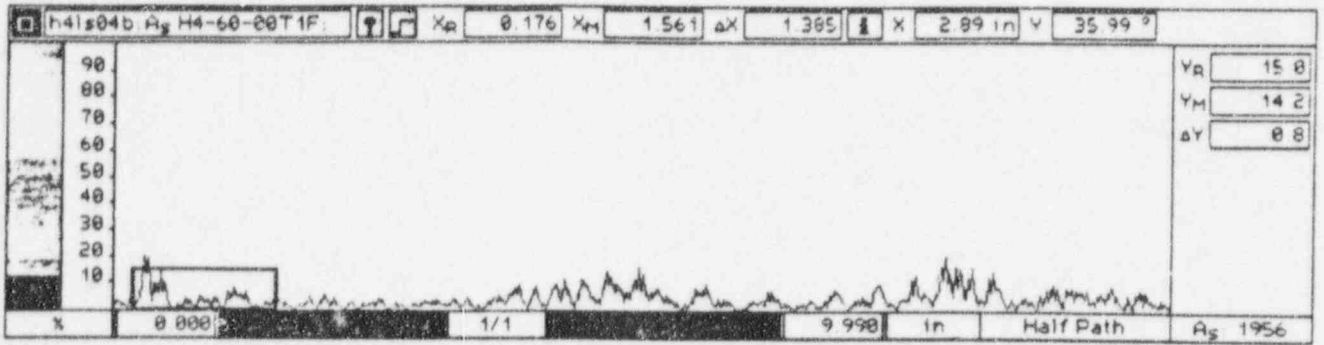
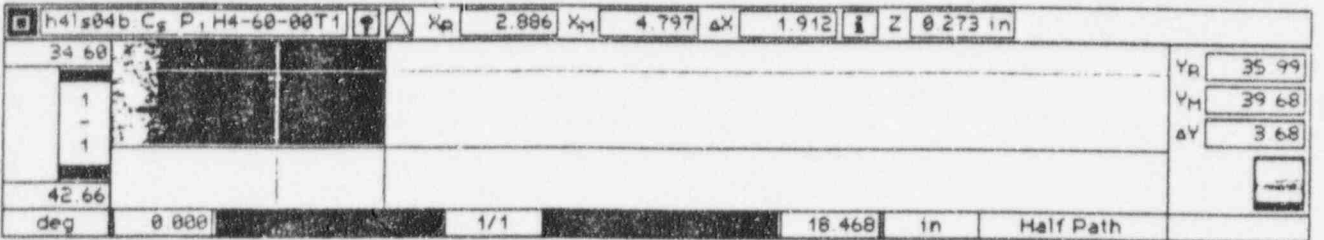
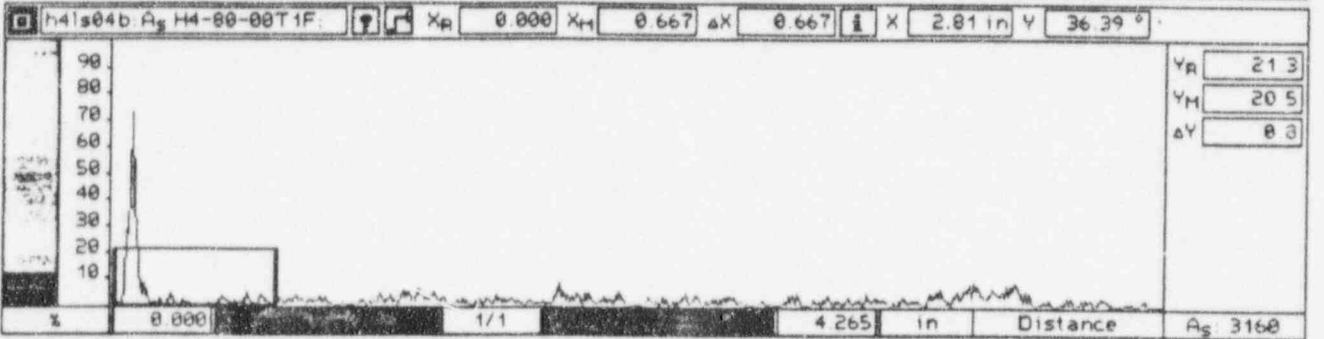
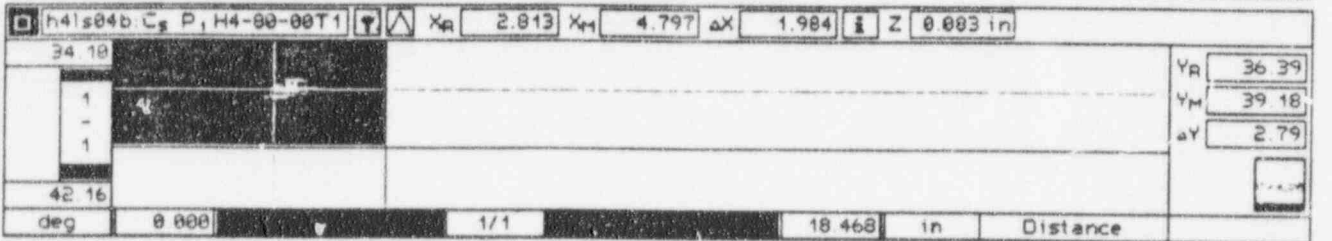
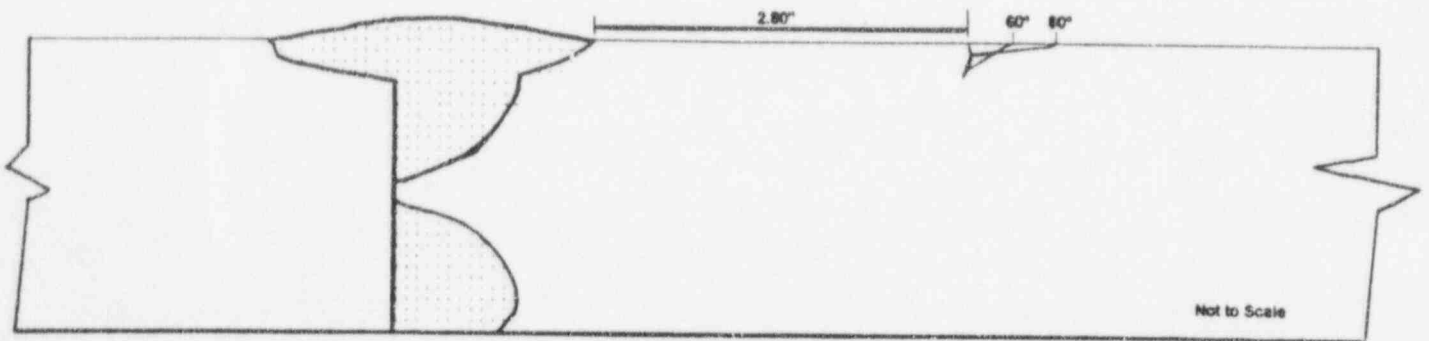
SITE: LASALLE UNIT: 1 PROJECT NO.: L1R07 SUMMARY NO.: RS-02
 WELD NO.: H-4 SEARCH UNIT: 60° & 80° INDICATION NO.: 1 PAGE: 4 OF: 21

Indication # 1, 3 and 4 are OD connected flaws as confirmed by UT. Indication # 1 was also confirmed by visual.

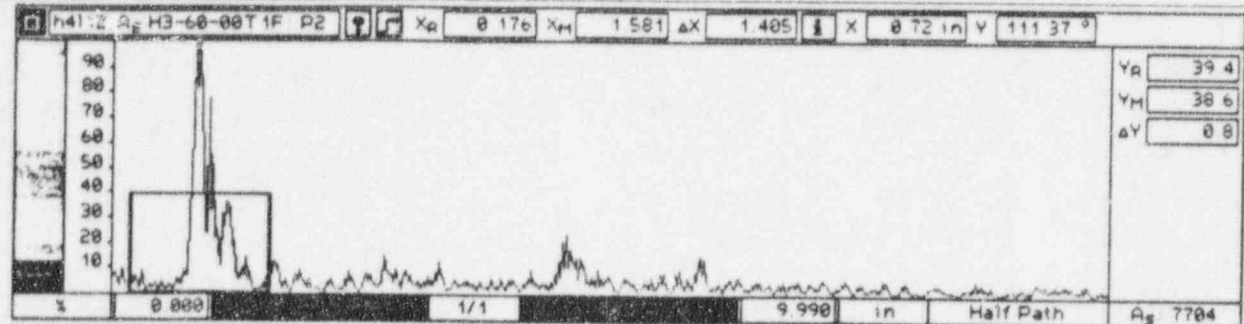
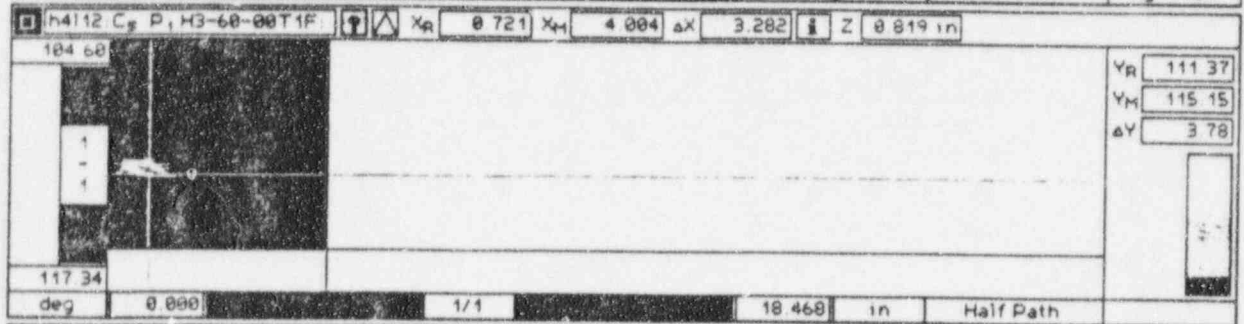
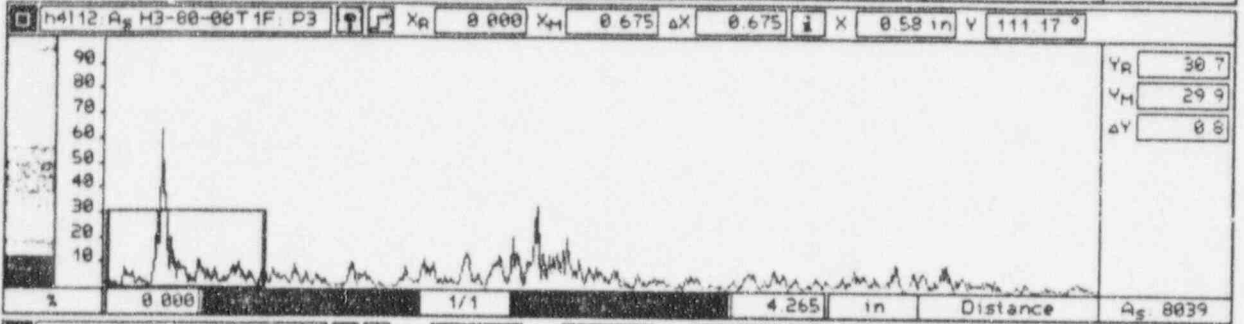
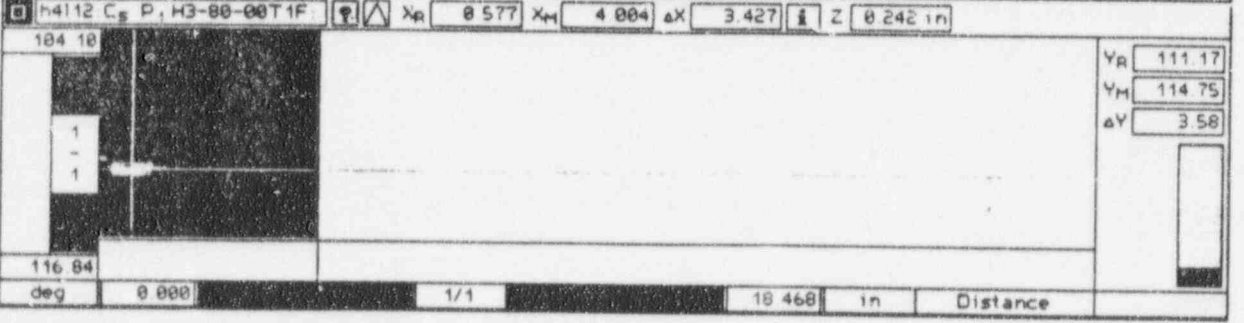
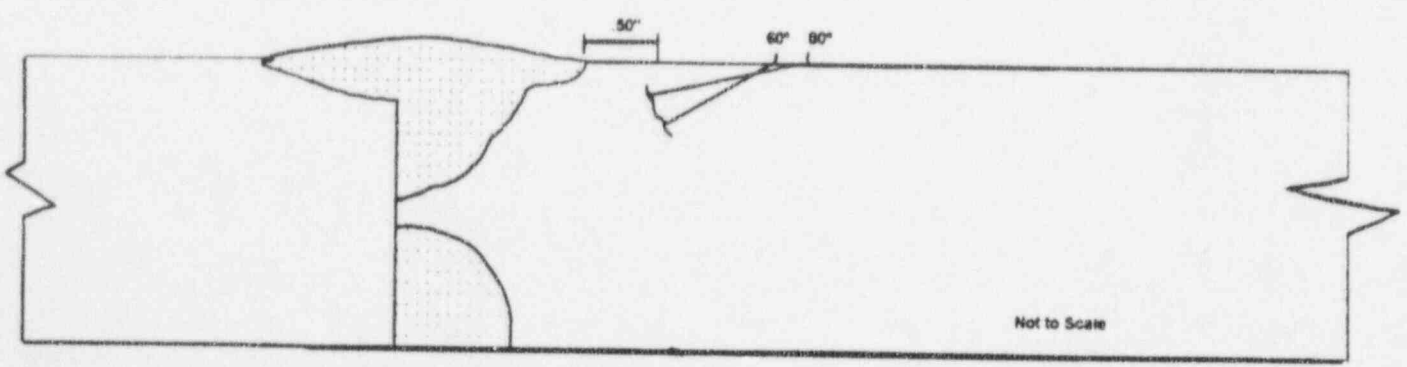
WELD NO.: H-4 SEARCH UNIT: 60° & 80° INDICATION NO.: 2 PAGE: 5 OF: 21

Indication # 2 a visual examination was performed and could detect no abnormal condition.

Indications # 2, 4, 5, 6, 7 and 8, the weld crown geometry prevents the search units from scanning over the indication, therefore OD confirmation could not be determined.
