SUBJECT: REVIEW OF PRELIMINARY ACCIDENT SEQUENCE PRECURSOR ANALYSIS OF
LICENSEE EVENT REPORT NO. 95-005-00 AT ARKANSAS NUCLEAR ONE, UNIT 1

LER No. 313/95-005

Event Description: Trip with one EFW train unavailable

TITLE (4)
Reactor Trip Initiated by Main Turbine Generator Protective Circuitry as a Result of a Logic Circuit Ground Caused by Vibration Induced Insulation Wear

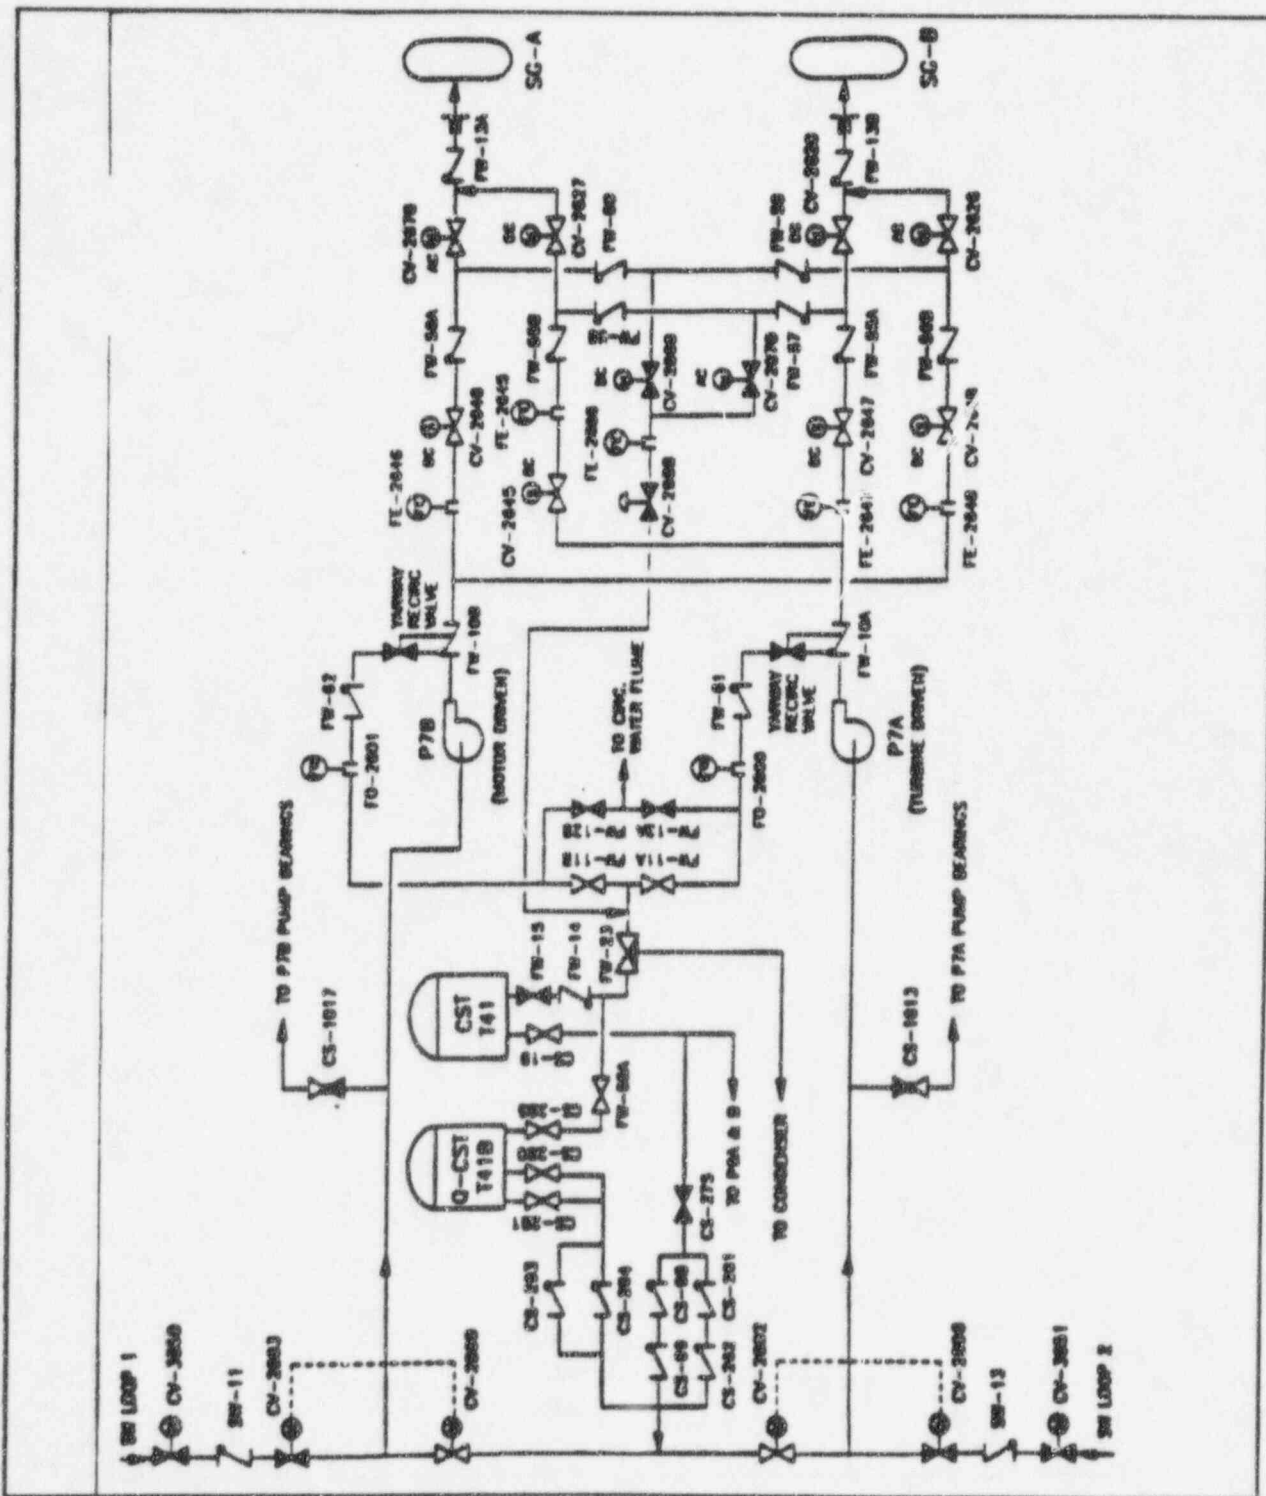
Figure 2 ANO 1 Emergency Feedwater System.

About an hour after the trip, a +5 volt dc power supply for train "A" of the emergency feedwater initiation and control (EFIC) system failed. This failure, believed to be caused by component failure in the voltage regulating circuit for the power supply, resulted in a half-trip of the EFIC system. Train "A" SG level indication was lost, as was control of atmospheric dump valve (ADV) CV-2668 and emergency feedwater valves CV-2646 and CV-2648 (see Fig. 2).

To adequately remove heat from the reactor core after a scram or a trip, only one of two EFW pump trains needs to be available to deliver water to at least one of the two OSTGs. The failure of the +5 volt power supply resulted in the loss of EFW flow control valves in the MDEFW train (CV-2646 and CV-2648) and ADV CV-2668 control in either automatic or manual control.

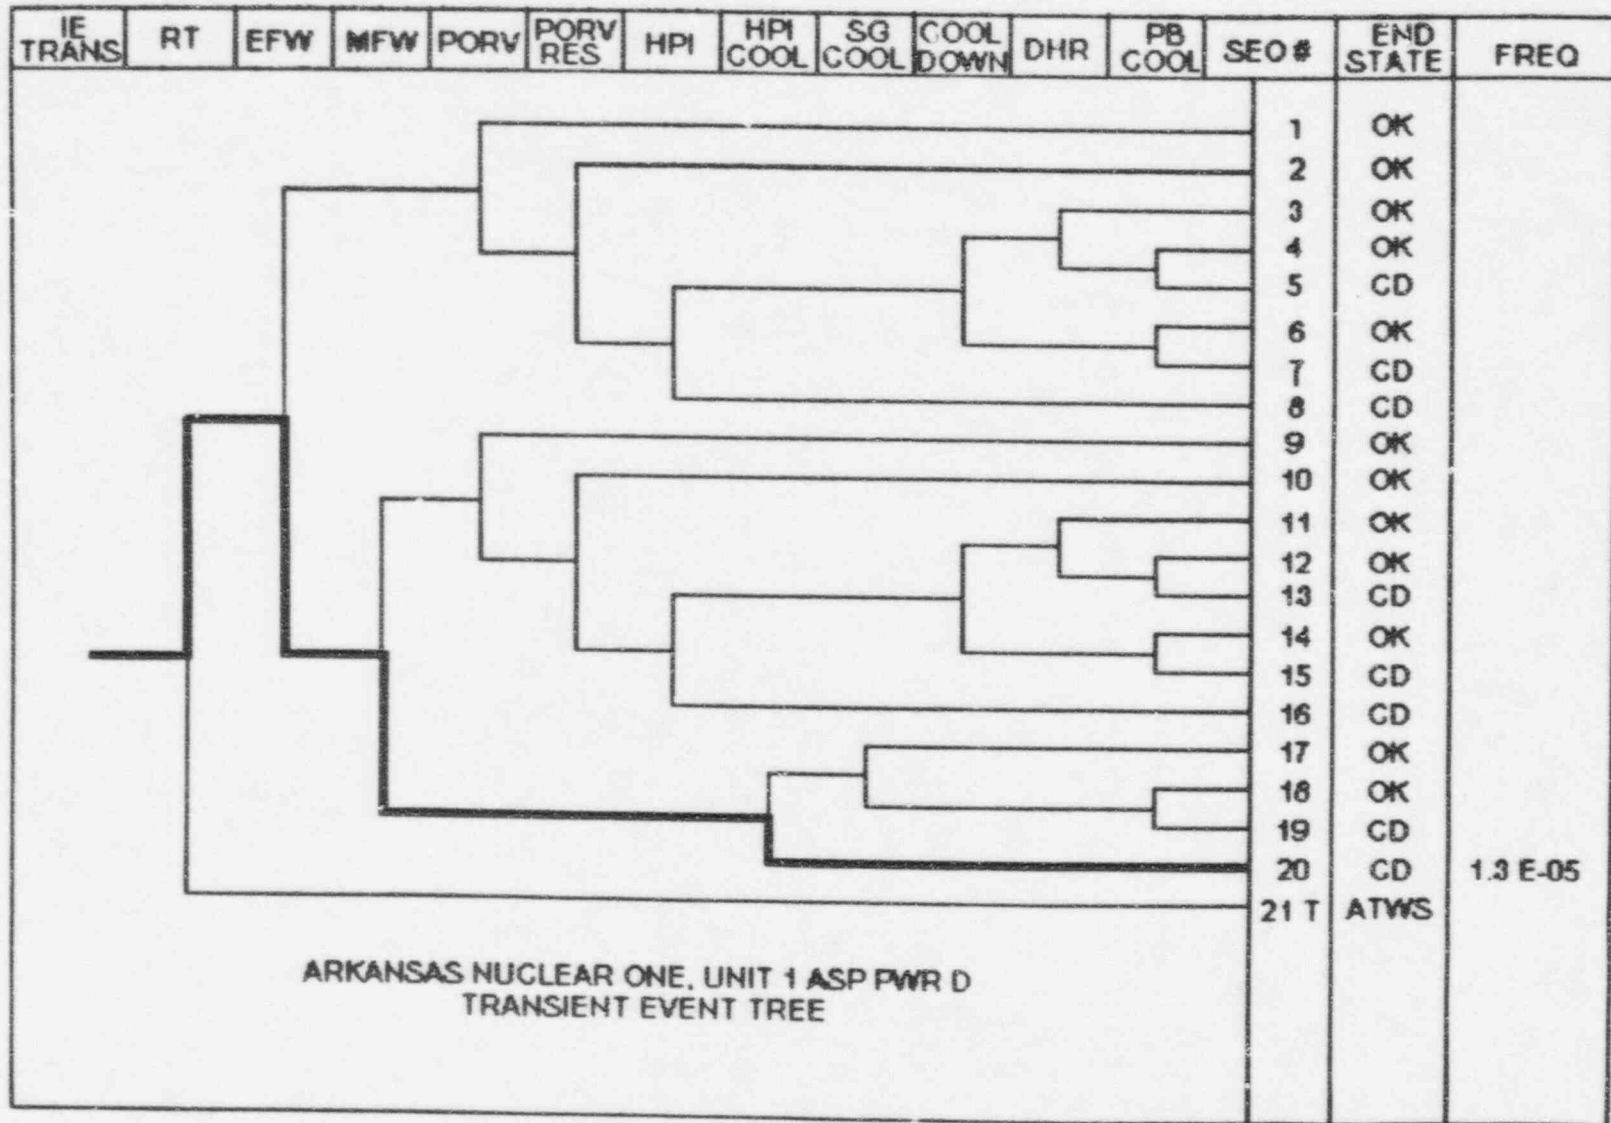
Figure 3 Dominant core damage sequence for LER 313/95-005.

The conditional core damage probability estimated for this event is 2.0×10^{-5} . The dominant sequence, highlighted on the event tree in Fig. 3 involves the observed trip and loss of MDEFW. The assumed inoperability of MDEFWP valves increased the failure probability for the MDEFW. In addition, with

MDEFW degraded, the feed and bleed capabilities become more important with respect to removing decay heat.
