SUBJECT: BWR VENT HEADER CRACKING

CLOSE-OUT OF DIVISION OF LICENSING TASK
ON VENT HEADER CRACKING IN MARK I AND II
BOILING WATER REACTORS

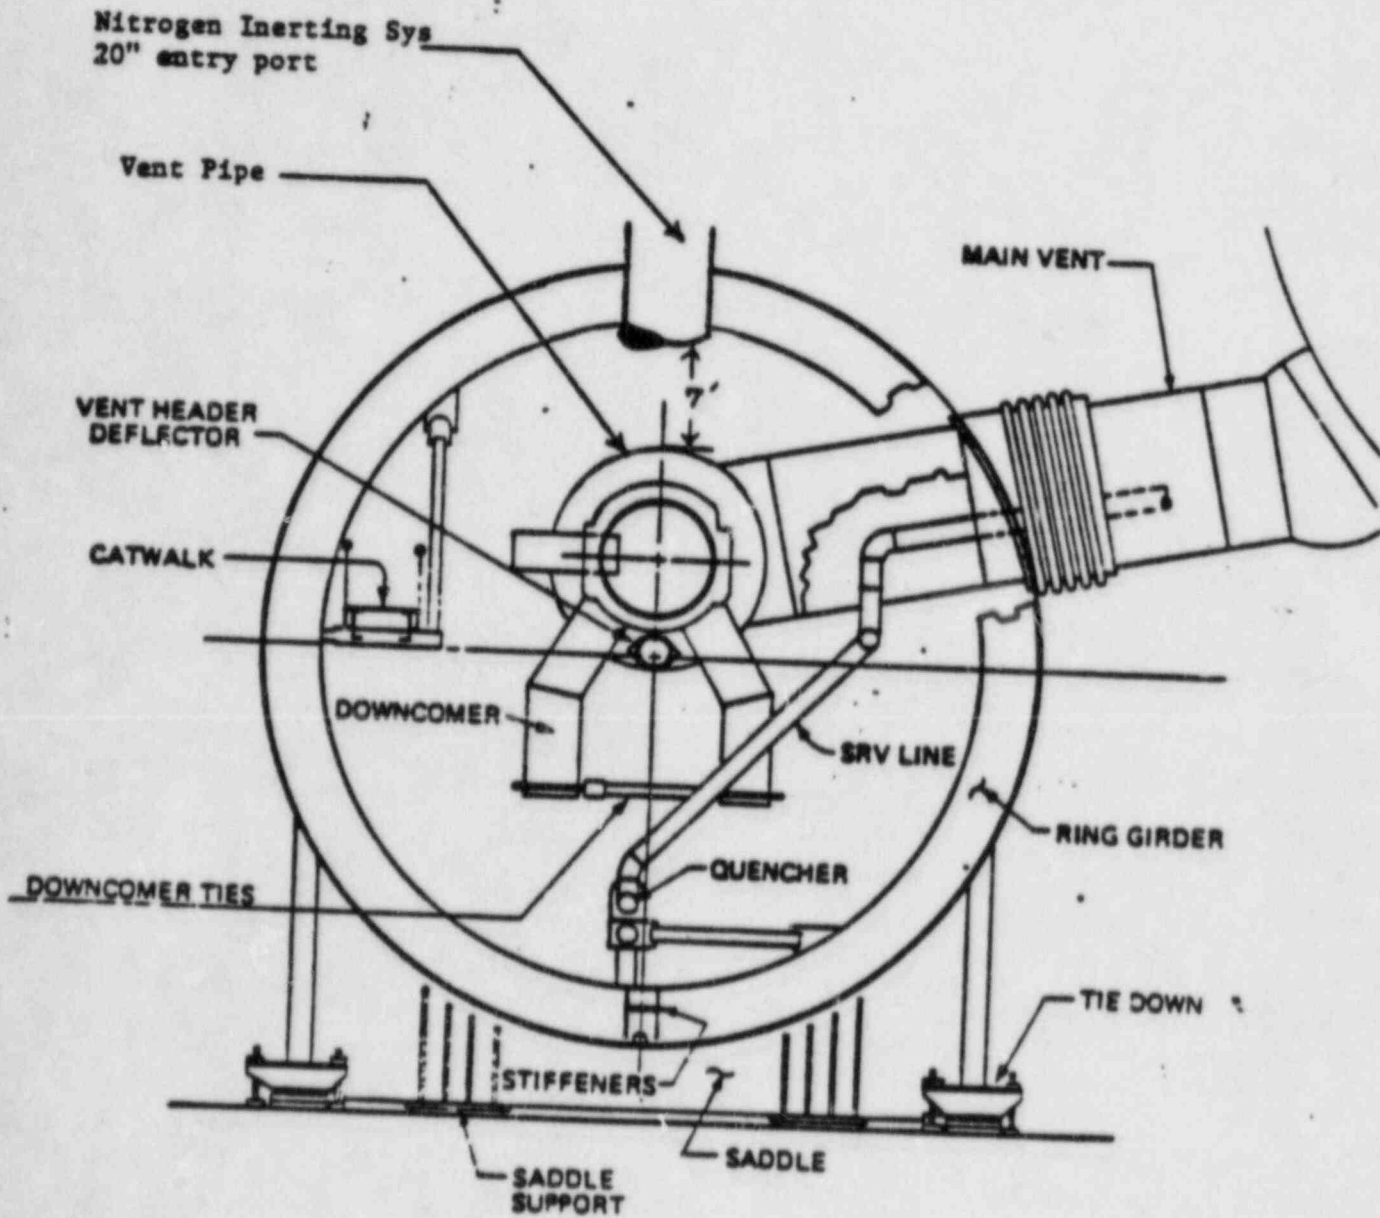
FIGURE 1

CROSS SECTION OF THE TORUS
Hatch Unit 2
