Collection and Evaluation of Complete and Partial Losses of Off-Site Power at Nuclear Power Plants

Prepared by R. E. Battle

Oak Ridge National Laboratory

Manuscript Completed: December 1984

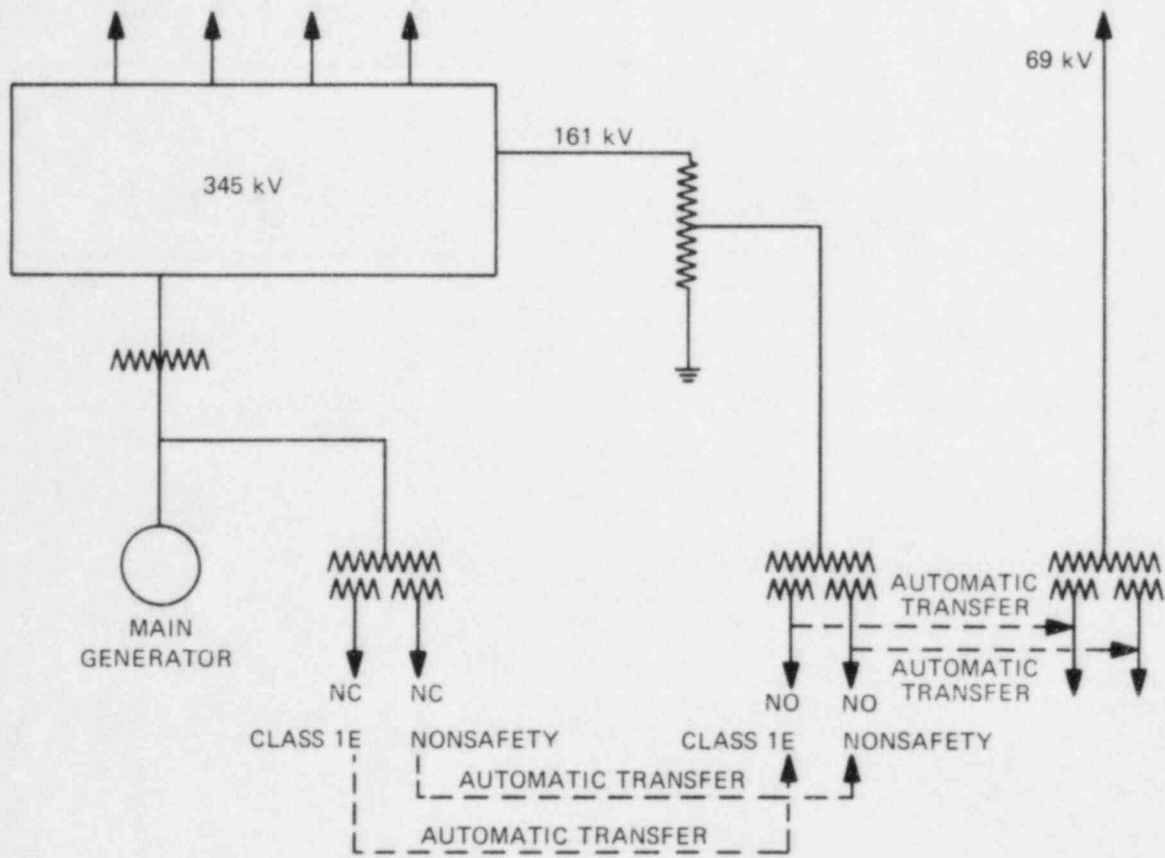
Fig. 2.1. Cooper 1 off-site power system.

Design features affect the probability of having a loss of off-site power. Plants that have electrically independent power sources from a separate switchyard or a separate transmission line, as shown in Fig. 2.1, appear less likely to suffer a plant-centered loss of off-site power than a plant where all sources are electrically connected. The 69-kV power source in Fig. 2.1 is connected automatically if the preferred source fails. Power plants that have suffered loss of the unit and preferred power sources but not of an electrically independent power source are the following: D. C. Cook, Cooper, Oconee, Pilgrim, and Vermont Yankee. Plant-centered losses of off-site power are usually not of long duration. Two separate switchyards or a transmission line not connected electrically to the main switchyard may reduce the frequency of the short-duration, plant-centered losses of off-site power, but will probably not reduce the frequency of the long-duration, severe weather events that may affect a large part of the transmission system.

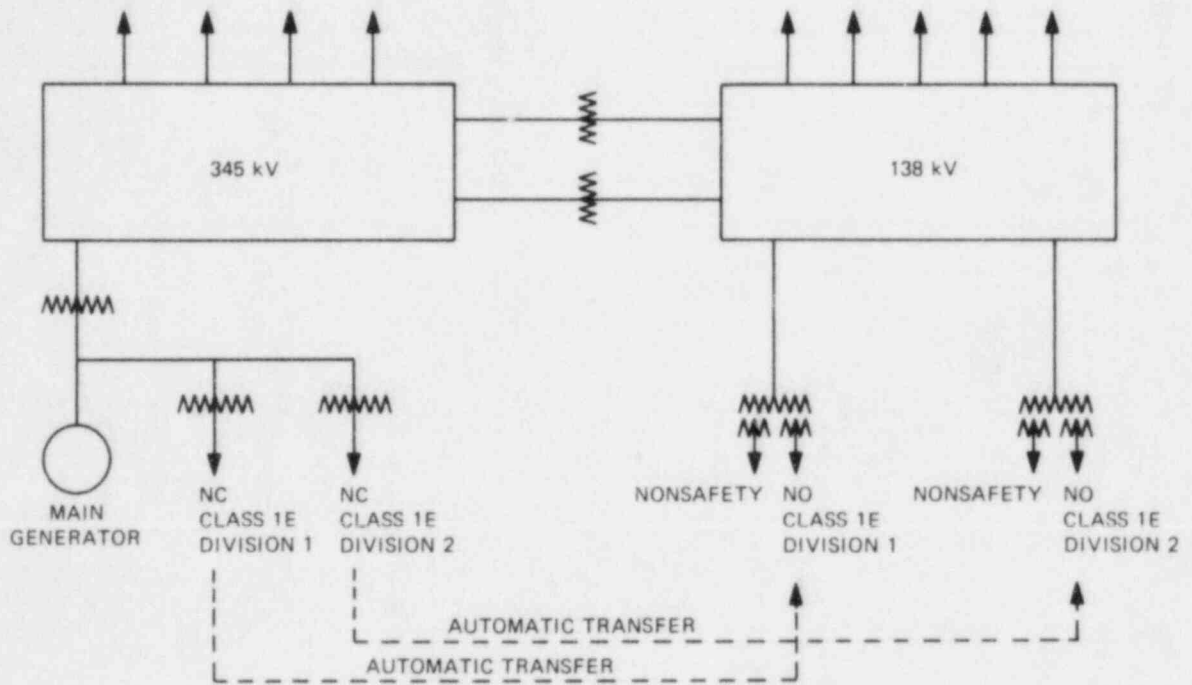
Fig. 2.2. Beaver Valley 1 off-site power system.

A parameter that has been identified for analysis is the normal source of power for the Class 1E buses. Some plants normally power the Class 1E buses from a unit transformer connected to the output of the main generator as shown in Fig. 2.2. If the unit trips, the Class 1E buses are automatically transferred to a preferred off-site power source. Other plants normally power the Class 1E buses from a preferred source as shown in Fig. 2.3. For the design shown in Fig. 2.3, a unit trip will not cause the Class 1E buses to transfer, and, if a preferred power source trips during reactor operation, a reactor trip may not occur even though a Class 1E bus loses power (although a reactor trip has occurred in some cases). This design feature concerning the normal power source for Class 1E buses is more important for plant-centered losses of off-site power than for grid-related power failures because an equipment failure or human error can prevent transferring to a preferred power source even though the switchyard remained energized.
