LICENSEE EVENT REPORT (LER)

FACILITY NAME (1) McGuire Nuclear Station Unit 2	DOCKET NUMBER (2) 0 5 0 0 0 3 7 0	PAGE (3) 1 OF 04
---	--------------------------------------	---------------------

TITLE (4)
Overpressurization of Auxiliary Feedwater Pump Suction

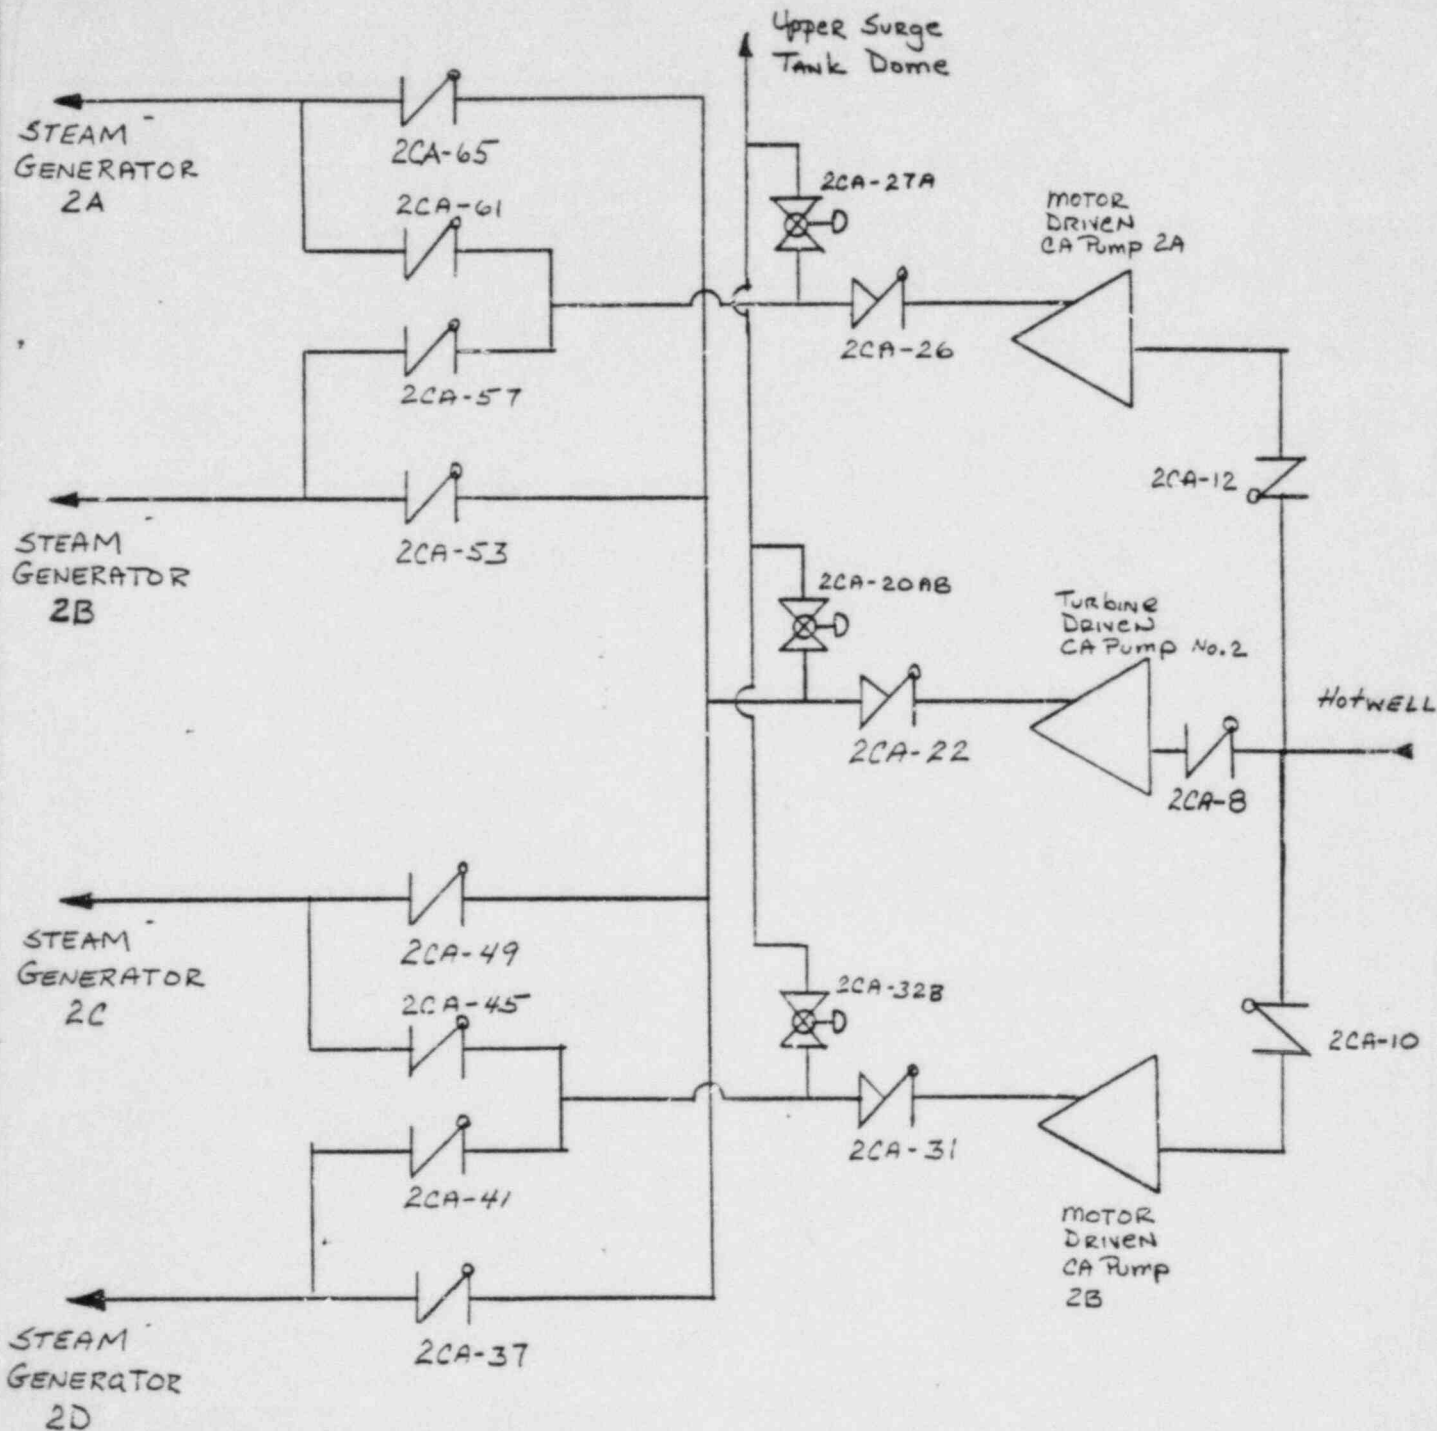
FIGURE 1

Swing check valve 2CA-49 (See Figure 1) contained a cracked weld in the valve's internals, which allowed water to leak past. Enough water leaked past check valve 2CA-49 to pressurize the piping, but not enough to move 2CA-22 to the check position. The water that leaked through was between 450° and 500°F at 1000 psig. When this water reached the low pressure side of 2CA-49, it flashed to steam and displaced some water. This process continued to displace water and heat up the pipe and the room. This displaced water moved toward the pump and the upper surge tank, but the flow was insufficient to check 2CA-22. The movement of the water passed through the pump and into the suction piping where it was contained by check valve 2CA-8. With the movement stopped, the pressure rose in the pipe until it opened the relief line.

The leak of 2CA-49 was sufficient to keep the relief valve open, but not enough flow passed through 2CA-22 to cause it to close. One possible explanation is that most of the flow was passing through 2CA-20AB to the condenser via the upper surge tank. A rise in level in the upper surge tank would go unnoticed by the operators since it dumps to the condenser when over-filled. The leakage of 2CA-49 had to be substantial, because it kept the relief valve in the pump suction open when most of the flow was going to the condenser via the upper surge tank.

Although 2CA-49 leaked, valve 2CA-22 may have closed if it had been installed properly. Valve 2CA-22 is installed in a vertical section of pipe. For this valve to operate properly, it must be installed in a horizontal section of pipe with the stem in the upright vertical position. Valve operation would then be aided by the force of gravity. The disk which checks on reverse flow, is free to move because it is not connected to the valve stem. In its application on the TDAFP, the force of gravity does not aid in closing the valve. The flow required to check the valve is greater than would be needed if the valve was installed correctly.

This instrumentation will be installed by the next scheduled refueling outage for each Unit. Valve CA-22 and the valves in corresponding applications in Units 1 and 2 will be relocated during the Spring 1985 refueling outage for each unit.
