LICENSEE EVENT REPORT (LER)

FACILITY NAME (1) MCGUIRE NUCLEAR STATION UNIT 2 DOCKET NUMBER (2) 0500003710 PAGE (3) 1 OF 10

TITLE (4) PIPE IN AUX. LETDOWN SYSTEM DAMAGED BY WATER HAMMER

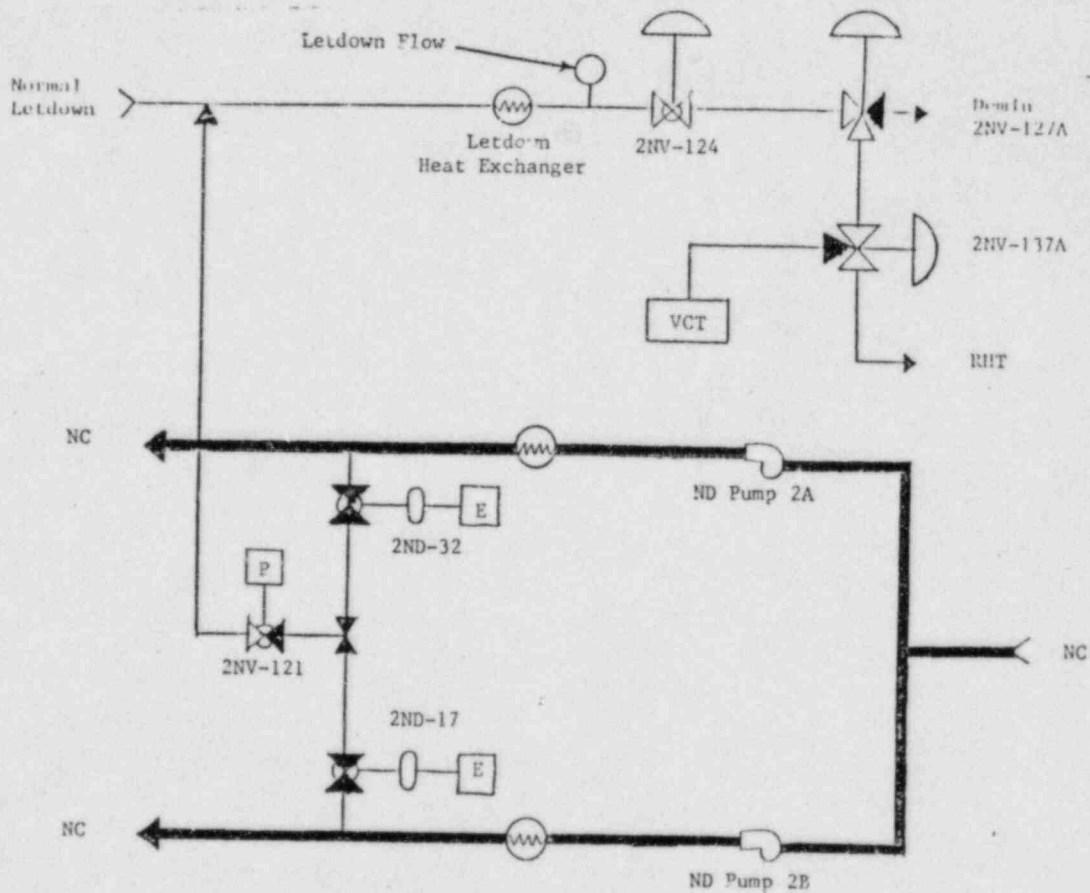
FIGURE 1  
SIMPLIFIED DRAWING  
OF  
AUXILIARY LETDOWN LINE

**EVALUATION:** The auxiliary ND to NV letdown path consists of two ND headers (see Figure 1) to the normal NV letdown line. The path is isolated from each header by motor operated Kerotest valves, 2ND-17 and 2ND-32. Flow to the letdown line is controlled by piston operated, Fisher regulating valve, 2NV-121. The weld that was broken was immediately downstream of 2ND-17, following the break, the pipe was completely separated. Maintenance personnel also found the packing assembly on 2NV-121 had moved away from the valve body, along the valve stem. The two nuts that secure the packing flange were completely off of the studs and were later found on the floor of the B ND Heat Exchanger Room. Both of the studs were undamaged, indicating that it was forced from the stud during the event. Since the nuts were relatively undamaged, the packing flange must have been loose prior to the event.

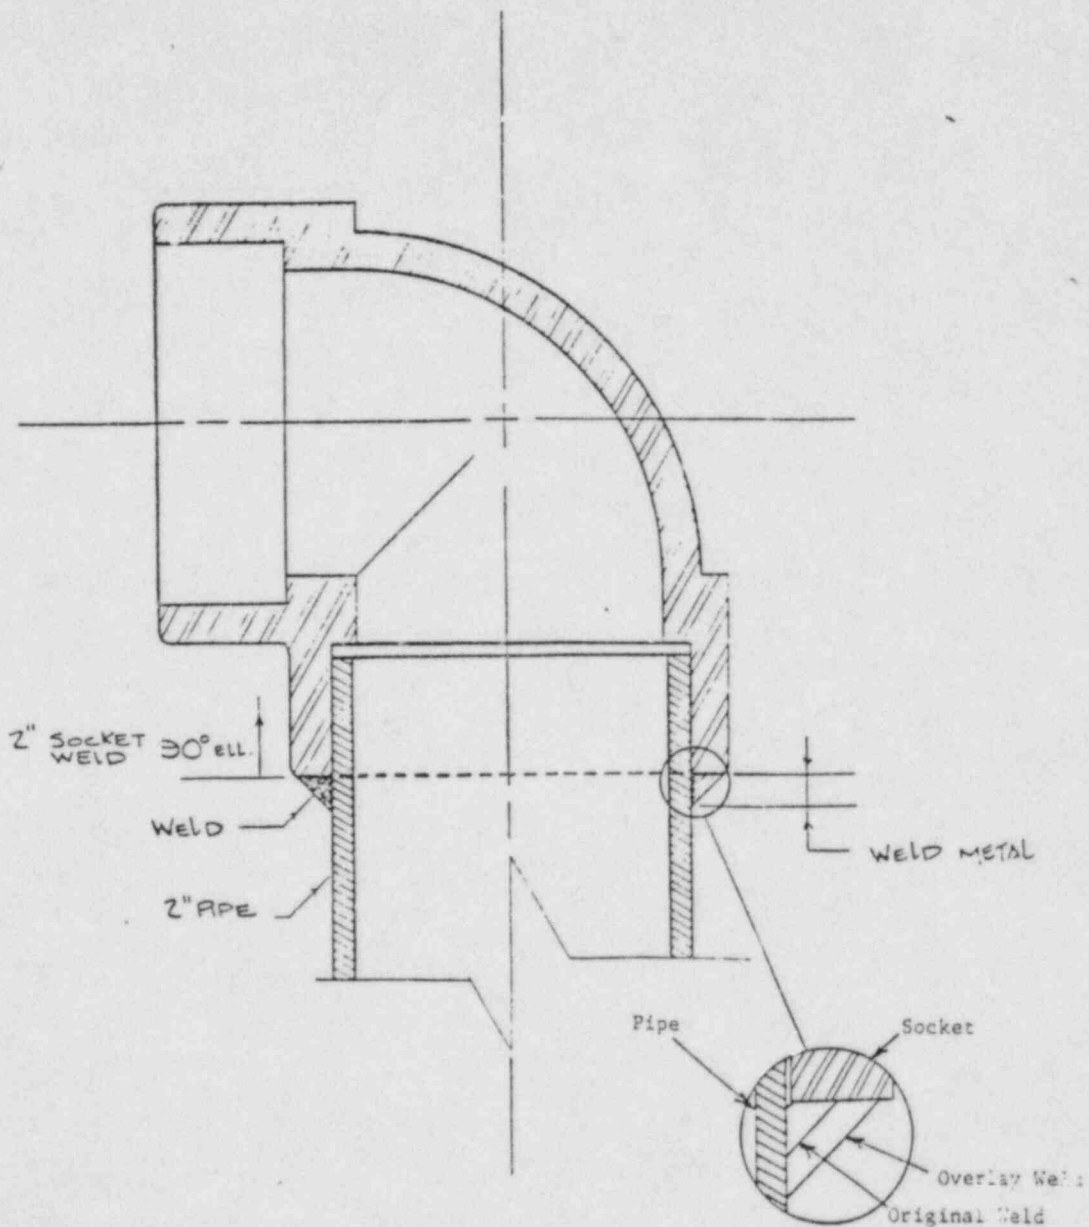
FIGURE 2  
SOCKET WELD  
(NO SCALE)

The broken weld (ND2FW22-23) was a 2" socket weld. It was properly installed and tested using dye penetrant. Proper gap was maintained between the end of the pipe and the socket during the fitup. Although there was some lack of penetration of the weld metal, this was very small and not unusual for this type of weld. The weld was found to be satisfactory in all aspects. The weld was inspected at McGuire, following the event, using a glove box and unmagnified observation. It was then further decontaminated and sent to a research laboratory for more detailed examination. Although the final report

has not been received, a preliminary report showed the weld broke in a ductile fashion, probably due to one high stress event; however, they also found a majority of the weld break area had been fatigued. A crack had started on the inside diameter of the weld and progressed radially outward. Although the crack appeared to have included 360° of the weld, it had not penetrated the outer surface of the weld at any point. Therefore, the welded area was not leaking prior to the failure. Since the weld was found to have been degraded by the fatigue induced crack prior to the event, other welds in the system that might have been subjected to the same vibration were examined. A section of pipe downstream of the broken weld was cut out for examination. The section included four welds. All four of the welds were radiographed by QA, and the films were inspected for cracks. No cracks were found. Two of the welds were cut radially into four section, polished as necessary, and tested with dye penetrant. No indications of cracks were found.
