Docket No. 50-423
B15669

LICENSEE EVENT REPORT (LER)

Millstone Nuclear Power Station Unit 3

Reactor Coolant System Pressure Boundary Leak from a Valve Bonnet Stem Leak-Off Pipe

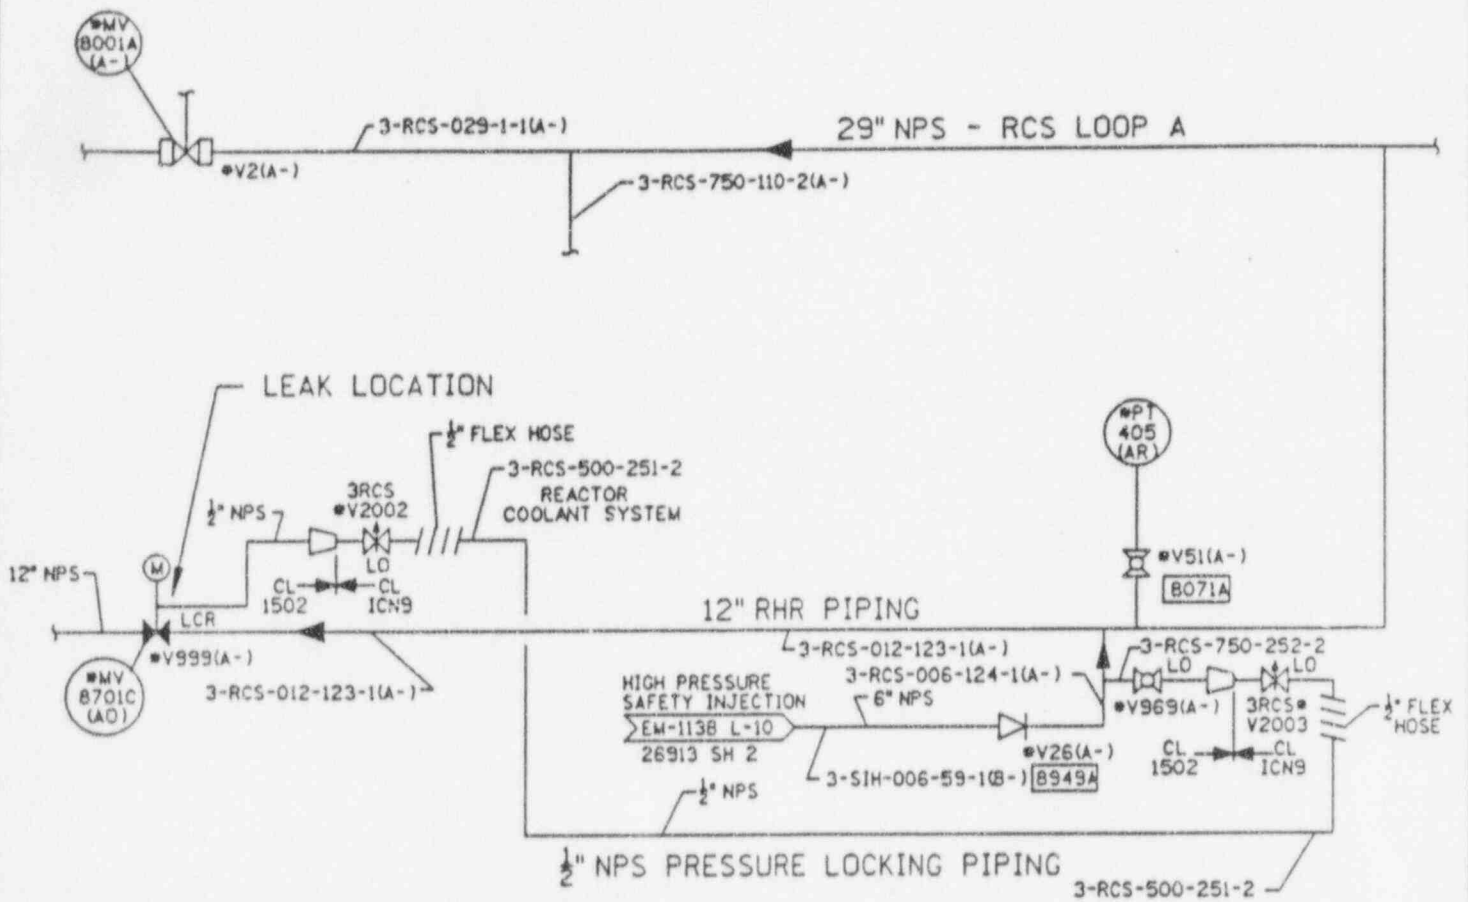
SKETCH 2

3RHS*MV8701C PRESSURE LOCKING / THERMAL BINDING PIPING

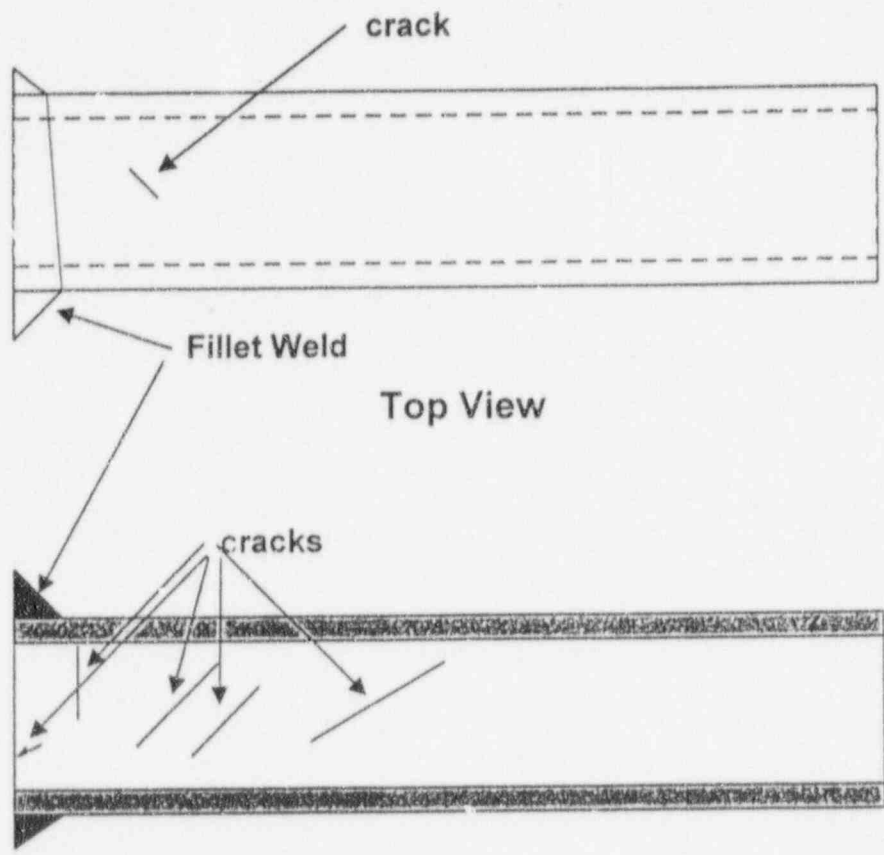
SKETCH 3
Locations of Linear Indications

An initial inspection indicated a crack near the toe of the fillet weld between the pipe and the valve body. The leaking section of pipe was removed for further evaluation which resulted in the discovery of six linear indications at a 45-degree angle to the pipe. (See Sketch 3 for inspection results). None of the indications were in the weld material, all were located in the pipe.

Initial inspection indicated a small crack in the pipe near the toe of the fillet weld between the pipe and the valve body. A further examination of the removed section of piping revealed six linear indications in the pipe, and none in the weld. Five of the indications were at a 45-degree angle to the pipe. The most likely cause of the indications is from mechanically induced tensile overload consisting of a bending or twisting motion. The failures were not the result of a fatigue mechanism, material incompatibilities, the welding process, or service related conditions. The attached Sketch 3 shows the locations of the linear indications.

The location and configuration of the linear indications are consistent with mechanically induced tensile overload consisting of a bending or twisting motion. It cannot be determined exactly when or how the leak-off pipe was mishandled. This condition may have been present since construction/startup. The problem then manifested itself after the pressure locking / thermal binding modification. During this modification, packing which normally isolates the leak-off piping from system pressure, was removed. This allows the upper bonnet area to vent to avoid the pressure locking / thermal binding. This would also be the first time that this pipe saw system pressures.

The failed pipe and valve bonnet weld were removed. A new pipe was installed and welded into the valve bonnet. The fit-up, visual, and liquid penetrant examinations of the weld were satisfactory. A visual examination of the weld was conducted at normal operating pressure and there was no leakage.

The now modified configuration is less susceptible to future tensile overloads. The longer piping configuration is readily visible and would distribute any loads over a longer length from the original six-inch pipe nipple. Additionally, flexible hose and pipe supports added as a result of the modification assist in protecting the pipe from future recurrences.
