Idaho National Engineering Laboratory

**Reactivity Initiated Accident Test Series
Test RIA 1-4 Fuel Behavior Report**

September 1984

NUREG/CR-3938
EGG-2336
Distribution Category: R3

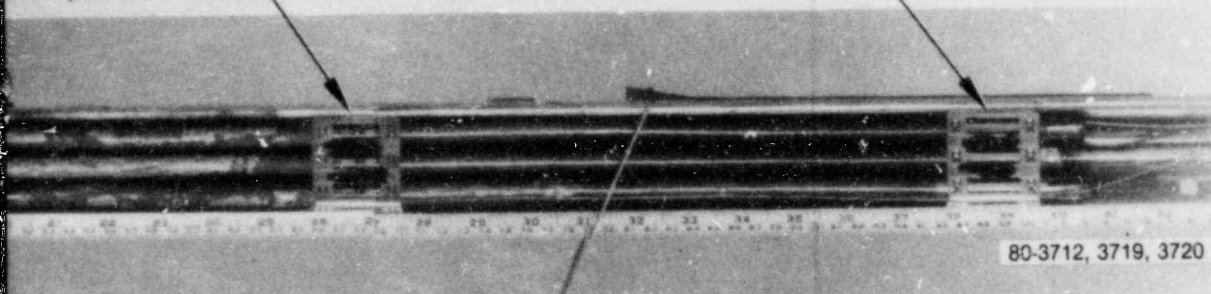
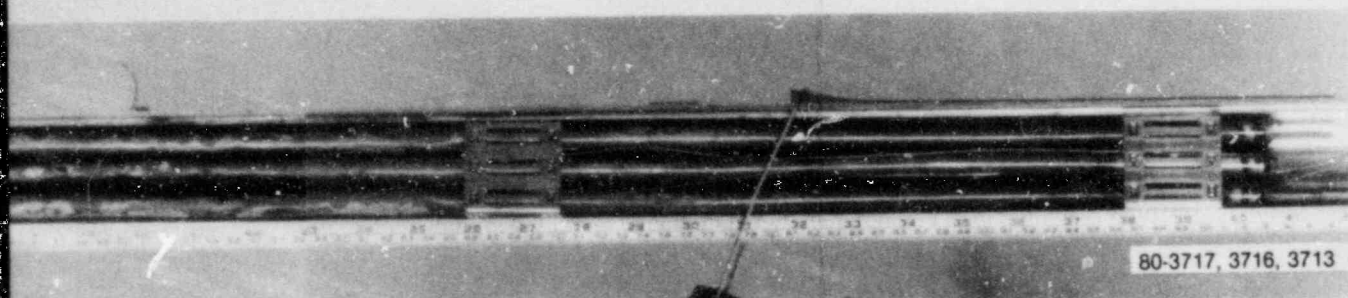
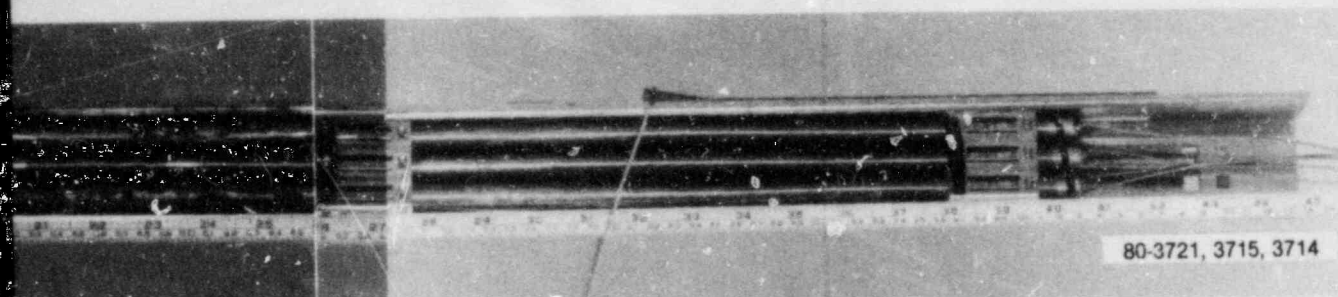
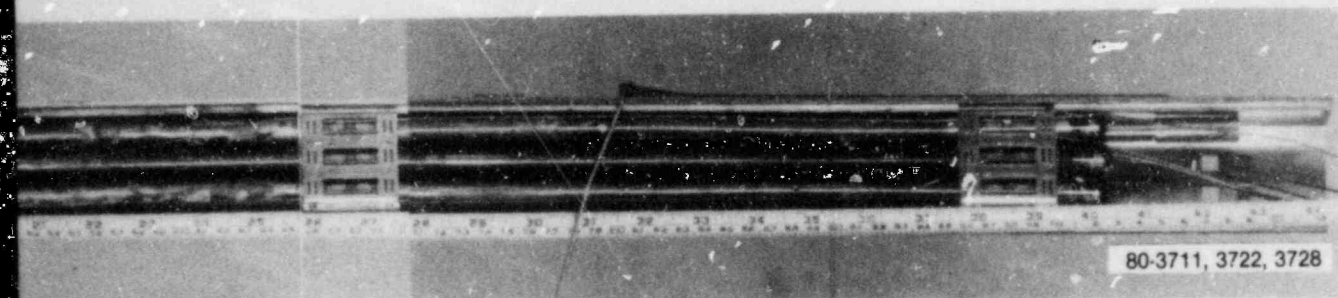
Bundle Condition. Photographs of each side of the bundle after disassembly are shown in Figure 7. Although all nine rods failed, the cladding was not fully oxidized and embrittled, and there was no rod fragmentation. Because of fast flow recovery after the power burst, only localized film boiling conditions prevailed for a short period of time, resulting in localized cladding oxidation. In general, the cladding oxidation and failures occurred mostly on the

sides of the rods facing the shroud walls. There are many heat affected regions on the inside of the west shroud wall, where molten material from Rods 804-1, -4, and -7 contacted the shroud wall (Figure 8). The west side of the bundle (Figure 7) shows failures in all three rods at the 47.5-cm elevation.

There appears to be material connecting Rods 804-8 and 804-9 at the 47.5-cm elevation, as viewed from the south side of the bundle. When the bundle was disassembled, it was discovered that Rod 804-8 was stuck to Rod 804-5 at this elevation. Figure 9 shows the materials from Rods 804-8 and 804-9 on Rod 804-5. Apparently, molten material from Rod 804-9 impinged on Rods 804-8 and 804-5, causing failures at the same elevation in those two rods. All of the failures of Rod 804-8 were on the sides facing Rods 804-3 and 804-5. The view of the east side of the bundle (Figure 7) shows material from Rod 804-3 impinging on Rod 804-6 at the 53.5-cm elevation.

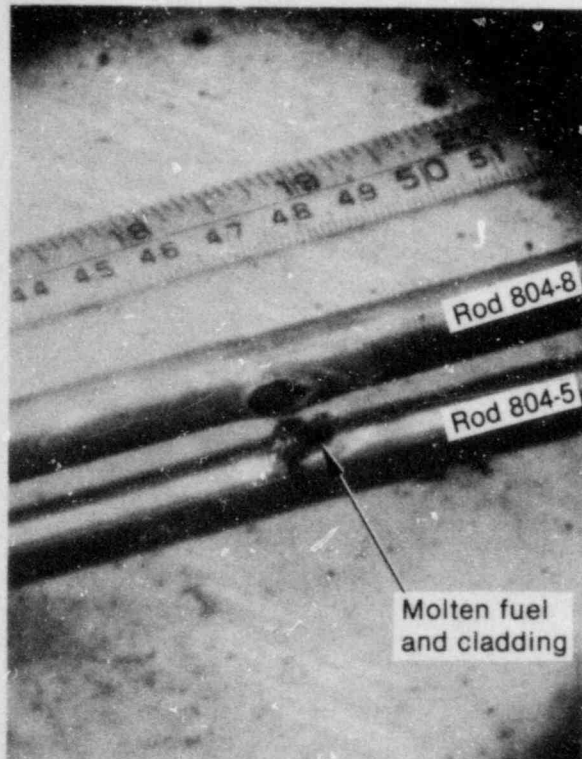
Figure 9. Previously molten materials from Rods 804-8 and 804-9 on Rod 804-5.

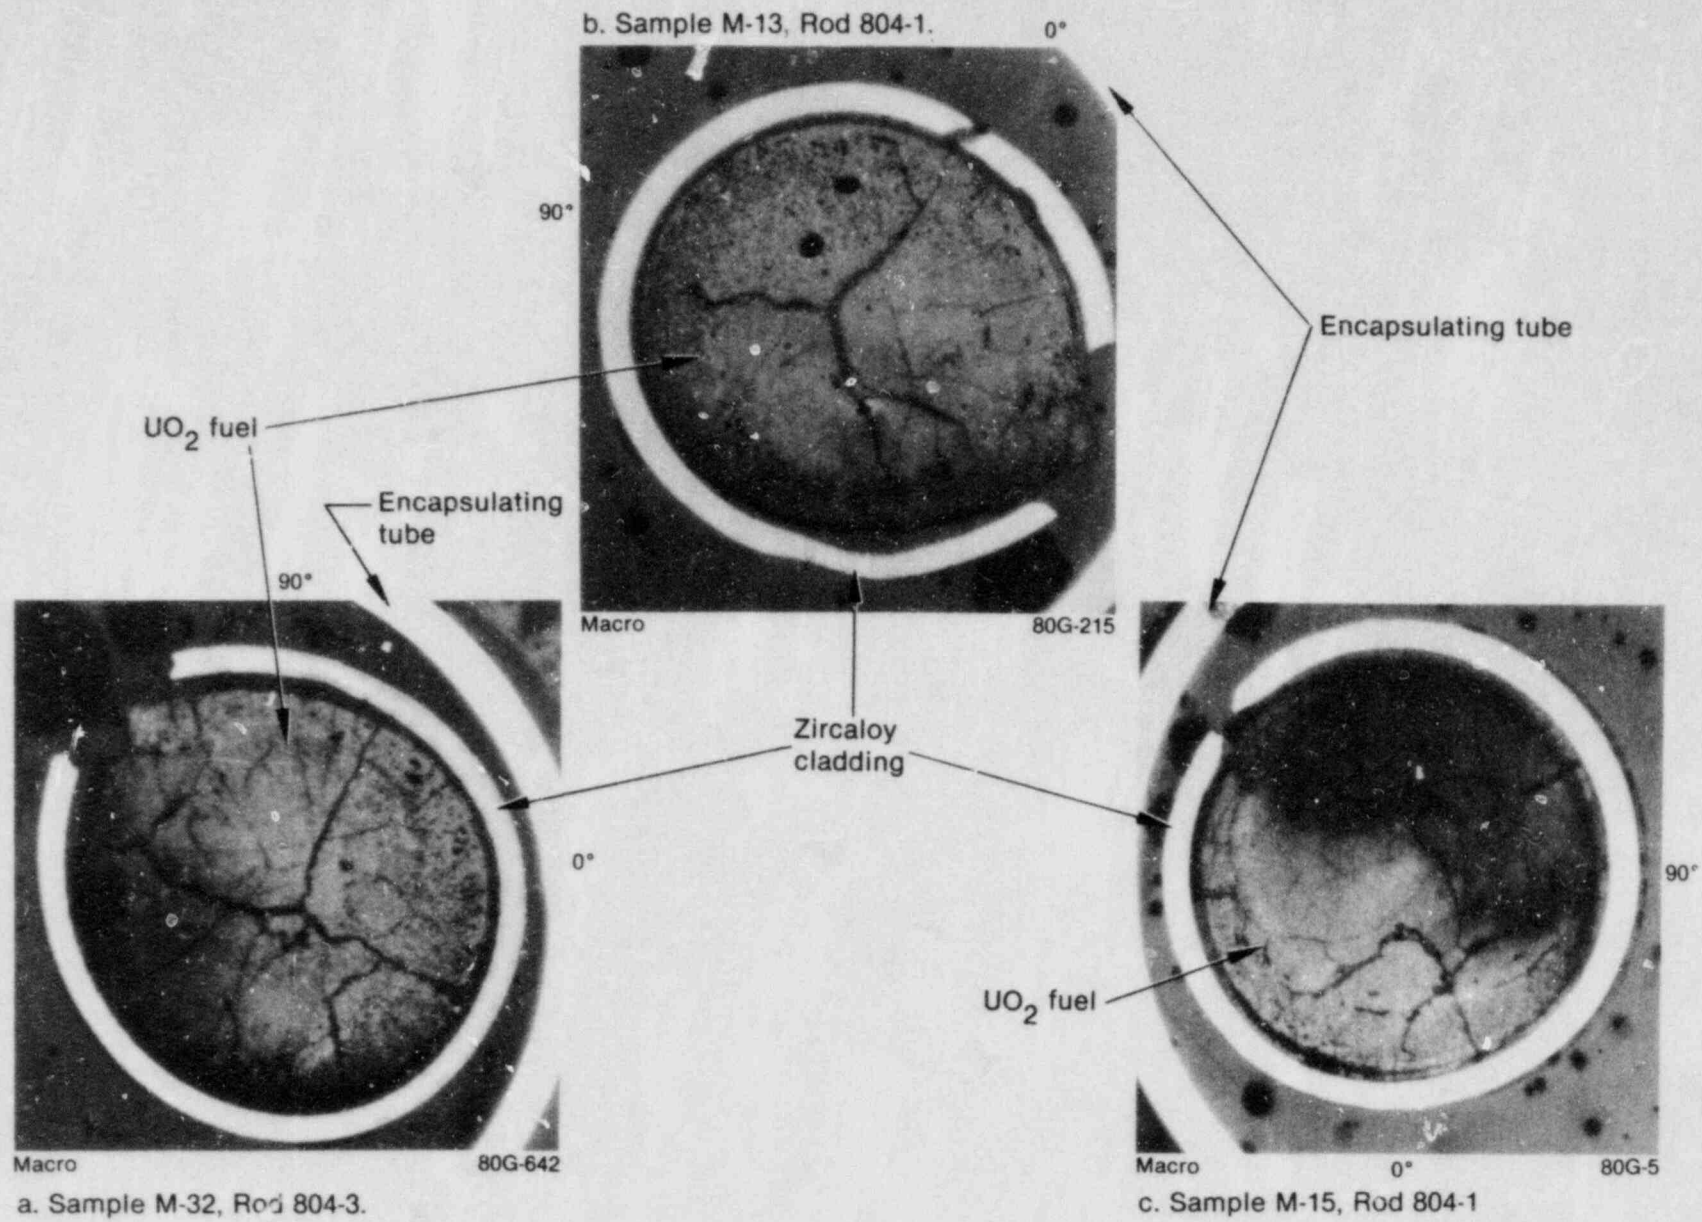
Figure 10. High-strain-rate failures at three cross sections of the RIA 1-4 rods.

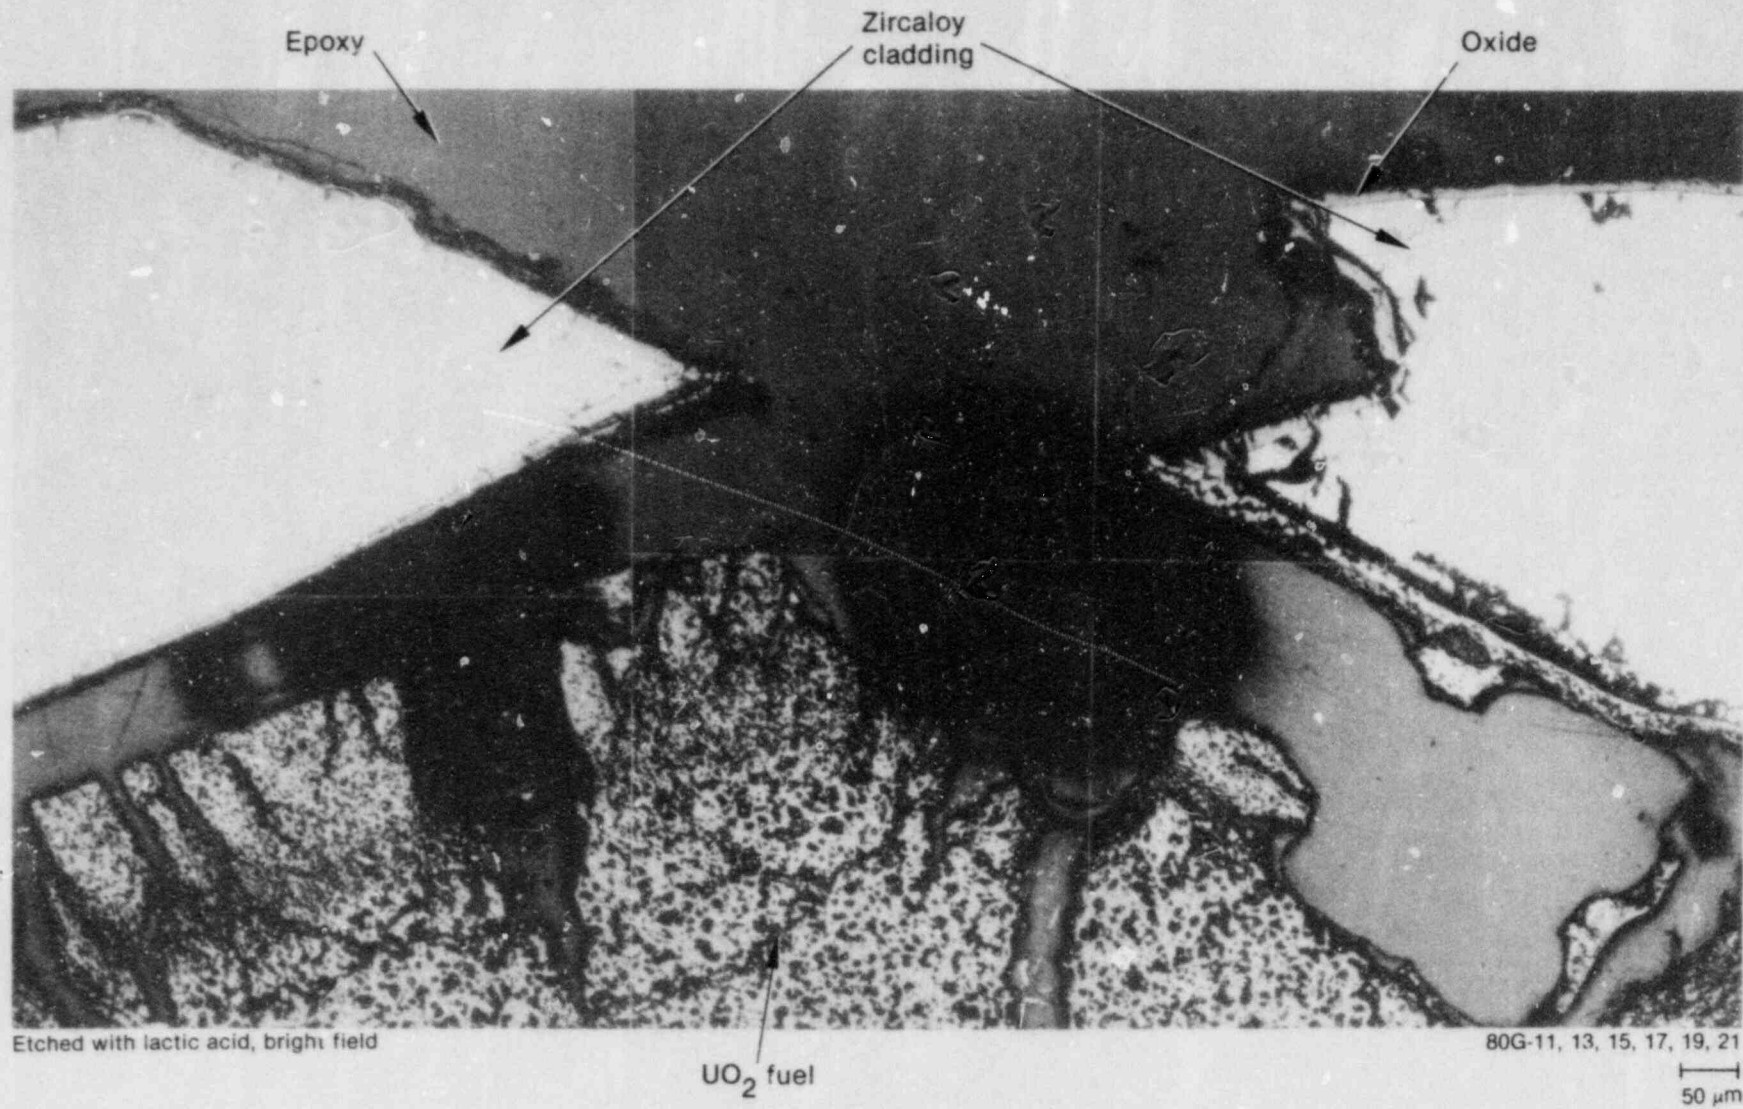
Figure 11. High-strain-rate failure from Rod 804-1.

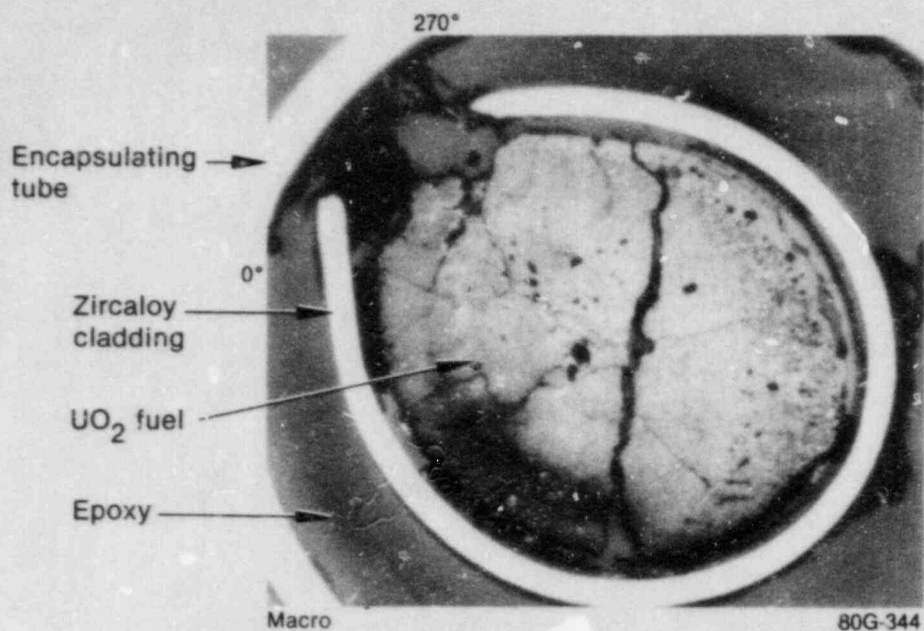
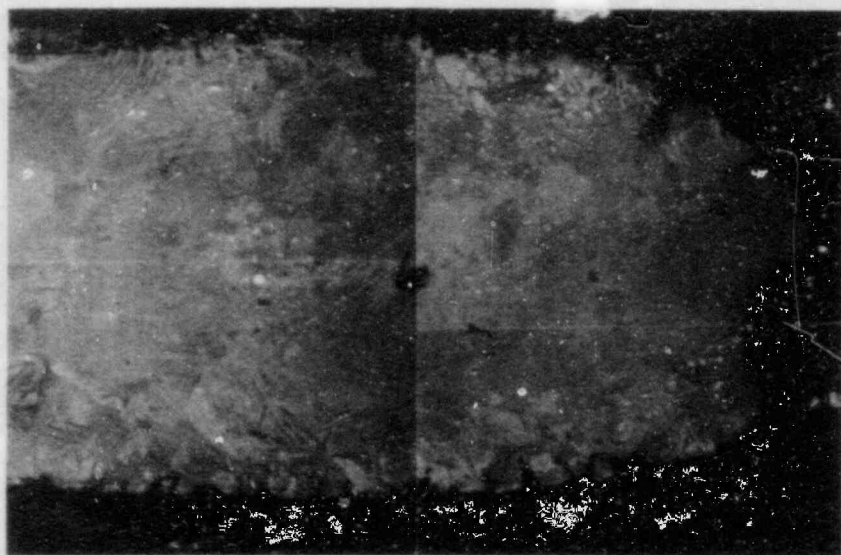
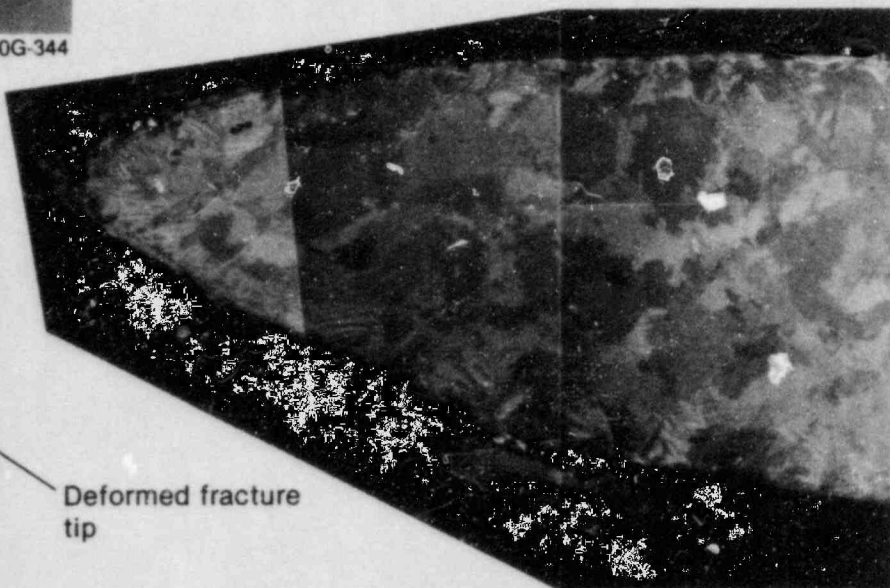
Figure 12. Failure from Rod 804-7 showing some plastic deformation.

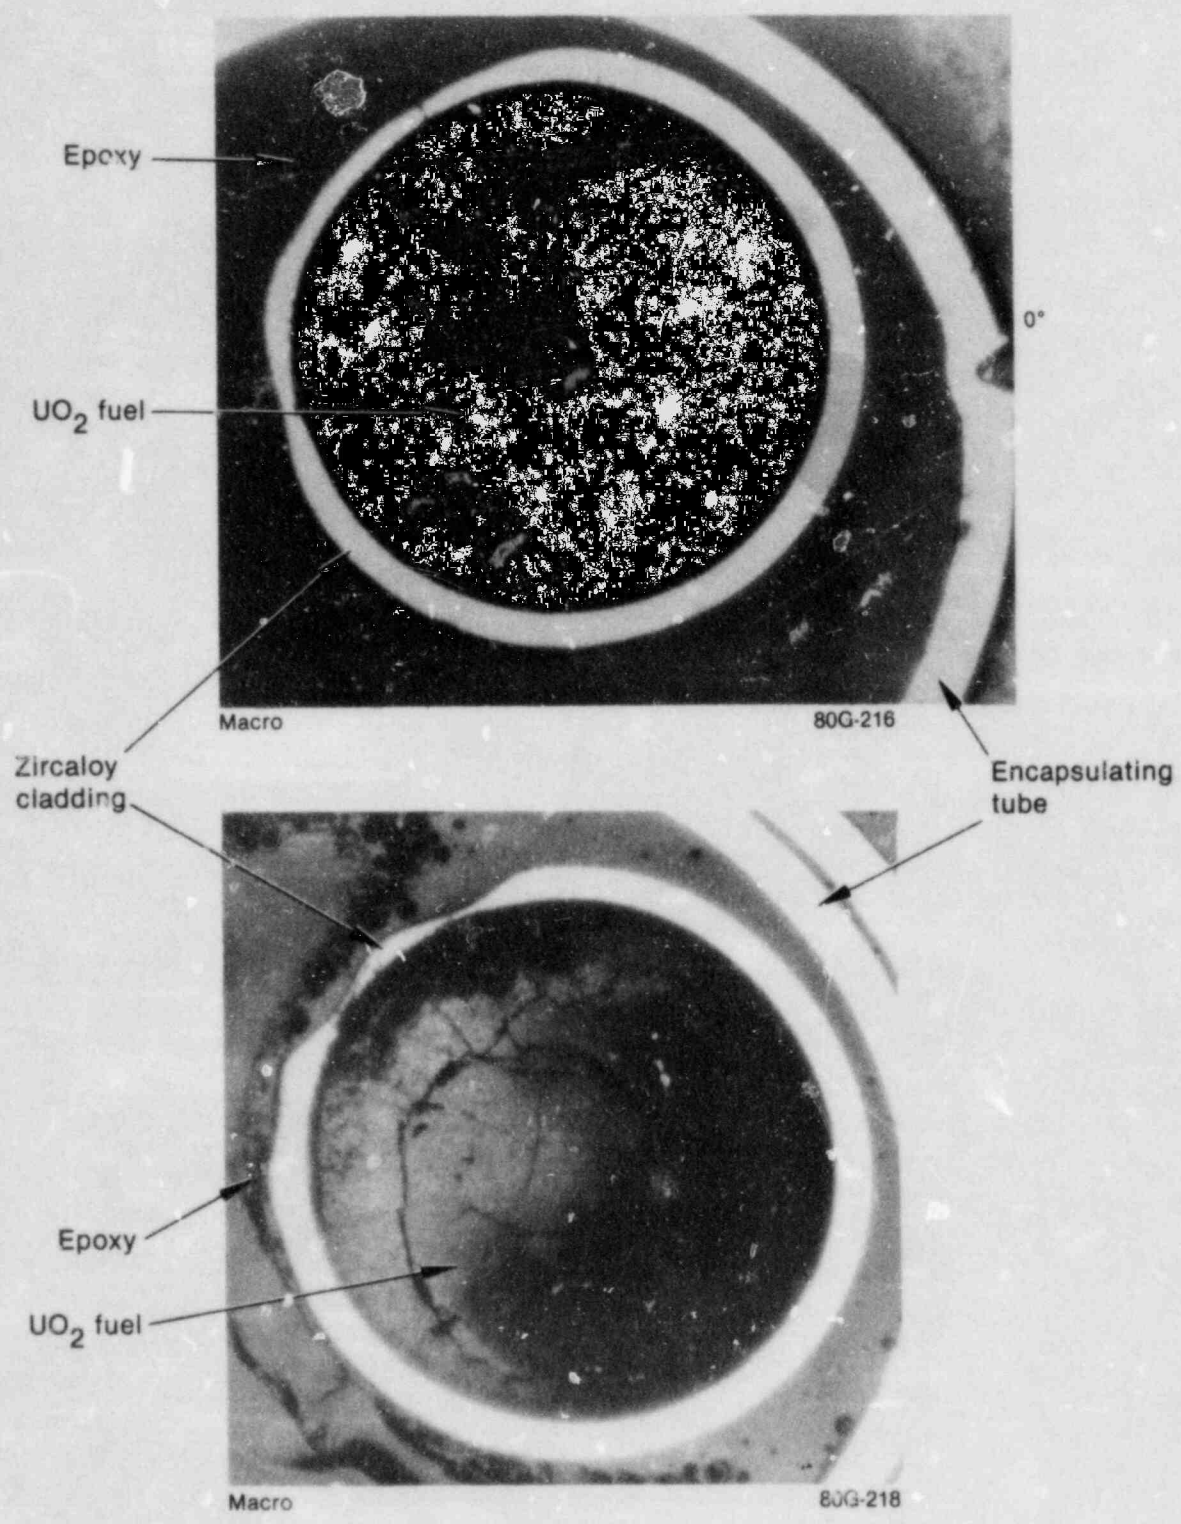
At even higher cladding temperatures, near the zircaloy melting point, significant wall thickening and thinning occurs without through-wall failures.

Figure 13. Cross sections of RIA 1-4 rods showing cladding thickening and thinning.

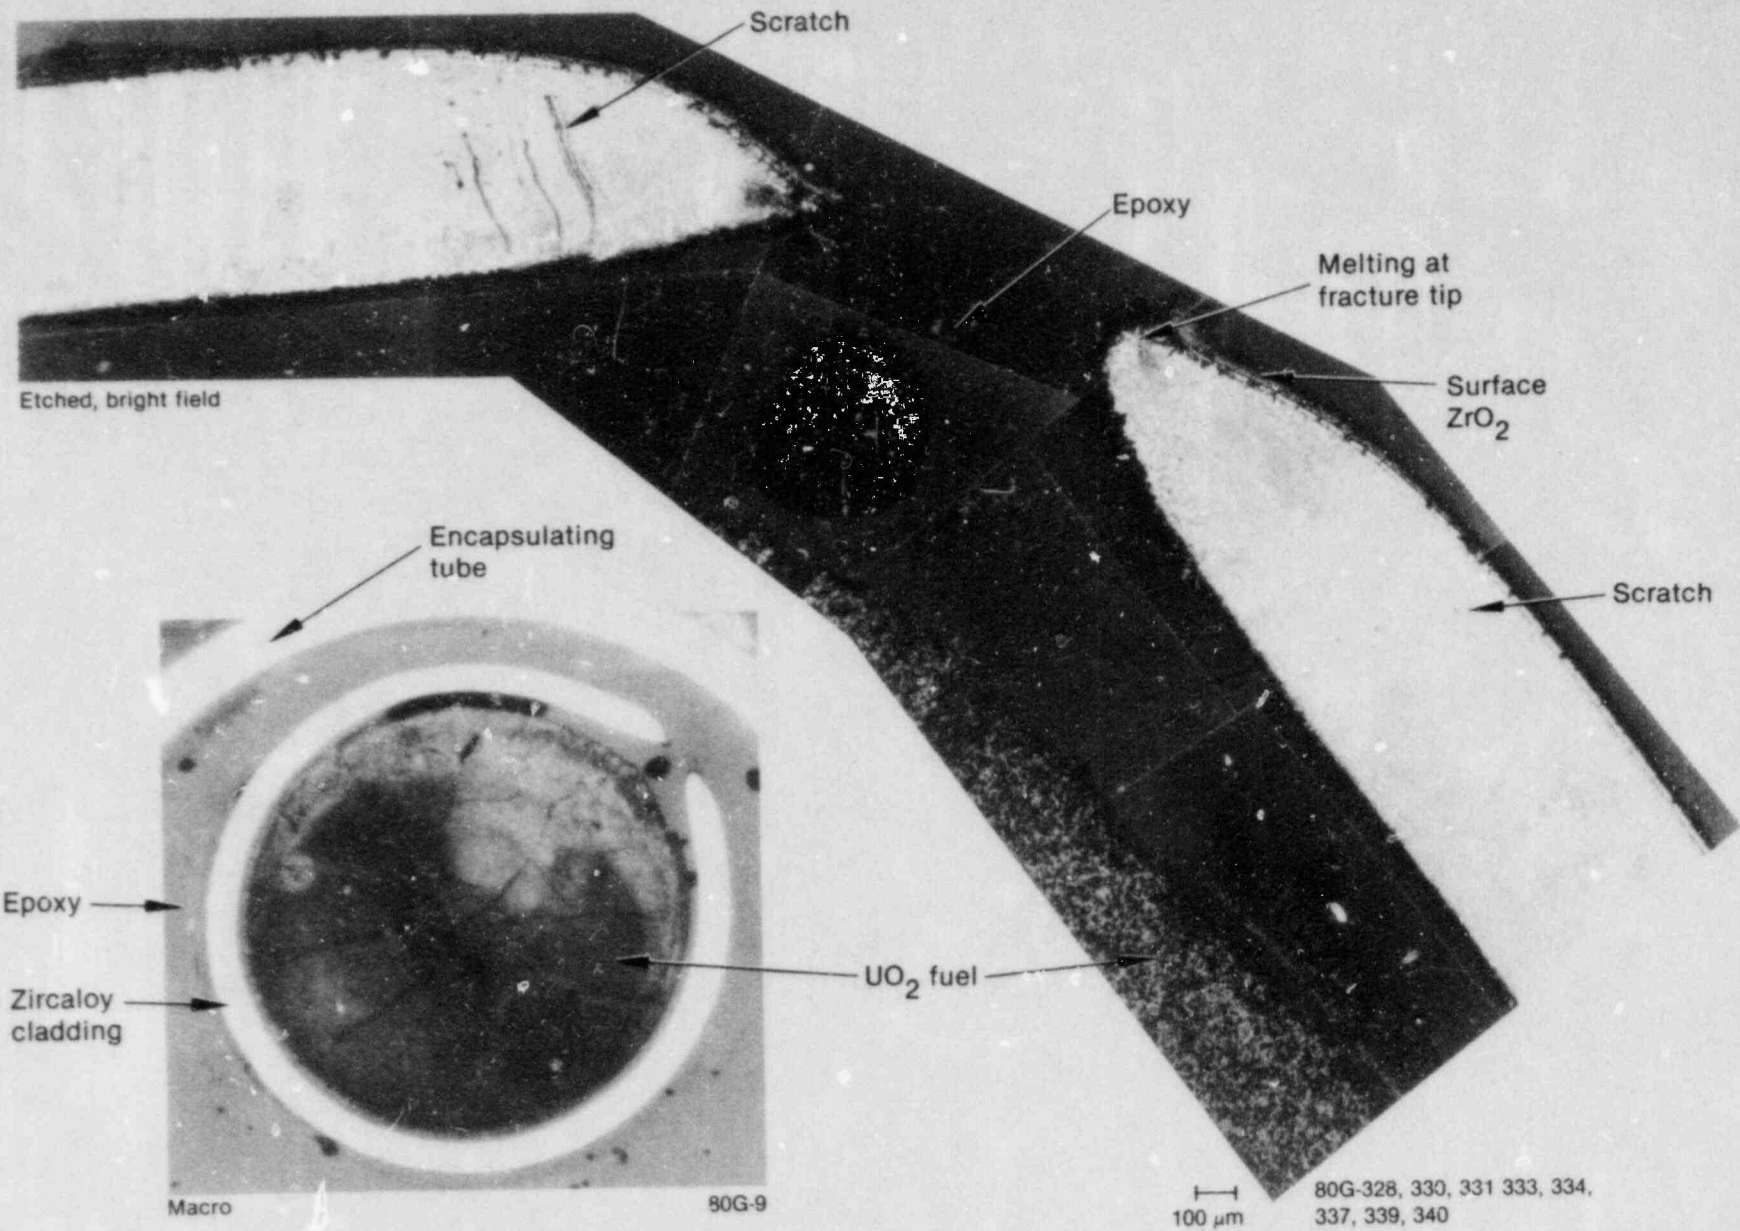
Figure 14. Melting observed at cladding fracture tip; Sample M-64 from Rod 804-6.

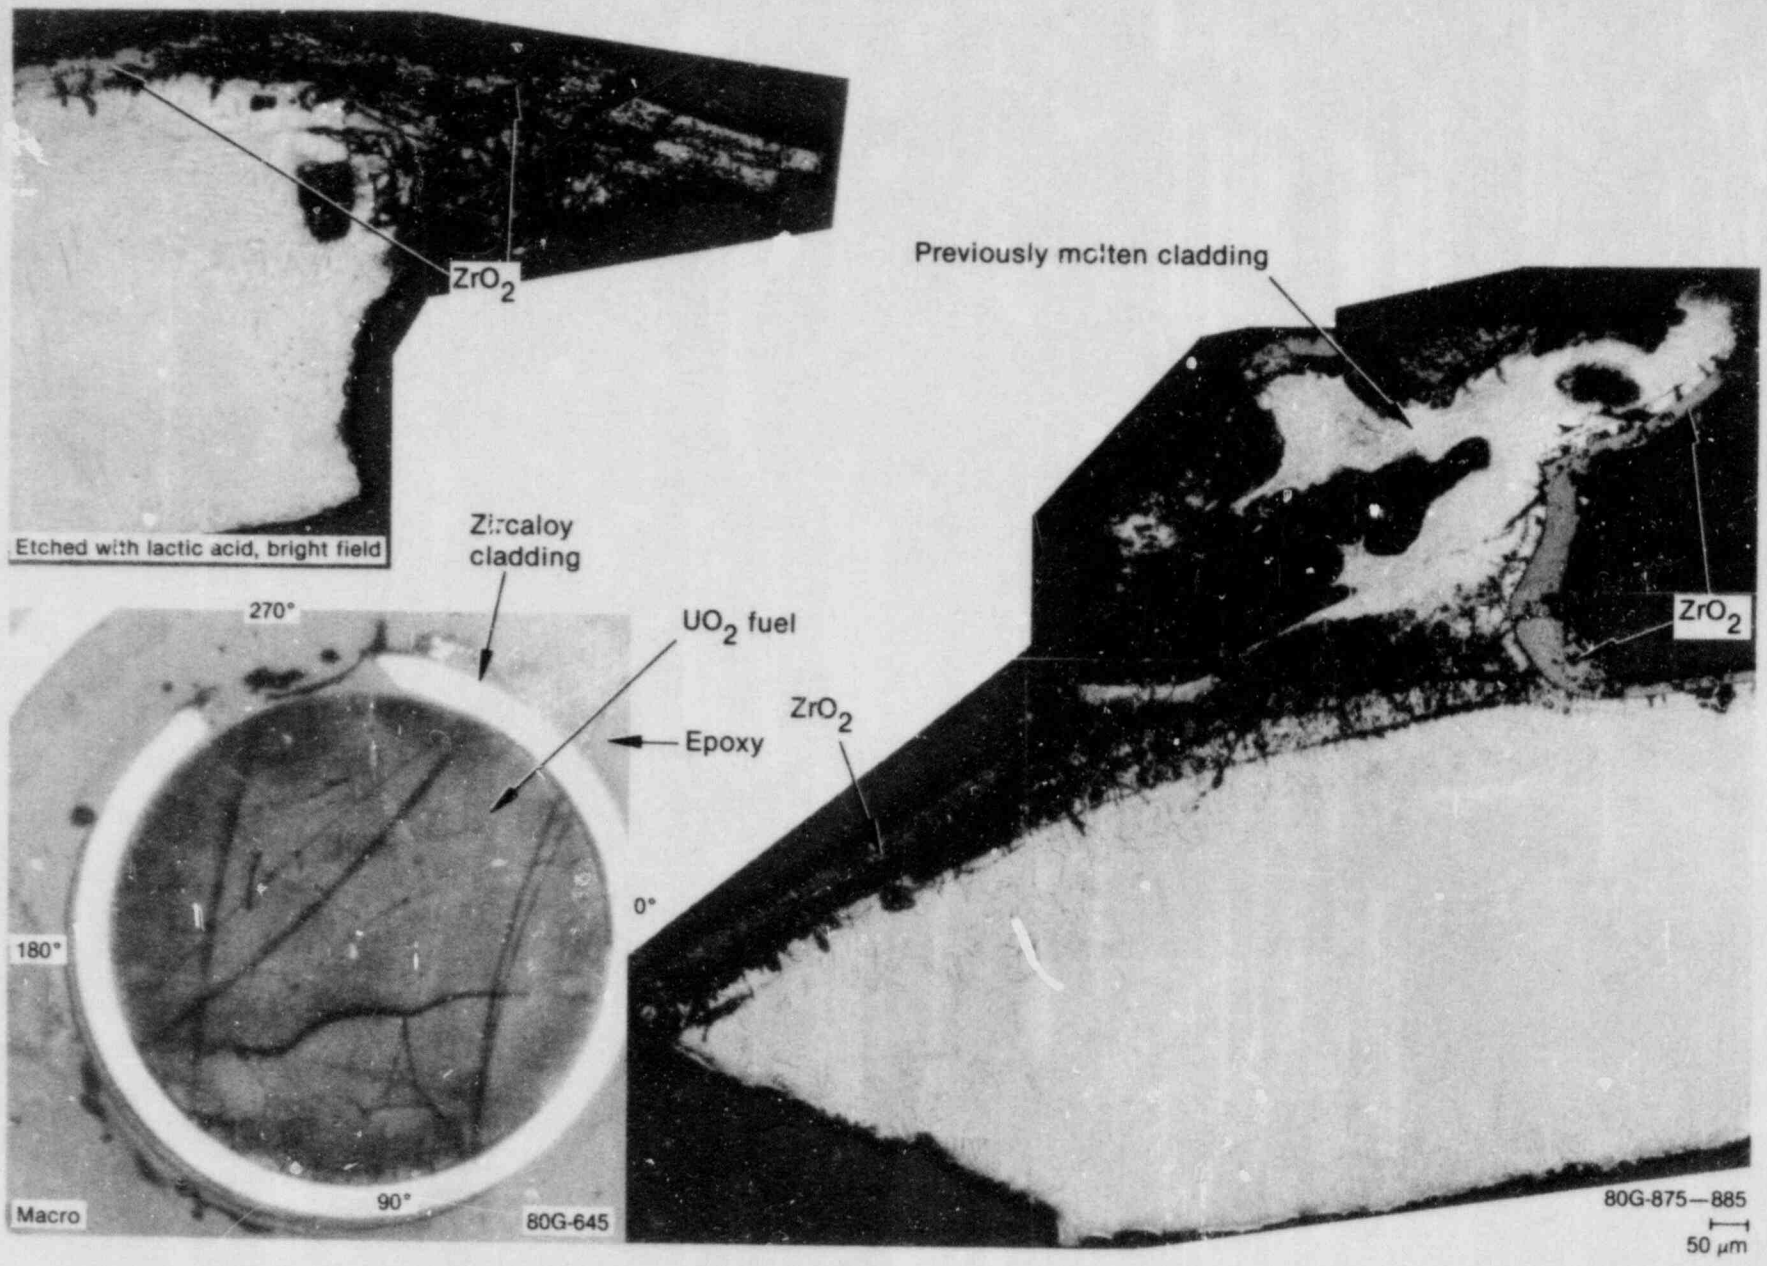
Figure 15. Melting observed at cladding fracture tip; Sample M-52 from Rod 804-5.

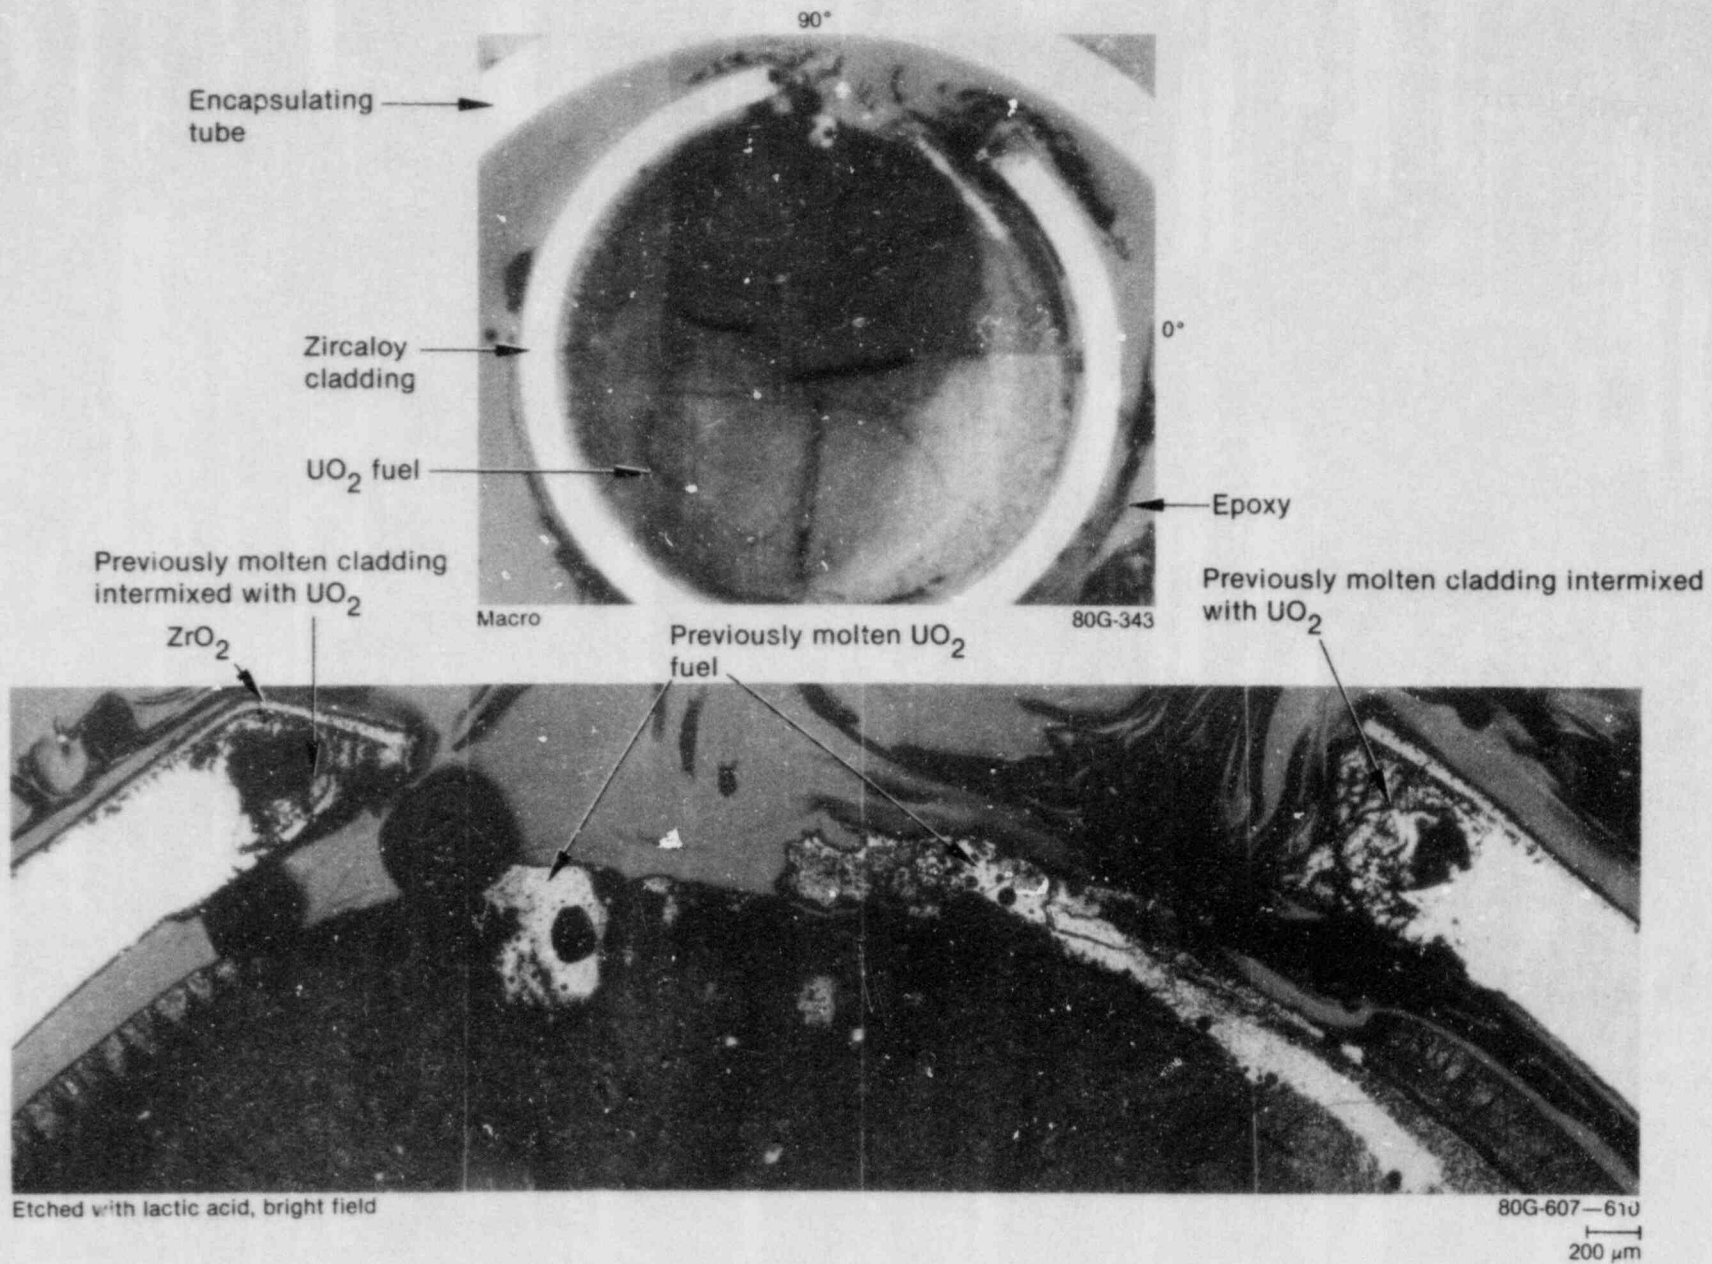
Figure 16. Previously molten fuel and cladding; Sample M-82 from Rod 804-8.

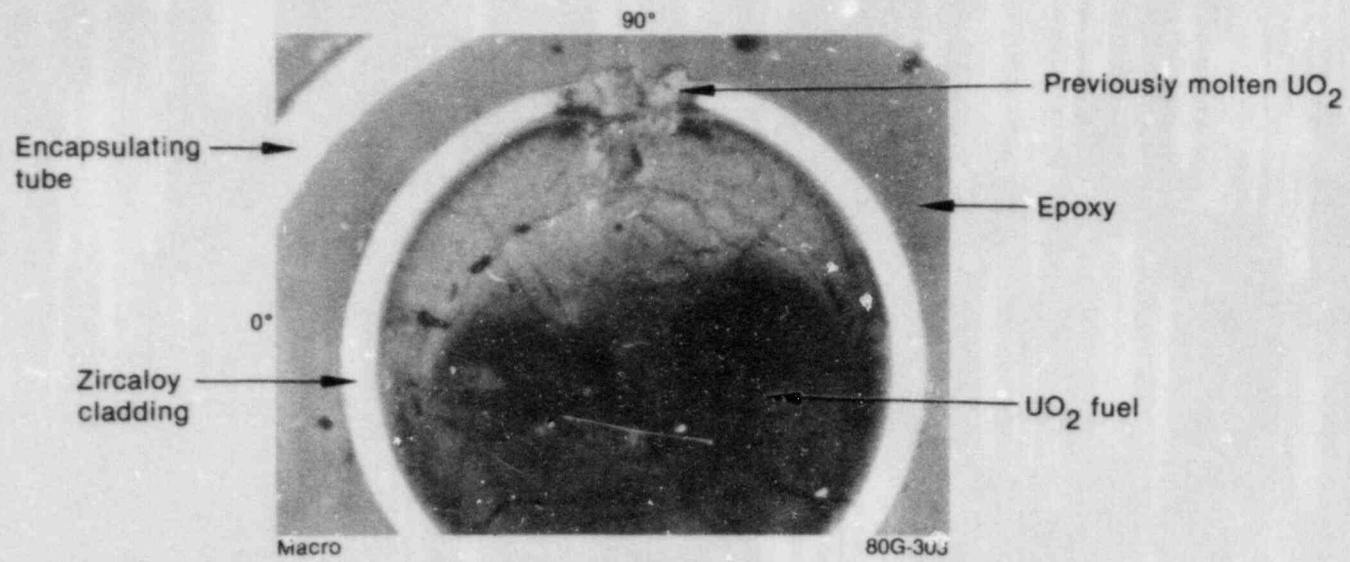
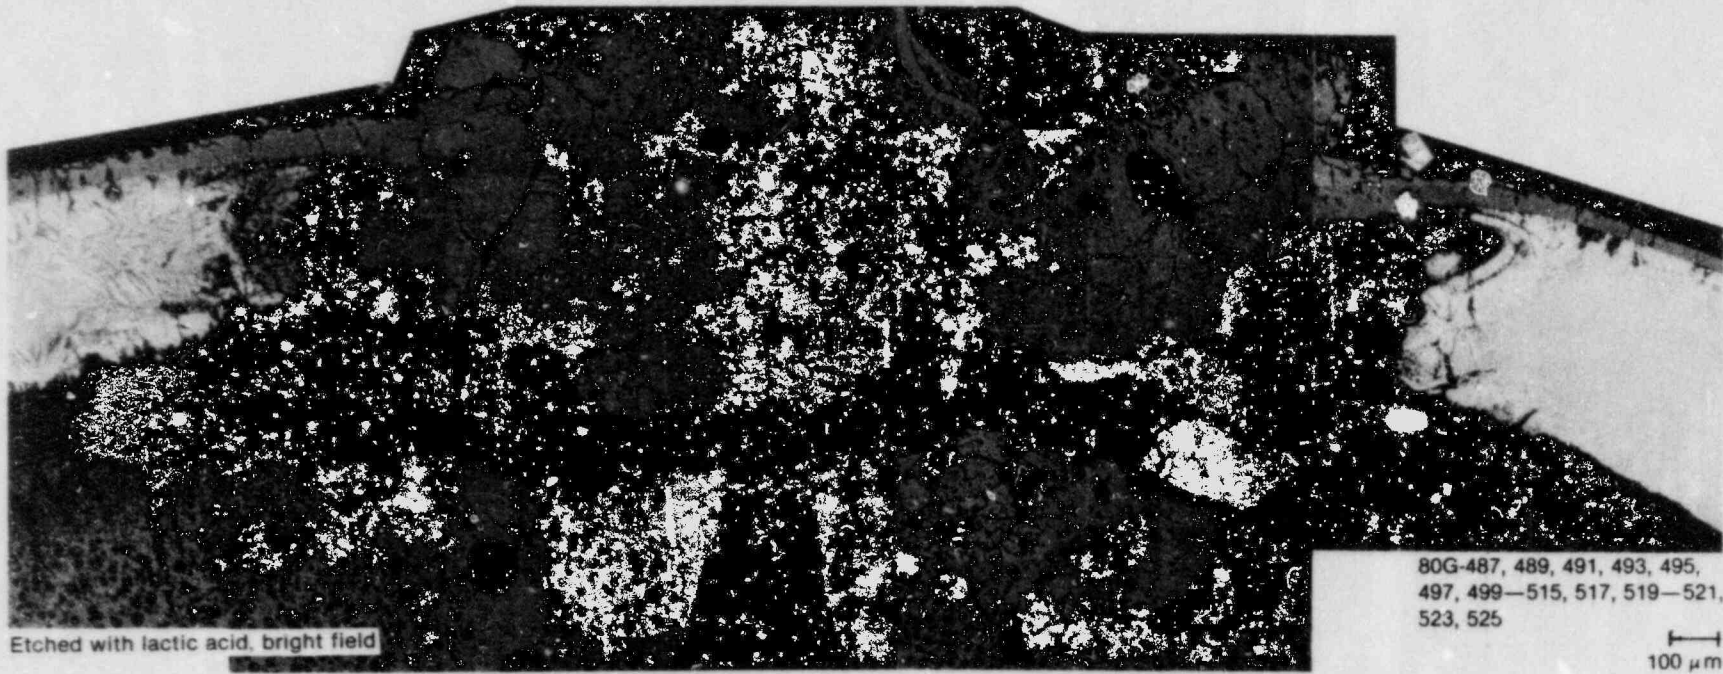
Figure 17. Previously molten fuel and cladding; Sample M-61 from Rod 804-6.

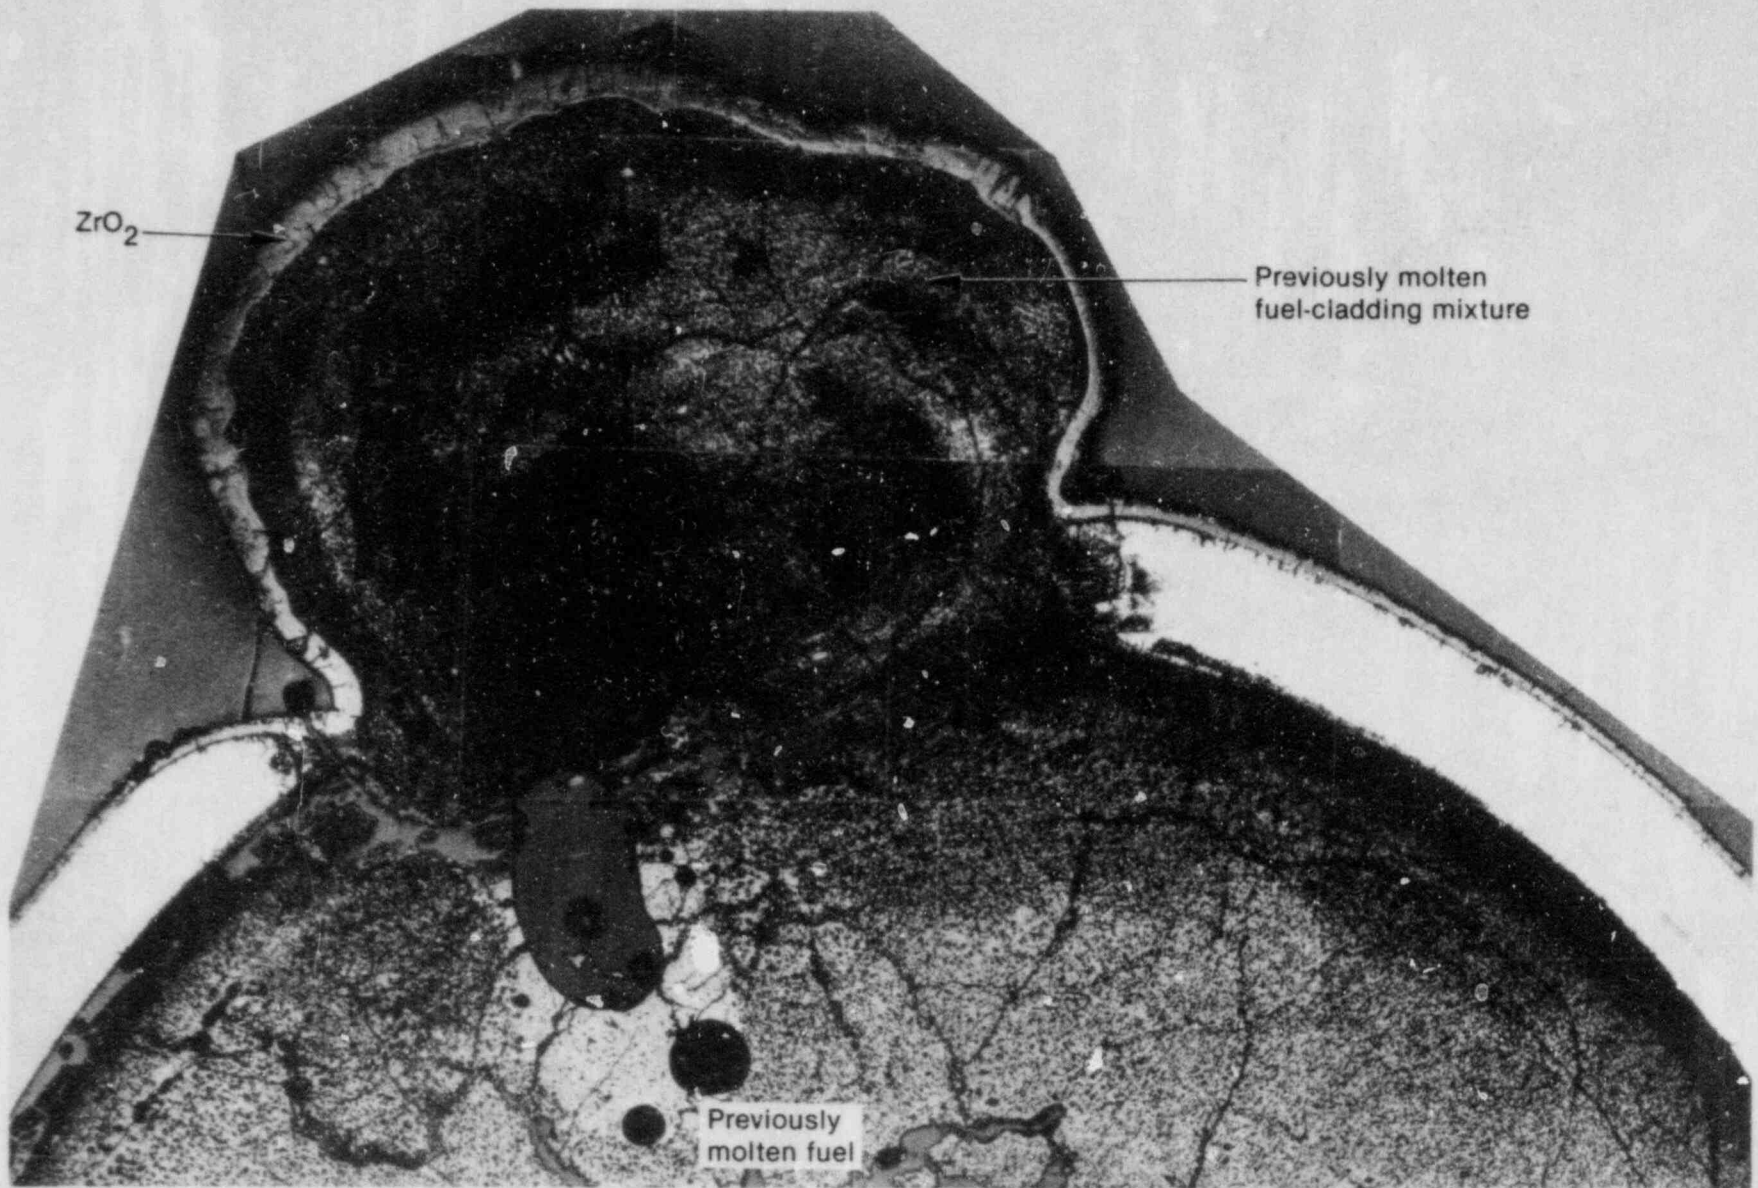
Figure 18. Previously molten fuel and cladding; Sample M-2 from Rod 804-10.

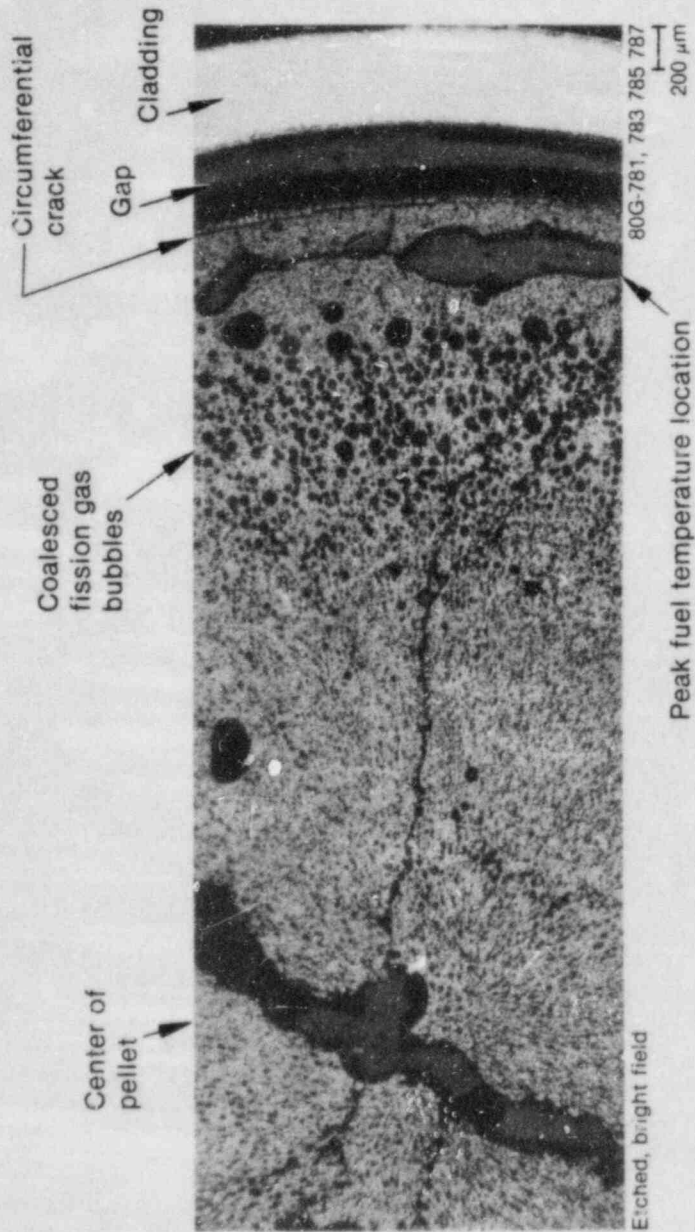
Figure 19. RIA 1-4 typical fuel structure showing location of peak fuel temperature.

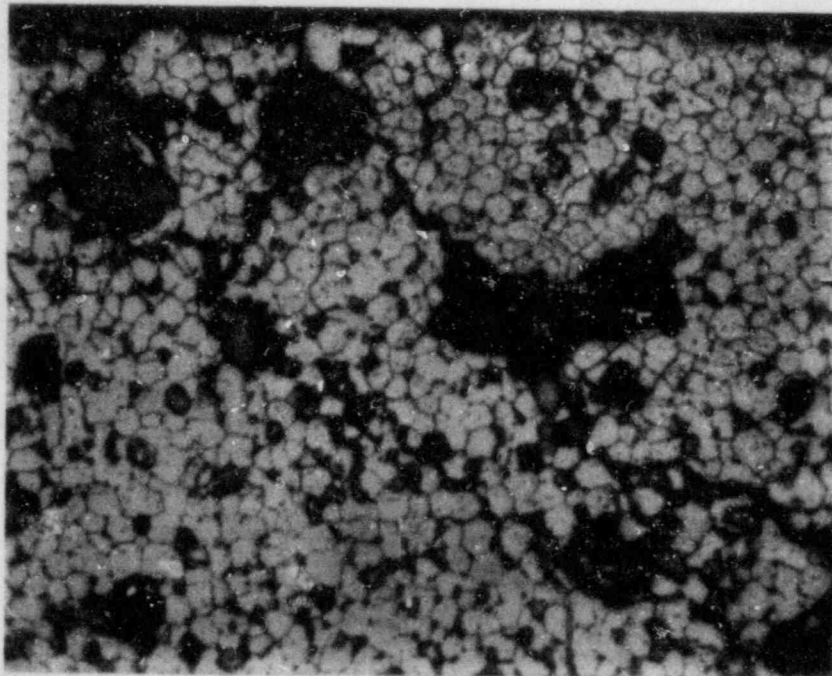
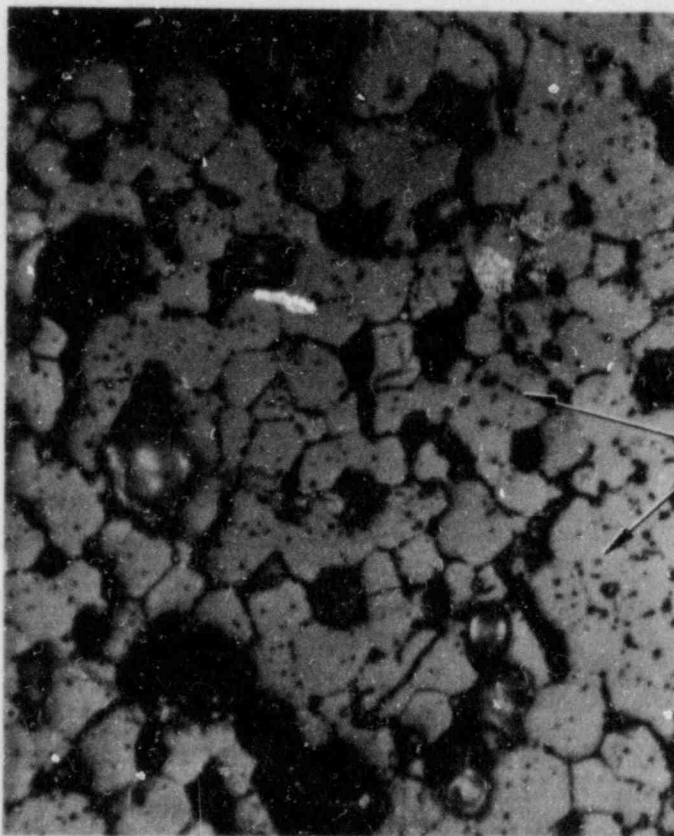
Figure 20. Fission gas bubbles in the fuel matrix.
