Idaho National Engineering Laboratory

**Reactivity Initiated Accident Test Series
Test RIA 1-4 Fuel Behavior Report**

September 1984

NUREG/CR-3938
EGG-2336
Distribution Category: R3

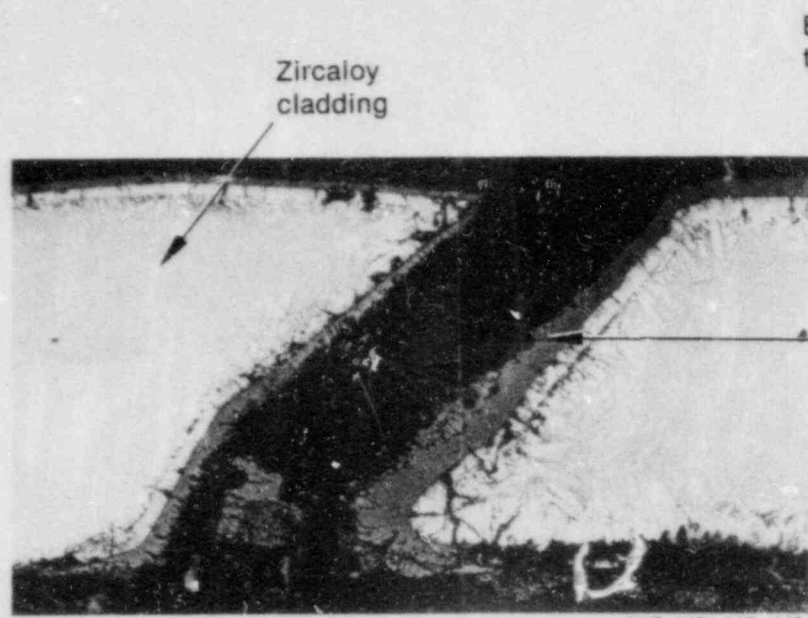
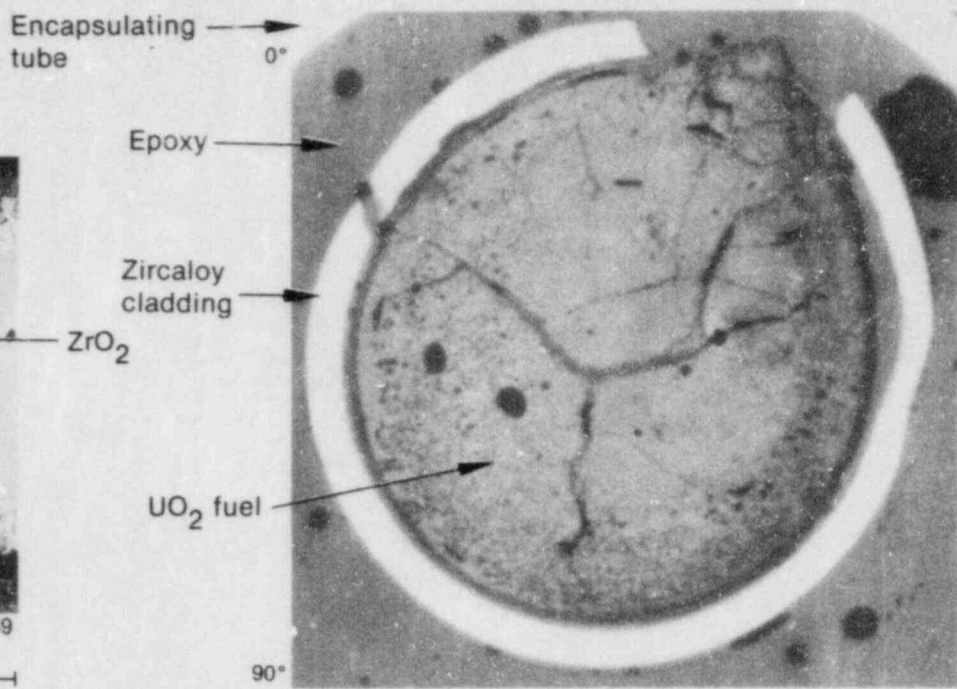
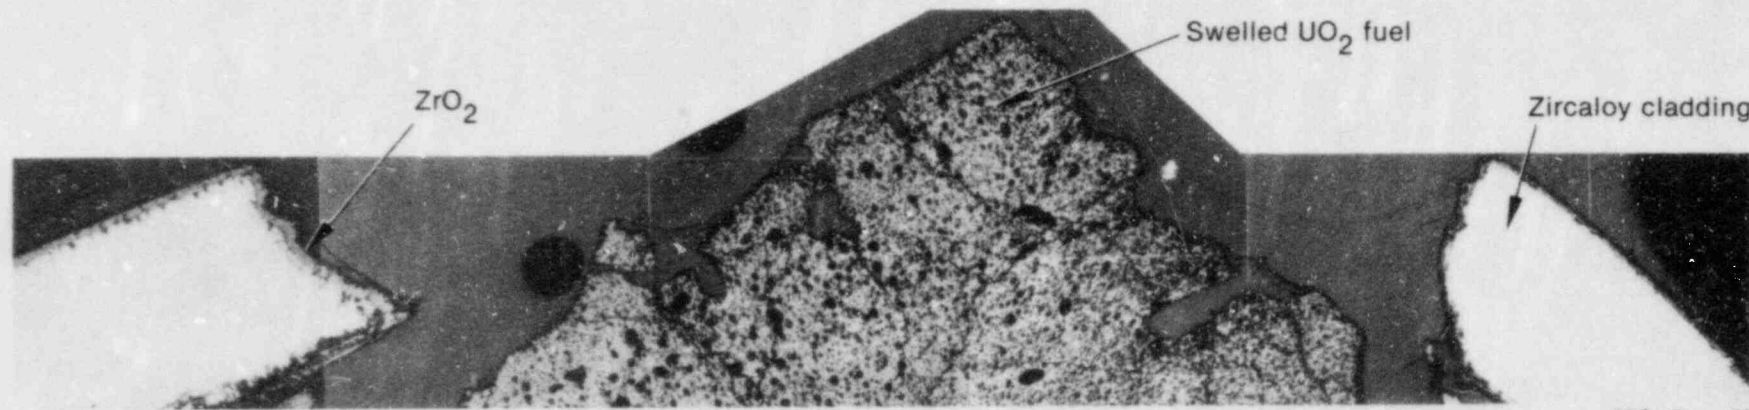
Figure 21. Fuel swelling in RIA 1-4 Rod 804-1.

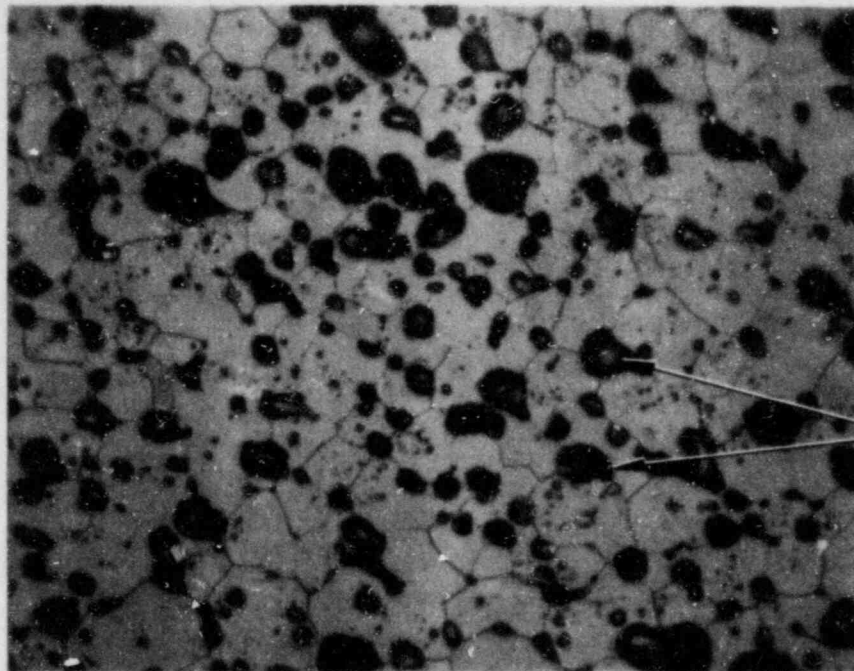
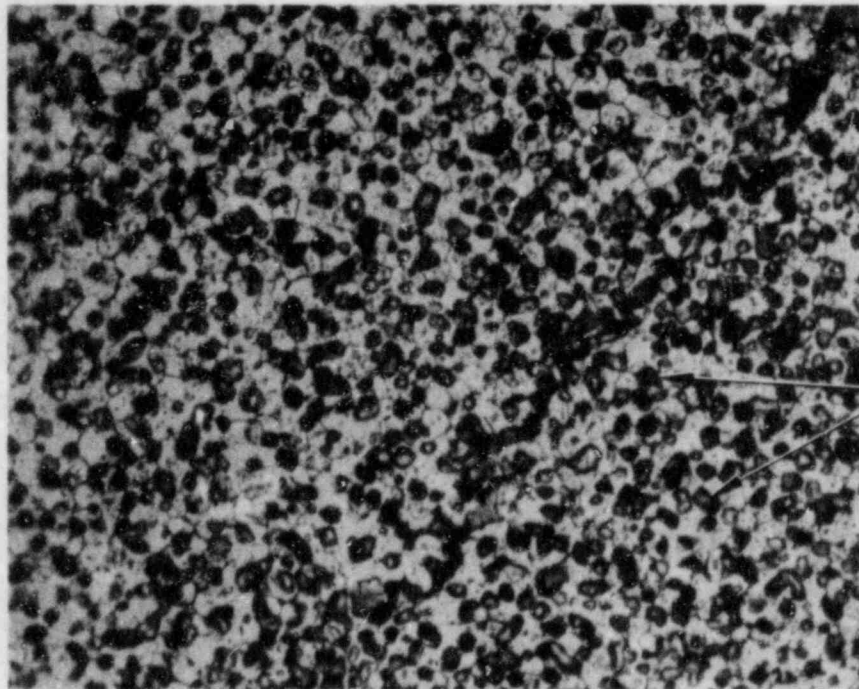
a. Region with grain growth.

b. Region with no grain growth.

Figure 22. Fission gas bubbles at the fuel grain boundaries

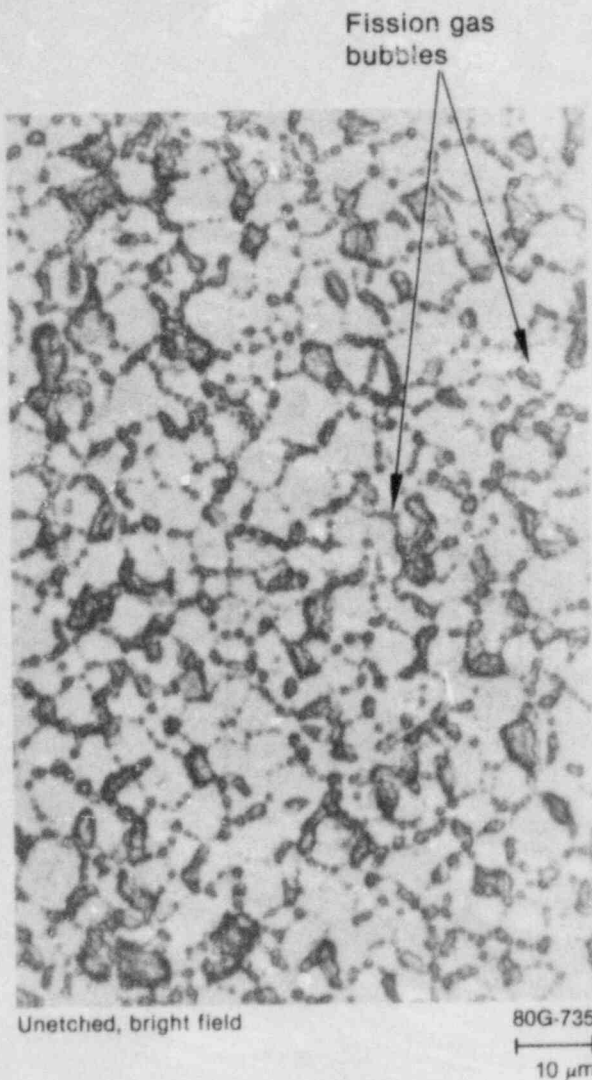
The gas bubbles move in a random pattern in a solid that is free from temperature gradients and mechanical stress. The bubbles move in a biased direction as a result of a temperature gradient or stress at speeds that depend on the bubble size. The moving bubbles can become trapped at grain boundaries and defects such as dislocations. Figure 22 shows two sections of fuel where the fission gas bubbles have been trapped at the grain boundaries, one in a region where some grain growth has occurred, and the other in a region with no grain growth. When the number and diameters of the grain boundary bubbles are large enough, the bubbles come in contact with one another, and the grain boundary breaks open and forms a continuous network for fission gas release to the fuel-cladding gap. An example of a near-continuous network of fission gas bubbles at the grain boundaries is shown in Figure 23.

Figure 23. Near-continuous network of fission gas bubbles at fuel grain boundaries.

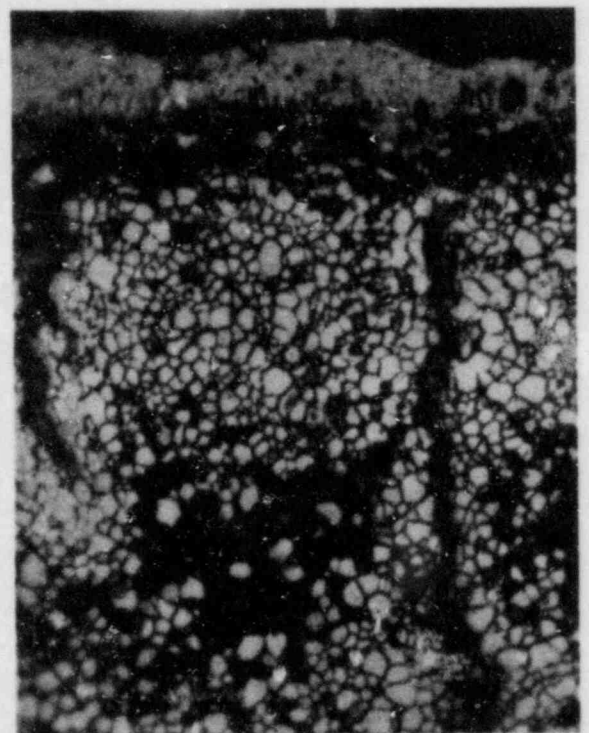
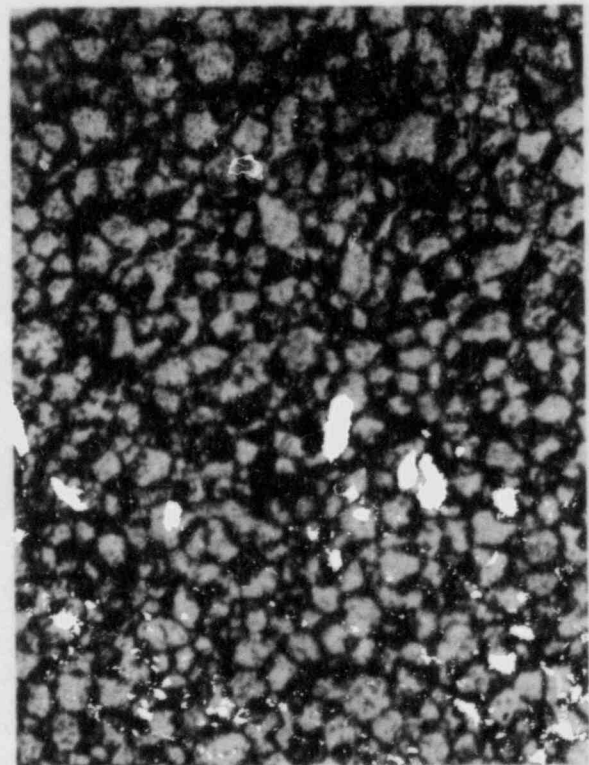
1900 K, and the shattering occurs on quench.¹⁷ There may be an optimum grain size for shattering to occur, because shattering is not present in fuel with significant grain growth. Because grain boundary fracturing occurs only on quench, it does not substantially affect fuel rod performance during a high temperature transient. Examples of fuel shattering are shown in Figure 24.

a. Fuel shattering near pellet edge.

b. Fuel shattering near center of pellet.

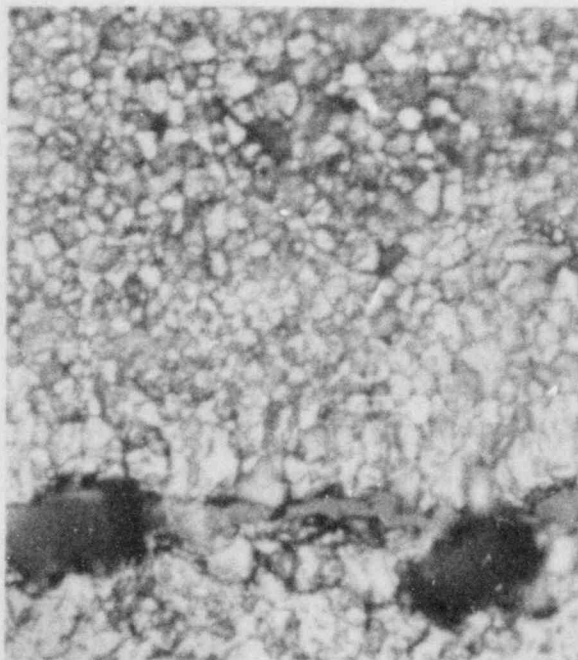
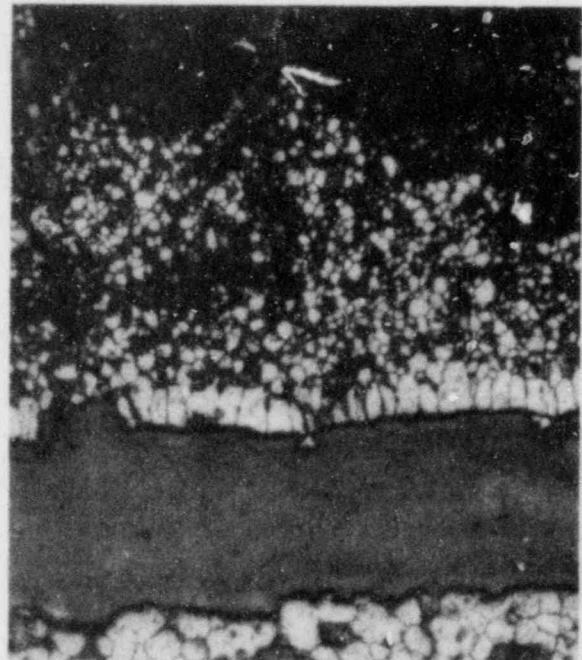
Columnar Grain Growth. A narrow ($\sim 22\text{-}\mu\text{m}$ wide) region of columnar grain growth was observed near the high temperature region at several elevations. The columnar grains probably formed early in the transient, when this region was at the highest fuel temperature. The columnar grains were formed by preferential pore migration up the temperature gradient for, in this case, a short time. As the location

Figure 25. Examples of columnar grain growth near the pellet surface.

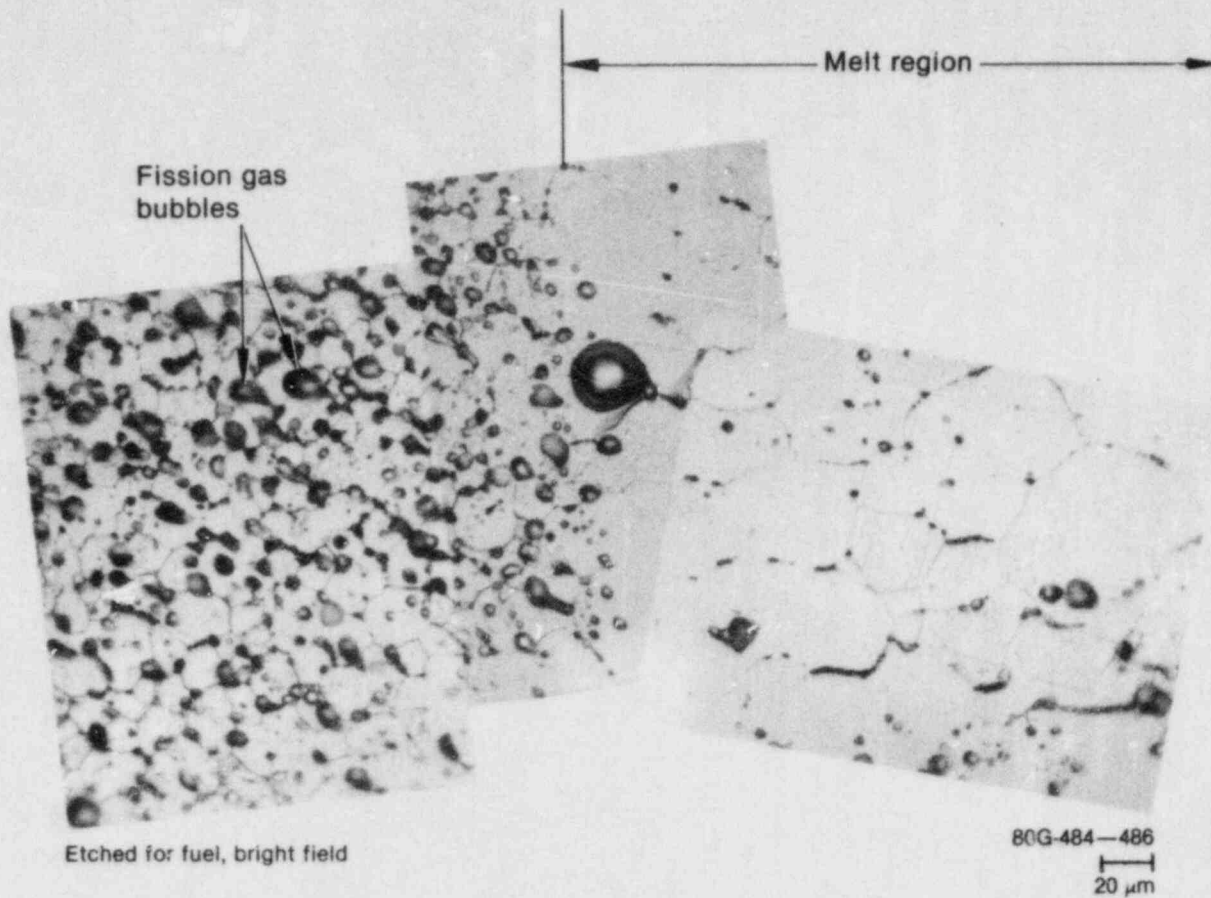
Figure 26. Localized UO₂ fuel melt region nearly swept clean of fission gas bubbles.

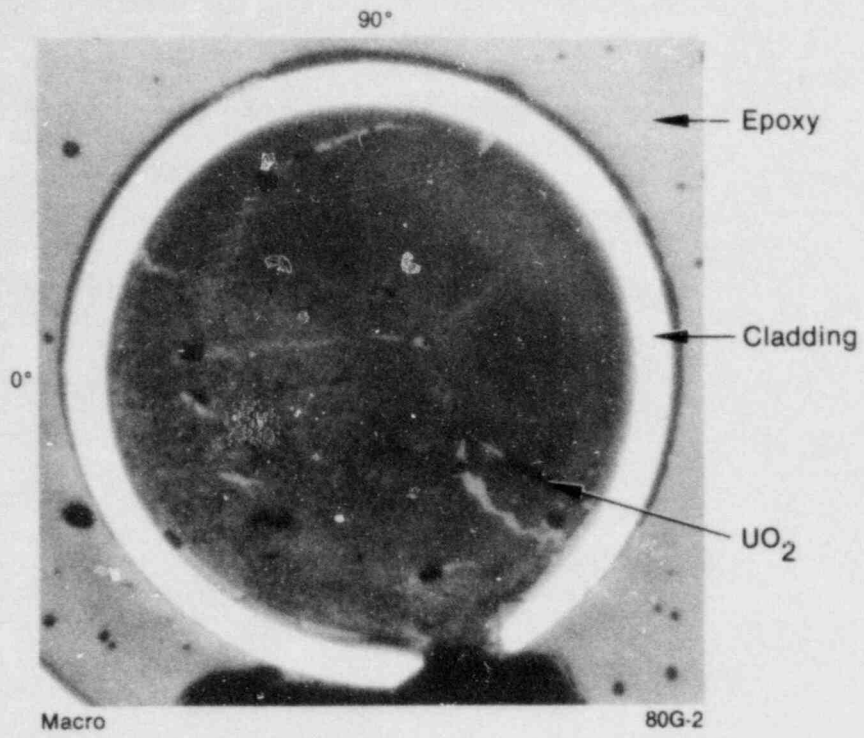
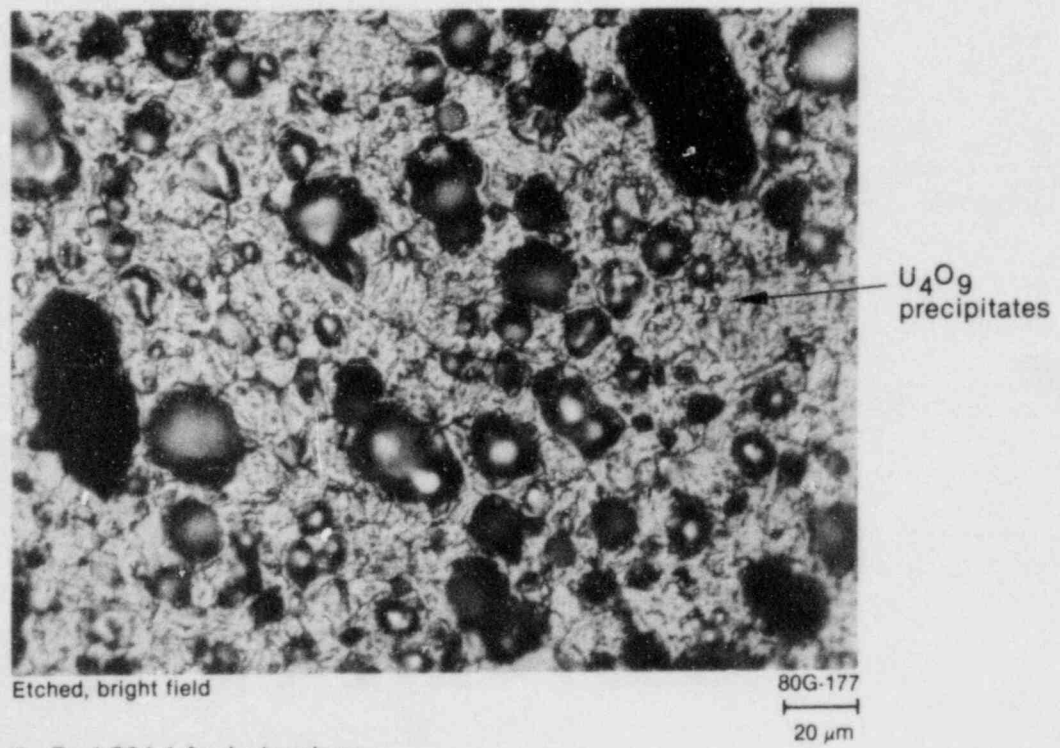
Fuel Oxidation. Oxidation of the UO_2 fuel can occur when the fuel is exposed to steam for an extended period of time.^{18,19} Only one of the locations examined of the nine fuel rods showed any indication of fuel oxidation. Figure 27 shows an overall photograph from the 0.312-m elevation of Rod 804-1 and also a higher magnification photograph of the fuel. The overall photograph shows a uniform color and structure in the fuel; therefore, the higher magnification photograph is representative of all regions in the fuel. The precipitates in the grains in Figure 27b have been identified in other PBF tests as U_4O_9 .¹⁸ The U_4O_9 is unstable at temperatures above 1460 K but forms upon cooling. The presence of U_4O_9 at ambient temperatures indicates an O/U ratio in the fuel of between 2.0 and 2.25. The melting point of the fuel is reduced and grain growth is increased with increasing oxygen content.

Samples from Rod 804-1 at elevations 4.1 cm below and 10.7 cm above the location in Figure 27 do not show fuel oxidation. The oxidation seems to be localized to the one elevation of Rod 804-1 and does not appear to have affected fuel rod performance significantly.

Figure 27. Fuel oxidation in RIA 1-4 Rod 804-1.
