NUREG/CR-3597  
SAND84-0938  
RV  
Printed September 1984

# Equipment Qualification Methodology Research: Tests of RTDs

Prepared for  
**U. S. NUCLEAR REGULATORY COMMISSION**

Ten resistance temperature detectors (RTDs), from three manufacturers, were subjected to an abbreviated loss-of-coolant accident (LOCA) environment (saturated steam and chemical spray) simulation test as part of the NRC-sponsored Equipment Qualification Methodology Research Test Program (A-1355). The test was a "screening test" on unaged specimens that lasted about 24 hours and was of short duration to isolate any obvious problem areas. The LOCA environment caused functional failures and some physical damage in four of the RTDs tested. One RTD failed early in the test, two others of the same type produced erroneous temperature readings 7.5 hours into the test. Post-test investigations revealed that water leakage into the head areas of the three affected RTDs (as well as one other of the same model) may have contributed to the anomolous behavior.

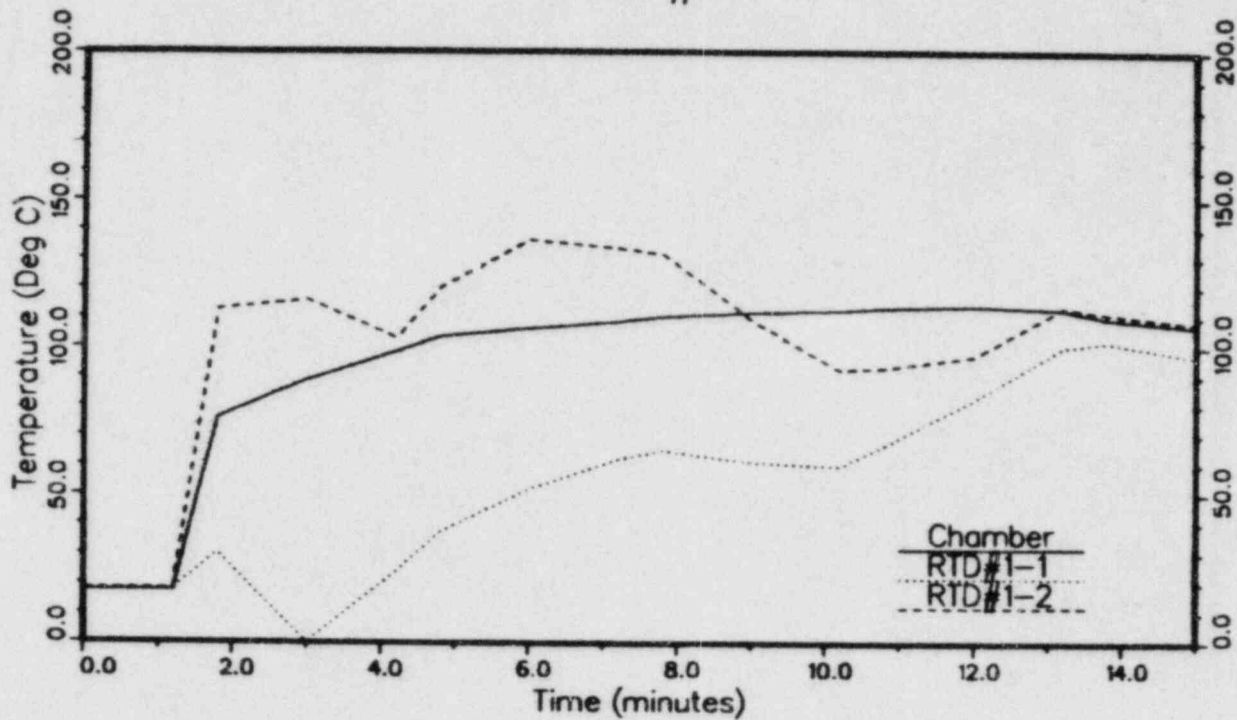
Exposure was begun at 0830, March 16, 1983. Within the first minute, a large steam leak was apparent around the cable of RTD No. 1 where the cable came out of the chamber. Post-test examinations revealed that the leak was around the screw cap sealing gasket at the RTD head. By 0831, RTD No. 1 readings had begun to diverge from the chamber temperature, and by 0832 it was clearly producing erroneous temperature indications. (Figure 6 shows the output for both circuits of RTD No. 1, and the average chamber temperature versus time, for this period.) By 0846 (16 minutes into the test - see the measured pressure drop in Figure 4) the test was temporarily shut down, the cables were cut on RTD No. 1 and the steam leak was sealed.

Figure 6. Test chamber and RTD #1 (circuit-1, and circuit-2) temperature profiles for the first 15 minutes of the LOCA test.

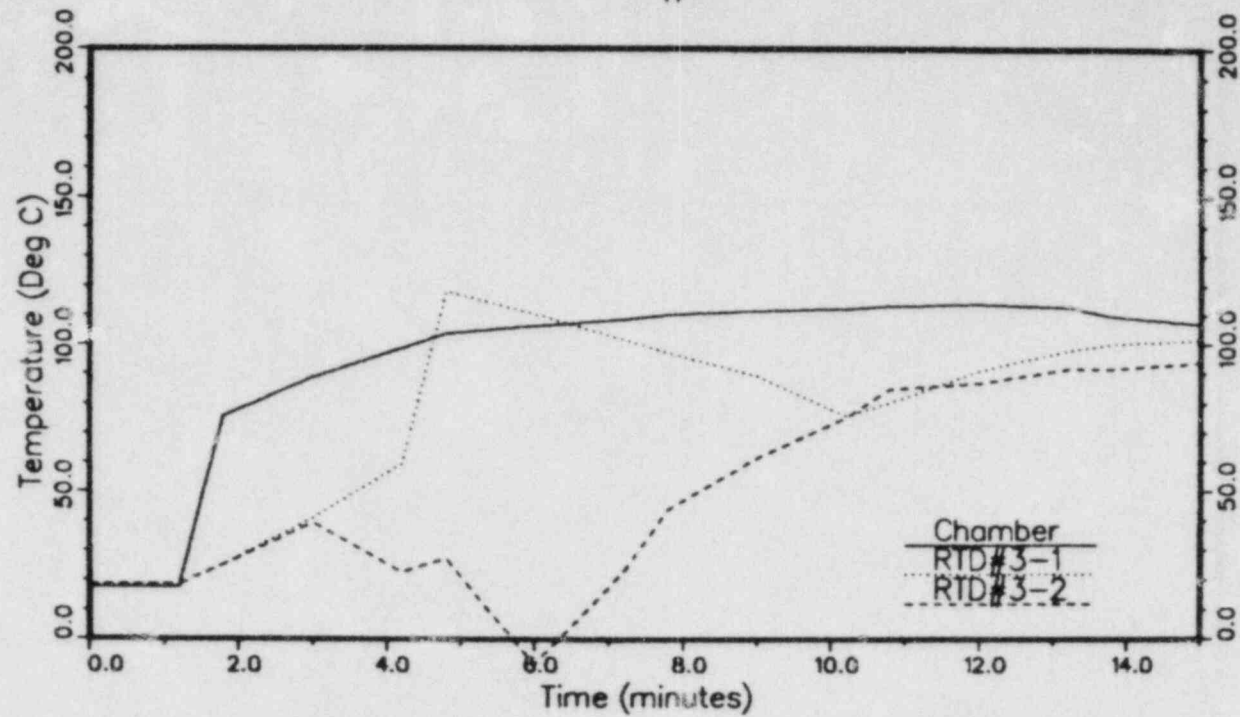
During the same time period, RTD No. 2 and RTD No. 3 also gave erroneous readings, suggesting that water had leaked into the RTDs (Figures 7 and 8). (After the conclusion of the exposure, RTD No. 2 was found to be leaking at the head gasket and also to have a small hole through the body casting. RTD No. 3 was found to have a small leak in the head gasket and a small leak in the flexible hose used to protect the cable.) By the end of the test, RTD No. 3 was also leaking at the flexible metal connector at the chamber head because the heat-shrinkable tubing had shrunk too far and had uncovered the connector. The problems with flexible hose and heat-shrinkable tubing are not attributable to Supplier A, as these elements were Sandia-furnished. (The flexible hose was supplied as nuclear-grade material, and the heat-shrinkable tubing had been used in the same way in previous Sandia tests.<sup>10</sup>)

Figure 8. Test chamber and RTD #3 (circuit-1, and circuit-2) temperature profiles for the first 15 minutes of the LOCA test.

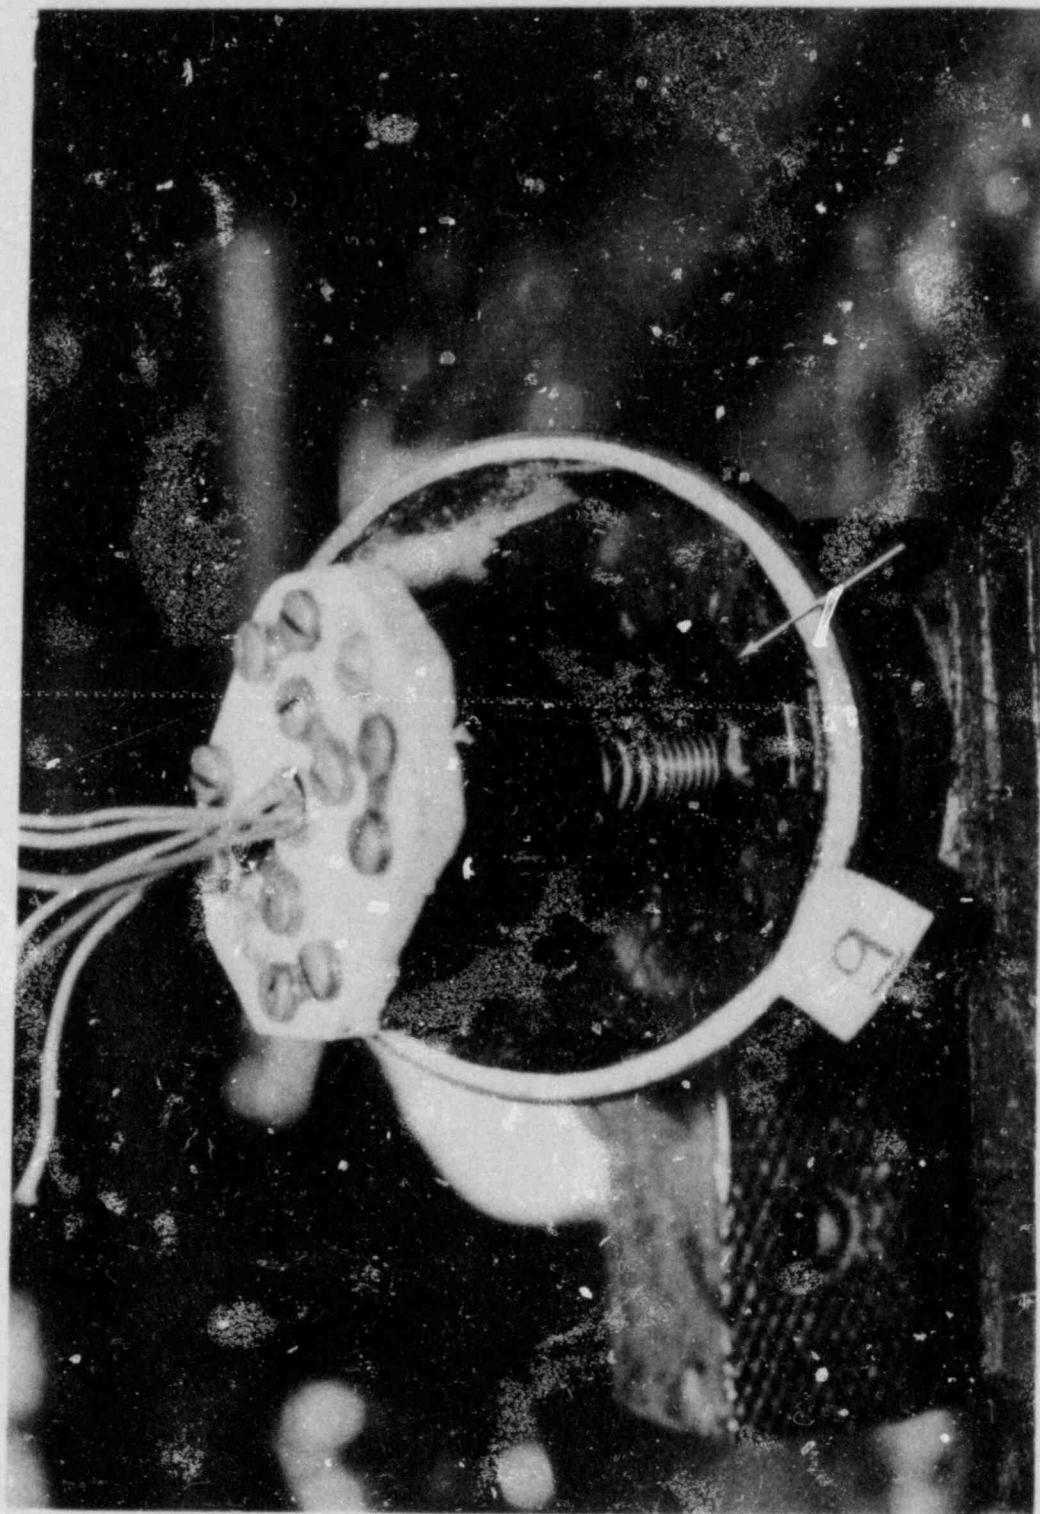
Figure 25. RTD No. 1, showing water inside the thermowell (arrow).

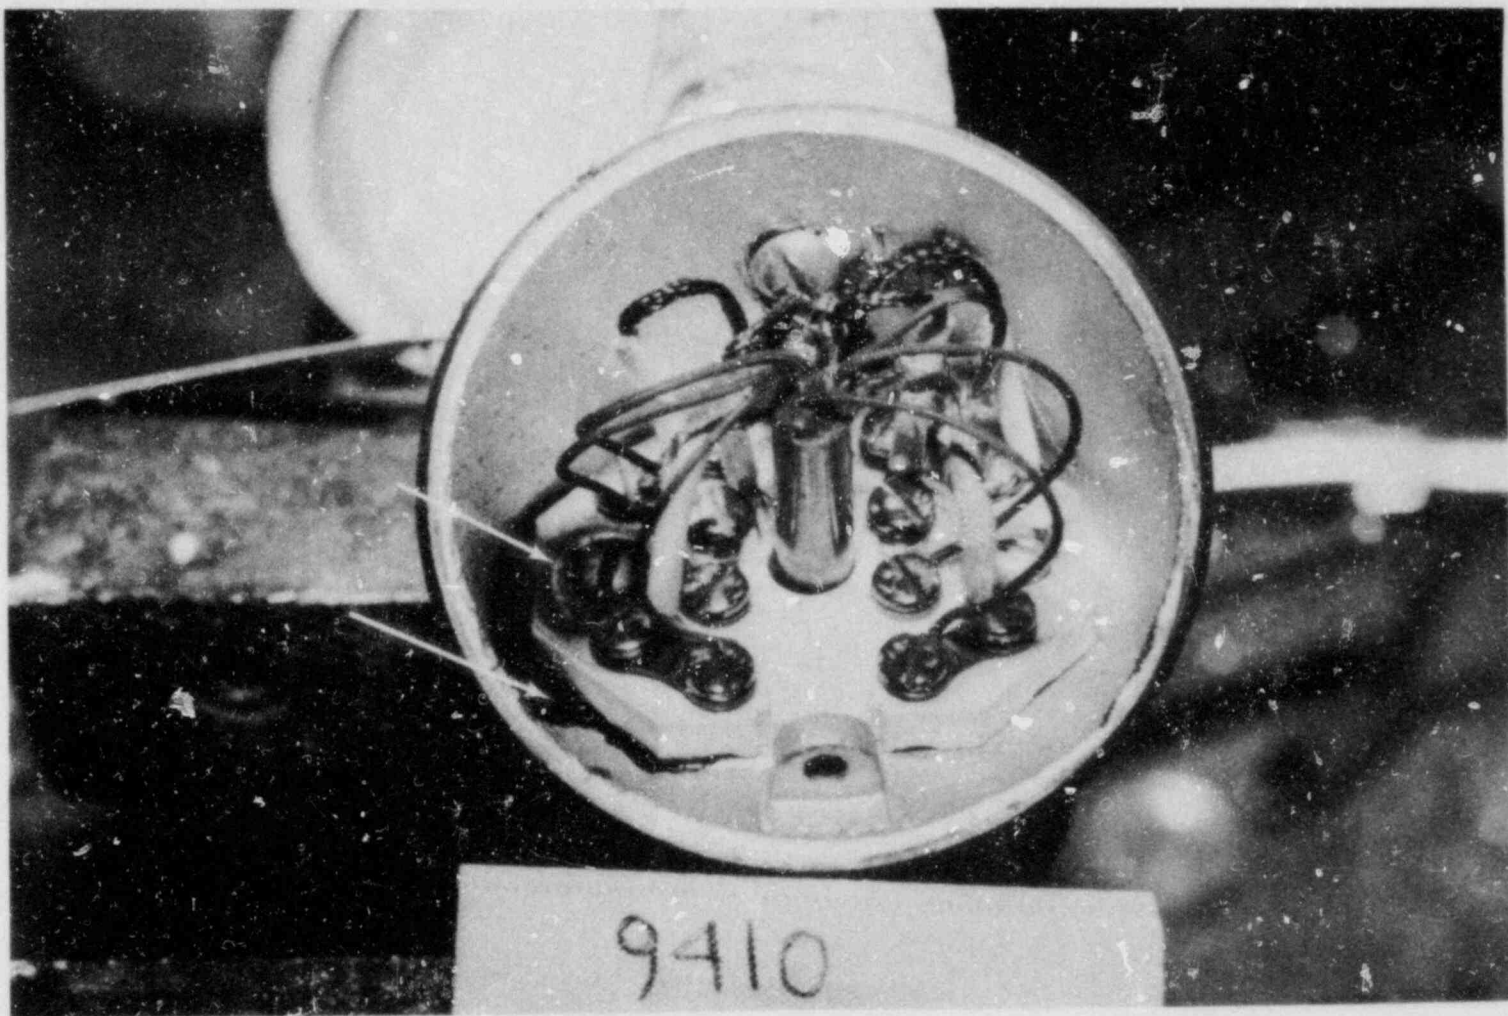
During inspection of the castings, RTD No. 2 was found to have a small hole through the body (Figure 26). Examination revealed that one of the tapped holes used for mounting the terminal board into the casting had a small break-through. Discoloration inside the casting indicated that water had leaked through this external hole into the tapped hole and then into the RTD body (Figure 27).

Figure 27. RTD No. 2, showing wet areas under the terminal board.

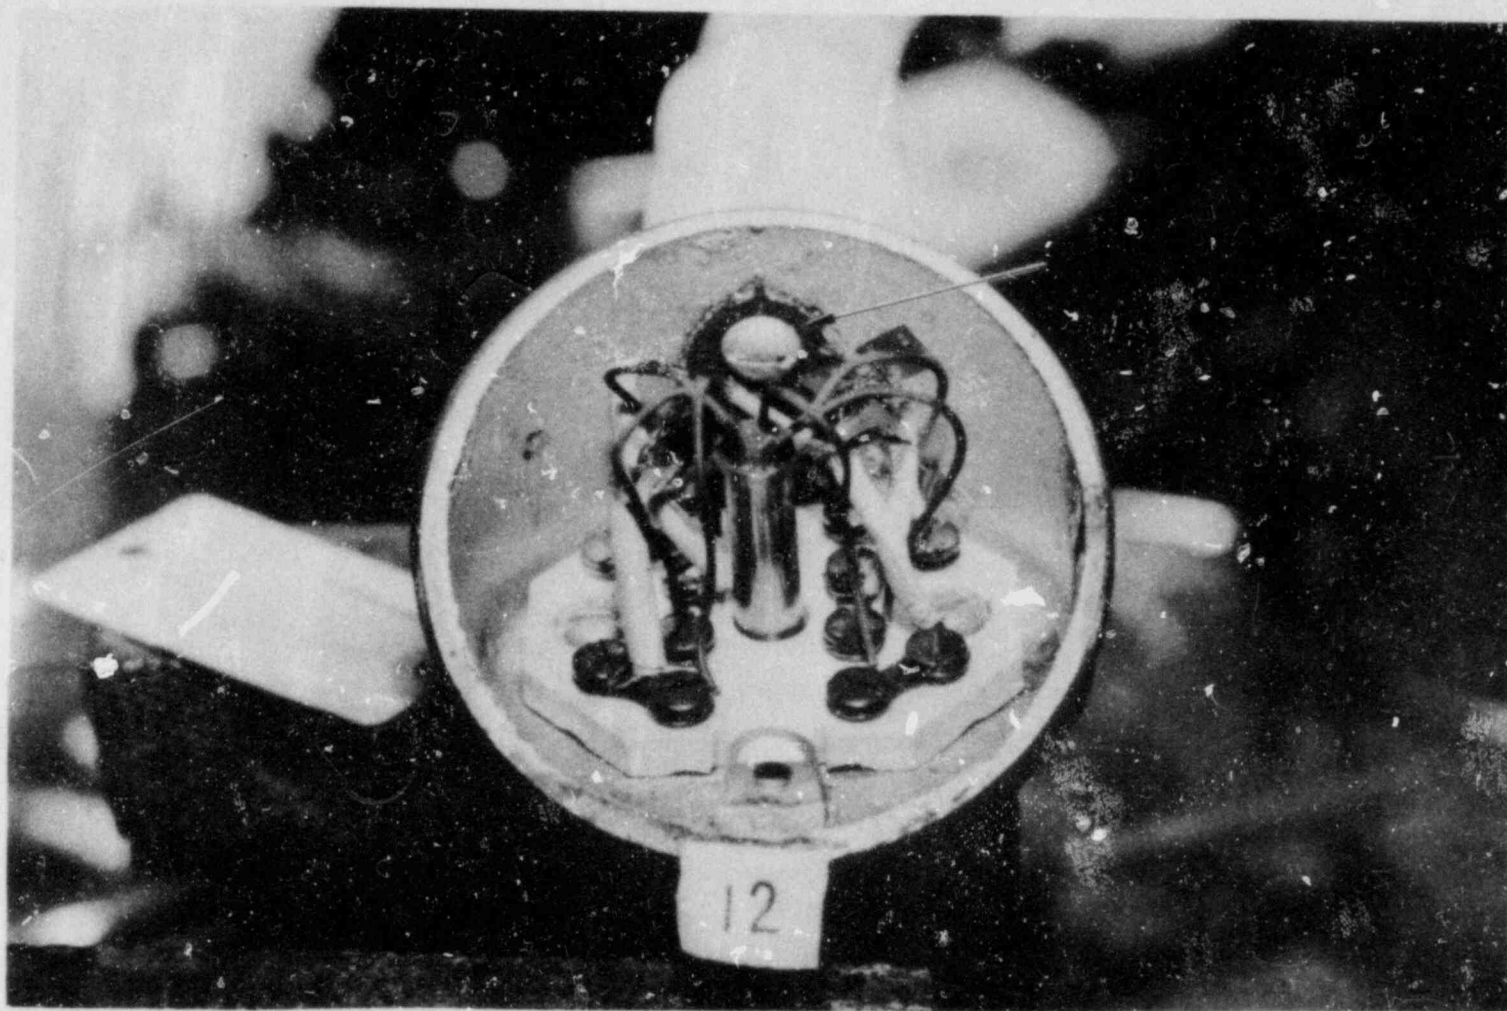
RTD No. 3 appeared to have a leak around the ground screw, in the cast body, as indicated by discoloration around the screw (Figures 28 and 29).

the casting. RTD No. 3, when x-rayed in the proper orientation, showed a small hole from outside going into a region of high porosity in the casting. The high porosity region was adjacent to the threaded ground-screw hole. It is reasonable to assume that this provided the leakage path for water, resulting in the discoloration around the ground screw and the moisture inside the RTD.

Figure 28. RTD No. 3, showing discoloration around the ground screw.

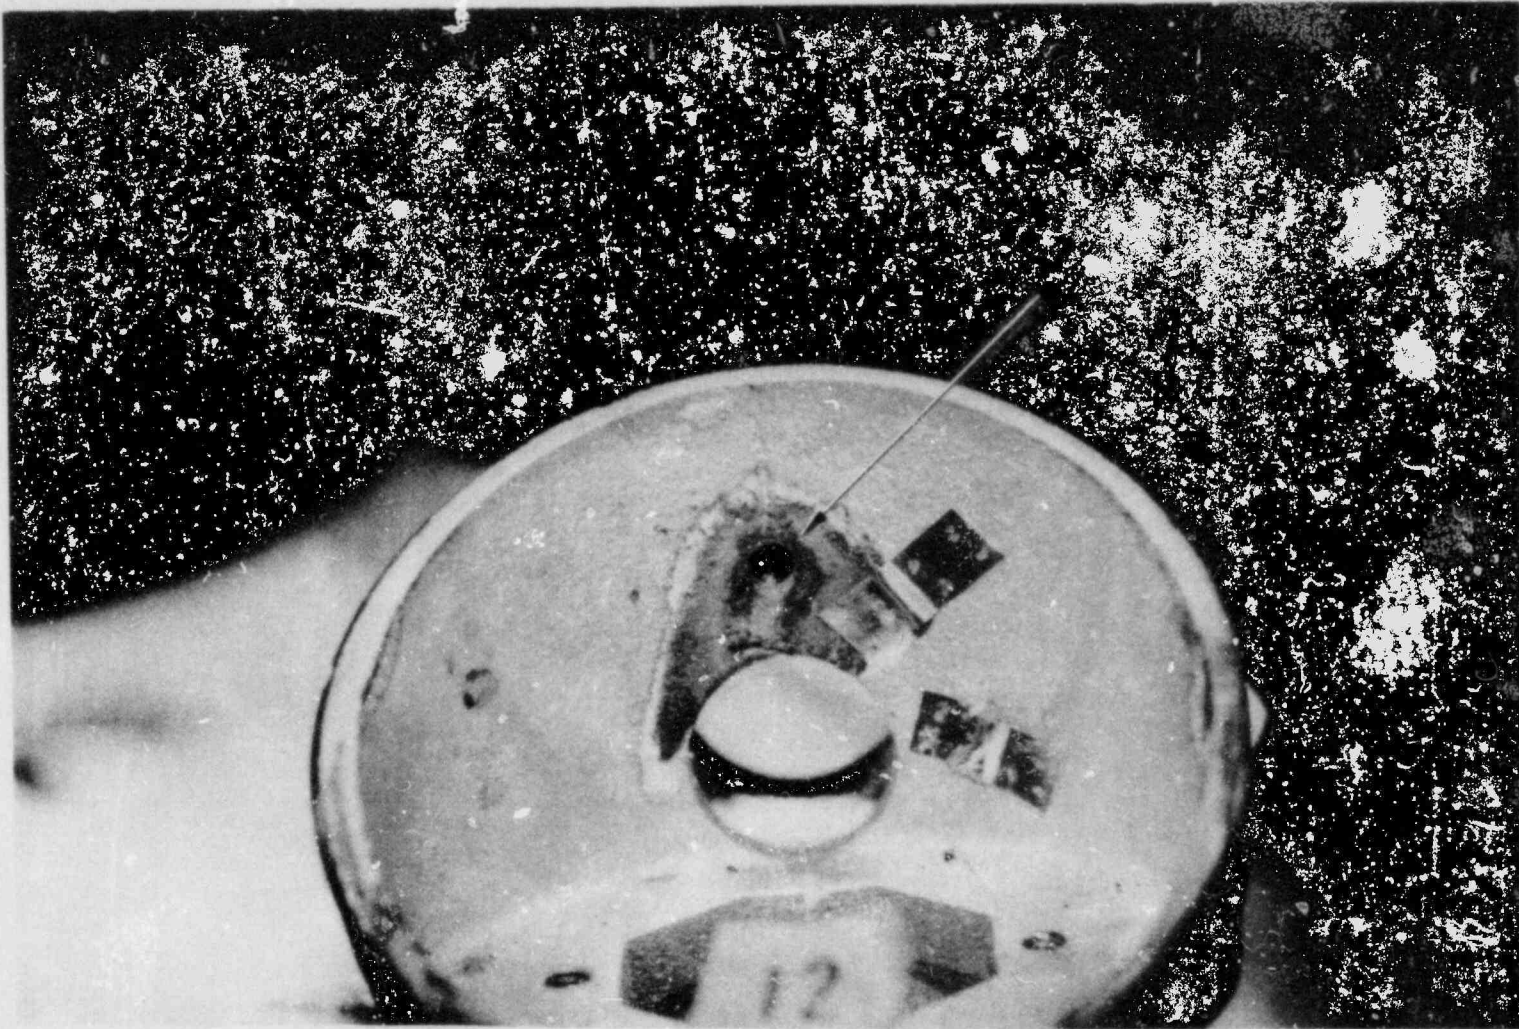
Figure 29. RTD No. 3, with terminal board elements removed, showing leak area around the ground screw hole.

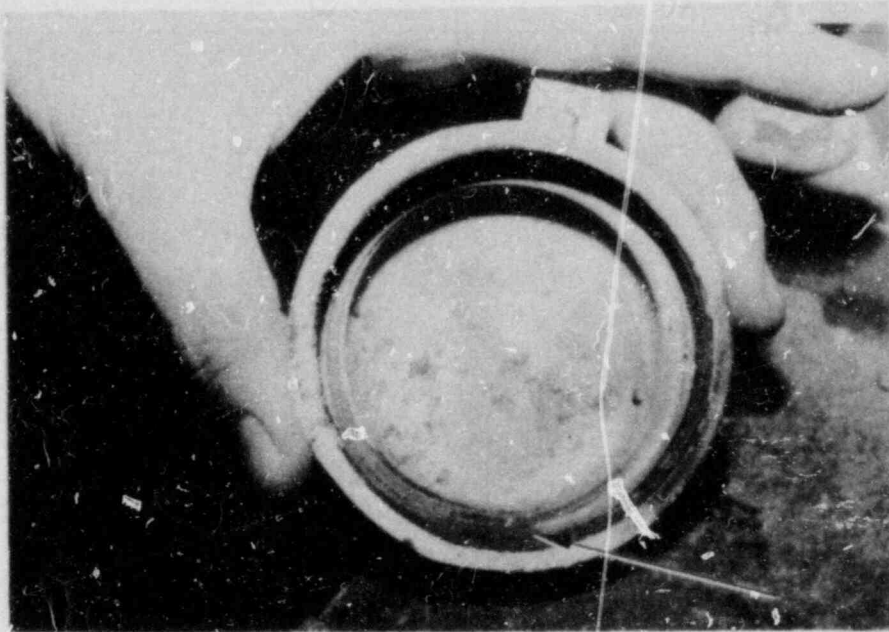
RTDs No. 1, No. 2, and No. 4 had leaked at the gasket (Figures 30 - 32). Before head-cap removal, a low-pressure air source (less than 4 psig) was held to the end of the flexible hose as it exited the chamber and Leak-Tec solution was applied to each RTD and cable system to determine the leak area. The areas found to be leaking by this test were those areas where discoloration occurred in the RTDs. RTD No. 1 had leaked very severely immediately upon admission of steam into the chamber. Leakage into RTD No. 4 was much less severe (see Figure 33).

Figure 30. RTD No. 1, showing discoloration of cap seal.

The results show that the primary mode of failure for Supplier A RTDs to be the leakage allowed by the head seal gasket material. In one case the failure occurred at 15 psia pressure; in two cases the failures probably did not occur until after the peak (115 psig) pressure condition had passed. The failures were manifested by shorting of the electrical connectors in the RTD head.

Considering the failure mode of these unaged components, it appears that the failures are related to the seal material rather than seal design (a contributing cause also appears to be poor quality control in the head casting process).

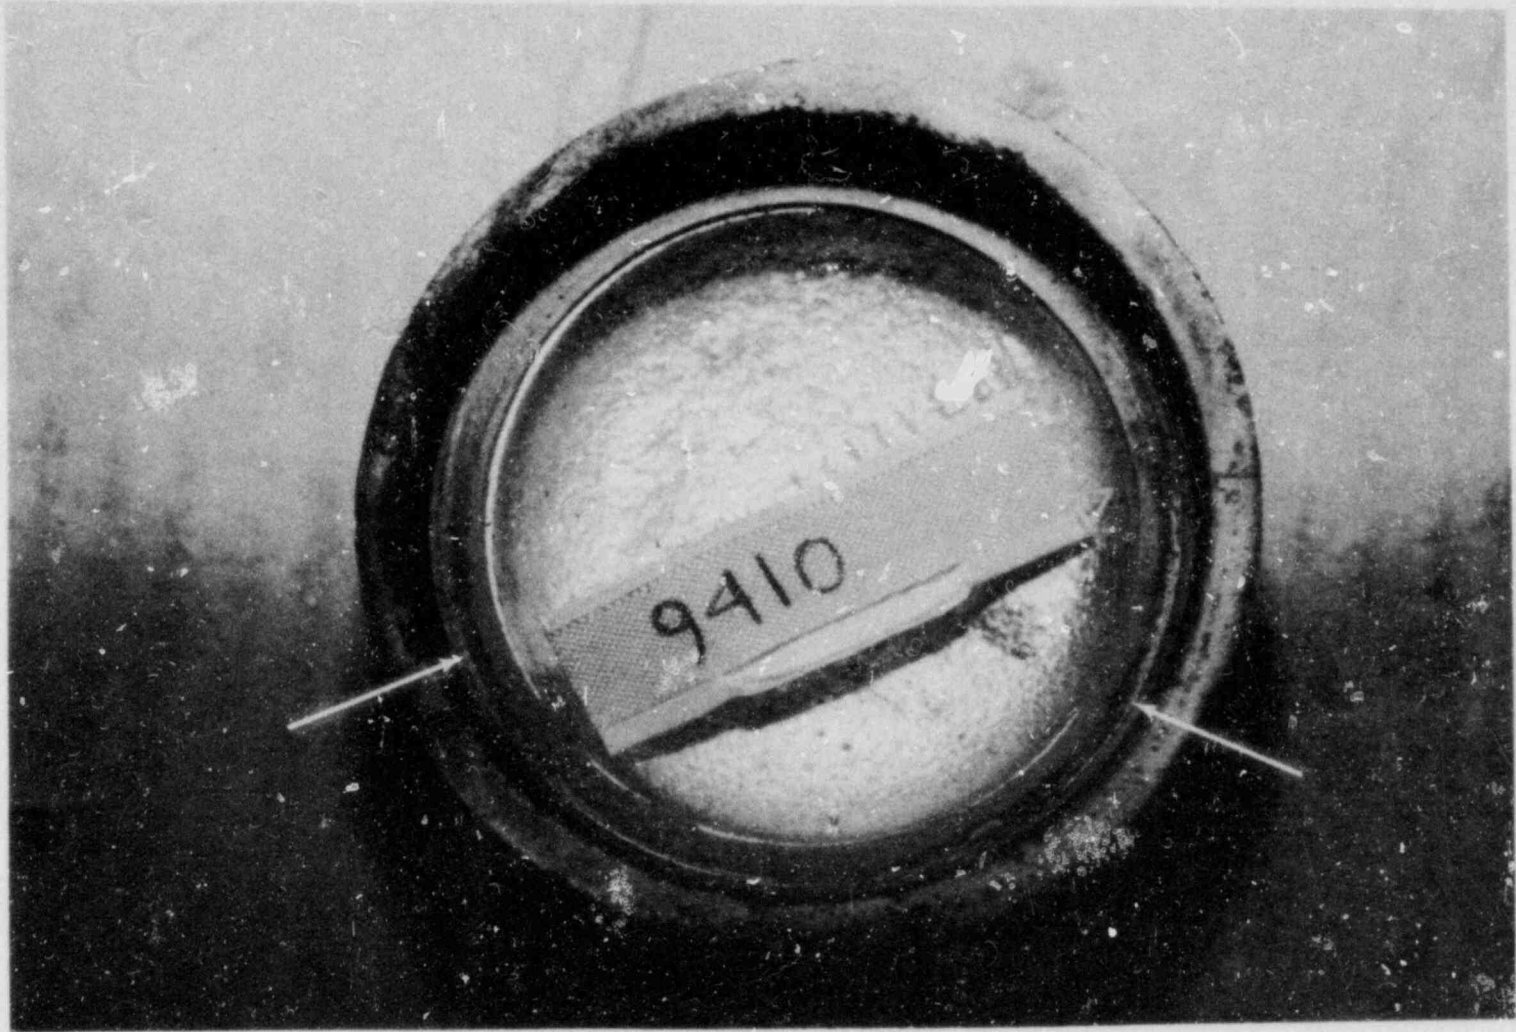
Figure 31. RTD No. 2, showing discoloration of cap seal.

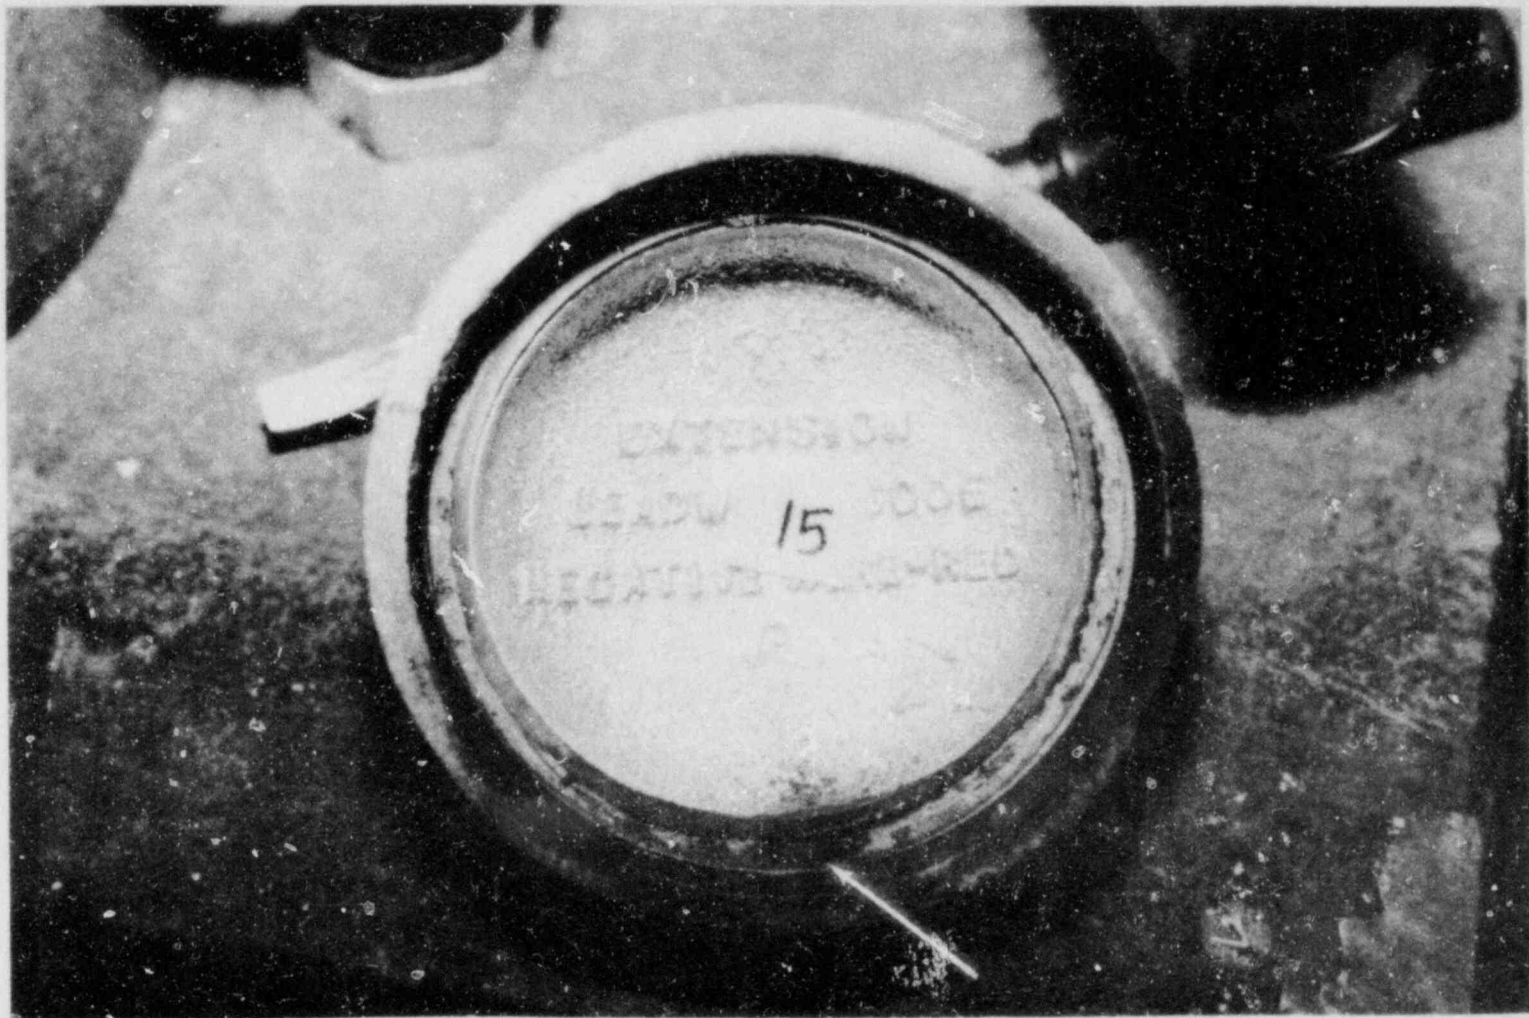
Figure 32. RTD No. 4, showing discoloration of cap seal.

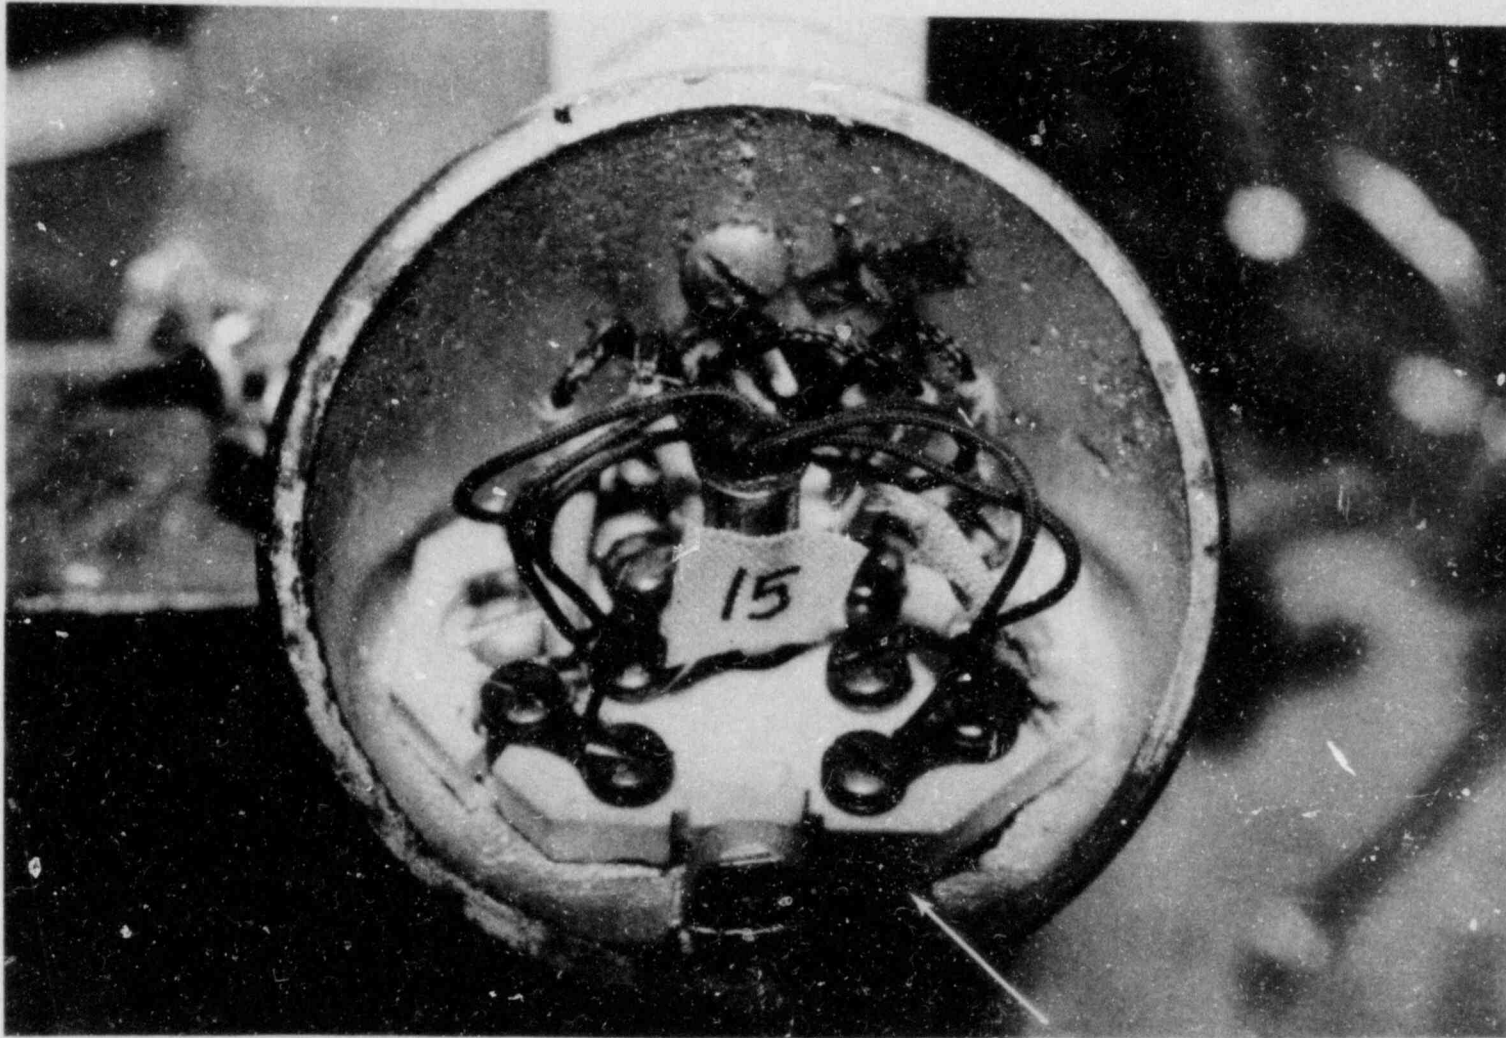
Figure 33. RTD No. 4, showing wet area under the terminal board.
