SUBJECT: WATERFORD 3 SES  
ADDITIONAL INFORMATION ON BASEMAT  
HAIRLINE CRACKS

The purpose of this report is to review the results of nondestructive testing (NDT) of Nuclear Plant Island Structure (NPIS) basemat hairline cracks to evaluate their significance with respect to the structural integrity of the NPIS.

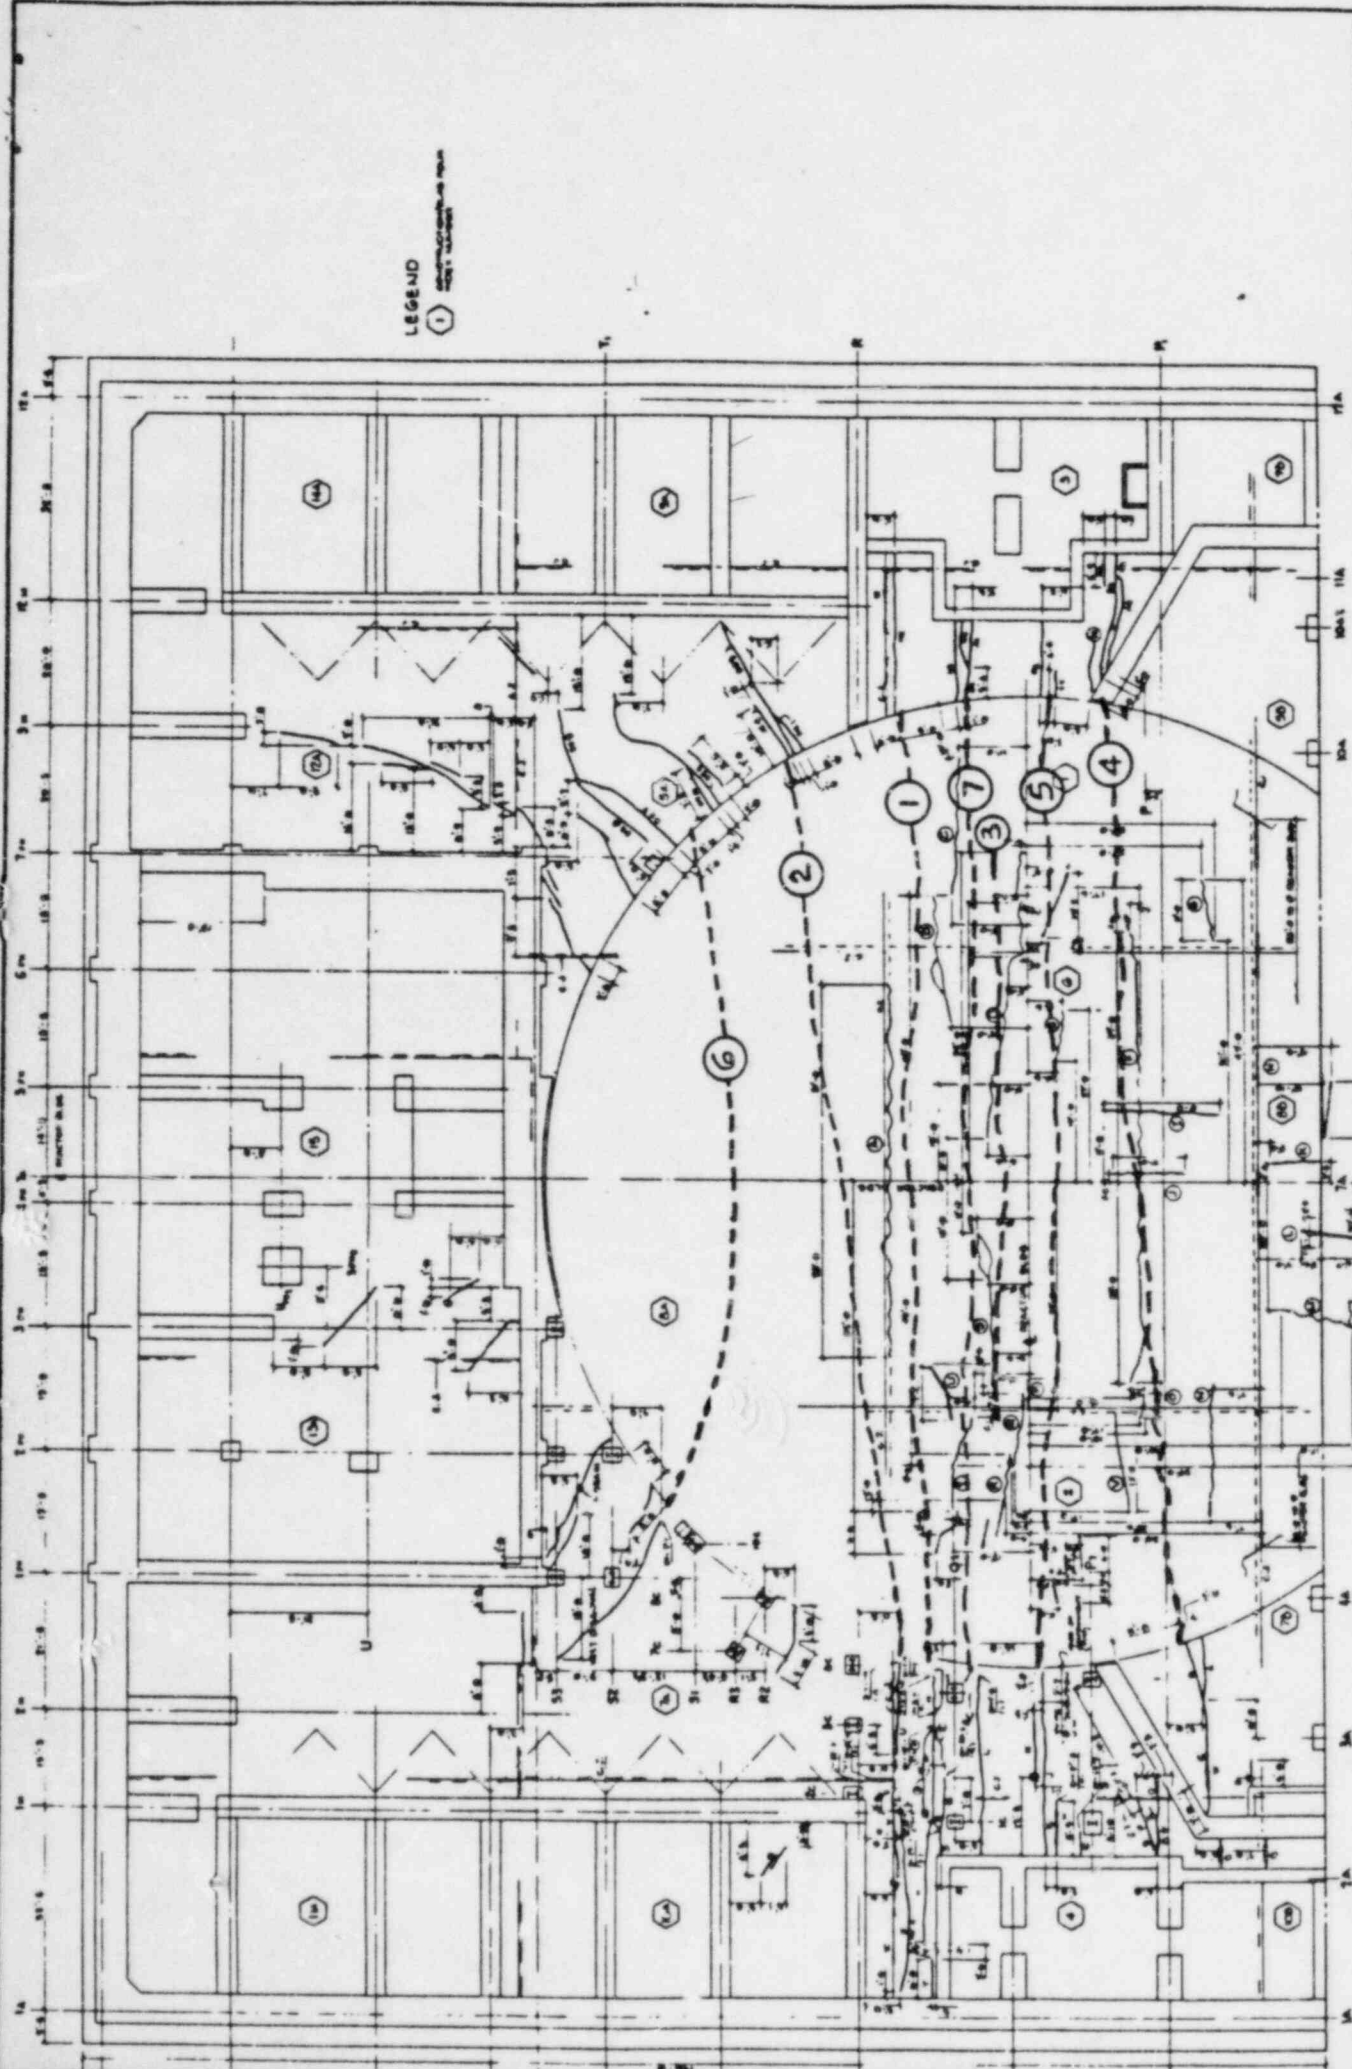
LOUISIANA POWER & LIGHT CO.  
 Waterford Steam Electric Station  
 BASE MAT  
 CRACK MAP  
 FIGURE 1

The majority of the hairline cracks are oriented in an east-west direction and located within a distance of thirty (30) feet from the east-west centerline of the RCB. Based on their appearance and nearness to each other they are grouped into 10 families:\* 4 on the east side of the RCB and 6 on the west side of the RCB. Seven cracks beneath the RCB were also identified by NDT, four of these cracks (Numbers 1, 4, 5 and 7) appear to coincide with east-west cracks on either side of the RCB and probably are interconnected (Figure 1).

Other cracks are oriented in a northeast/southwest or northwest/southeast direction and they are grouped into a total of 7 families. Of these families, 4 of them were evaluated by NDT: 3 in the northeast and 1 in the northwest corners of the RCB. These cracks are also referred to as East or West Diagonal cracks in the Muenow and Associates, Inc. Report. Two of the cracks beneath the RCB (Numbers 2 and 6) appear to coincide with the East or West Diagonal cracks and probably are interconnected (Figure 1).

6. The crack pattern is predominantly in an east-west direction (Figure 1), localized in a band running east-west and centered near the RCB centerline. This band is within the region subjected to the most extreme convex curvature during the early stages of construction (Figure 2). This evidence indicates that the cracks resulted from early settlements of the basemat occurring during placement or shortly thereafter. The cracks lying in a northeasterly or northwesterly direction were influenced by the rigidity of the early placements of the RCB wall.

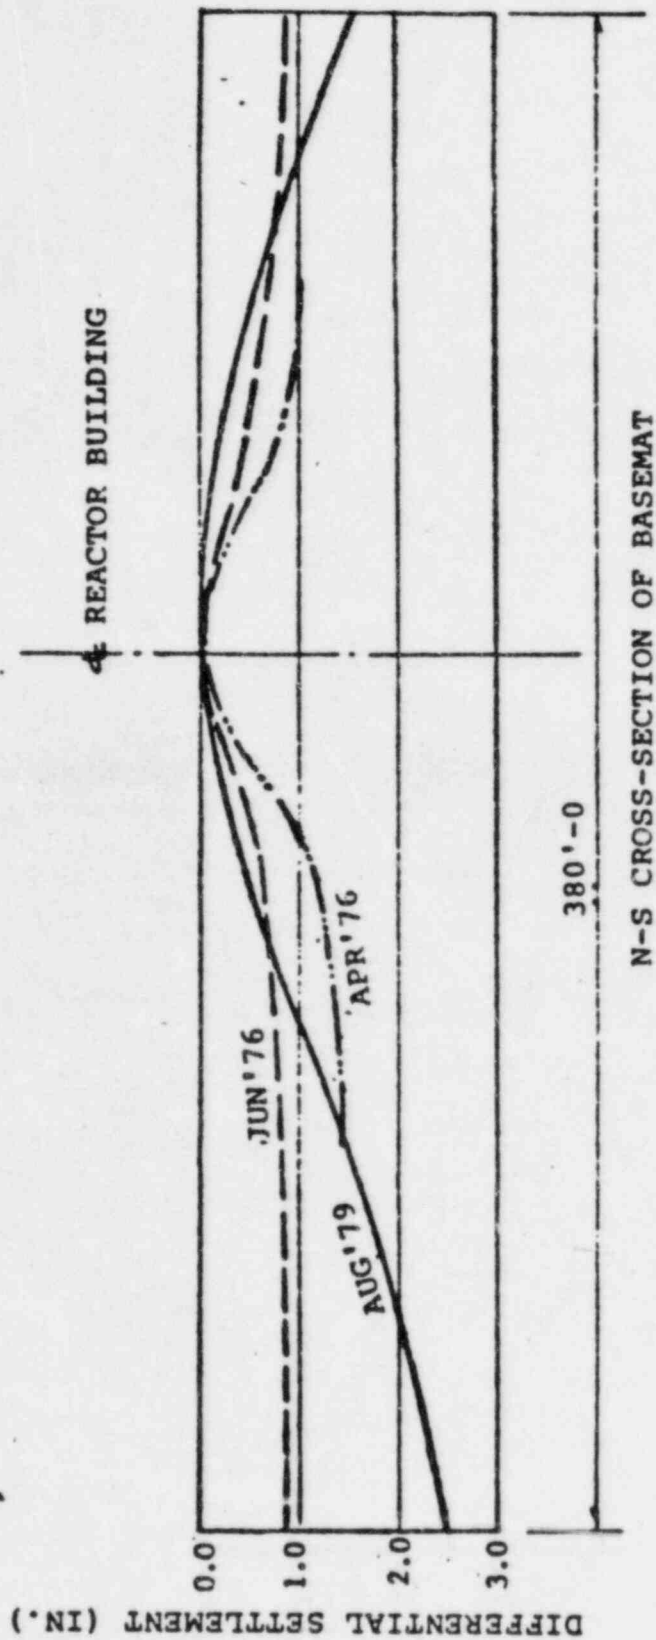
From the summary of NDT results, it is clear that the top cracks are greater in number than the bottom cracks. This reflects that the crack pattern generally followed the basemat flexure, which was found to be predominantly convex shape throughout the construction stages. The top cracks are located primarily in an east-west band centered on the RCB centerline. This matches closely the area of maximum convex flexure of the basemat in the early stages of construction as shown on Figure 2.
