Florida Power

CORPORATION
Crystal River Unit 3
Docket No. 50-302

Subject: Licensee Event Report (LER) 96-009-00

TITLE (4)
Failure to Re-attach Instrument Tubing to Seismic Supports After Modification Leads to Operation Outside Design Basis

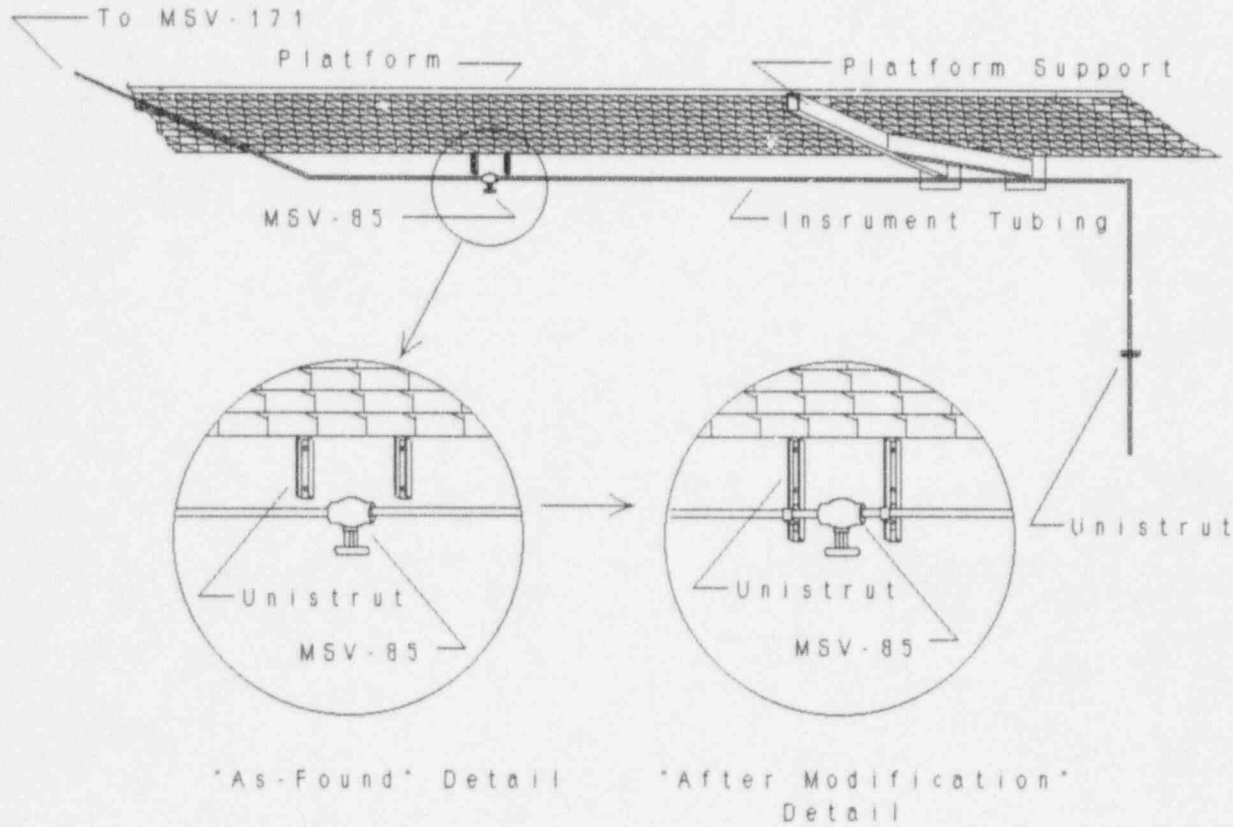
Figure 2

EFIC System components essential to safe shutdown are designed as Seismic Category I in order to maintain system functional integrity during an earthquake. Shortly after the reporting of this event, engineering personnel evaluated the as-found condition of the unsupported section of tubing and noted it was stressed above code (Power Piping Code USAS B31.1) allowables due to deadweight. The evaluation determined that under seismic loading, the tubing would have been stressed above the ultimate tensile capacity of the tubing material, ASTM A213, TP304. As a result, it was concluded that the affected section of tubing would not have been capable of performing its design function during a design basis seismic event. As a minimum, the tubing would have crimped and resulted in inaccurate instrument reading. It is also possible this section of tubing would have ruptured, causing a breach in the secondary side of the OTSG pressure boundary. Although the analysis conservatively indicated the section of tubing was at yield stress under normal loading, no permanent deformation of the tubing was noted on field observation of the as-found condition. It is reasonable to conclude that a more rigorous analysis would demonstrate the tubing did not yield. It is Engineering's conclusion that no permanent damage or degradation was experienced by this section of tubing as a result of this event.

The cause of this event was personnel error/inattention to detail. The crossover platform between RCP-1C and RCP-1D was one of several work platforms installed in the Reactor Building (RB) in 1992 (Refuel 8R). The platforms were installed for required maintenance and access to valves located throughout the RB for inspection and line-up. A review of the work package reveals there are no instructions that address the need to detach instrument tubing. Consequently, there are no instructions that address the need to re-attach the tubing which was removed from its supports. There is no record of anyone notifying field engineering personnel that supports for this tubing were not long enough to mount the clamp that supported the tubing. The original supports were 8 inches long and needed to be at least 11 inches long to provide sufficient clearance around a structural member associated with the work platform. See Figure 2. The tubing would have required bending in order to re-attach to the original supports.

UNSUPPORTED INSTRUMENT TUBING

1. A modification was installed to modify the original instrument tubing supports on both side of MSV-85 to facilitate re-attaching the instrument tubing, thereby returning the instrumentation to full qualification.
2. A memorandum has been issued to Maintenance Department supervision including a copy of this LER as an attachment. Maintenance supervision will be requested to convey the information to responsible department personnel as a "lessons learned".
3. Discussions have been held using this LER as a basis, with Project Managers who are responsible for closing out modification packages. These discussions served to raise the sensitivity of the Project Managers to this issue and promoted a questioning attitude with respect to those modifications that may not require an independent walkdown of the work activity.
