LICENSEE EVENT REPORT (LER)

FACILITY NAME (1) Fort St. Vrain, Unit No. 1 DOCKET NUMBER (2) 0 5 0 0 0 2 1 6 7 1 OF 0 1 9

TITLE (4) Corrosion of PCRV Tendon Wires (Voluntary LER)

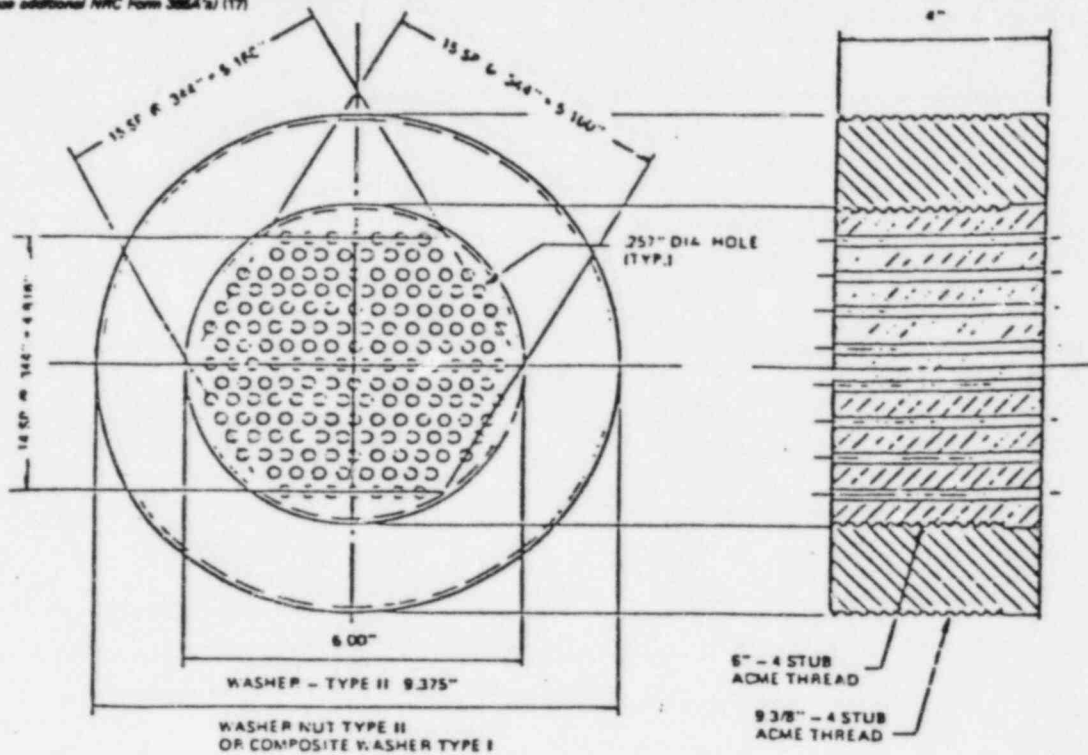
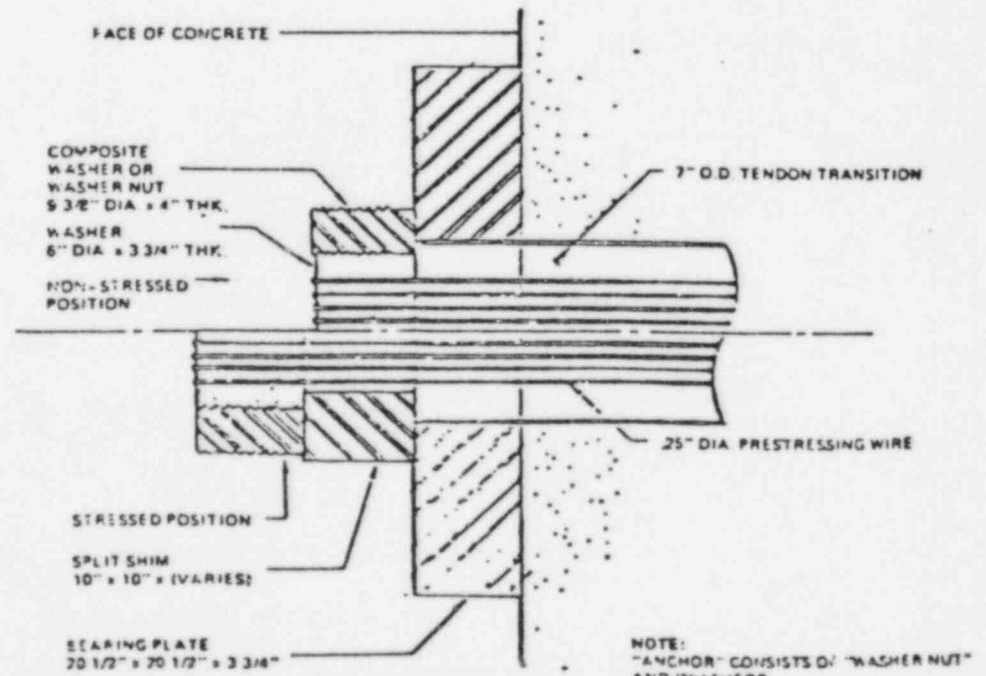
FIGURE 1

The Prestressed Concrete Reactor Vessel (PCR) utilizes a system consisting of 448 prestressing tendons in two basic configurations consisting of 152 or 169 1/4 inch diameter wires. Each wire terminates at a buttonhead supported by an anchor (buttonhead) washer which seats through a split shim onto a bearing plate on the PCR surface (see Figure 1). The tendons may be delineated into four different types according to the following table (also see Figure 2).

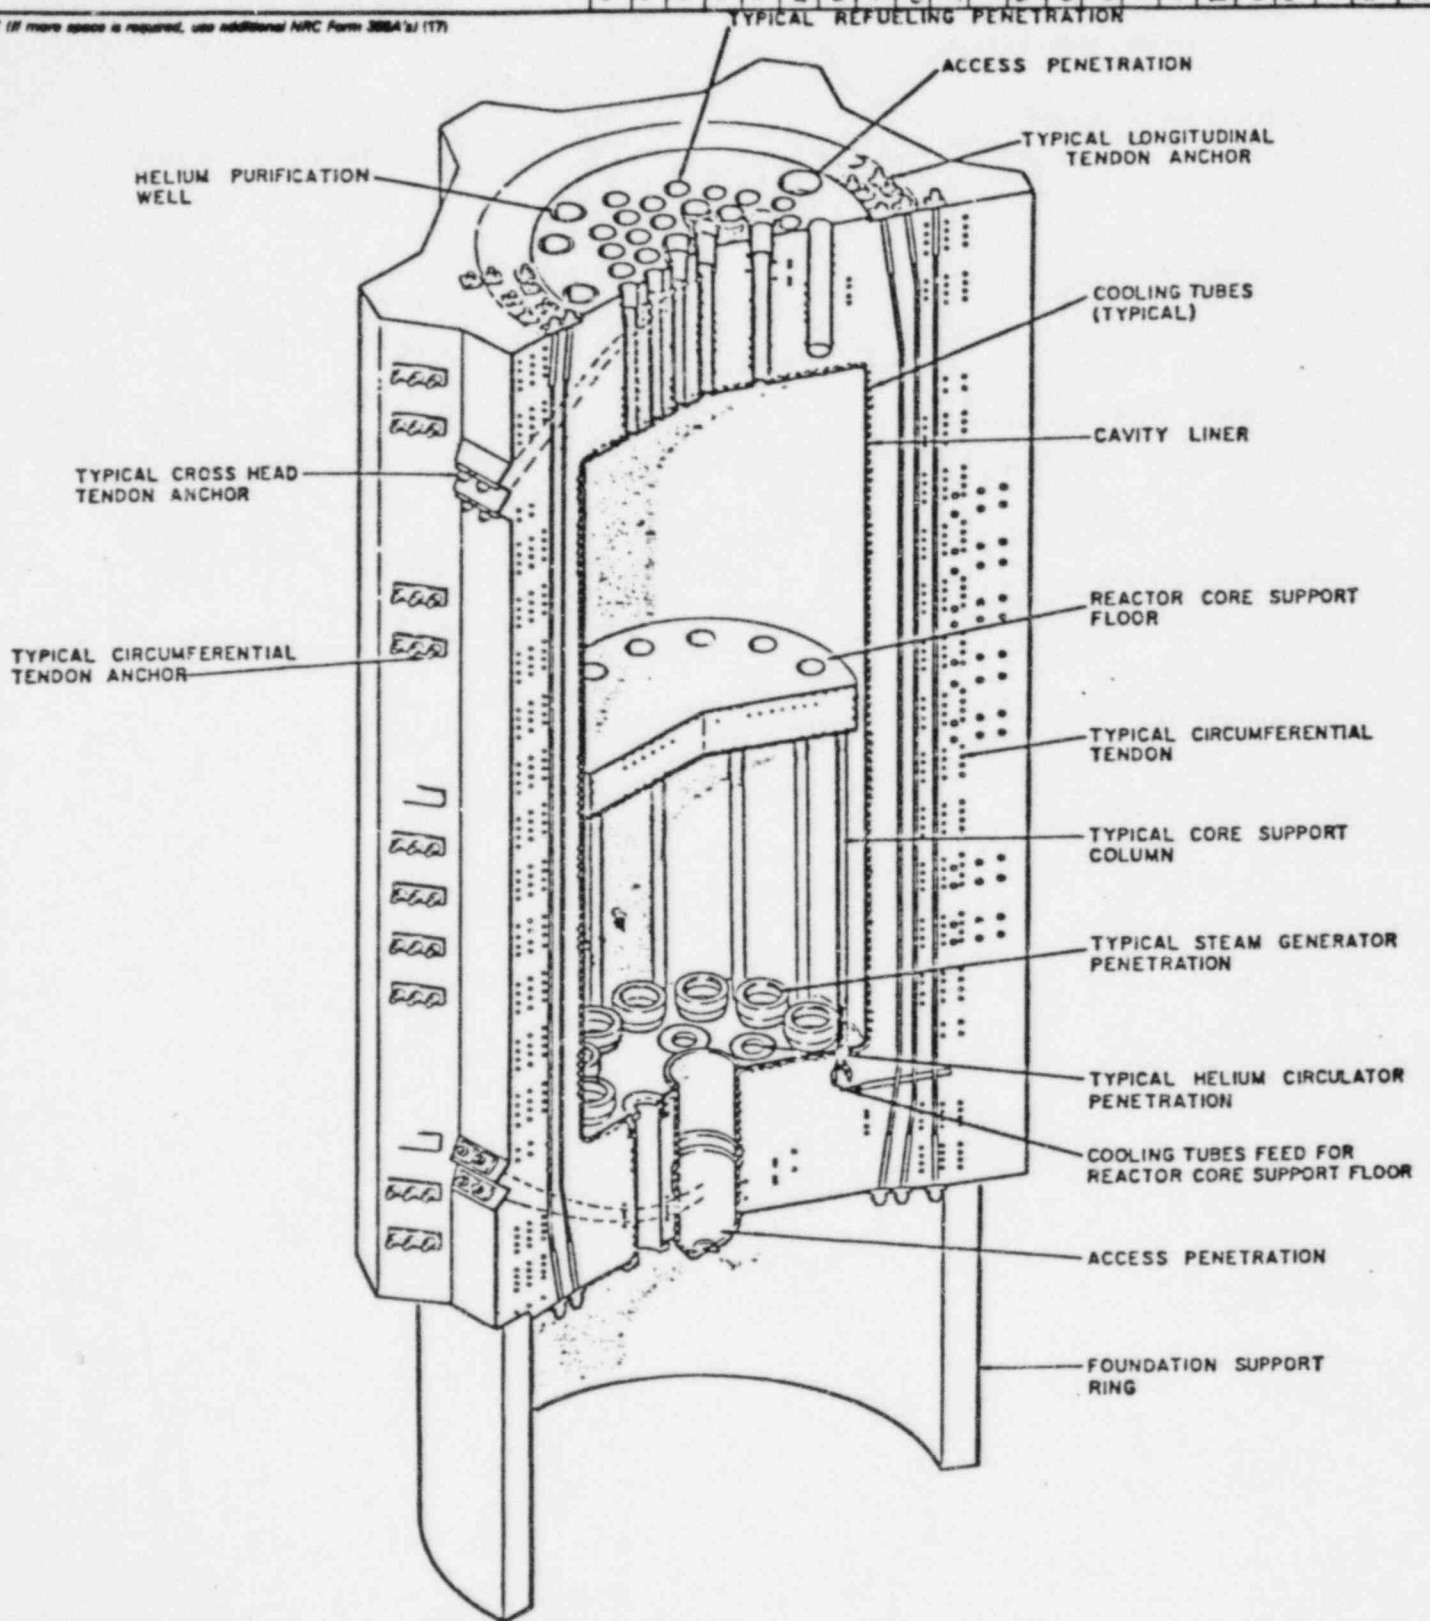
FIGURE 2

448 Tendons Total	27 Load Cells
310 Circumferential	17 Load Cells
90 Vertical	6 Load Cells
24 Top Cross Head	2 Load Cells
24 Bottom Cross Head	2 Load Cells
