LICENSEE EVENT REPORT (LER)

FACILITY NAME (1) Fort St. Vrain, Unit No. 1 DOCKET NUMBER (2) 050002671 OF 12 PAGE (3) 1

TITLE (4) High Reactor Pressure Scram & Ensuing Control Rod Automatic Insertion Failures

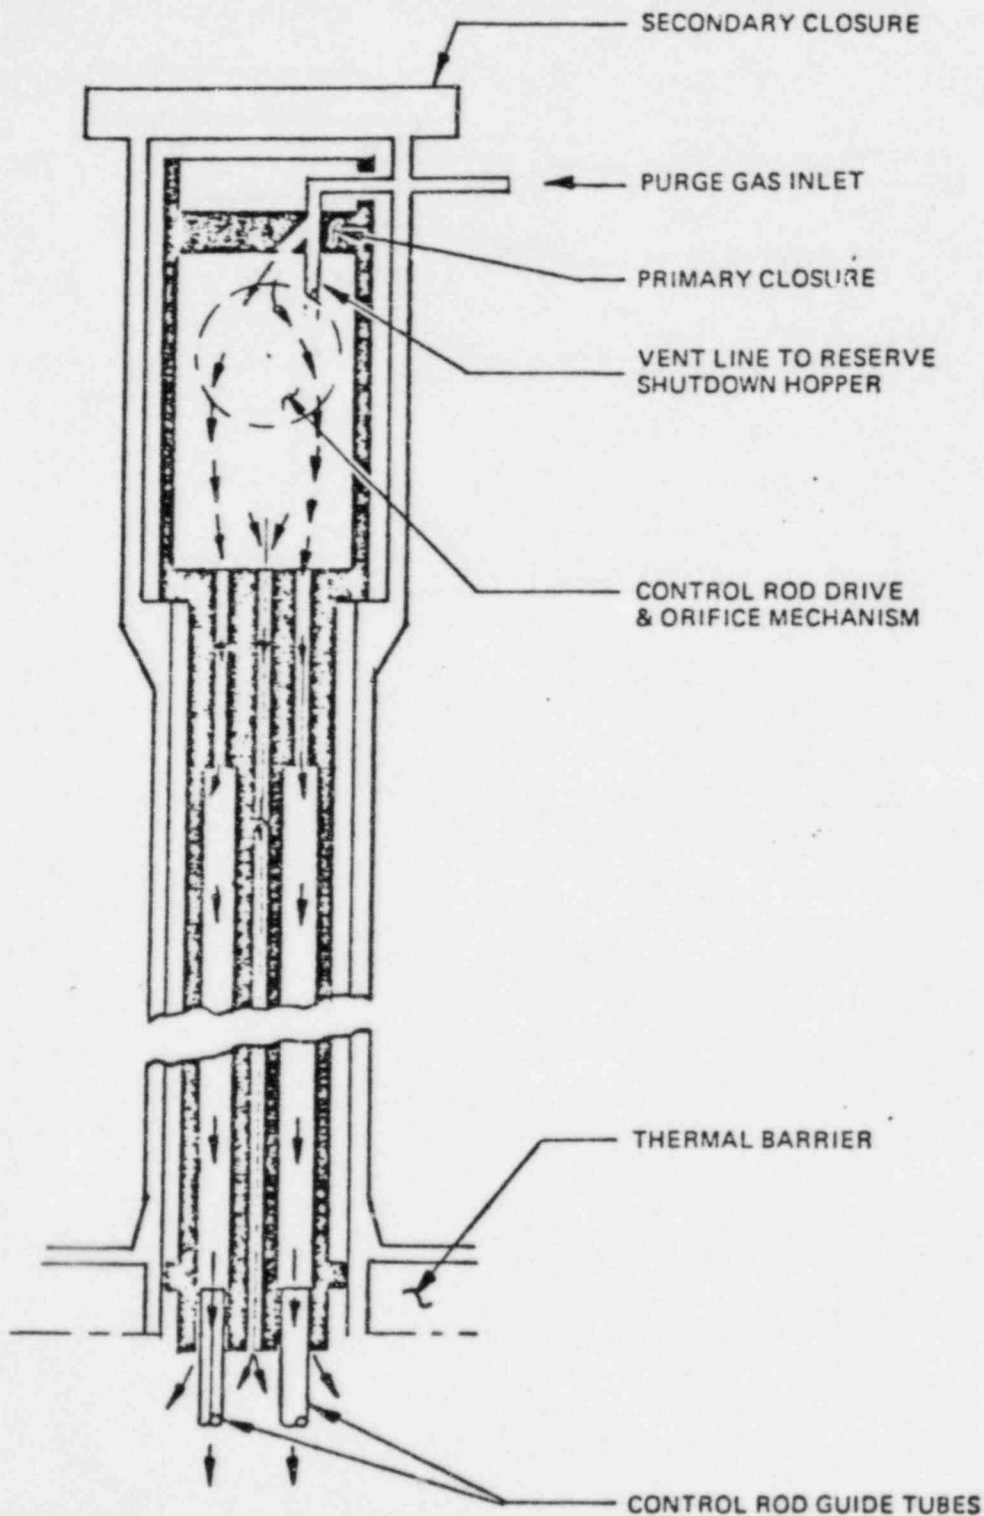
FIGURE 3

The control rod drive mechanism operates in a helium environment within the PCRV at reactor pressure (Figure 2). Ambient temperature is nominally maintained at approximately 150 degrees Fahrenheit by the refueling penetration cooling system and a thermal barrier between the drive and the reactor core. Shielding, interposed between the drive and the reactor core, limits the radiation level at the control rod drive to approximately 1 rad per hour. A helium purge flow of about 5.5 pounds per hour floods the drive assembly and reduces the ingress of contaminated reactor helium coolant (Figure 3).

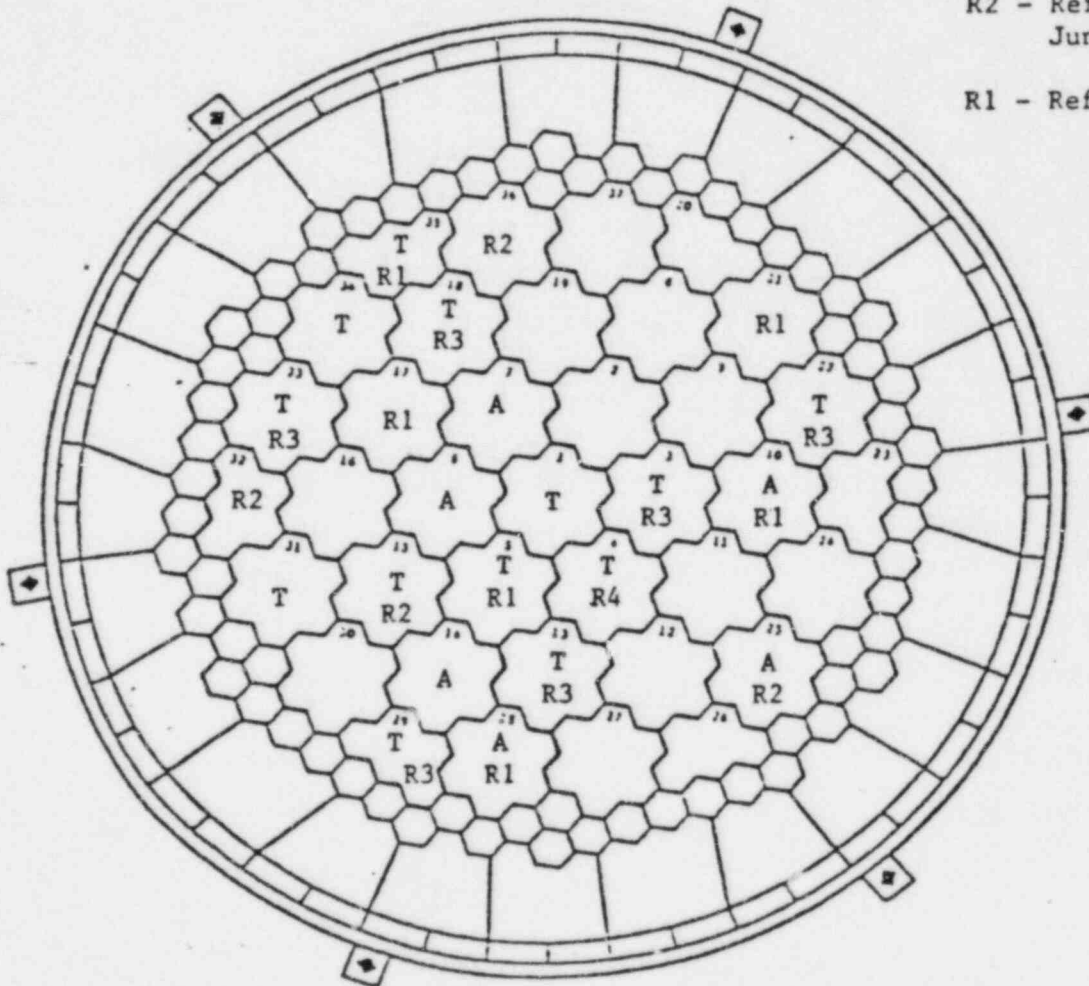
FIGURE 4

At 0029, with reactor power at 23% and being decreased, the reactor automatically scrammed on programmed vessel pressure high. Although the reactor was verified subcritical following the automatic scram, it was noted that 6 of the 37 control rods (in Regions 6, 7, 10, 14, 25, and 28) had failed to automatically insert and these were driven in over the following 20 minute interval (see Figure 4). A subsequent calculation using a computer code analysis (Gauge) verified that a shutdown margin of 0.0225 delta ρ ($K_{eff} = 0.978$) existed even with the above rods not scrammed. The Fort St. Vrain Technical Specifications consider 0.01 delta ρ to be an acceptable shutdown margin.

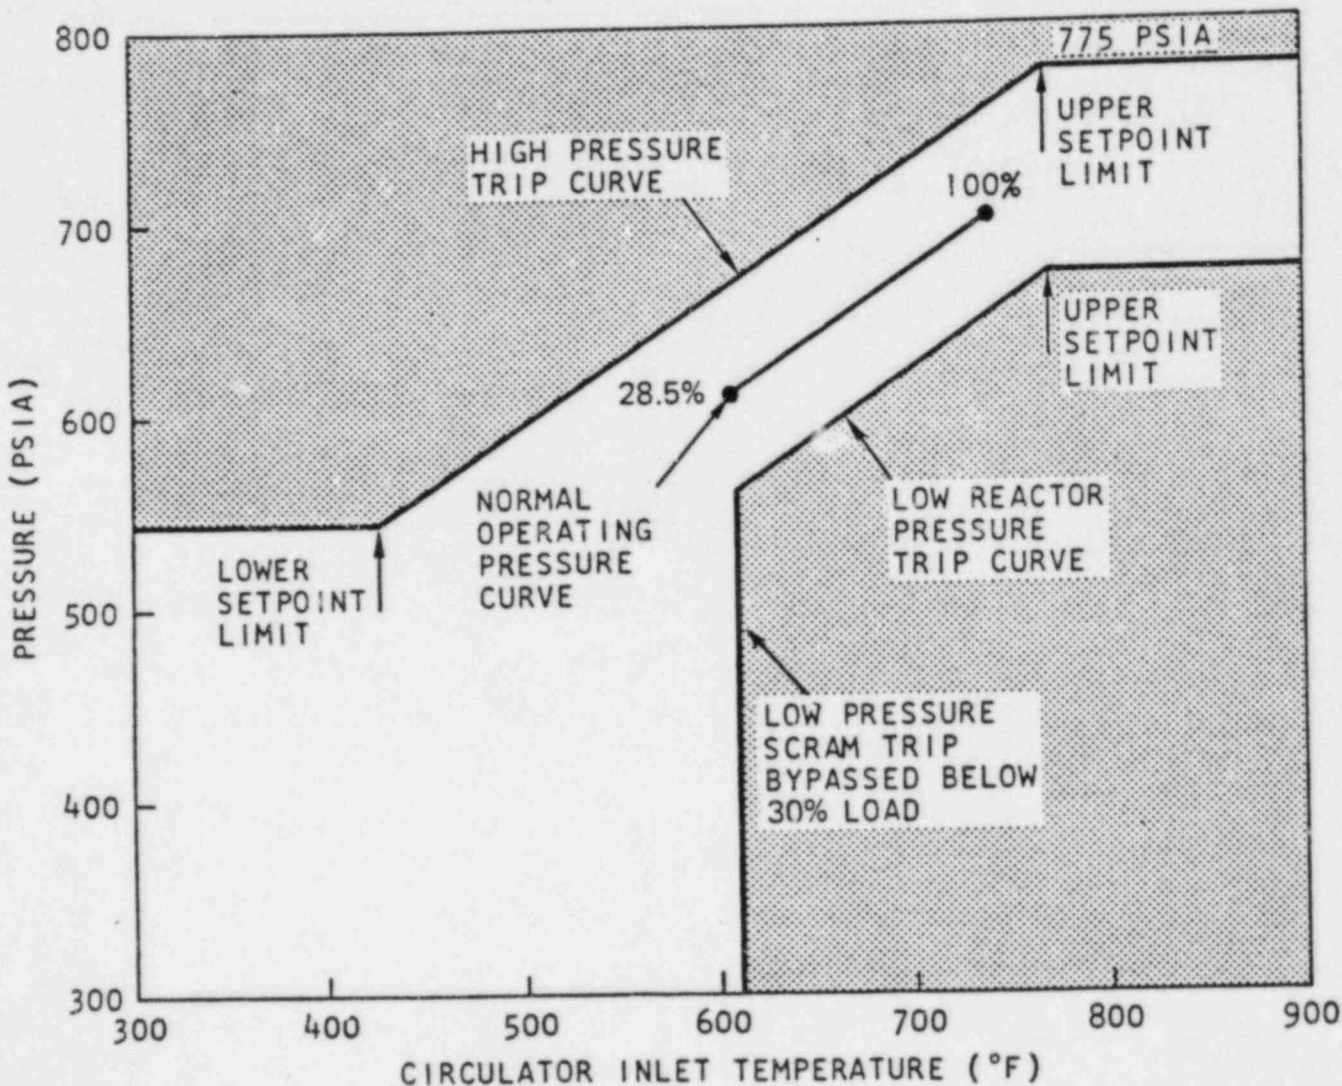
FIGURE 5

| The icing up of the helium purification system was not abnormal under the observed | high moisture conditions. Prior to the trip, the high pressure setpoint was | decreasing as programmed with circulator inlet temperature (indicating a power | reduction). When the depressurization flow path was blocked, the trip point was | exceeded as temperature continued to decrease without a corresponding decrease in | pressure (Figure 5).
