Please find attached a final report on the subject deficiency concerning
ND System socket weld failures on Catawba Unit 1.

FINAL REPORT
CATAWBA NUCLEAR STATION

REPORT NUMBER: SD 413/84-01

FACILITY: Catawba Nuclear Station - Unit #1

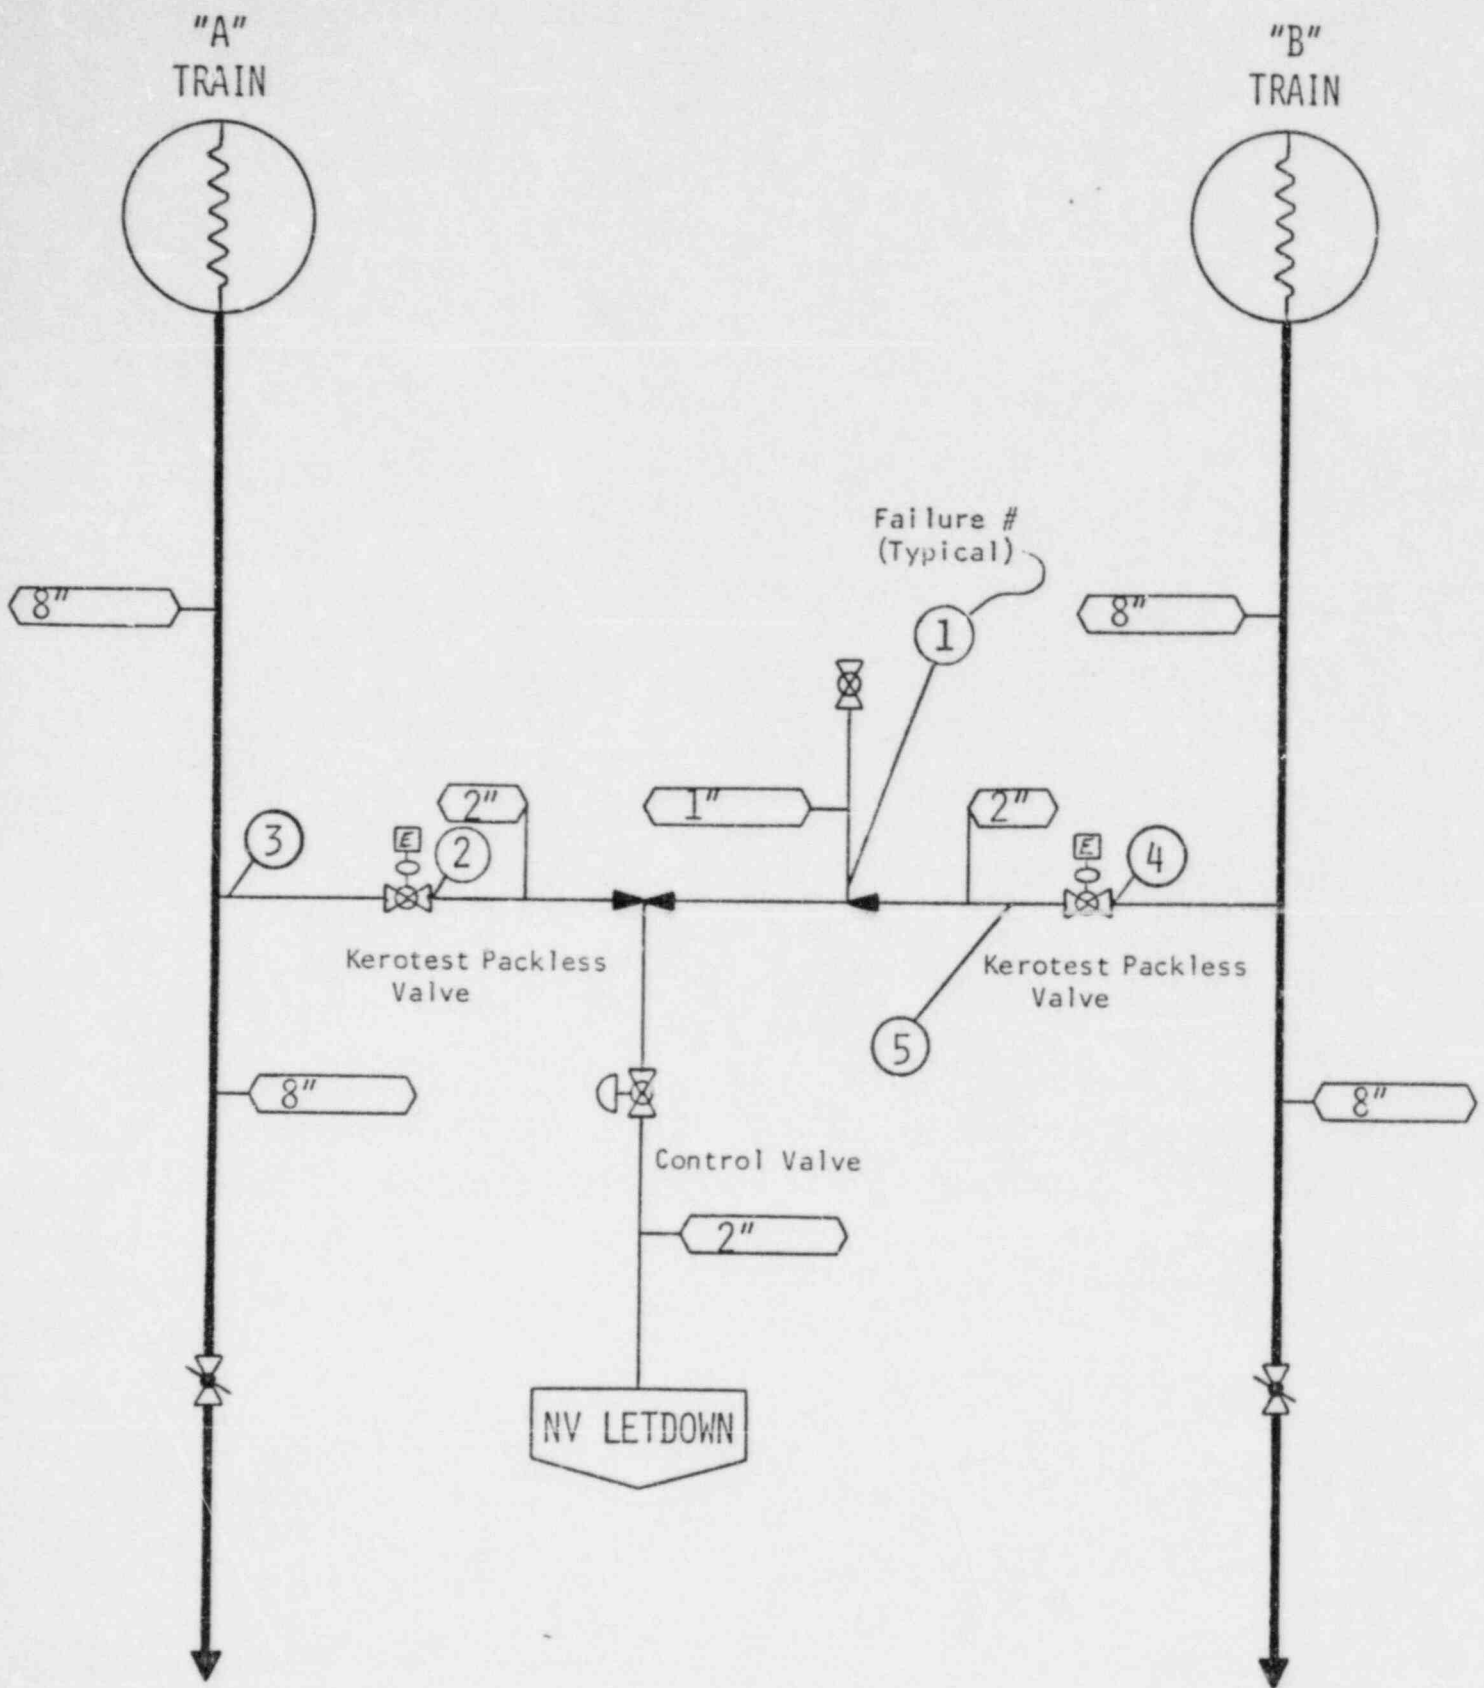
FIGURE 1
PARTIAL SCHEMATIC OF
MNS & CNS ND SYSTEM

Similar deficiencies have occurred on 3 occasions at McGuire Nuclear Station (MNS). The deficiencies and other specific details of the MNS and CNS piping failures are listed on Table I and deficiency locations are illustrated schematically on Figure 1. Schematically, the affected portions of ND Systems

As illustrated on Figure 1, all of the failures have occurred in the crossover line between the 8" lines, at socket welds. Except for the 1" vent line break at MNS, all failures were in 2" lines. Piping layouts and specific location of the failed welds are different for all 5 cases at the two stations.

4. Due to insight derived from the 8/84 MNS deficiency and subsequent associated MNS and CNS testing, root cause for both the MNS and CNS deficiencies has been determined. The low cycle fatigue vibration definitely occurs from reverse flow through the 2" crossover Kerotest valves (refer to Figure #1). Testing of the CN initial pressurization transient on 10/10/84 conclusively demonstrated this root cause.

The following is a tabulation of the failures in the ND System. Failure locations are illustrated on Figure 1.
