UNIVERSITY OF VIRGINIA
DEPARTMENT OF NUCLEAR ENGINEERING AND ENGINEERING PHYSICS
NUCLEAR REACTOR FACILITY
SCHOOL OF ENGINEERING AND APPLIED SCIENCE
CHARLOTTESVILLE, VA 22901

Subject: Licensee Event Report

Description of Incident - Levels and Causes

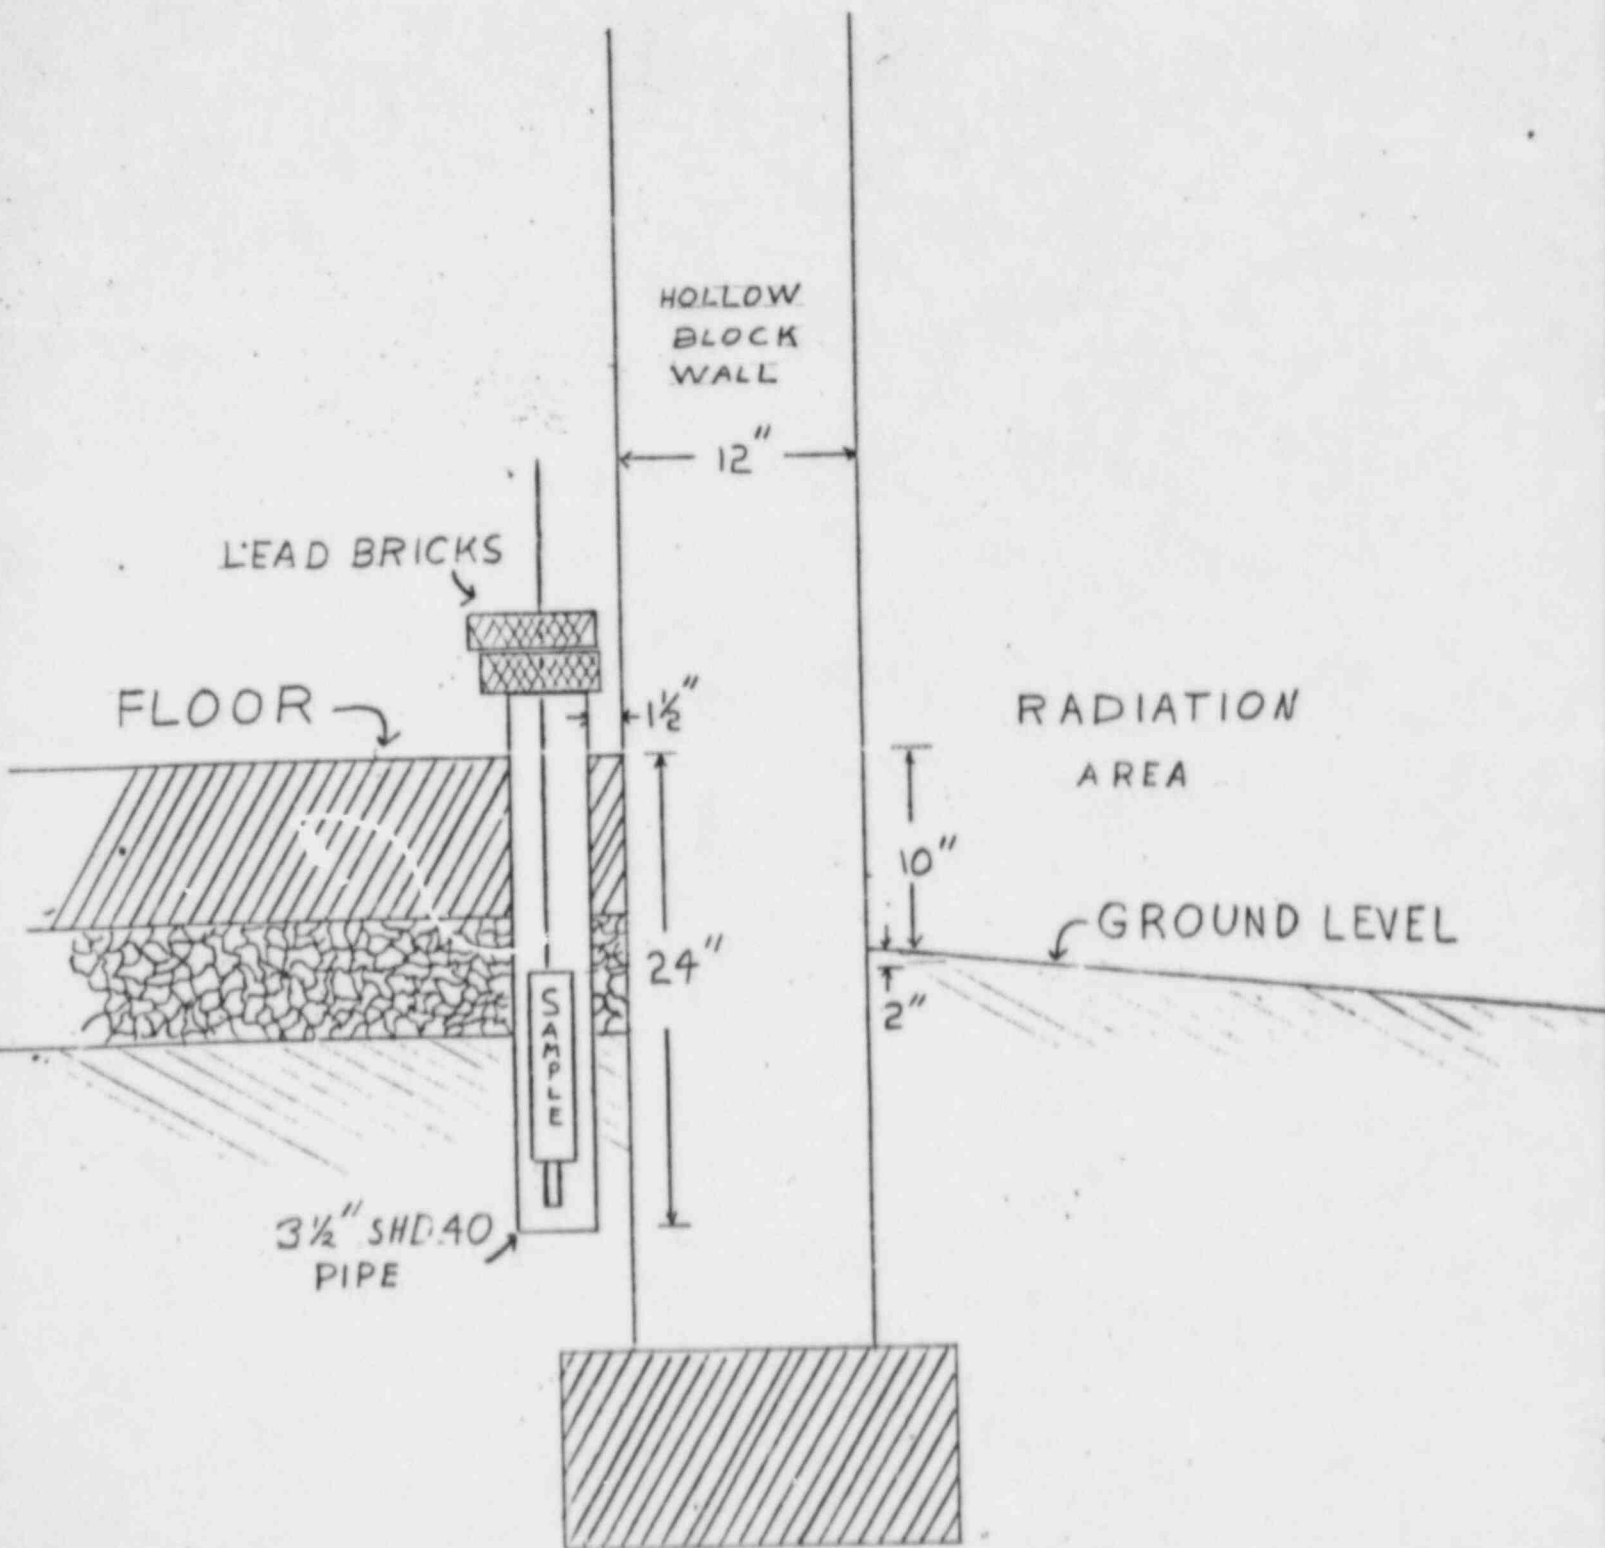
RADIATION AREA DIAGRAM

On October 2, 1984, during a routine unannounced inspection conducted by NRC Region II Inspector Mr. Roy Weddington, of the University of Virginia Reactor Facility in the areas of health physics, effluent control and radiation safety, a high radiation "hot spot" was discovered at ground level along the outside wall of the UVAR reactor room, between the escape hatch and the gate to the roof leading to the cooling tower (Please refer to the attached enclosures). The maximum radiation level at ground level was measured at just below 40 mR/hr. The established radiation field was such that 5 mR/hr levels were reached at distances of about 30" in a circular radius about the hot spot and out to about 40" away from the wall.

The "hot spot" was produced by an experiment which had been placed in one of a series of 4" I.D. steel pipes, sunk into the reactor room floor next to the reactor room's outer wall at the time of construction of the Facility. The intended purpose of these shielding pipes was to accommodate and shield the activated reactor control rods, during repairs to the control rod drives or reactor core. In actuality, these pipes had been rarely, if ever, used before this instance, for this intended purpose or for the shielding of experiments.

The radiation field in question was inadvertently created, in part because of a reactor room building construction design deficiency. The grade level on the building's external side was 10" below the reactor room floor level, compromising the effective shielding to the outside of the Reactor Room. For lack of windows, this situation of reduced shielding to the outside with adequate shielding on the inside was never realized.

The "shielded" storage pipes have long since been filled and sealed to prevent further use. The incident was reviewed during the following weekly Staff Meeting and was well discussed and analyzed. The incident was further reviewed during an Enforcement Conference (October 22, 1984) and a U.Va. Reactor Safety Committee Meeting (October 26, 1984).

The Facility's radiation survey program has already been revised to include more extensive exposure measurements, including ones at ground level. Upgrading and diversification of survey equipment is being studied, and consideration is being given to additional use of audible rate indicating instruments.
