Crystal River Unit 3

Subject: Revised Response to a Notice of Deviation

FLORIDA POWER CORPORATION
NRC INSPECTION REPORT NO. 50-302/95-16
REPLY TO A NOTICE OF DEVIATION

DEVIATION 50-302/95-16-05

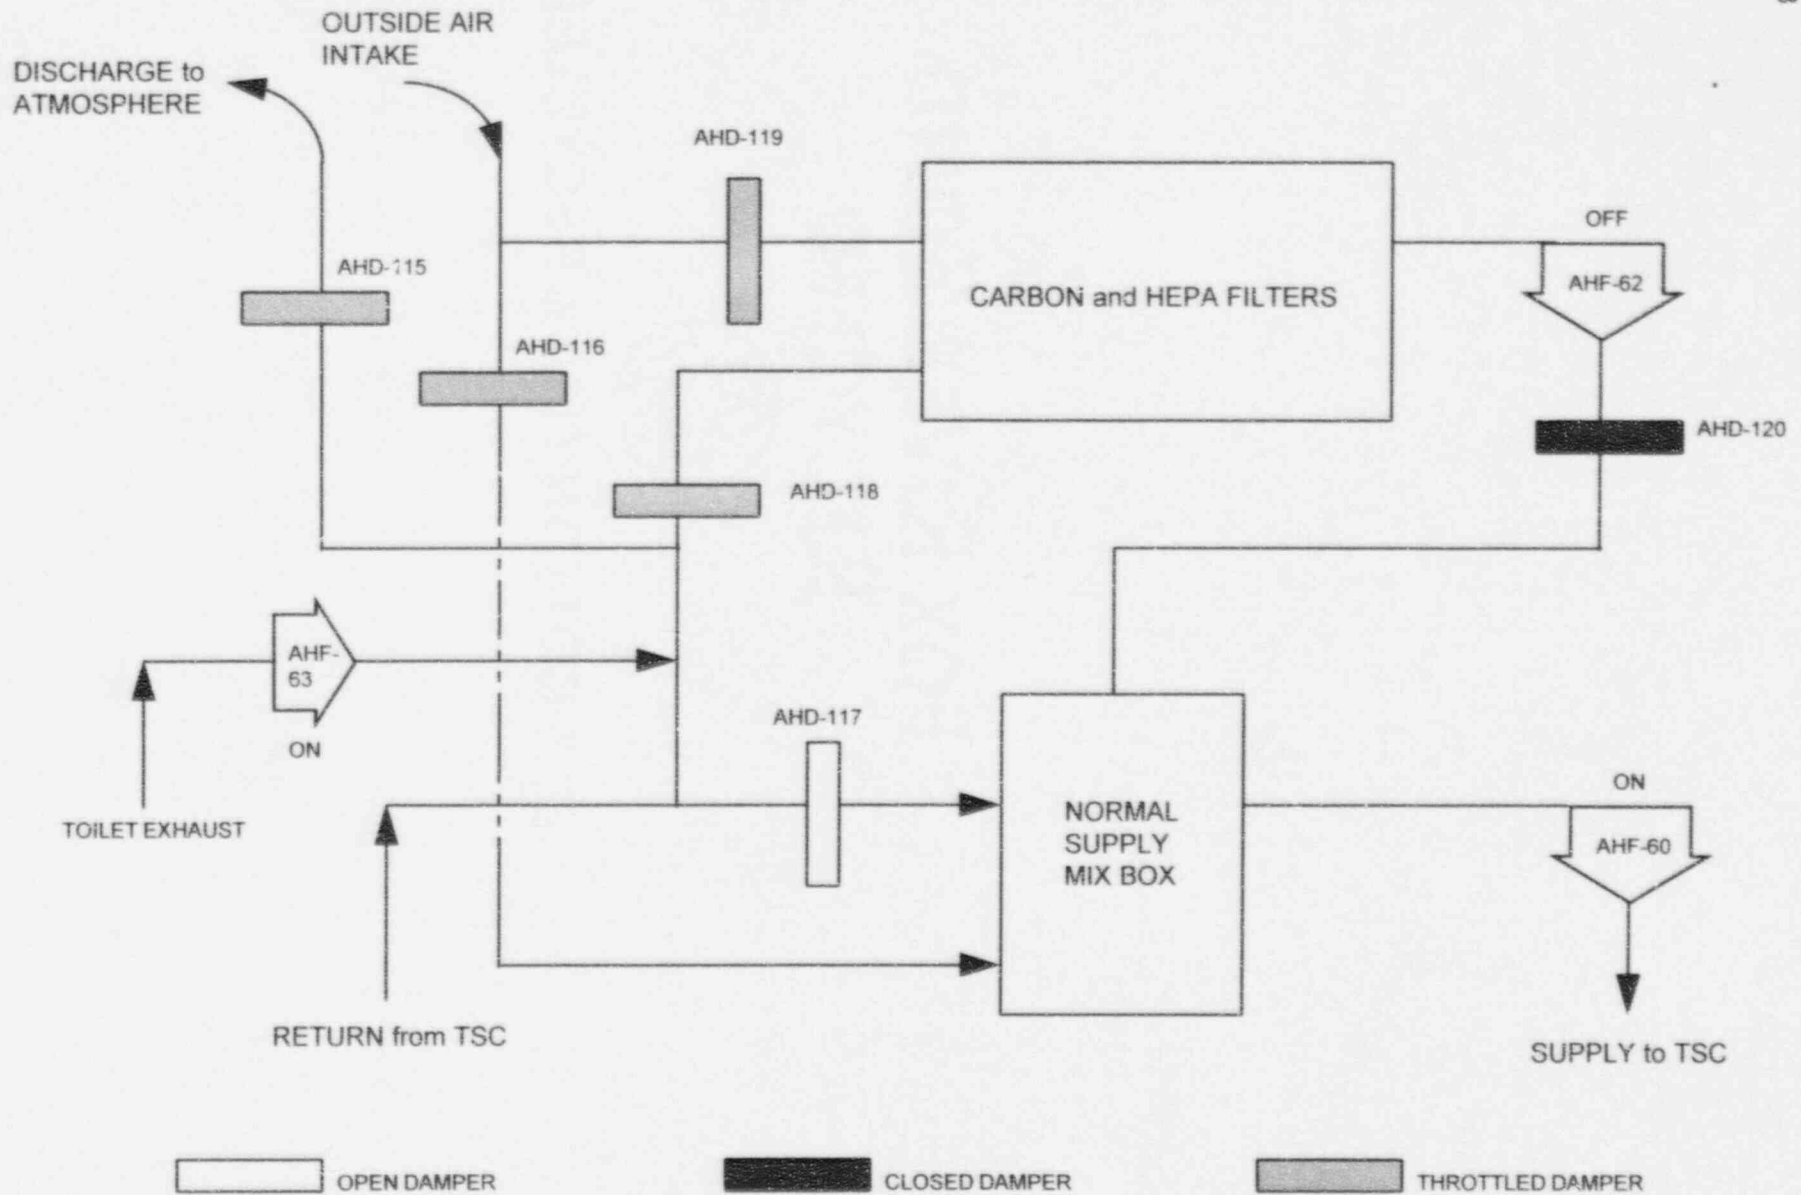
Figure 1

1. Fan performance substantially exceeded design flow requirements. This required throttling of system dampers to a point where slight changes had significant effects on system flows.
2. Motorized dampers were used to balance system flows. In conjunction with the excessive fan performance, repeatability of damper position when the system was cycled could have affected flows.
3. System operation relies on a positive building pressure to prevent in leakage and assumes zero leakage past the normal make-up damper (AHD-116) and relief air damper (AHD-115). These were found to be leaking. See Figures 1 and 2 for flow diagrams of the original TSC Ventilation system.

Original TSC Ventilation System - Normal Operation
