Subject: NRC Staff Position Regarding Detection of Linear Indication
on the Multi-Vane Diffuser Shroud in Safety Injection Pumps
Installed in Comanche Peak Steam Electric Station (Units 1 and 2)

Texas Utilities Company
Comanche Peak Units 1 and 2
Docket Nos. 50-445/446

I. INTRODUCTION

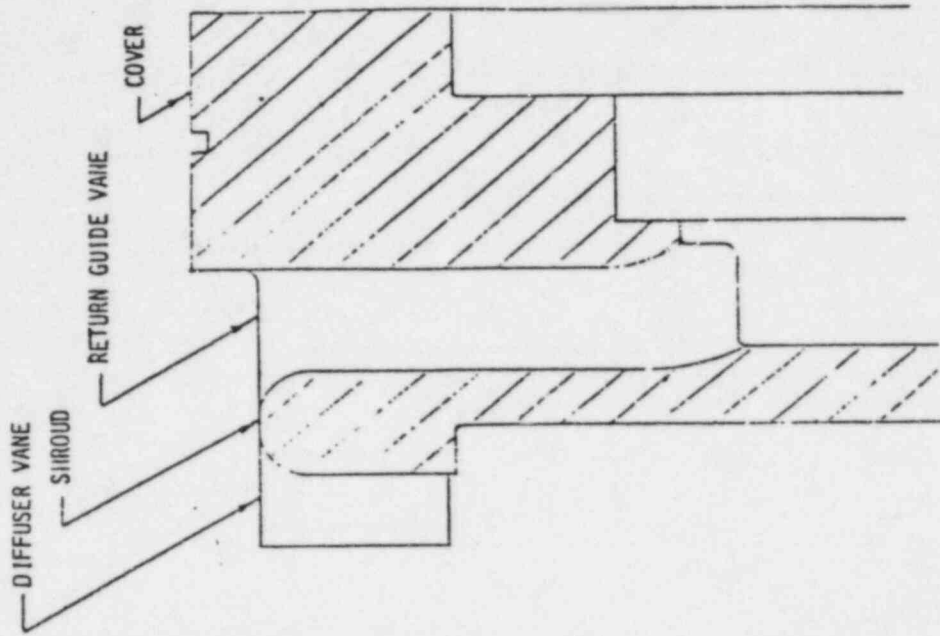
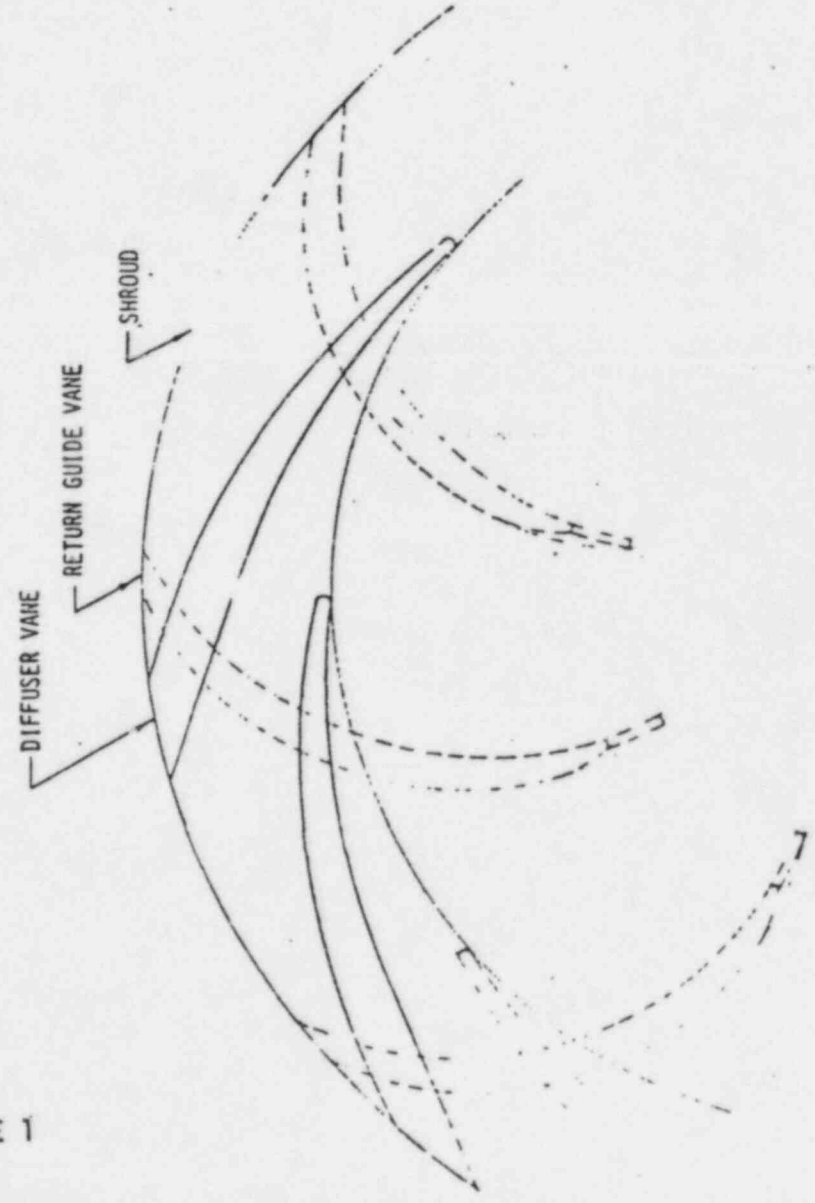
FIGURE 1

The stresses carried by the pump intermediate cover (see Figure 1) were analyzed by the finite element method to show the generally low stress condition in the area of indication and to provide data for use in a fracture mechanic analysis. The cover shown in Figure 1 is one of a number of static members assembled at the same time as the impellers and alternate with the impellers. Each cover serves to guide the water from the outlet of a previous impeller to the inlet of a subsequent impeller where the water is pumped to a higher pressure. As a result each "cover"

has one stage of differential pressure across it. It becomes, in effect, a piston hydrostatically loaded by the pressure buildup of the pump. This load is carried by the return guide vane, shroud, and diffuser vane into the next lower stage cover or into the case at the first stage. Although this is the only significant source of load on these parts, the manufacturer has considered this load to be made up of two superimposed components. The first component is a "static" component represented by the required design pressure increase of approximately 145 psi in each stage. The second component is a high frequency dynamic component caused by the blade passage of the impeller. Experience shows that the second component is typically 1% of the developed pressure but for calculation of stress an upper bound of 3% is used. Since the loads accumulate from stage to stage the finite element analysis was performed assuming that the full pump differential pressure of 1590 psi acts across one cover. Other sources of stress such as hydrodynamic forces or thermal cycling have been considered to be much less than the pressure forces discussed above. The possibility of significant thermal stresses and thermal fatigue are precluded by the fact that the section is flooded on all sides and is relatively thin. In addition, the pump is subjected to very few significant thermal cycles.

For the actual analysis, the equivalent pressure load was applied to the cover end of the part with the diffuser vane end fixed in the axial direction. Three models were run to determine if any significant redistribution of local stresses occur due to the presence of the indication in the part. The indication was simulated by removing thin elements to create a notch-type void in two of the models. The third model includes the complete section. The finite element analysis showed that the stress distribution in the shroud is mostly due to a bending load acting across the section. This agrees with expected behavior since the load path is predominantly from the return vane to the diffuser vane and is introduced into the shroud as bending from the forces applied by adjacent vanes. In addition, the analysis shows that the absence or presence of the indication does not significantly alter the stresses. The magnitude of the stresses are quite small especially when

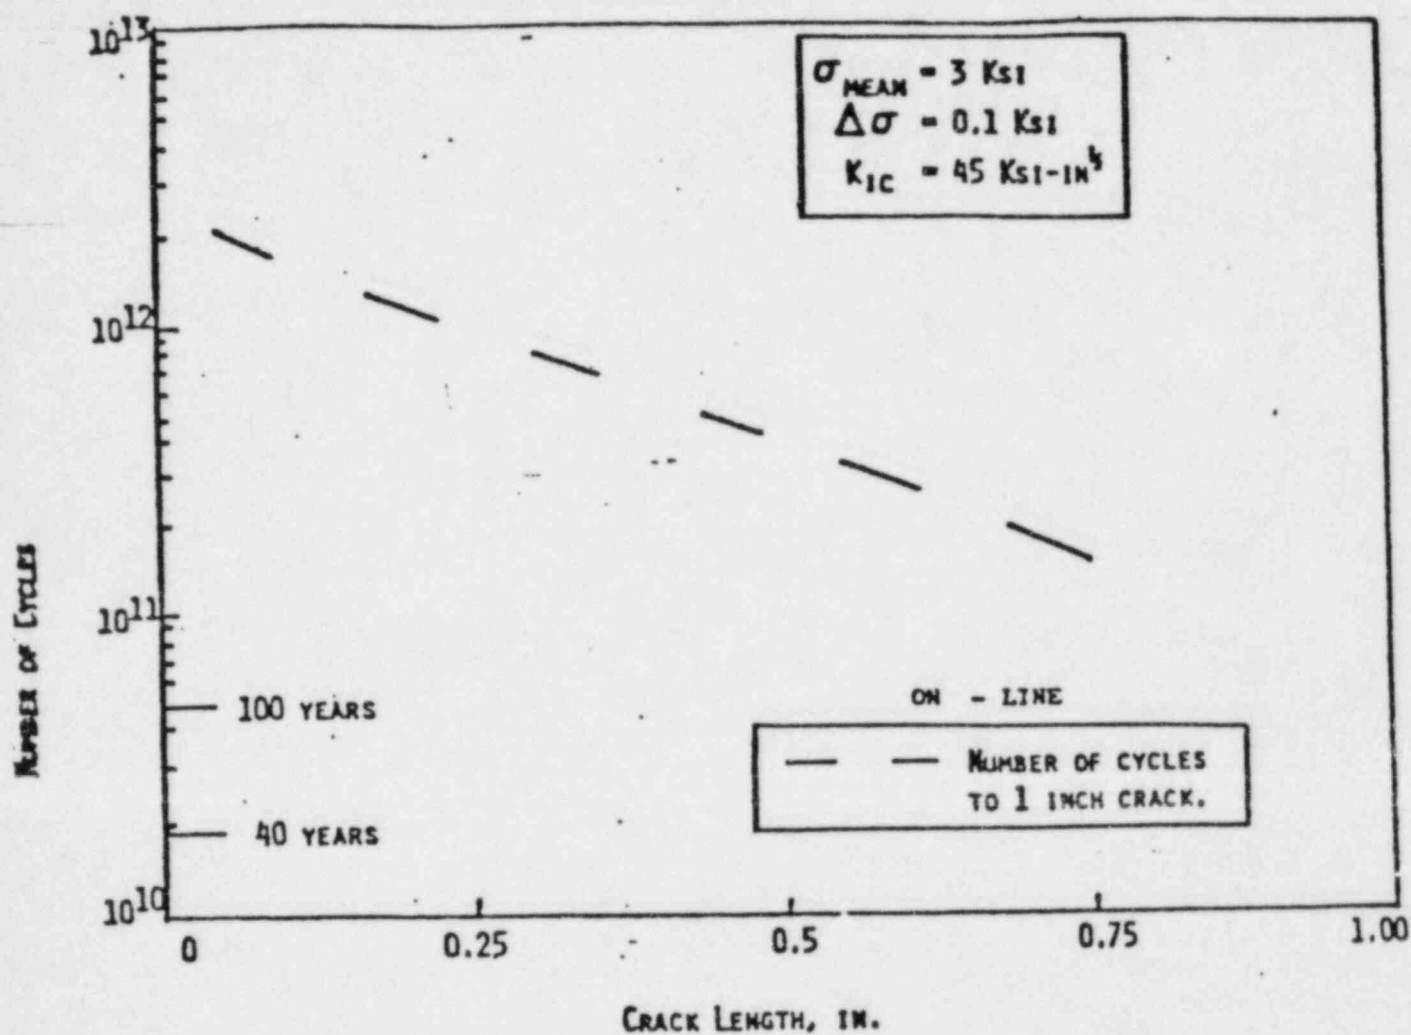
and calculating the number of cycles for a hot-tear to extend to 1-inch, the number of cycles to extend the hot tear to 1.0 in. is shown on Figure 2. As noted, over 100 yrs of projected on-line pressure pulses would be required. Similarly, over 40,000 years of projected start-up cycles would be required to extend the hot tear to 1.0 in. radial length.

FIGURE 2. Predicted number of on-line fatigue cycles required to extend a radially oriented edge crack to 1-inch in length. Initial size or depth of hot tear is indicated on horizontal axis.

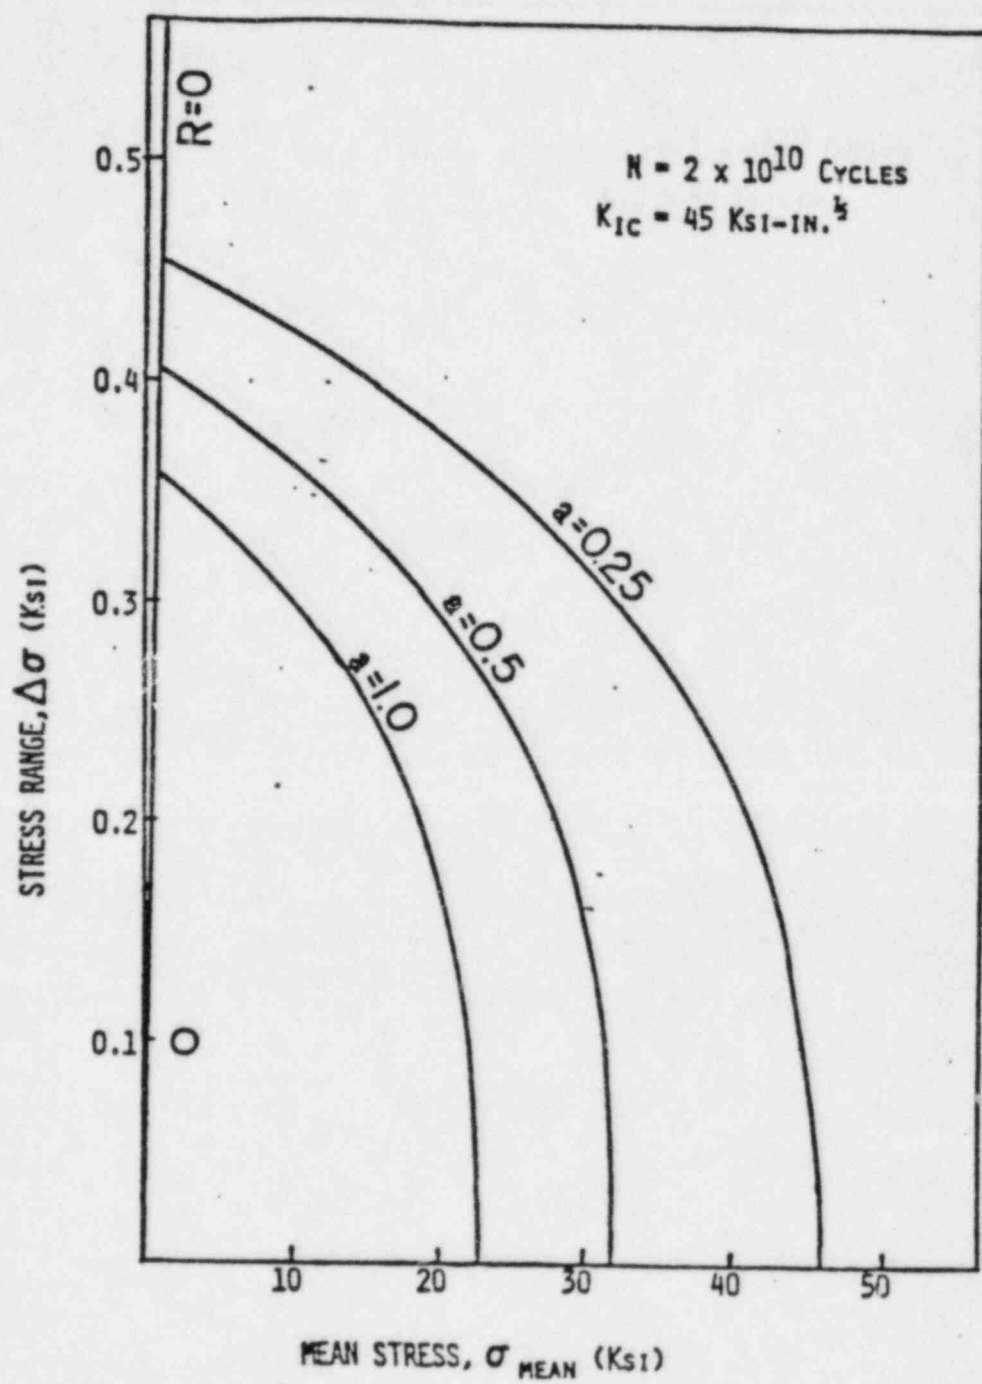
The stress range $\Delta\sigma$ and σ mean can be delineated as shown in the fracture mechanics modified Goodman diagrams of Figures 3 and 4.

As observed on studying Figures 3 and 4, the operational stresses are far below any combination of mean and alternating stress range that would exceed the safe-life zone delineated by the lines for $a_0 = 0.25, 0.50,$ or 1.0 in. Obviously these zones decrease in size as the assumed initial size of the hot tear increases.

FIGURE 3. Safe-life design envelope for a projected 20,000 million cycles of on-line pressure pulses. Circle indicates actual operating conditions.

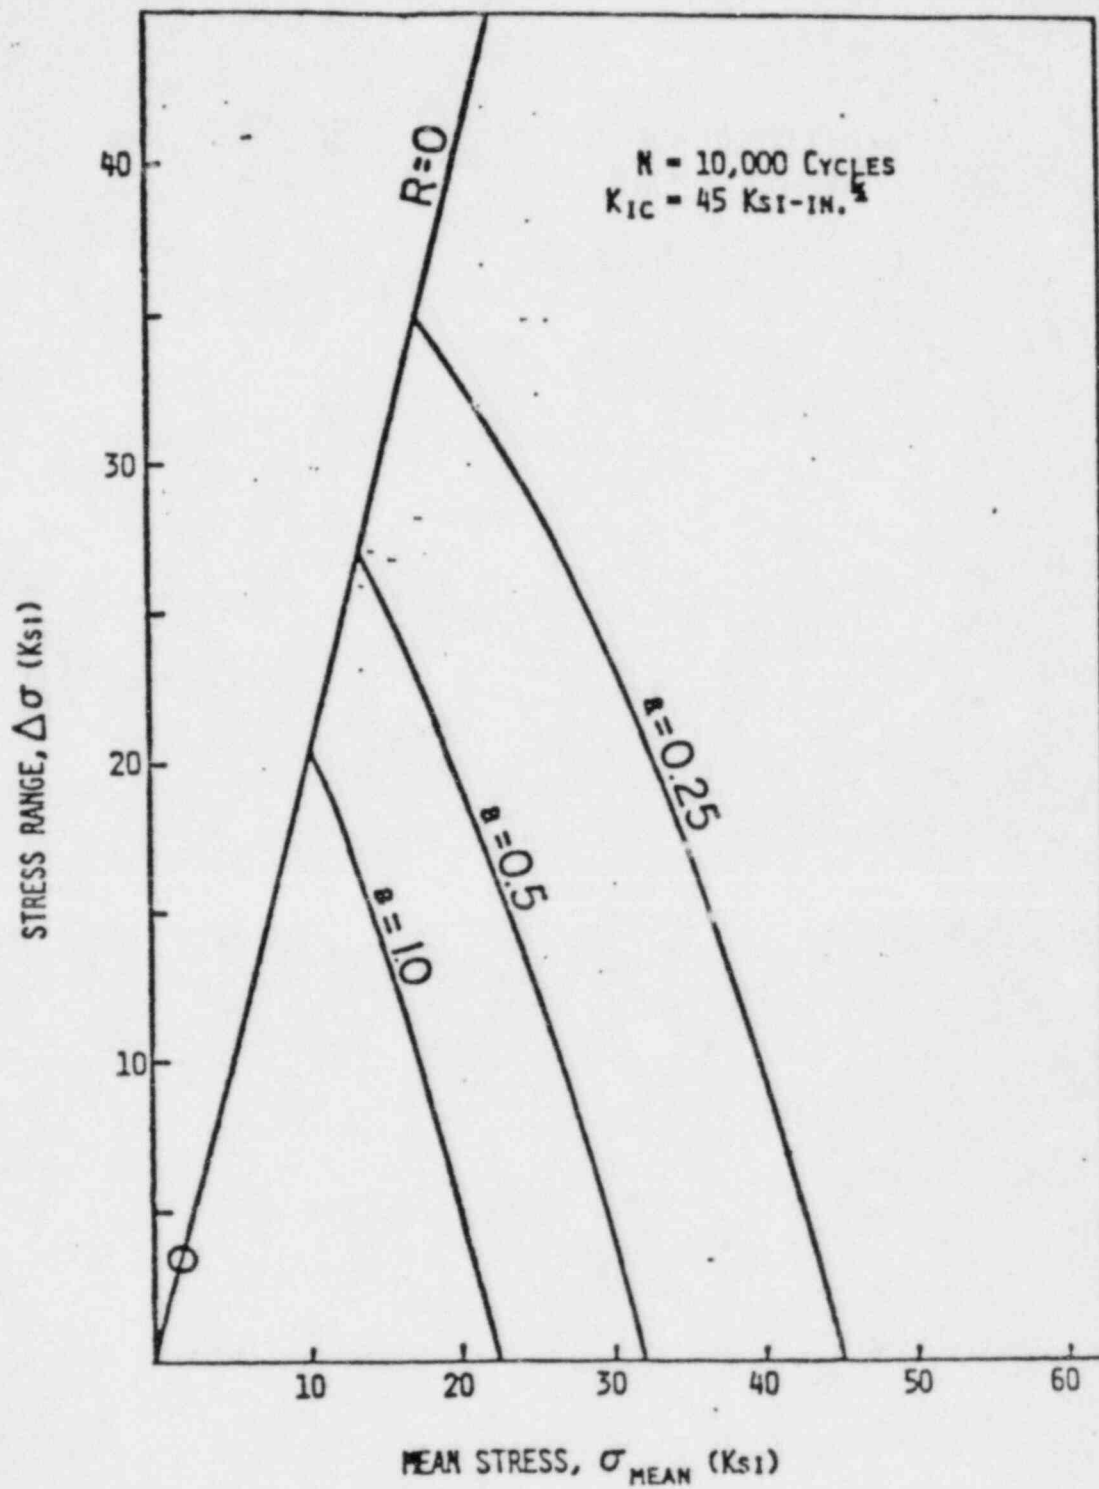
FIGURE 4. Safe-life design envelope for a projected 10,000 start-up cycles. Circle indicates actual operating conditions.
