NUREG/CR-6074
04-4448-010
Vol. 2

Sealed Source and Device Design Safety Testing

Technical Report on the Findings of Task 4

Investigation of Failed Nitinol Brachytherapy Wire

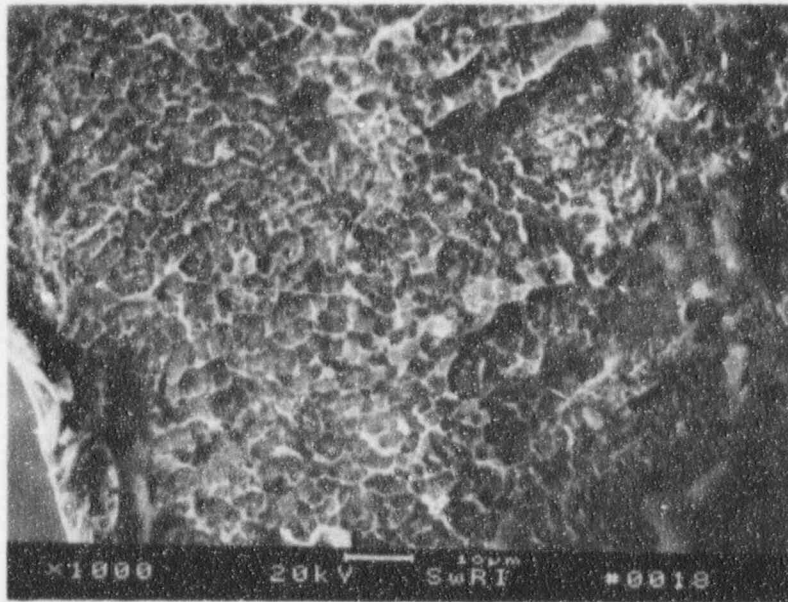
Figure 2-1 SEM Photomicrographs of Failed Source Wire from Facility A (Sample No. 410). Fracture surface on wire side of failure. Bottom of source cavity is evident in (b). Block arrows mark match points for two views.

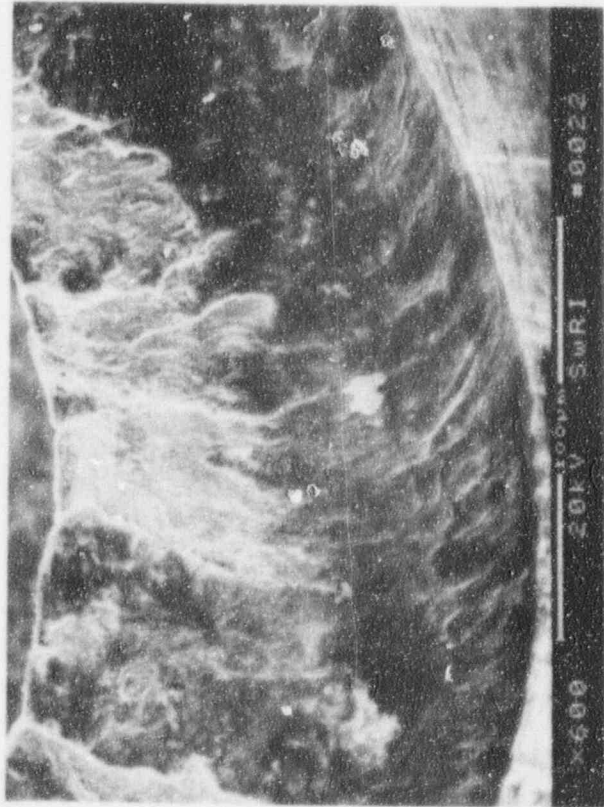
Figure 2-4 SEM Fractographs from Slant Fracture Zone of Sample 410. See Figure 2-1 for locations.

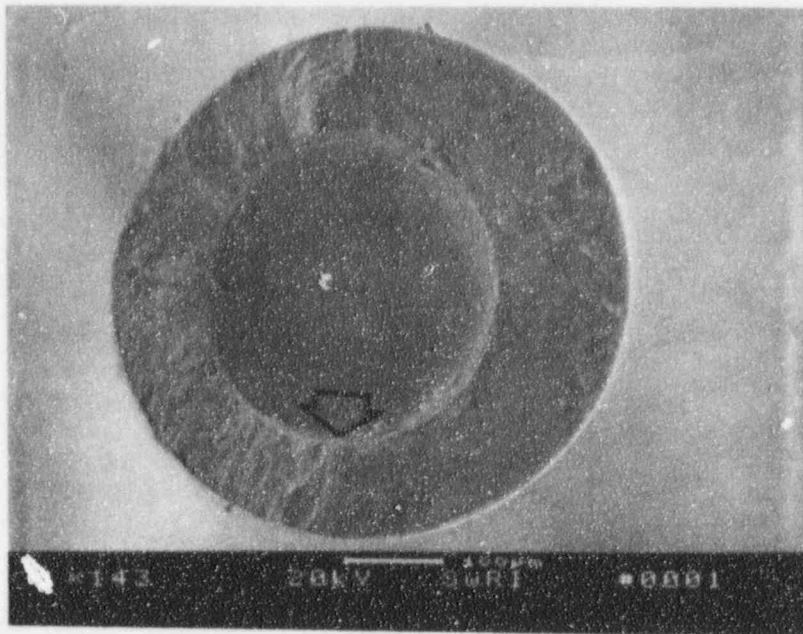
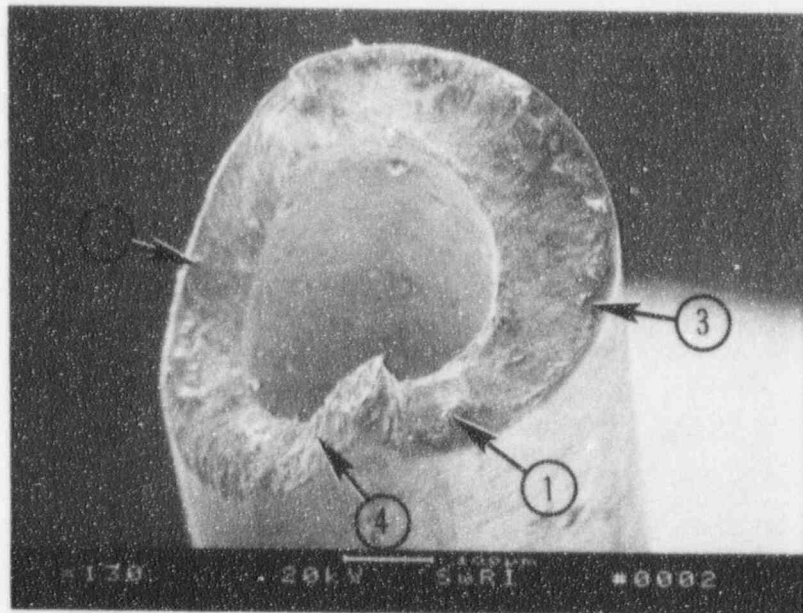
Figure 2-6 SEM Photomicrographs of Failed Source Wire in As-Received Condition.
Sample No. 410. Block arrows mark match points for two views.

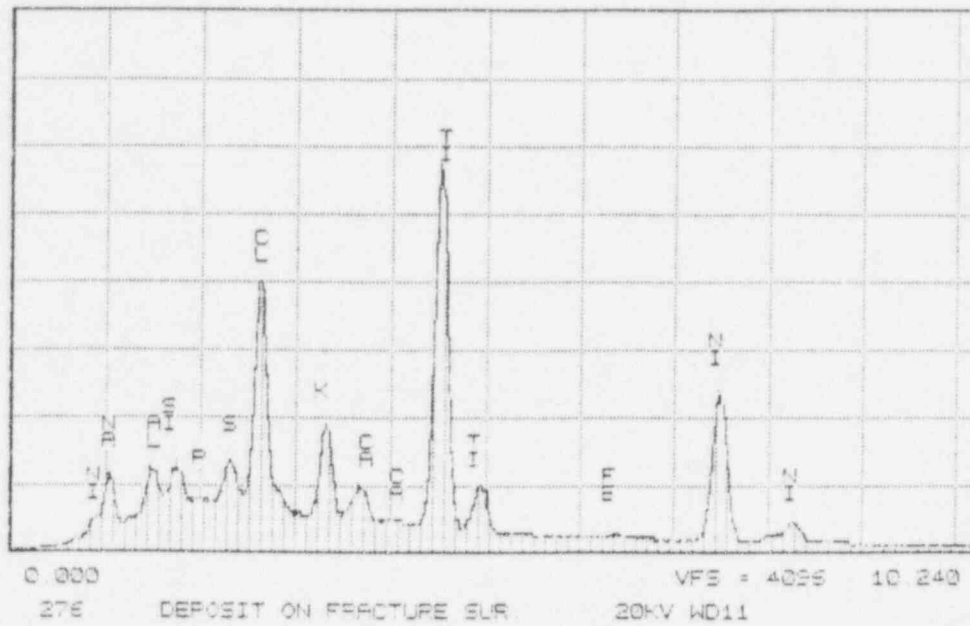
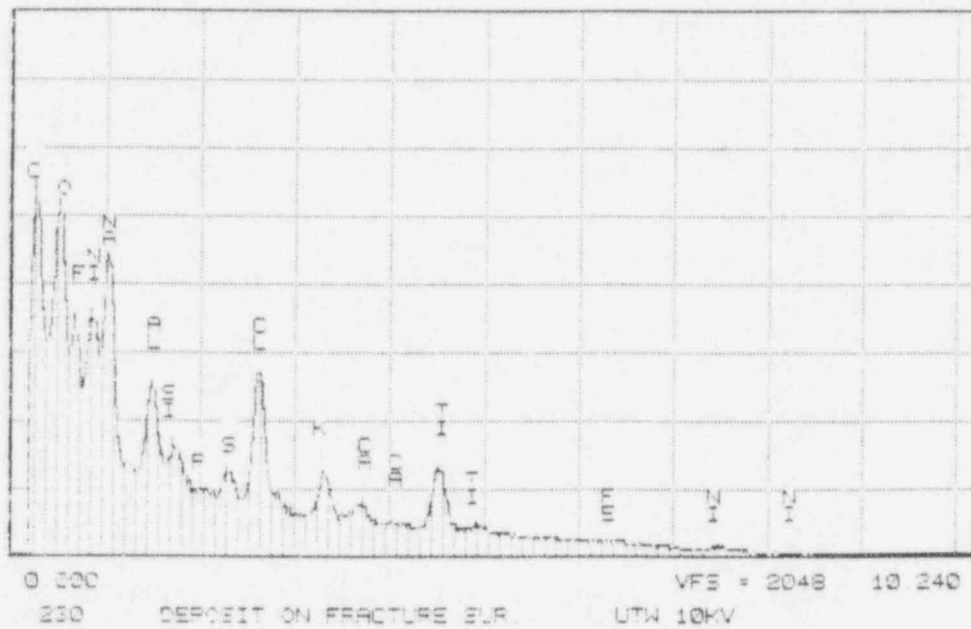
Figure 2-7 X-ray Energy Spectra from Fracture Surface. Sample No. 410. Location 1, Figure 2-6. Upper: β e window, 20 kV; Lower: Ultra-thin window, 10 kV

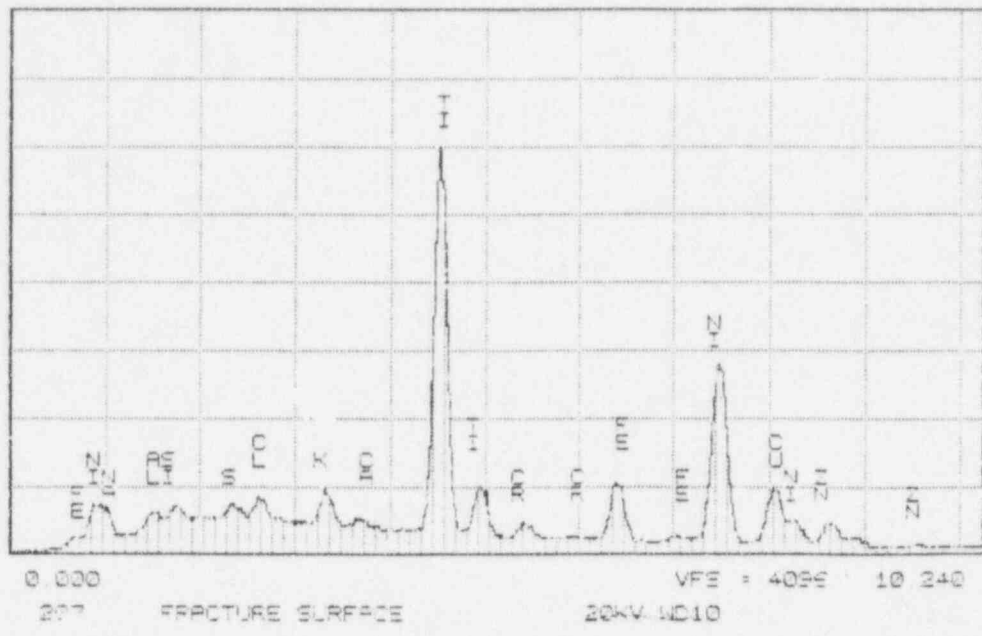
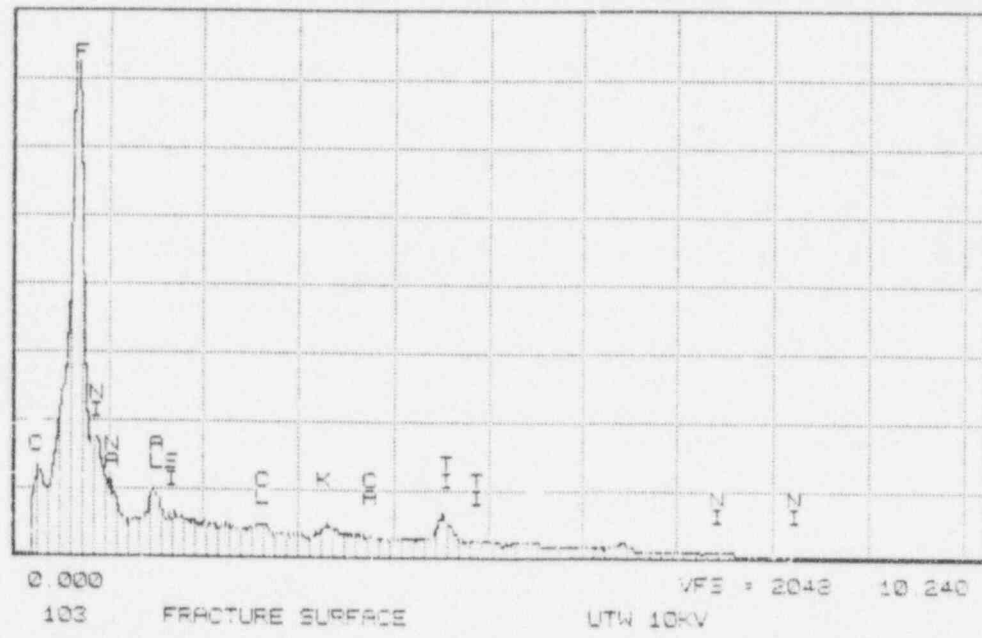
Figure 2-8 X-ray Energy Spectra from Fracture Surface. Sample No. 410. Location 2, Figure 2-6. Upper: β_e window, 20 kV; Lower: Ultra-thin window, 10 kV

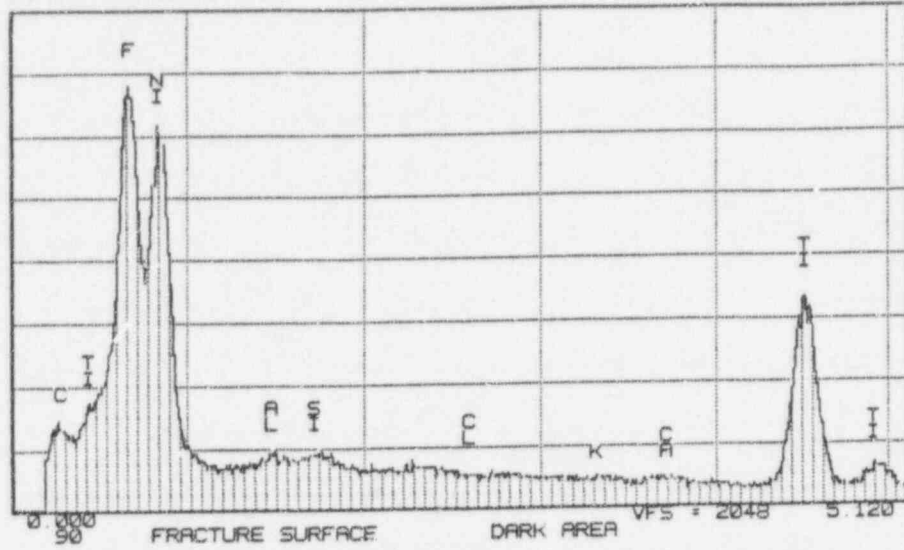
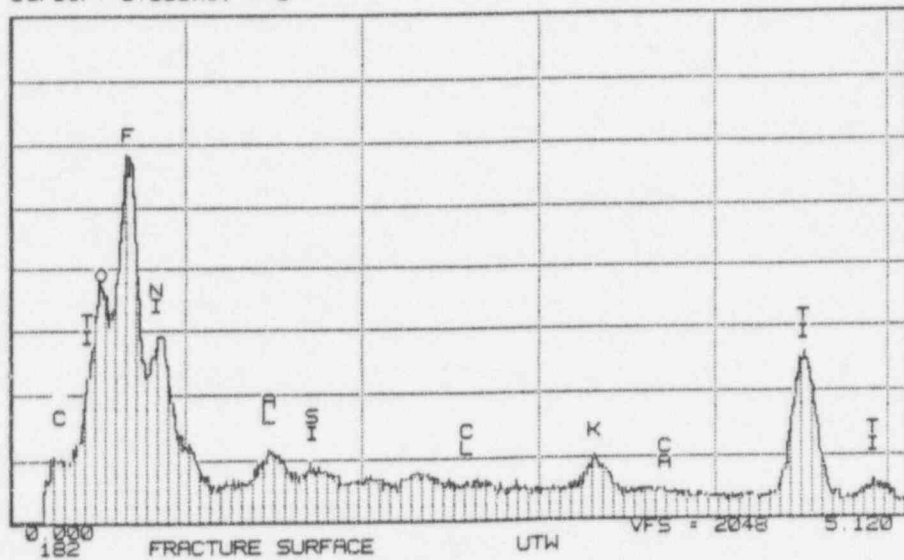
Figure 2-9 X-ray Energy Spectra from Fracture Surface. Sample No. 410. Both spectra are for light element window with 10 kV potential.

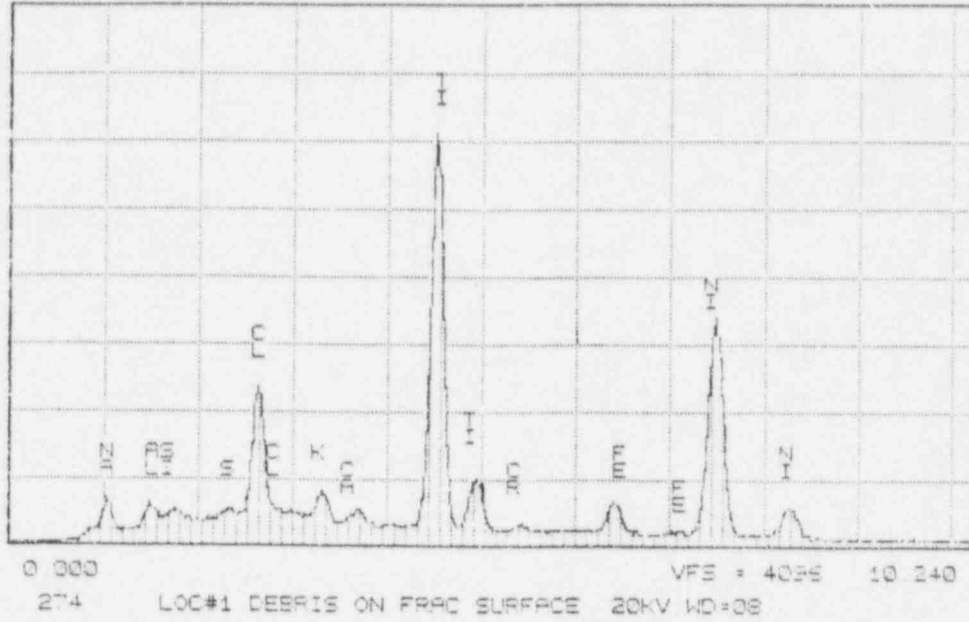
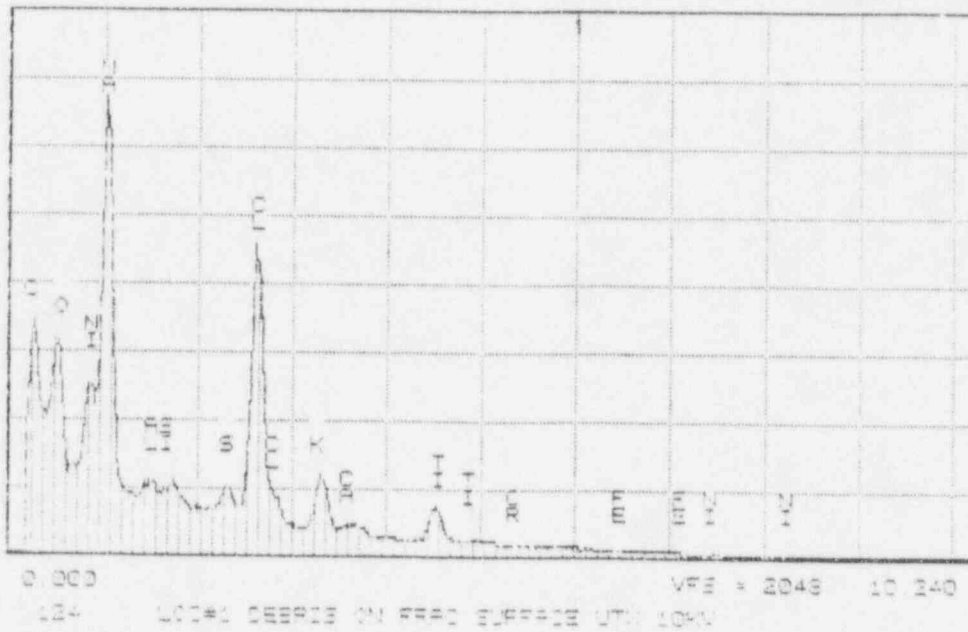
Figure 2-21 X-ray Energy Spectra for Debris on Fracture Surface. Sample 411. See Figure 2-20. Upper: β window; Bottom: Ultra-thin window

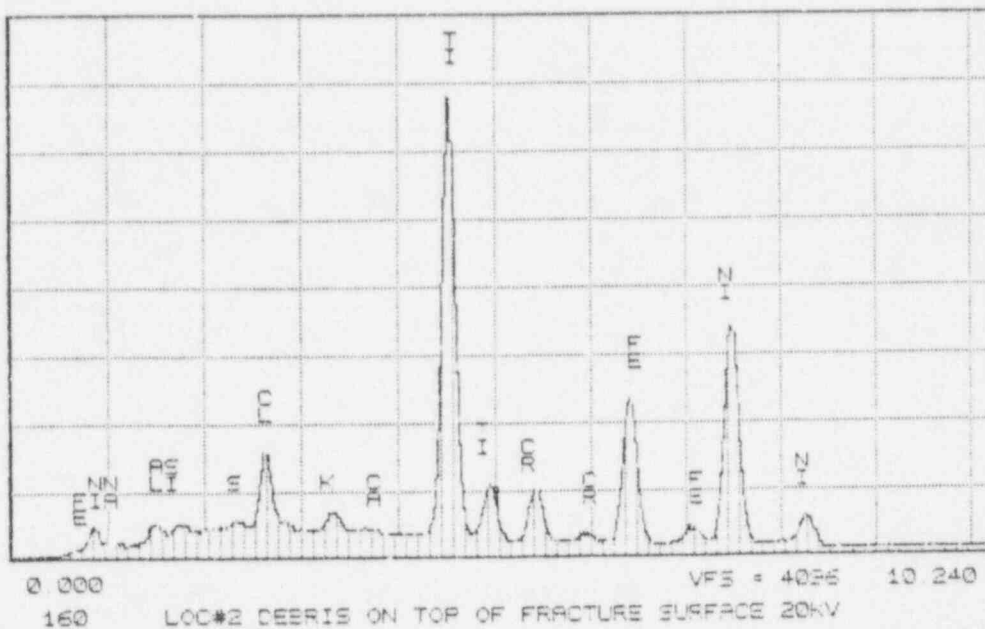
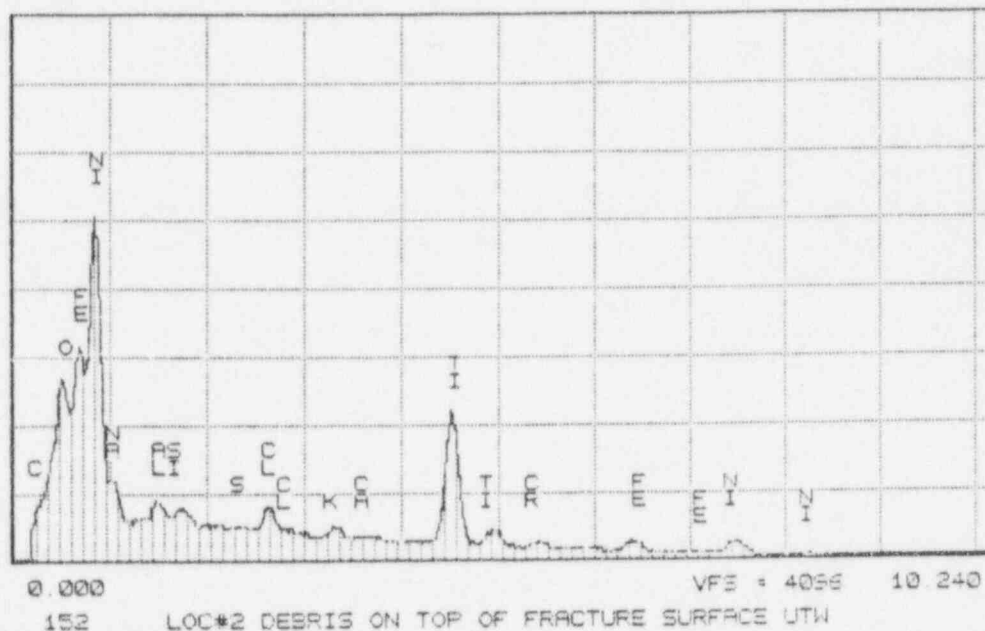
Figure 2-22 X-ray Energy Spectra for Debris on Fracture Surface. Sample 411. See Figure 2-20. Upper: β window; Bottom: Ultra-thin window

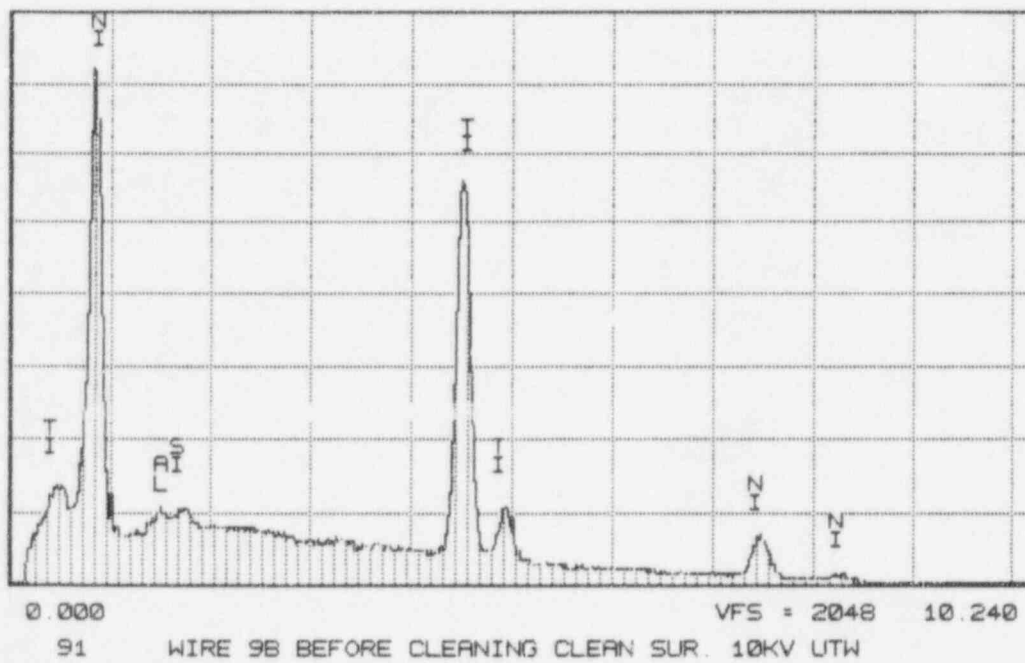
Figure 3-5. EDX Spectra of Residual Product on the Fracture Surface.

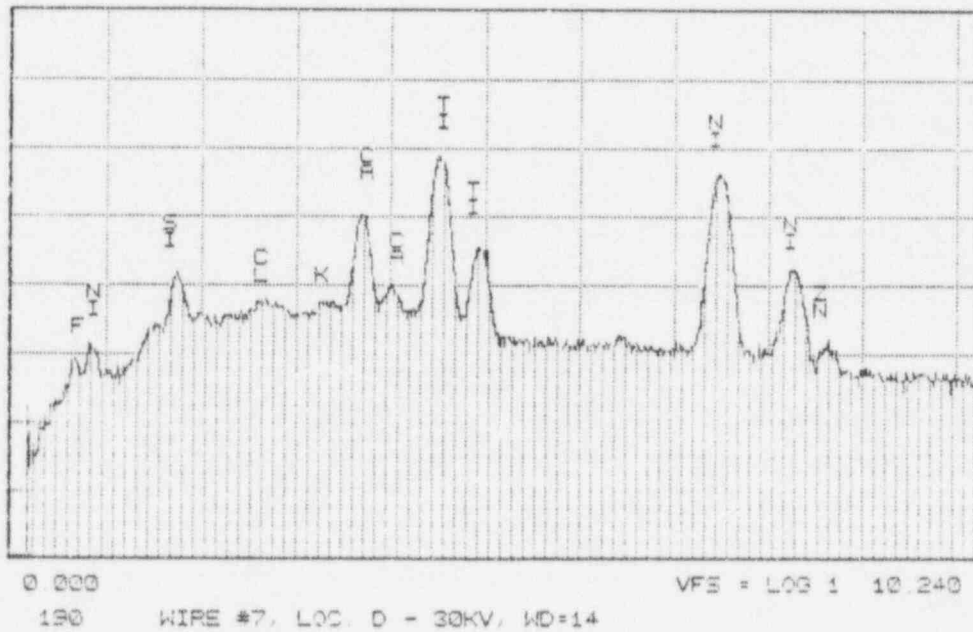
Figure 4-7. Energy Dispersive X-Ray Spectra of the Uncleaned Fracture Surface of SwRI Wire No. 416.

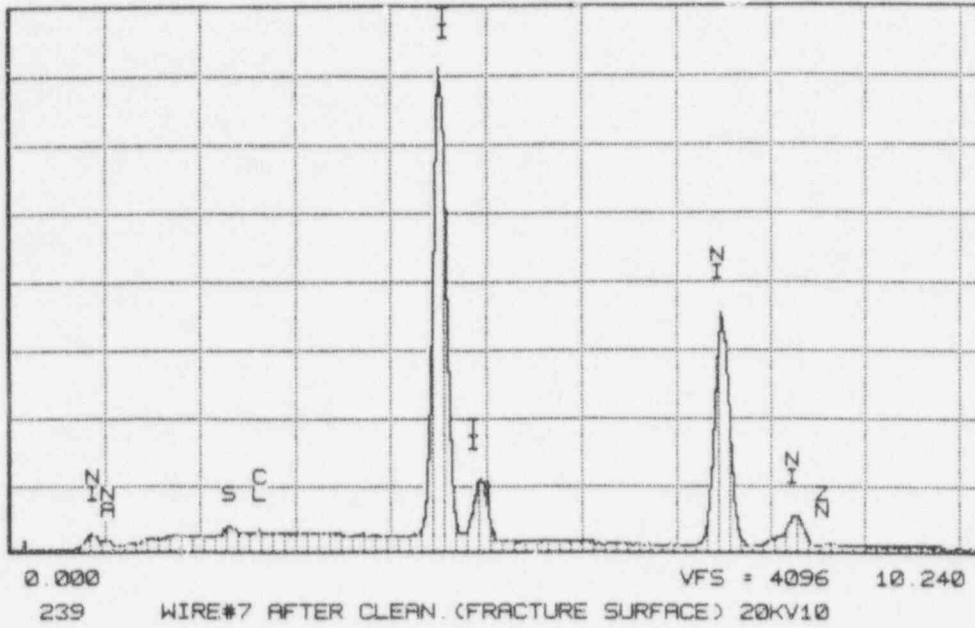
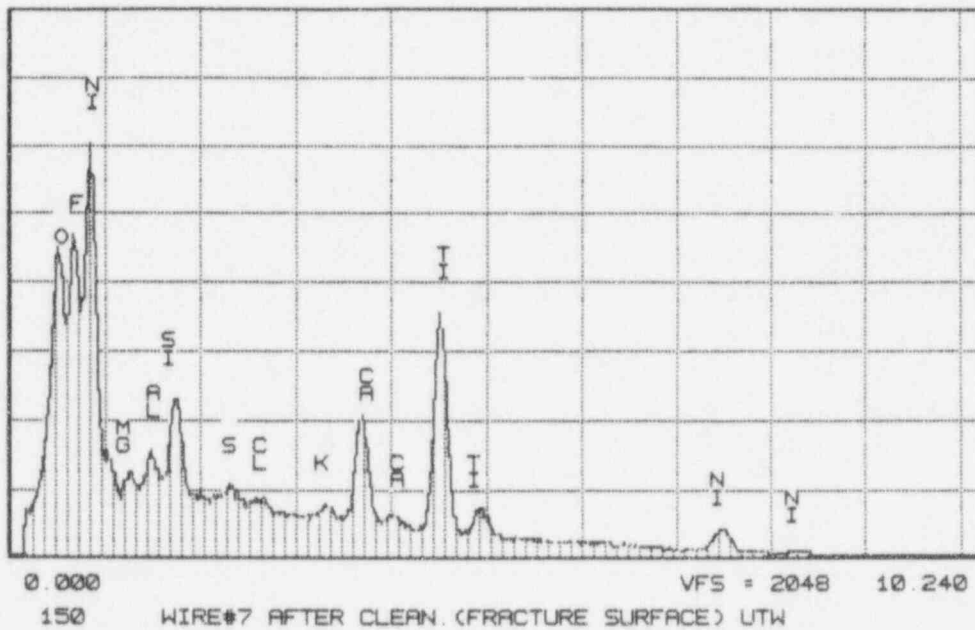
Figure 4-8. Energy Dispersive X-Ray Spectra of the Cleaned Fracture Surface For SwRI Wire No. 416.

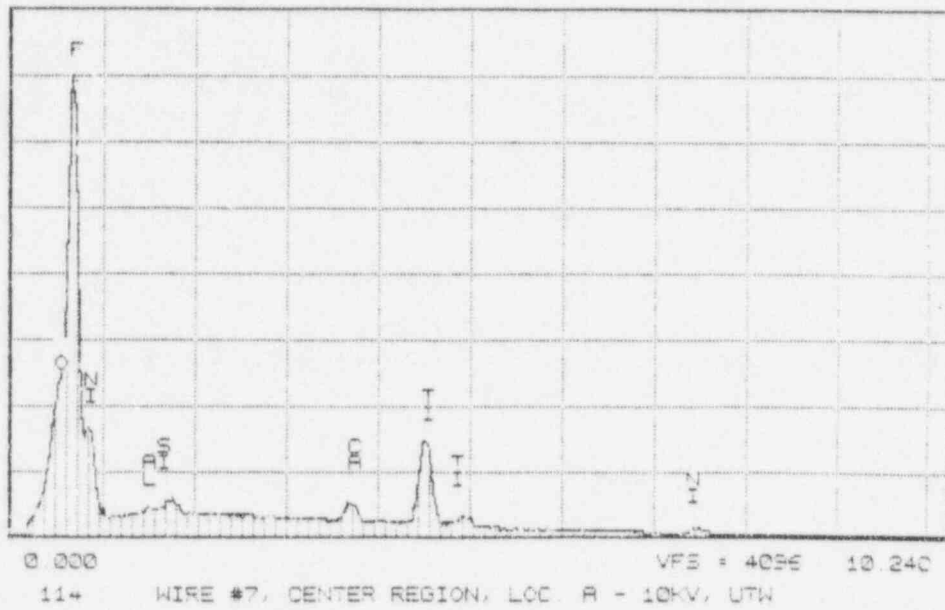
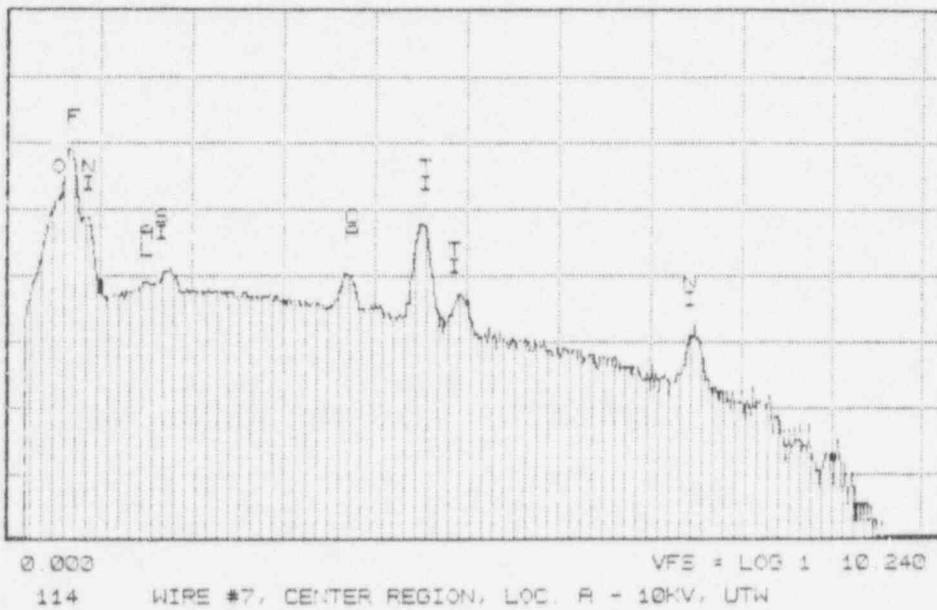
Figure 4-9. Energy Dispersive X-Ray Spectra of the Center Portion of Failed SwRI Wire No. 416.

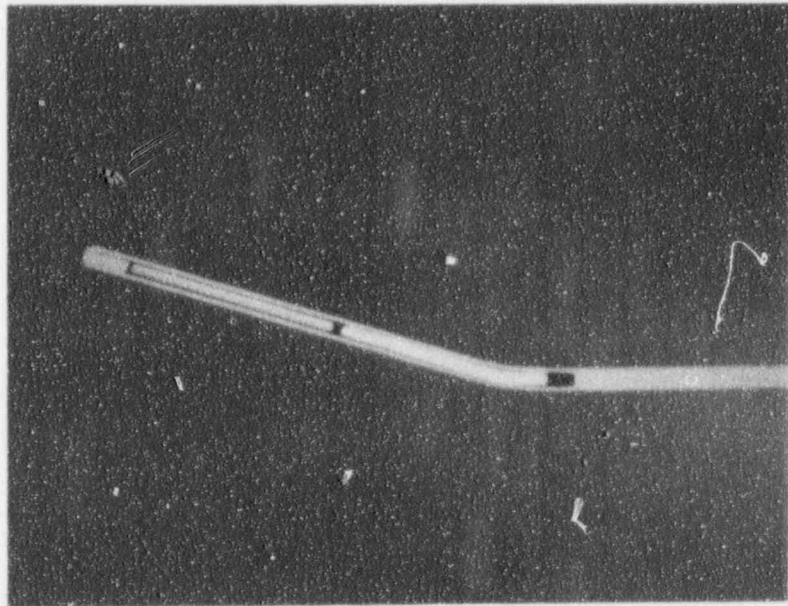
Figure 5-13. Photomicrograph of a Cross Section of SwRI Wire No. 435-3 that Had Plastic Deformation but No Failure

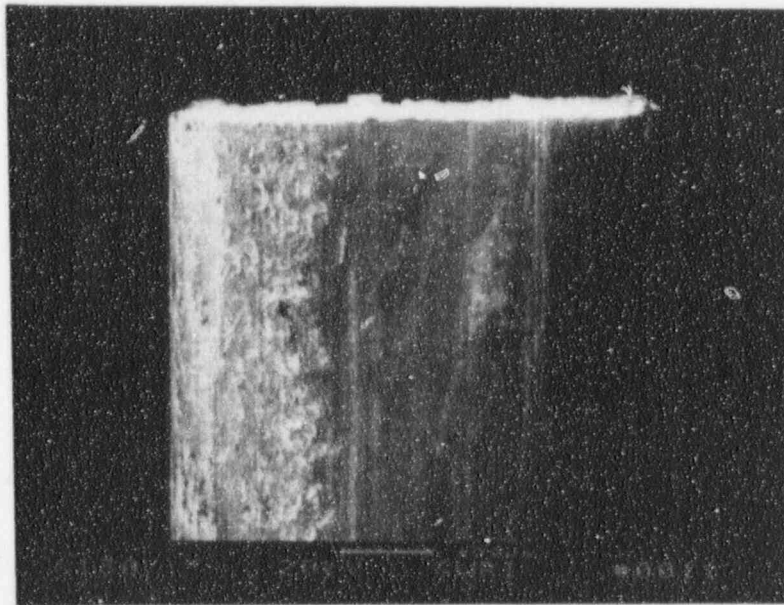
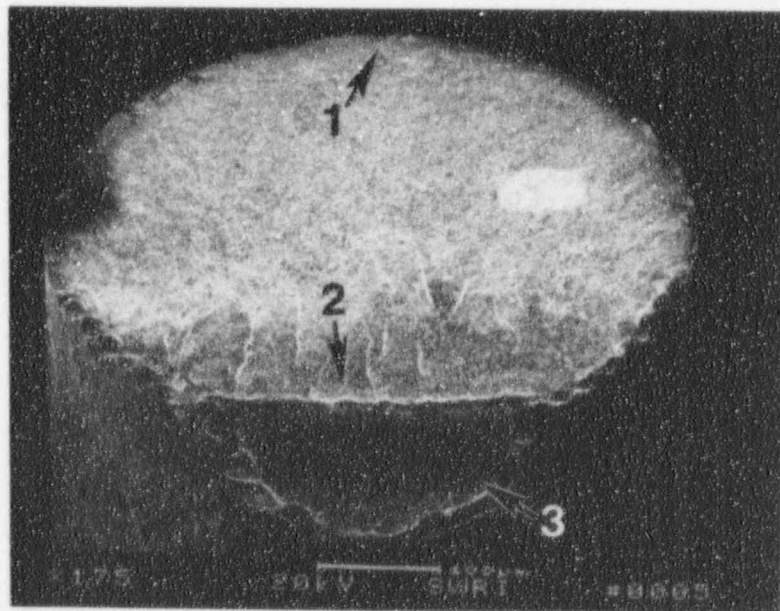
Figure 5-28. SEM Photomicrographs of Fracture in Hydrogen-Charged Specimen.
Test No. HC-6

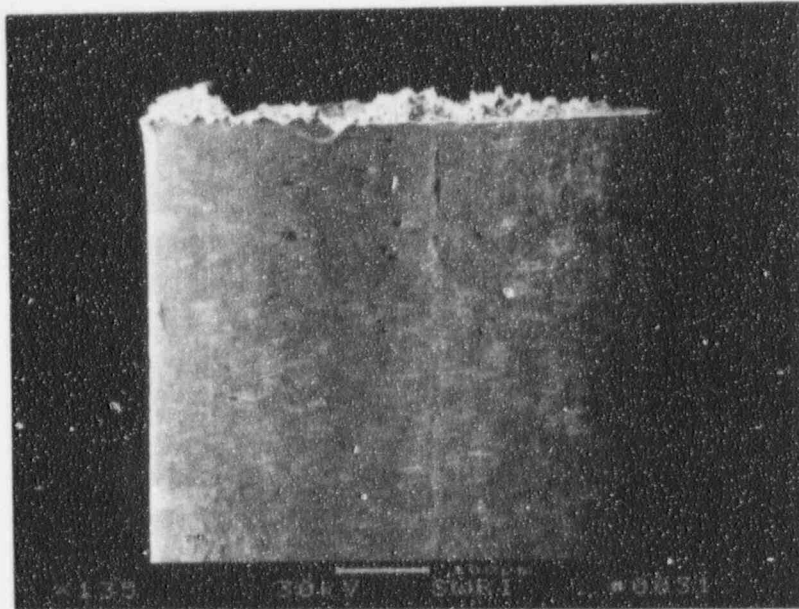
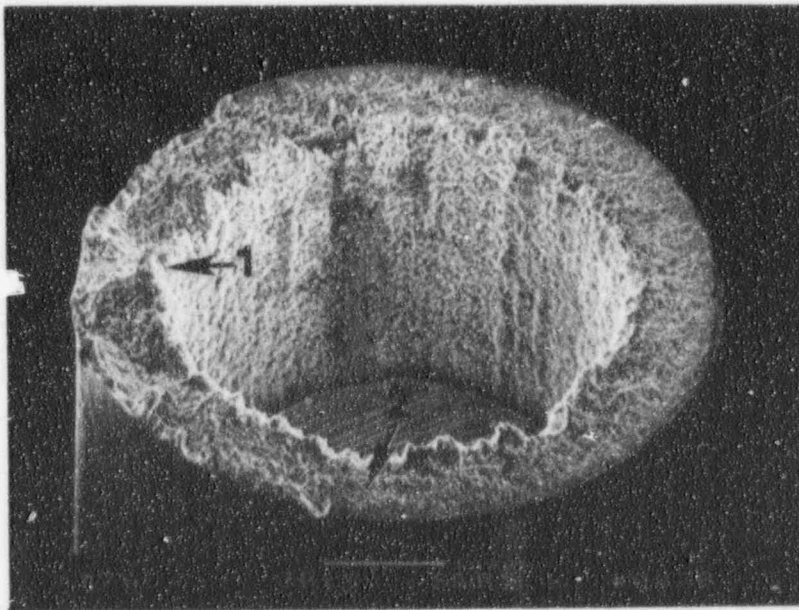
Figure 5-30. SEM Photomicrographs of Fracture in Hydrogen-Charged Specimen. Test No. HC-10, simulated sourcewire. Inside of bend is at LHS in (a) and (b).

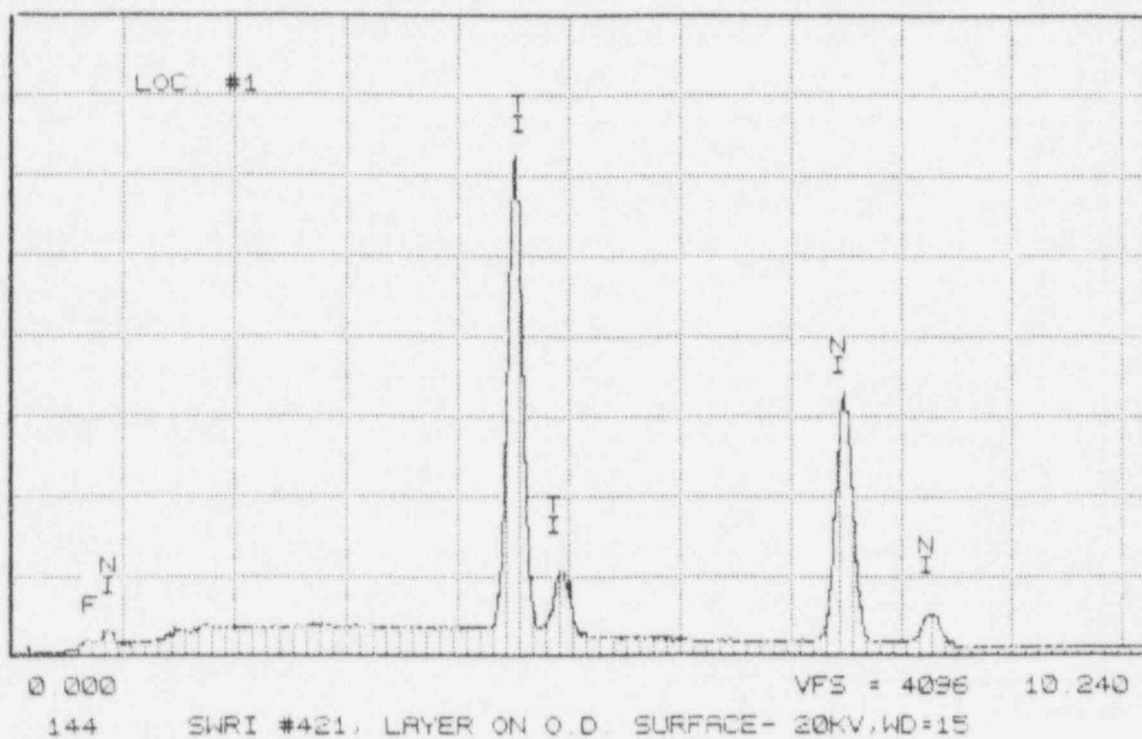
Figure B-14. Energy Dispersive X-Ray Spectra for the OD of SwRI Wire No. 421-1, Location 1

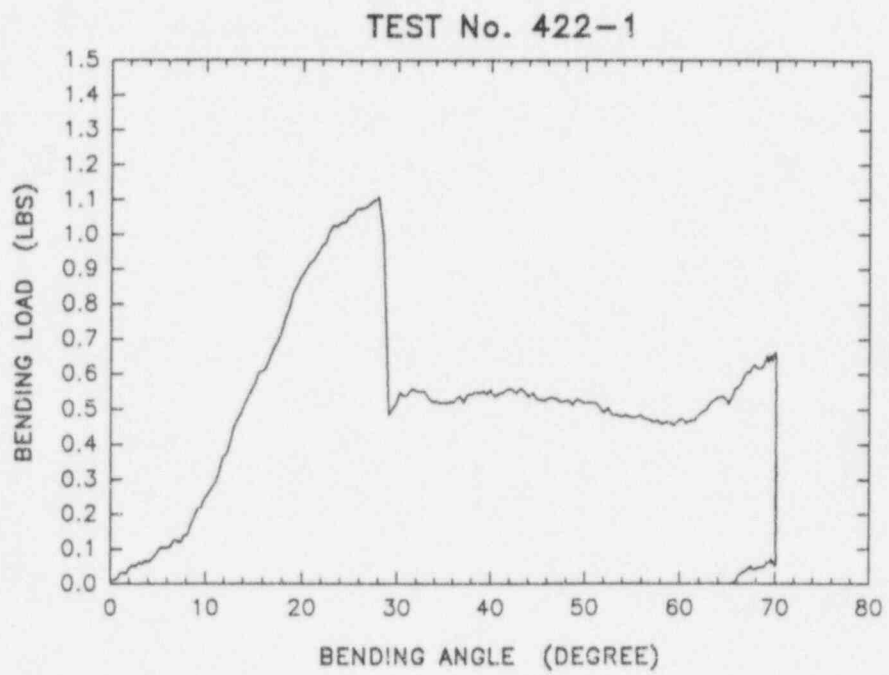
Figure C-1. Plot of Bending Load vs. Angle of SwRI Wire No. 422-1.
