SOUTH CAROLINA ELECTRIC & GAS COMPANY

December 14, 1984

Subject: Virgil C. Summer Nuclear Station
Docket No. 50/395
Operating License No. NPF-12
Diesel Generator Testing

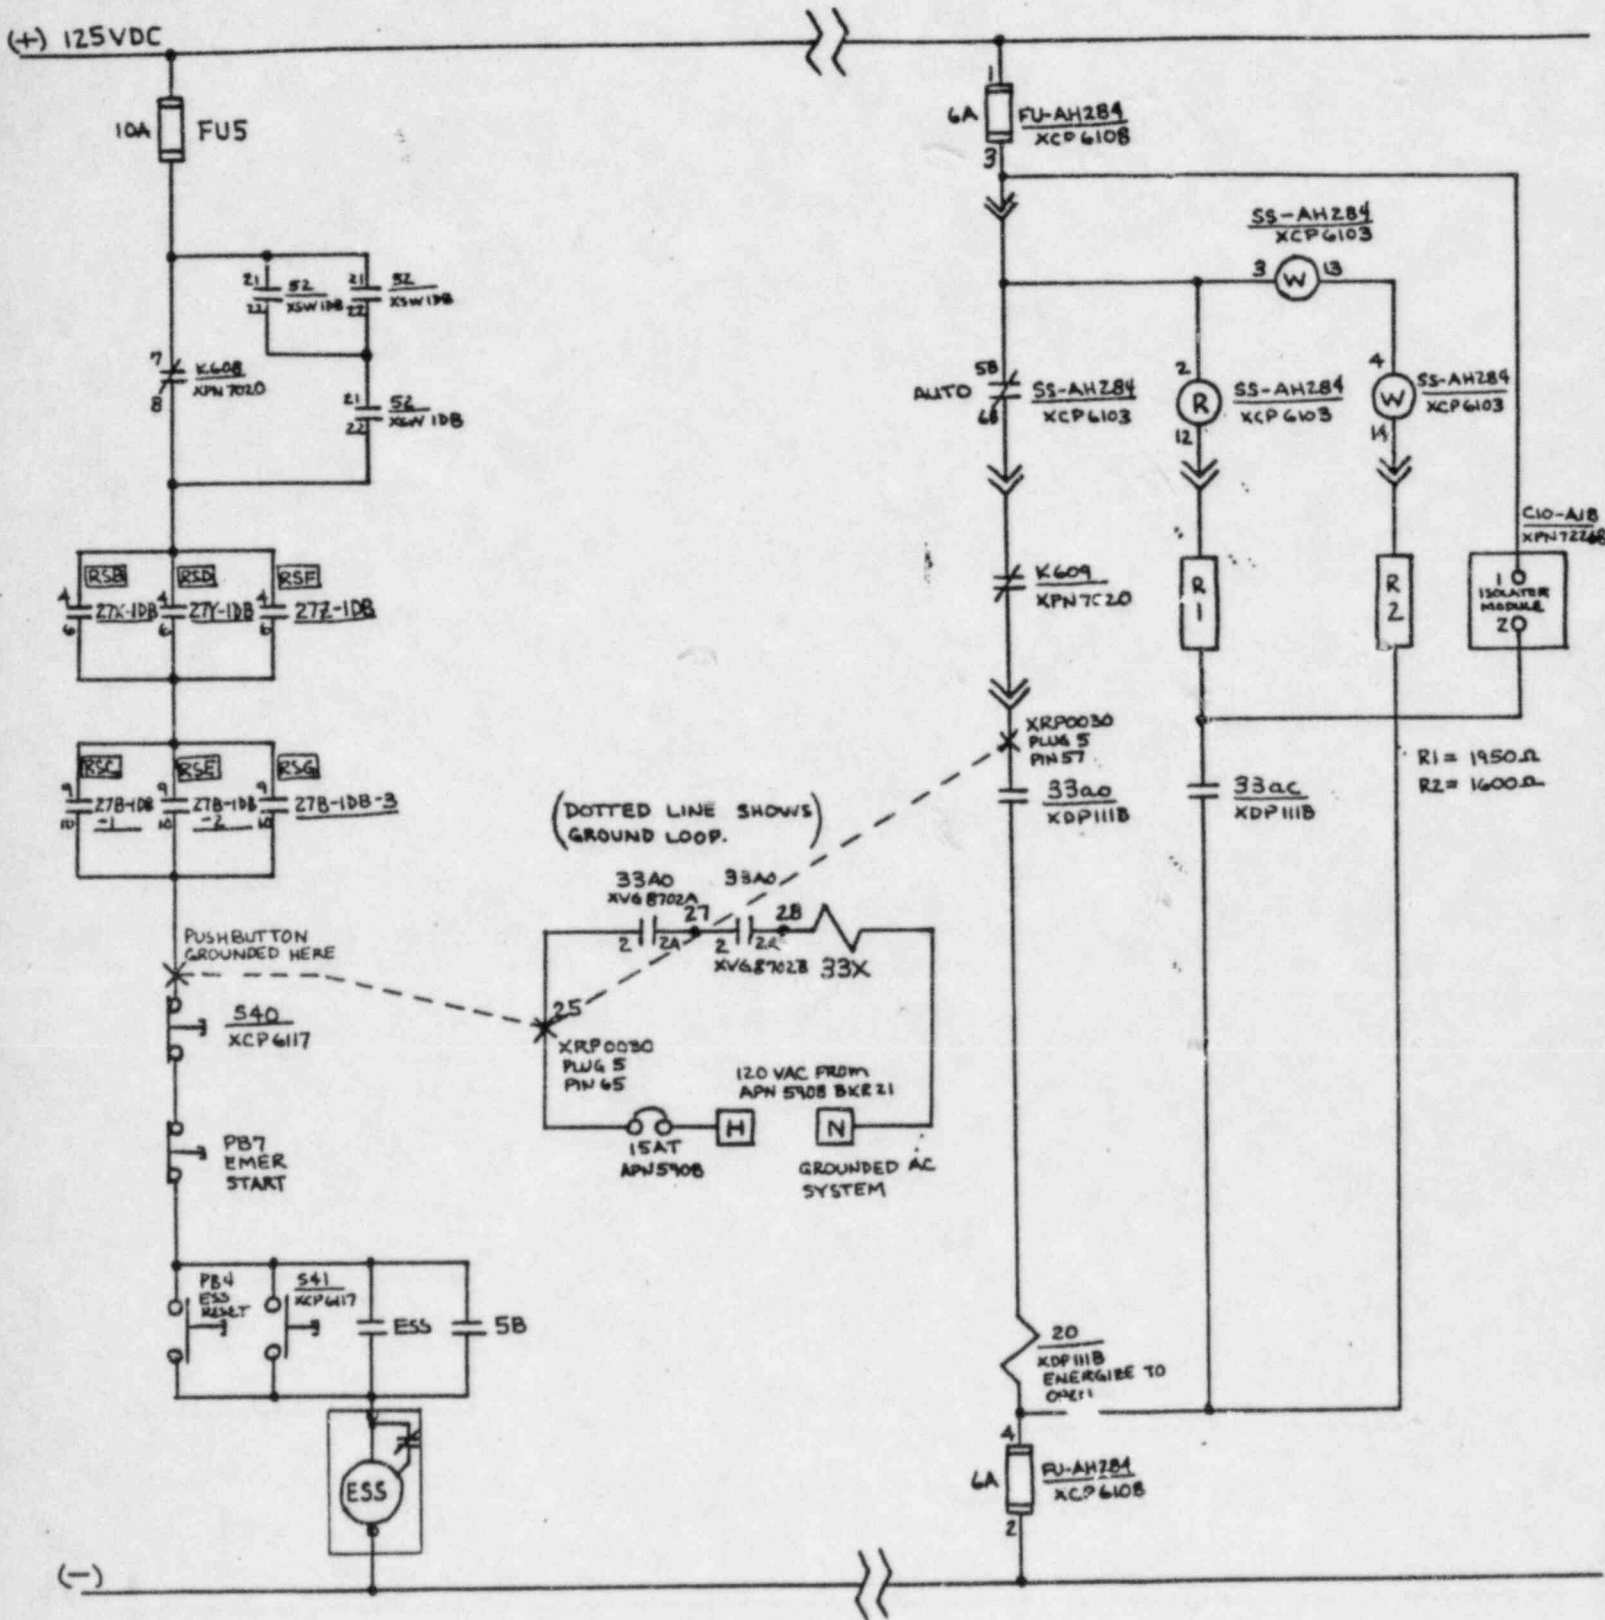
The situation which caused the start failure was a ground on both the positive DC bus side of the Emergency Start Pushbutton (located on the main control board) and the positive DC bus itself at penetration XRPO030-PS, plug 5, pins 57 and 65 (see Attachment I). In this condition two (2) current paths were available to keep the Emergency Safeguards System (ESS) relay energized: (1) the normal control circuit path, and (2) the path through the ground connection to the positive DC bus. On initiation of the UV test, the UV contacts opened which should have deenergized the ESS relay causing the diesel to start. However, the current path through fuse FU-AH284 and the ground loop back to the positive DC bus still existed. Under the pre-test conditions the parallel current contribution to FU-AH284 was minimal, but when the UV contacts opened the only path left to keep the ESS relay energized was through the ground loop. This additional current exceeded the 6 amp rating of the fuse, thus opening the circuit and allowing the ESS to relay drop out. When this occurred the diesel started and the test was completed without further incident.

The ground at the main control board resulted from the pushbutton rotating in its assembly and grounding on the metal enclosing the pushbutton. The ground at XRP-0030-ES occurred when the circuit, which is not a portion of the diesel generator unit design, was energized after performing a modification to the plant during the present refueling outage. This ground, in conjunction with the pushbutton ground on the control board, prevented the successful start of the diesel generator. The pushbutton ground alone would not have prohibited a successful start, and therefore, the malfunction in the circuitry not associated with the diesel design caused the failure.
