Draft Radiological and Engineering Assessment

Vicinity Property No. SLC 021

DRAFT
THE RADIOLOGICAL AND ENGINEERING ASSESSMENT
AND FINAL DESIGN
FOR
SALT LAKE CITY PROPERTY
SL-021

December 3, 1984

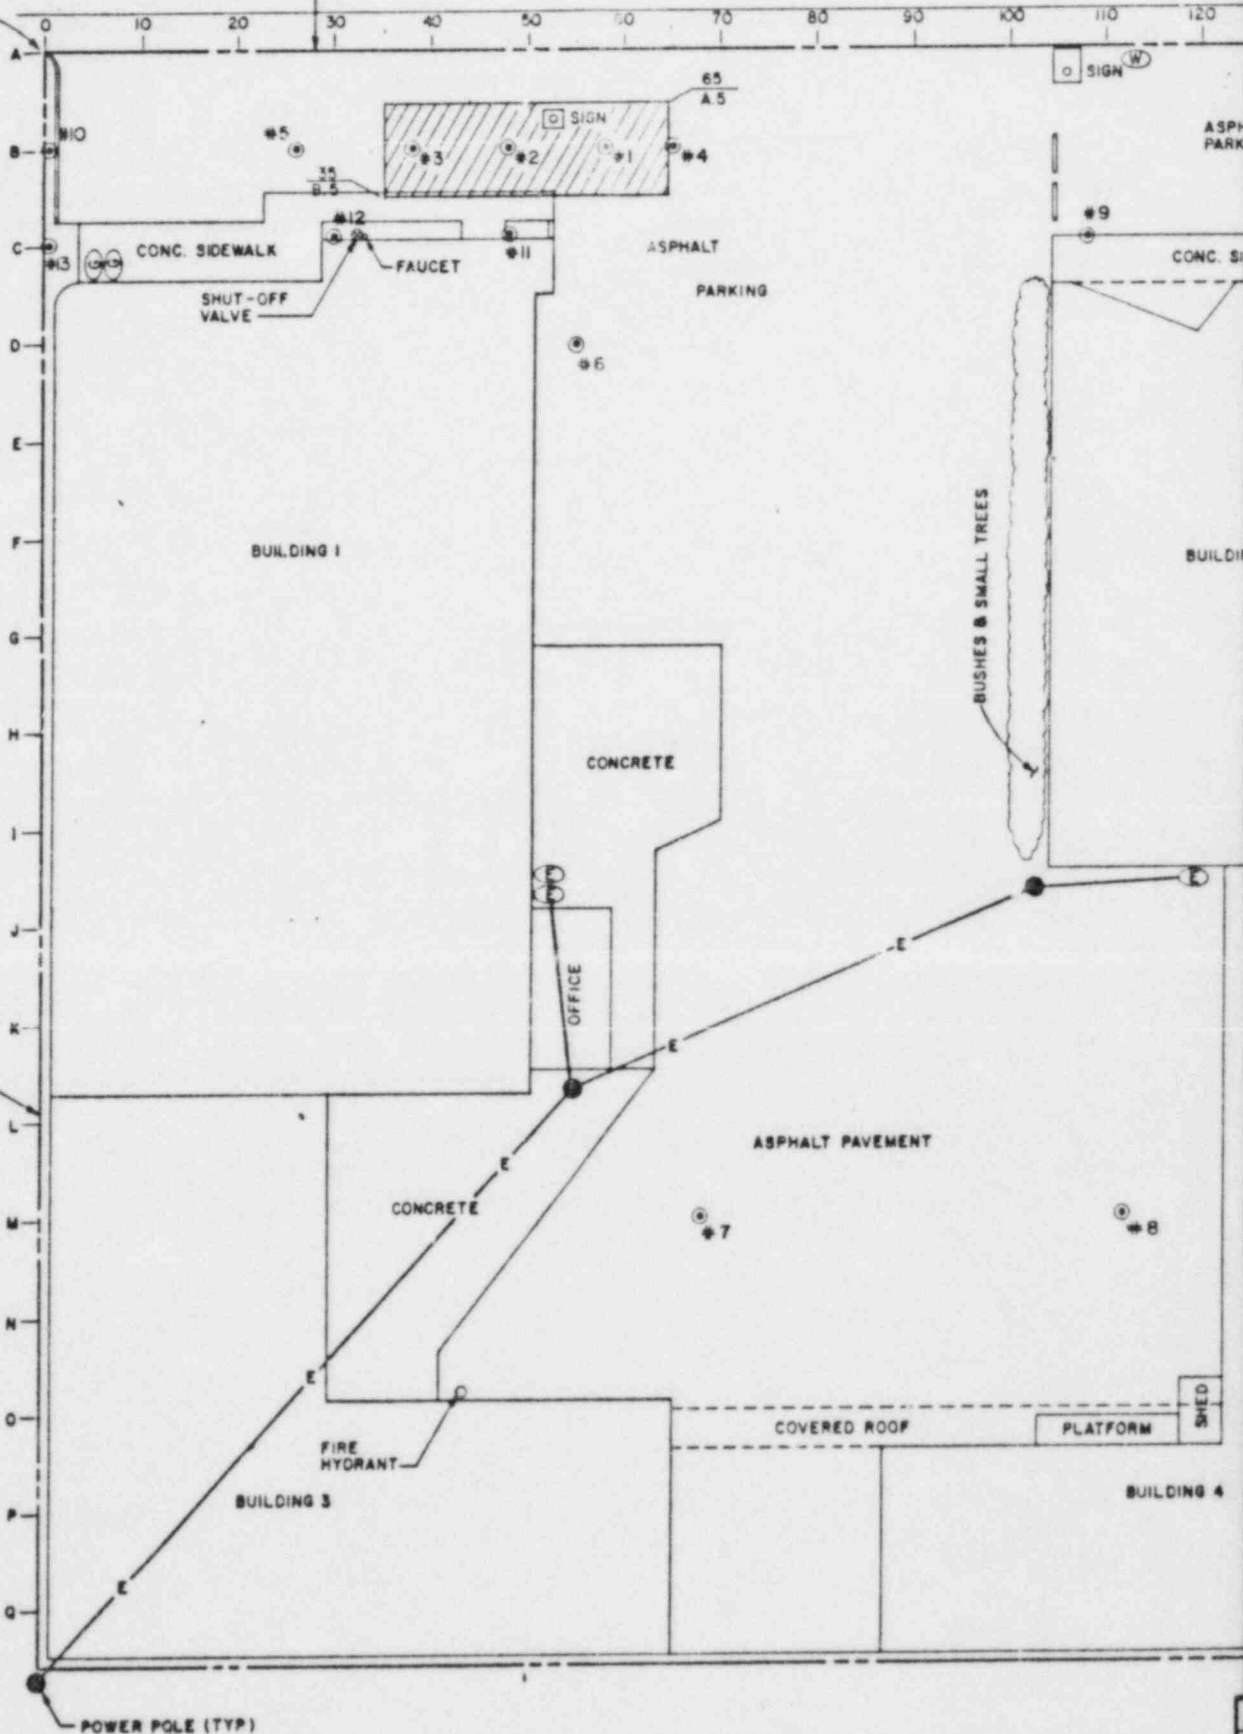
FIGURE 3.1

Surface gamma readings on the property, as shown in Figure 3.1, range from 11 to 38 micro R/hr (Table 3.1). This may be compared with the background for the Salt Lake City site of 8 micro R/hr.

Contamination was found in 3 of the 10 outdoor holes augered. The location and depth of the contamination is described in Table 3.2 and is shown in Figure 3.1.

There is one area of contamination on vicinity property SL-021. Borehole survey points in this area show contamination as deep as 36 inches. This area corresponds to the area identified in the inclusion survey.

HOLE	LOCATION	CONTAMINATION DEPTH
1	B+58	0-24"
2	B+48	0-18"
3	B+38	0-36"
4	B+65	--
5	B+26	--
6	D+55	--
7	M+68	--
8	M+112	--
9	C+108	--
10	B+0	--
11	C+48	--
12	C+30	--
13	C+0	--
