## LICENSEE EVENT REPORT (LER) TEXT CONTINUATION

FACILITY NAME (1)  Oyster Creek, Unit 1	DOCKET NUMBER (2)  05000219	FILE NUMBER (8)			PAGE (3)		
		YEAR	SEQUENTIAL NUMBER	REVISION NUMBER			
		84	017	01	02	OF	11

Fifteen (15) Primary Containment Isolation valves inadvertently repositioned. No violation of the Technical Specifications occurred since primary containment was not required at the time of the incident.

Subject: Oyster Creek Nuclear Generating Station  
Docket No. 50-219  
Licensee Event Report

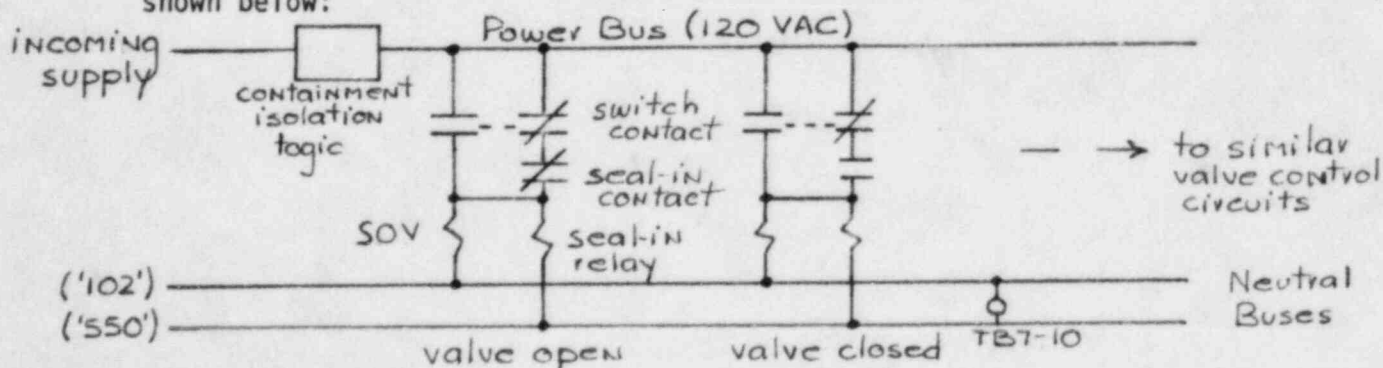
The computer tie-in previously discussed required that the neutral feed from panel 11F to panel 10F be interrupted due to the lifting of the '102' lead (11F neutral) from contact 10 of Terminal Board '7' (TB7-10) in panel 11F. The other contact on TB7-10 remained connected to the 10F neutral bus (referred to as the '550' neutral string). Since the '550' neutral string was disconnected from the panel 11F neutral, it was now possible for a voltage potential to develop between the two neutrals. As a result of a containment isolation switch relay modification conducted in 1981, the basic valve control circuit consisted of an SOV connected to the 11F neutral ('102') in parallel with a seal-in relay connected to the 10F neutral ('550'), as shown below:

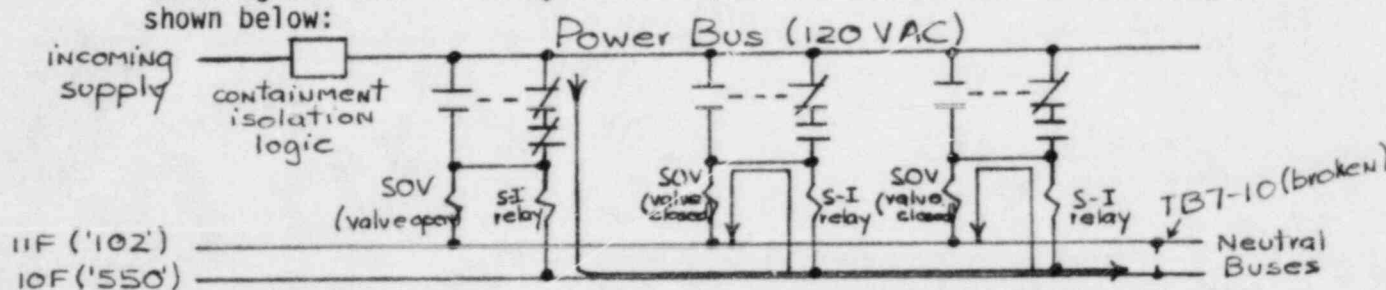
A total of 18 containment isolation valves (including MSIVs) have seal-in relays connected to the '550' neutral string. During normal operation with the valve open, the seal-in relay and SOV are energized. The seal-in contact is held shut by the energized seal-in relay. When power is interrupted to the control circuit, the SOV and seal-in relay de-energize, and the valve closes. Since the seal-in contact is now open, restoration of power will not cause the valve to automatically re-open. (The operator must place valve control switch to the 'open' position.) This was the intent of the 1981 control circuit modification. There is only one connection between the '102' bus and the '550' neutral string. This occurs at TB7-10. If the connection at this point is interrupted, an abnormal current flowpath can result from an energized seal-in relay (valve open) through a de-energized seal-in relay and SOV (valve shut) to the 11F neutral, as shown below:

This occurs due to the fact that the '550' neutral is 'floating' with respect to the 11F neutral once the TB7-10 connection is broken, and the current flow seeks a neutral (11F) through a seal-in relay and SOV in series. If sufficient voltage drop occurs across the seal-in relay for a closed valve, (determined by the number of valves initially open) the seal-in relay will energize. This shuts the seal-in contact for the closed valve, which allows full bus voltage to be applied across the SOV, resulting in the opening of the valve. Since the seal-in relays for all 18 valves are connected to the '550' neutral, all valves will open when the threshold voltage drop across their seal-in relays is reached. This theory explains the phenomena which occurred during the computer point termination on the day of the event.
