U.S. NUCLEAR REGULATORY COMMISSION

Report No. 50-461/96004(DRP)

Clinton Power Station

Special safety inspection of the circumstances involved in the partial loss of offsite power and subsequent reactor scram event on April 9, 1996.

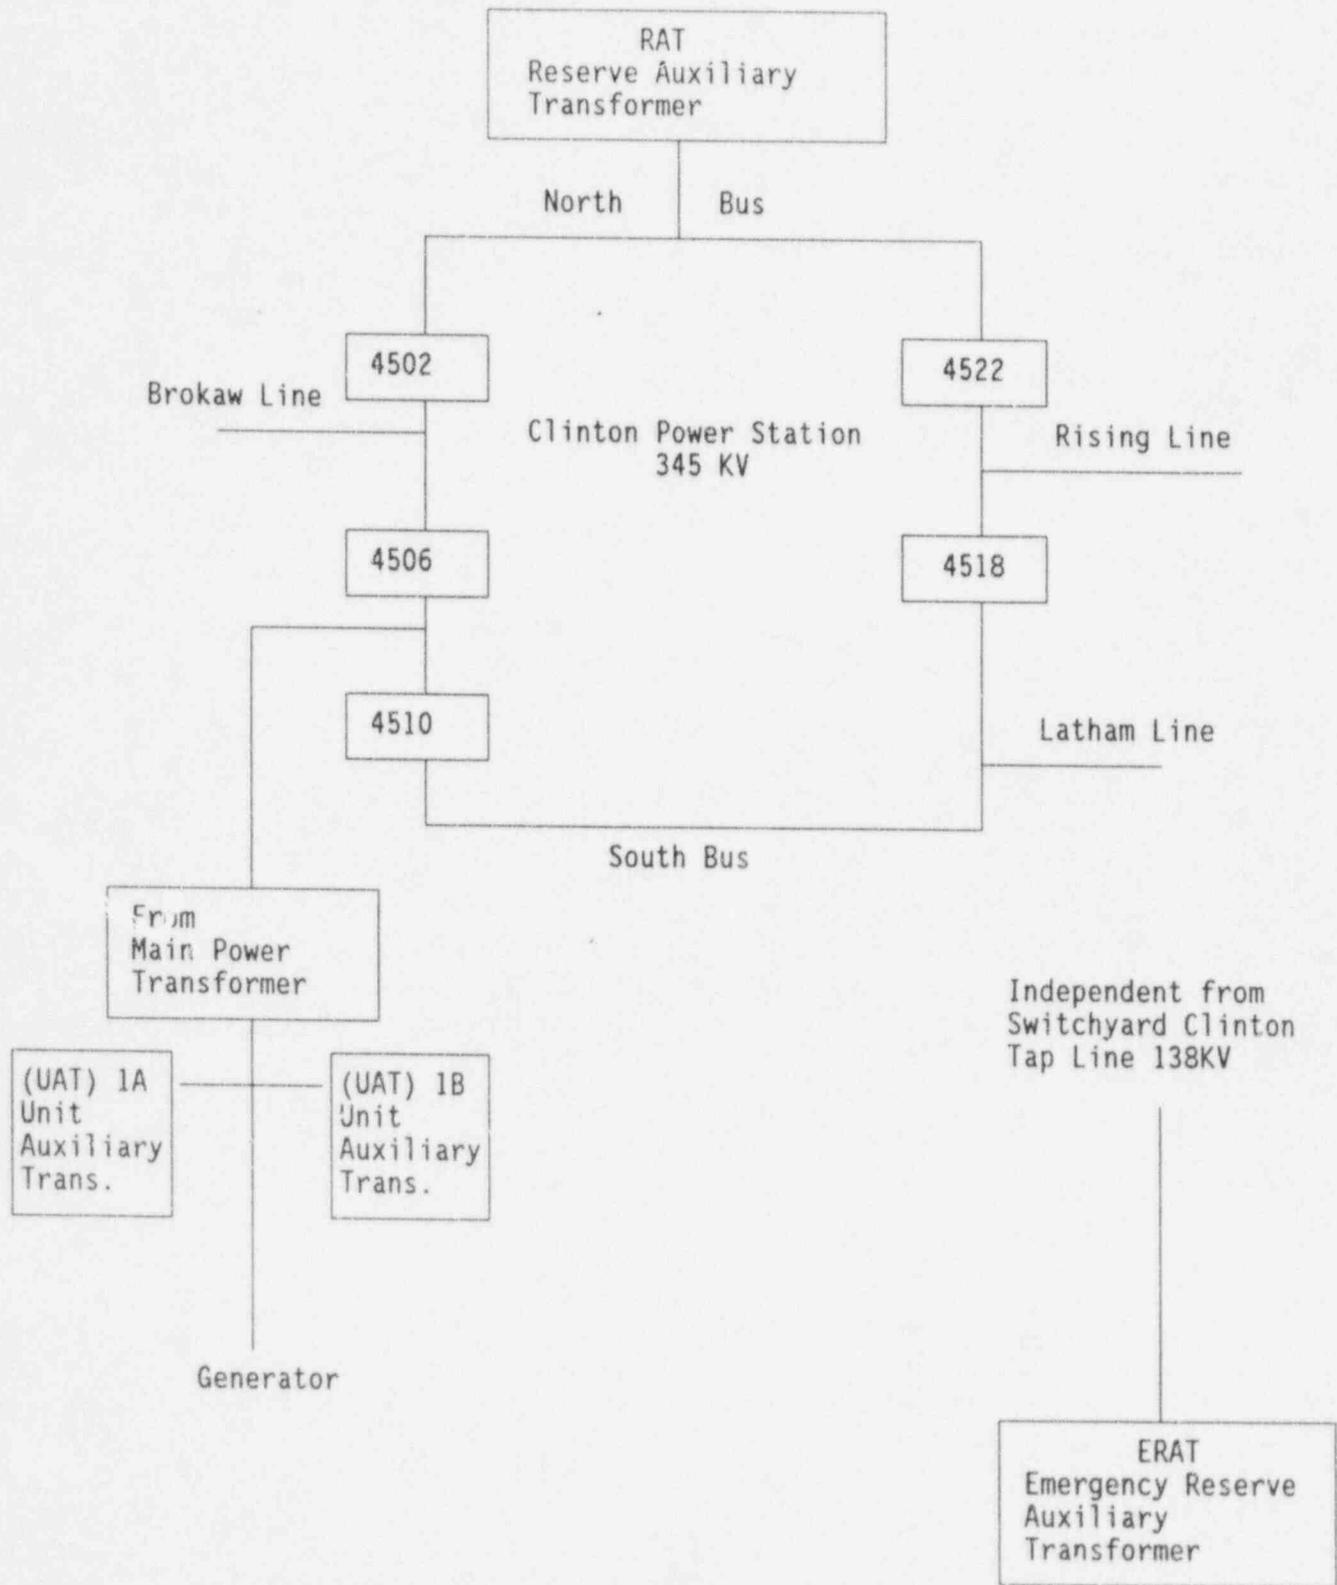
Because the breaker poles could move independently, the breaker's protective logic specifically monitored the alignment of the three poles as one logic condition. The other logic conditions were low insulating gas pressure or low hydraulic pressure. As part of the breaker PM, both of these systems were depressurized. As Electrical Maintenance personnel moved the phase "C" pole, per the vendors guidance, a pole disagreement condition as generated and a pole disagreement contact closed in the breaker's protective relay logic. With the low insulating gas pressure and low hydraulic pressure relay contacts already made up, the pole disagreement caused the GCB4522's local breaker failure relay to energize. This actuation sent a trip and lock out signal to the adjoining breakers of GCB4522 (see attached sketch). GCB4502 and GCB4518 tripped and locked open. Since GCB4522 was already open, the RAT was de-energized.

Additionally, the licensee assumed that electrical current was required for the local breaker failure relay to actuate. Although true for all other switchyard breakers, GCB4522 did not require current to be available in order to actuate the local breaker failure relays.

EM manually stroked the linkage for phase "C" of the breaker as part of the PM. This action generated a pole disagreement condition with phases "A" and "B." Since the breaker's hydraulic system was already depressurized and the SF₆ gas drained, the breaker's protective logic was met. The logic activated the local breaker failure relay for breaker GCB4522 and caused breakers GCB4502 and GCB4518 to trip and lock open. With breaker GCB4522 open for maintenance, the opening of GCB4502 de-energized the RAT causing an immediate undervoltage condition on the safety-related (SR) busses. (See attached sketch of switchyard)
