Subject: Clinton Power Station - Unit 1  
Licensee Event Report No. 96-004-00

FACILITY NAME (1) Clinton Power Station		DOCKET NUMBER (2) 05000461	PAGE (3) 1 OF 8
--	--	-------------------------------	--------------------

TITLE (4)  
Inadequate Job Preparation for a Preventive Maintenance Task on a Switchyard Breaker Causes Main Steam Line Isolation Valve Closure and Reactor Scram

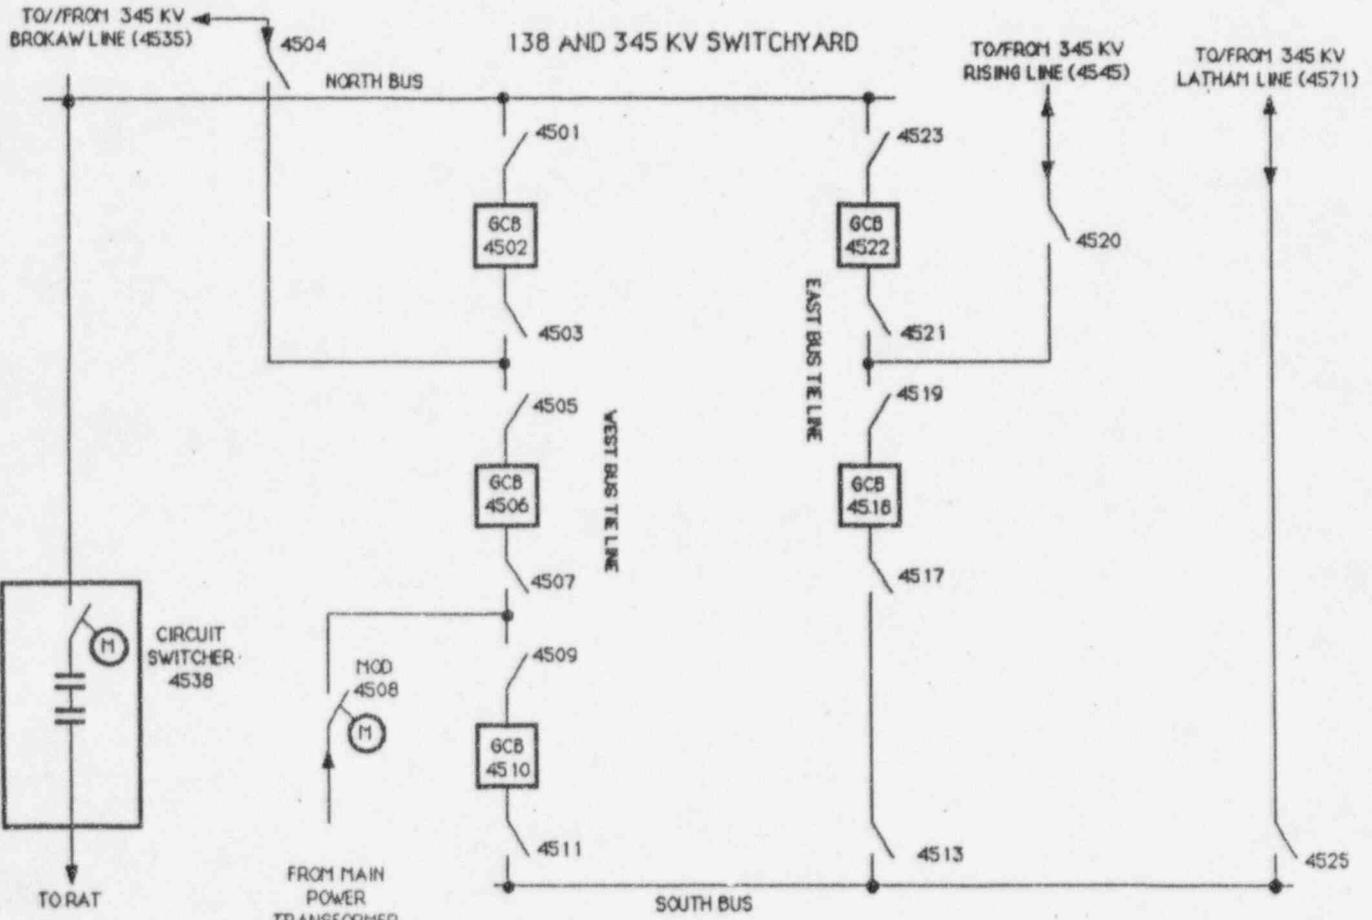
Figure 1  
Clinton Power Station  
Switchyard Schematic

GCB 4522 is in one of the two electrical supply paths that connect the plant's north bus to the south bus. The north bus supplies power to the reserve auxiliary transformer (RAT) [XRFM]. The RAT is the normal offsite power supply to the plant's safety-related power buses [BU]. The RAT also provides offsite power to the balance of plant electrical buses when the unit is not on-line. A one line diagram of the CPS switchyard [FK] is provided as Figure 1 of this report.

At about 1331 hours, utility electrical maintenance personnel moved the "C" phase pole of GCB 4522 so that the breaker contacts could be visually inspected. The protective relaying for GCB 4522 is designed so that if there is low insulating gas pressure or low hydraulic pressure in GCB 4522 and all three poles in the breaker are not in the same position (pole disagreement), a protective relaying scheme is actuated. When the "C" phase pole was closed, the conditions necessary to actuate the protective relaying scheme were met since the insulating gas, and hydraulic pressure were removed earlier from GCB 4522 and all three poles were not in the same position (pole disagreement). The protective relaying scheme for GCB 4522 sent a signal for GCB's 4502, 4518, and a breaker at the Rising substation, which is outside the CPS switchyard, to trip. The tripping of GCB 4502, in conjunction with GCB 4522 being out of service, caused the RAT to lose power. The electrical maintenance personnel in the switchyard heard GCB 4502 trip. They left the "C" phase pole closed and went to the relay house to help determine what caused GCB 4502 to trip. They did not believe at that time that the work that they were performing on GCB 4522 could have caused breaker 4502 to trip and interrupt power to the RAT. The loss of power to the RAT

The design of the breaker failure logic for GCB 4522, which caused the interruption of power to the RAT, is significantly different than the other GCB's in the Clinton Power Station (CPS) switchyard. One difference is that the breaker failure logic for the other GCB's in the switchyard require current to be flowing through the breaker to cause it to actuate. GCB 4522 does not require current flow through the GCB for the trip to occur when the breaker has low insulating gas pressure, or low hydraulic pressure and one of the three poles is not in the same position (pole disagreement).

After this event the breaker failure relay logic for GCB 4522 was isolated to prevent any impact from this logic on the plant during the preventive maintenance task. A system impact matrix was added to preventive maintenance task PEMS004 to ensure that all of the potential impacts for performing this task have been identified.
