UNITED STATES  
NUCLEAR REGULATORY COMMISSION  
WASHINGTON, D. C. 20555

Carolina Power and Light Company  
ATTN: J. A. Jones  
Senior Executive Vice President  
and Chief Operating Officer  
411 Fayetteville Street  
Raleigh, NC 27602

This refers to the inspection conducted by members of the USNRC Region II staff from April 26 to May 16, 1980, of activities authorized by NRC Operating License Nos. DPR-71 and DFR-62 for the Brunswick facility.

RESPONSE TO NOTICE OF VIOLATION - IMPROPER DISPOSAL OF RADIOACTIVE MATERIAL

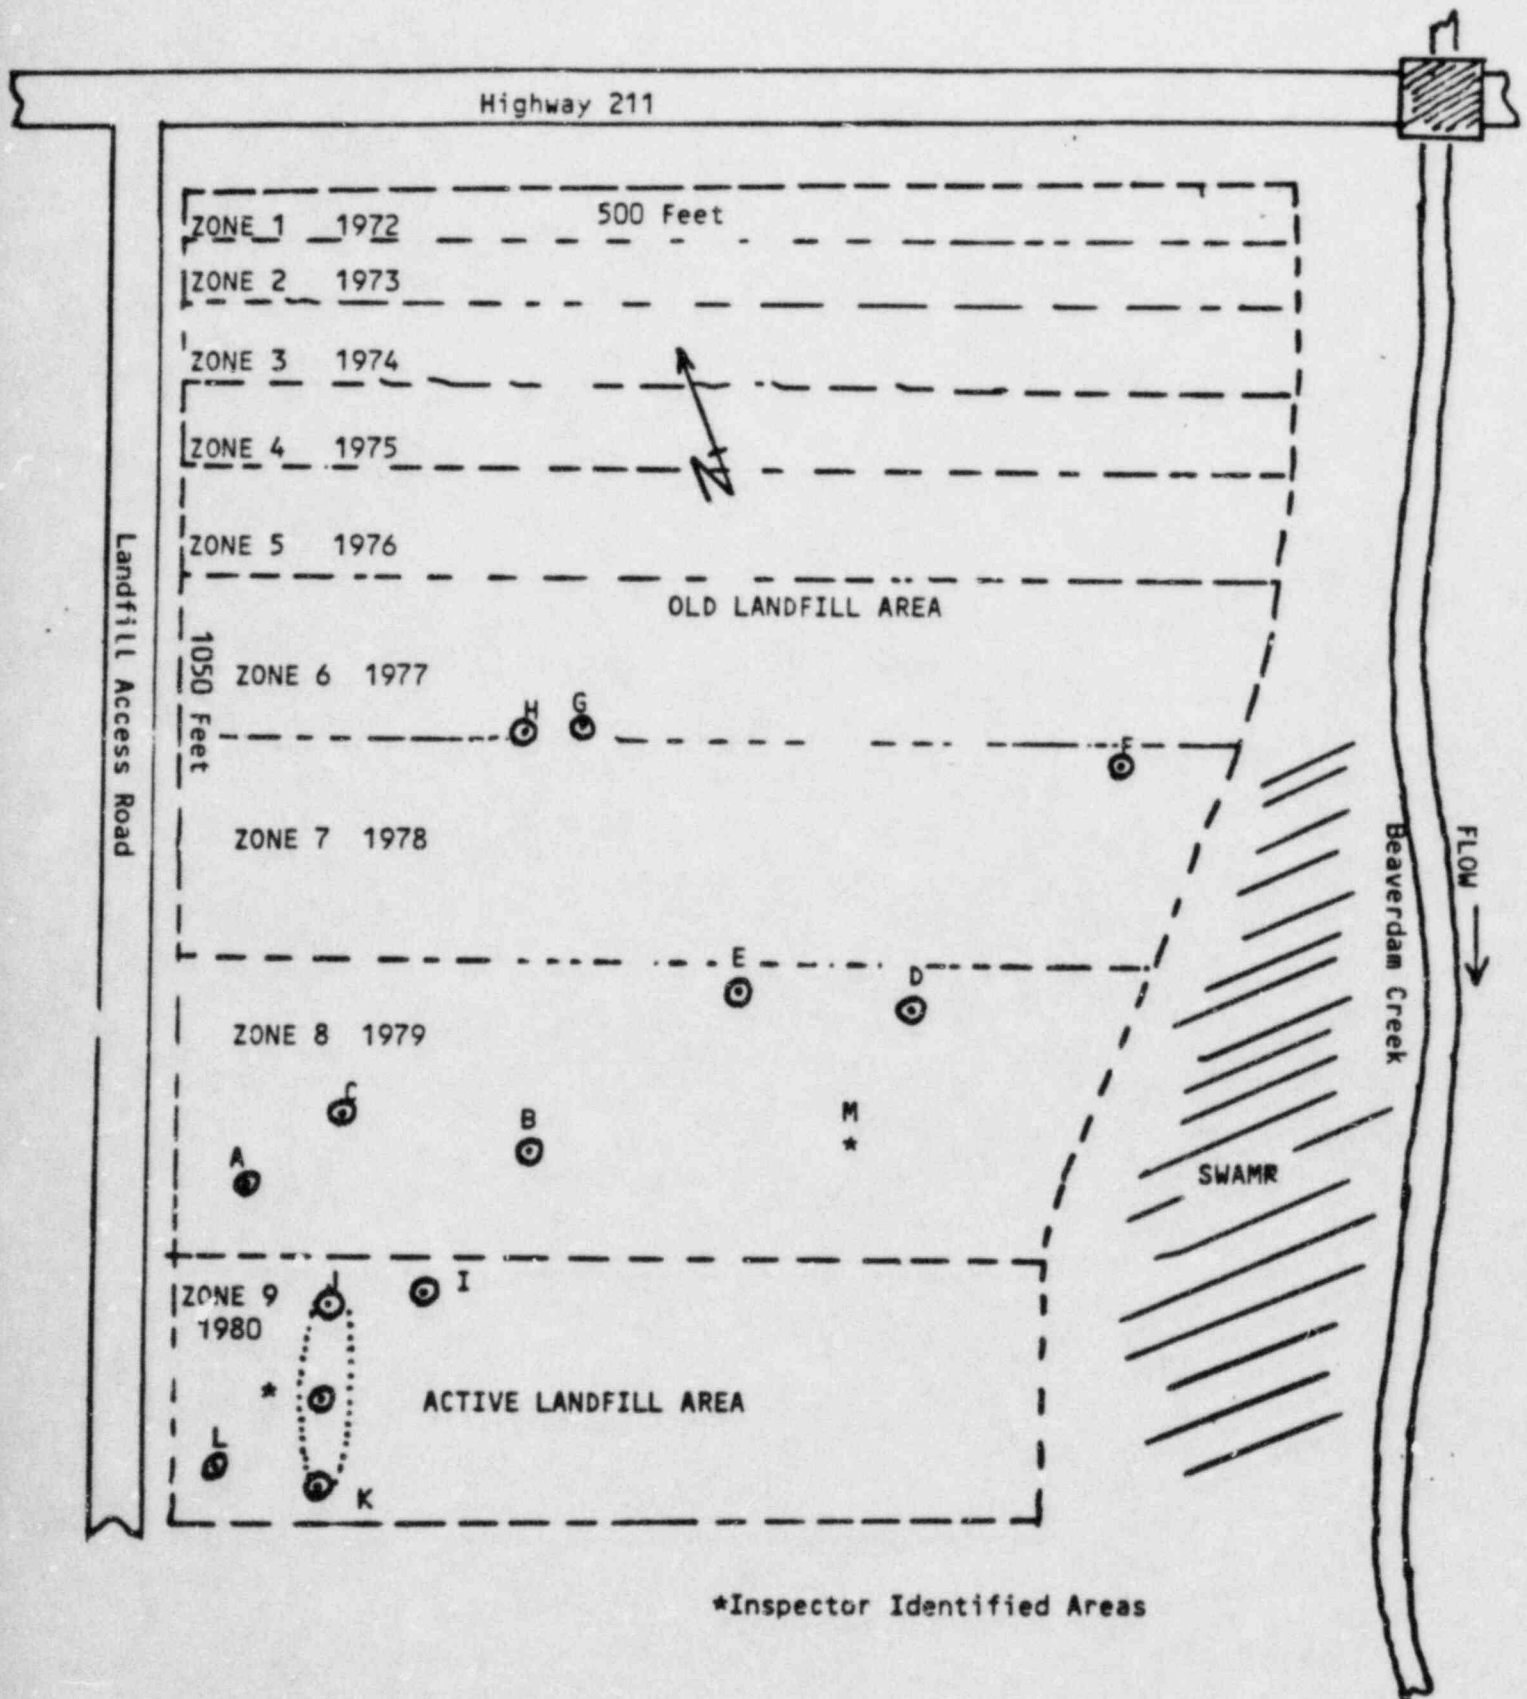
Figure 1

Sketch of Brunswick County Southport Landfill  
With Initial Survey Points Identified
