UNITED STATES
 NUCLEAR REGULATORY COMMISSION
 REGION II
 101 MARIETTA ST., N.W., SUITE 3100
 ATLANTA, GEORGIA 30303

This refers to the inspection conducted by members of the USNRC Region II staff on March 10-14 and March 29 - April 3, 1980, of activities authorized by NRC Operating License Nos. DPR-71 and DPR-62 for the Brunswick facility.

Inspection Report Nos. 50-325/80-12
 and 50-324/80-11

Facility Name: Brunswick

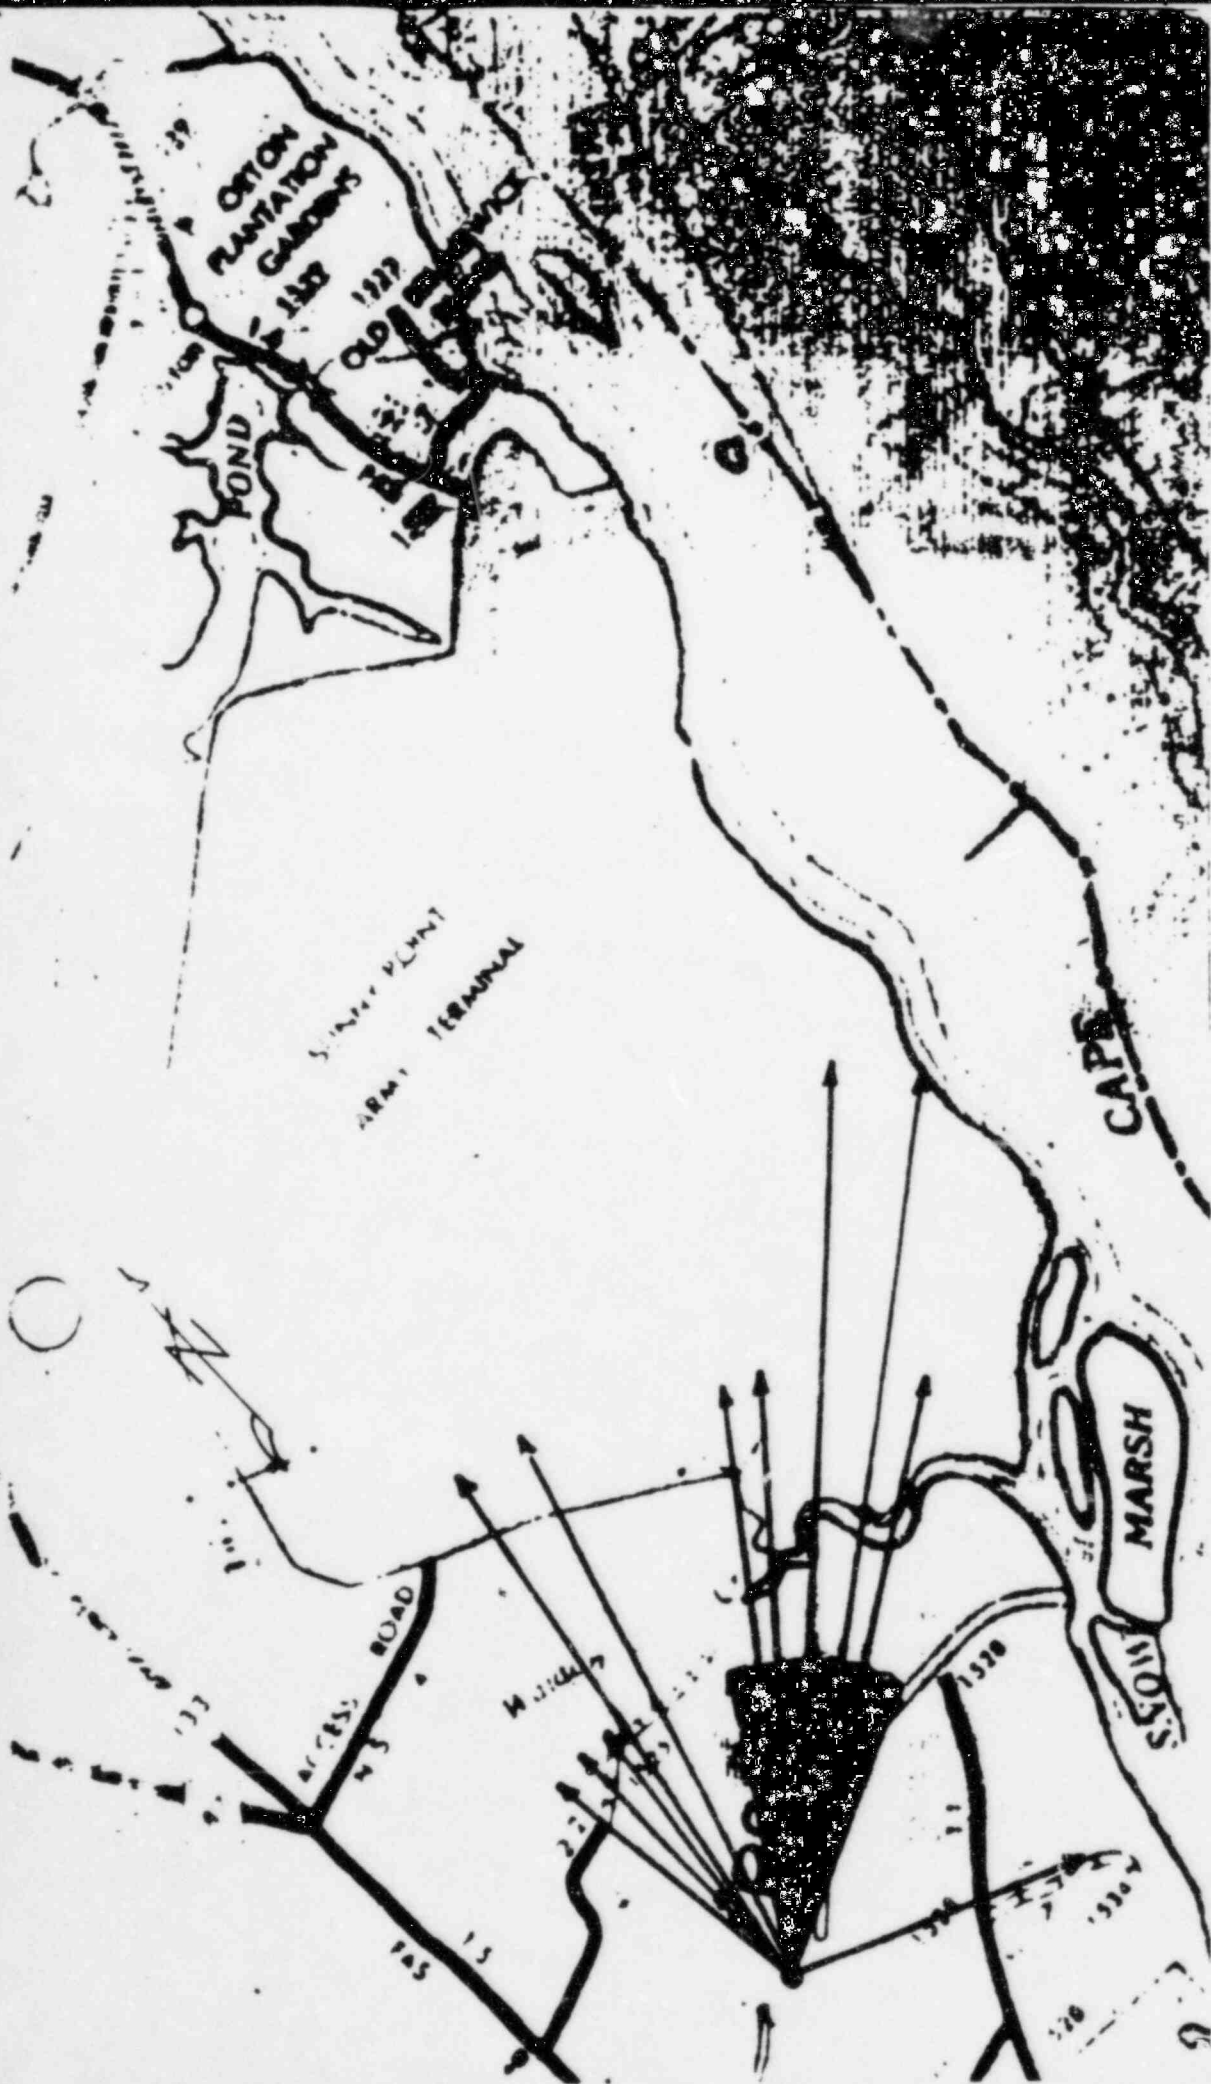
- b. Since the samples taken from February 22 to April 4 were only terrestrial vegetation, the inspector reviewed these levels against previous background samples. As shown in Table III.1 and Figure III.1, the levels of activity were elevated by a maximum factor of 164 onsite and 51 offsite (9 miles NE at Snow's Cut). However, the licensee acknowledged that the effects of rain and snow (noted in Figure III.1) would act to "wash off" the activity from the pine needles. Table III-2 shows the amount of precipitation, measured by the National Oceanic and Atmospheric Administration, at Wilmington, North Carolina. Currently, there are no studies or documentation available to determine the "retention factor" of pine needles.
