Houston Lighting & Power South Texas Project Electric Generating Station P. O. Box 289 Wadsworth, Texas 77483

May 31, 1996
ST-HL-AE-5377
File No.: G09.16
10CFR50.55a

South Texas Project
Units 1 & 2
Docket Nos. STN 50-498 & STN 50-499
Request for Relief from ASME Boiler and Pressure Vessel Code,
Section XI Requirements (Relief Request RR-ENG-14)

**REQUEST FOR RELIEF FROM ASME BOILER AND
PRESSURE VESSEL CODE, SECTION XI REQUIREMENTS
(RELIEF REQUEST RR-ENG-14)**

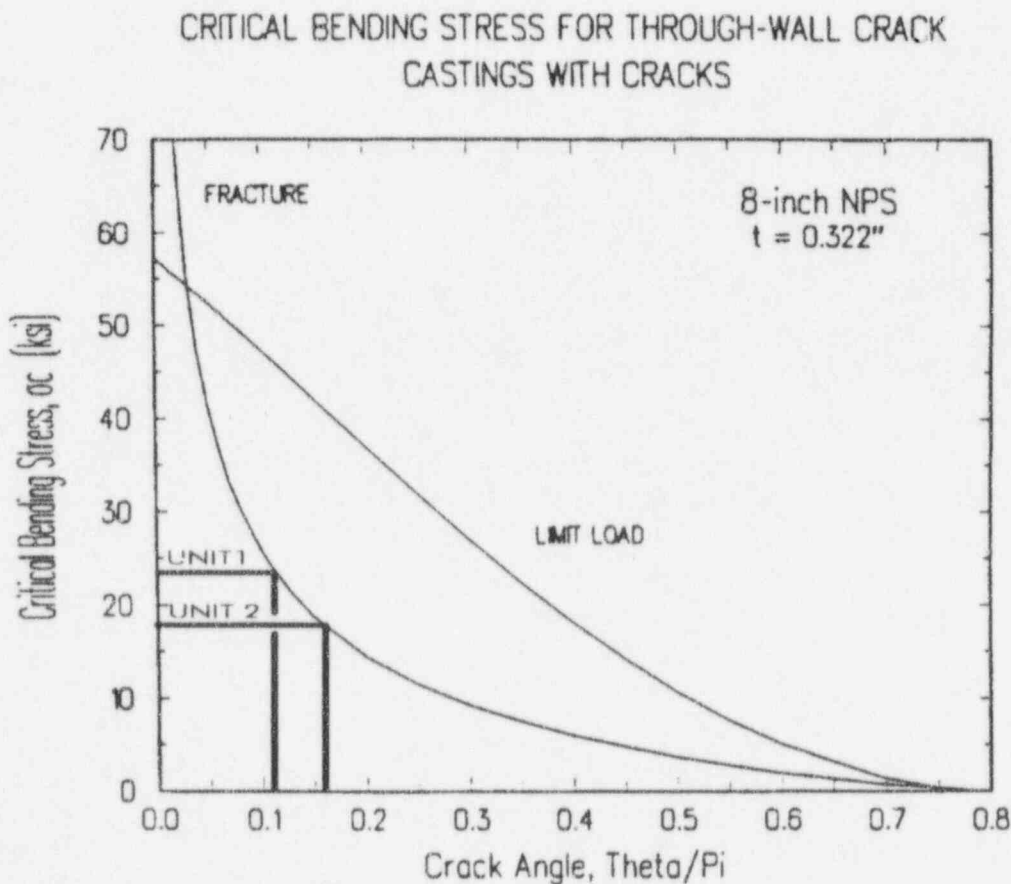
Critical Bending Stress for 8-Inch Nominal Pipe Size Castings With Cracks.

As shown above, linear elastic fracture mechanics provides the more limiting analysis for the crack angle to be analyzed; therefore, only the detailed linear elastic fracture mechanics were analyzed in South Texas Project Calculation CC06401 (Reference 6). In addition, since the Unit 1 flaw is bounding, and the same design stress values apply to both flaws, the presented results will only be for Unit 1.

The results of South Texas Project Calculation CC06401 (Reference 6) show that the Critical Bending Stress for fracture, σ_b^c equals 17.26 ksi. This is in agreement with the figure "Critical Bending Stress for 8" Nominal Pipe Size Casting with Cracks" shown on the previous page.
