B.5 LER No. 346/98-006

Event Description: A tornado touchdown causes a complete (weather-related) loss of offsite power

Date of Event: June 24, 1998

Plant: Davis-Besse 1

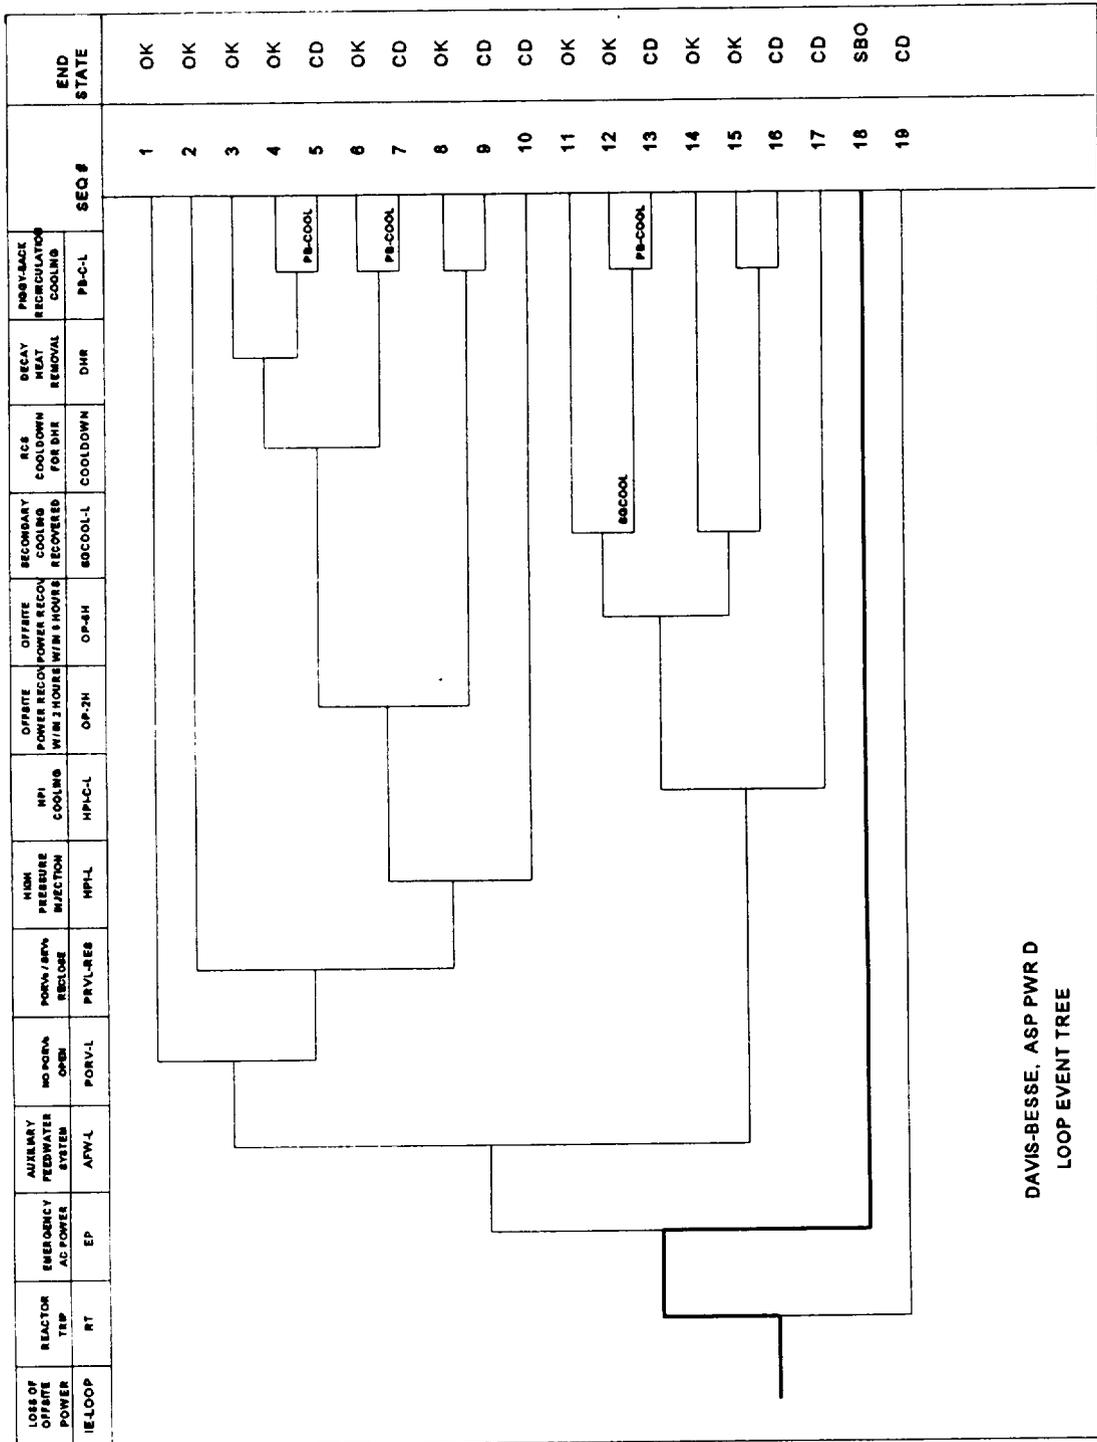
Fig. B.5.1 Dominant core damage sequence for LER 346/98-006.

The CCDP estimated for this event is 5.6×10^{-4} . All of the dominant sequences for this event involve station blackout (SBO) sequences coincident with the depletion of the batteries (sequences 18-02 and 18-11 in Fig. B.5.2), the failure of the RCP seals because offsite power was not recovered in a timely manner (sequences 18-09 and 18-18), or a PORV sticking open with the failure to recover offsite power in the short term (sequence 18-20). The dominant sequence, highlighted on the event trees in Figs. B.5.1 and B.5.2, involves a SBO sequence, LOOP Sequence 18-02:

- a LOOP,
- a successful reactor trip,
- a failure of emergency ac power,
- a successful initiation of auxiliary feedwater,
- no challenge to the power-operated relief valves (PORVs) or the safety valves,
- sufficient cooling so that the RCP seals do not fail, and
- a failure to recover offsite power before the batteries are depleted, which leads to core damage.

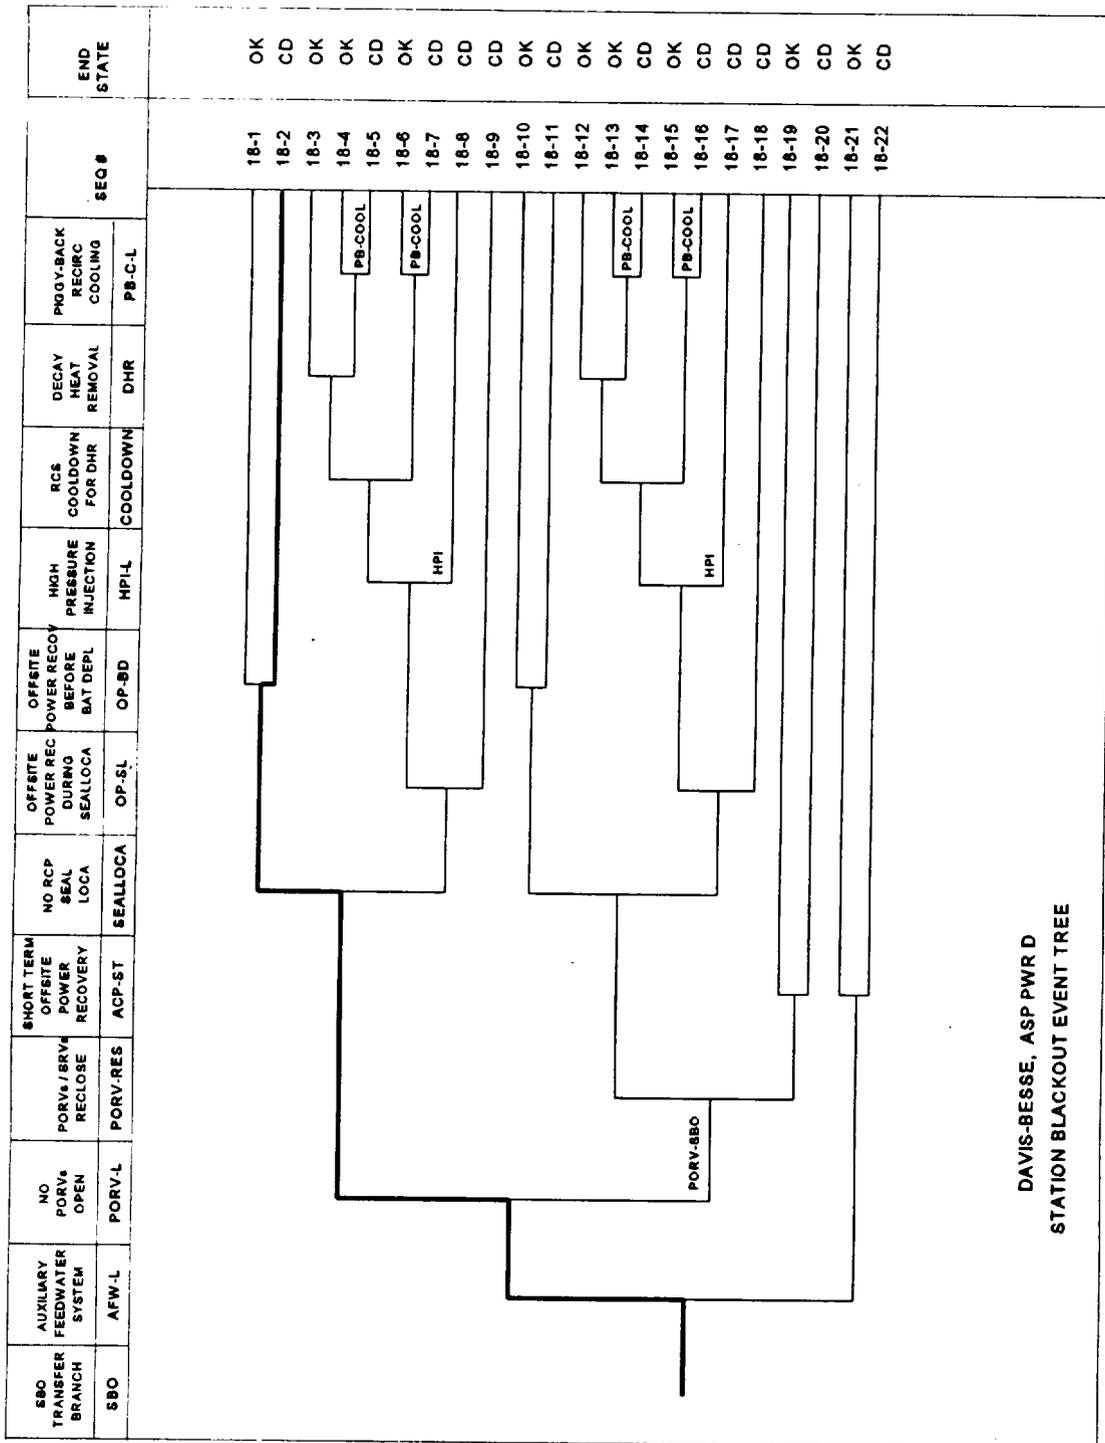
Fig. B.5.2 Dominant core damage sequence for LER 346/98-006.

The next most dominant sequences, LOOP Sequences 18-11 and 18-09 in Fig. B.5.1 and Fig. B.5.2, contribute approximately 32% and 7%, respectively, to the CCDP. LOOP Sequence 18-11 involves an SBO, the PORVs open and reclose successfully, the RCP seals do not fail, and failure to recover offsite power before battery depletion, resulting in core damage. LOOP Sequence 18-09 involves an SBO, failure to recover offsite power in the short-term, and failure to recover offsite power before a seal LOCA occurs, leading to core damage.
