TOPICAL REPORT

EXAMINATIONS OF PORTIONS OF THE REACTOR
BUILDING SPRAY SYSTEM PIPING FROM
THE ARKANSAS NUCLEAR PLANT NO. 1

February 7, 1975

Warren E. Berry, William N. Stiegelmeier,
and Walter K. Boyd

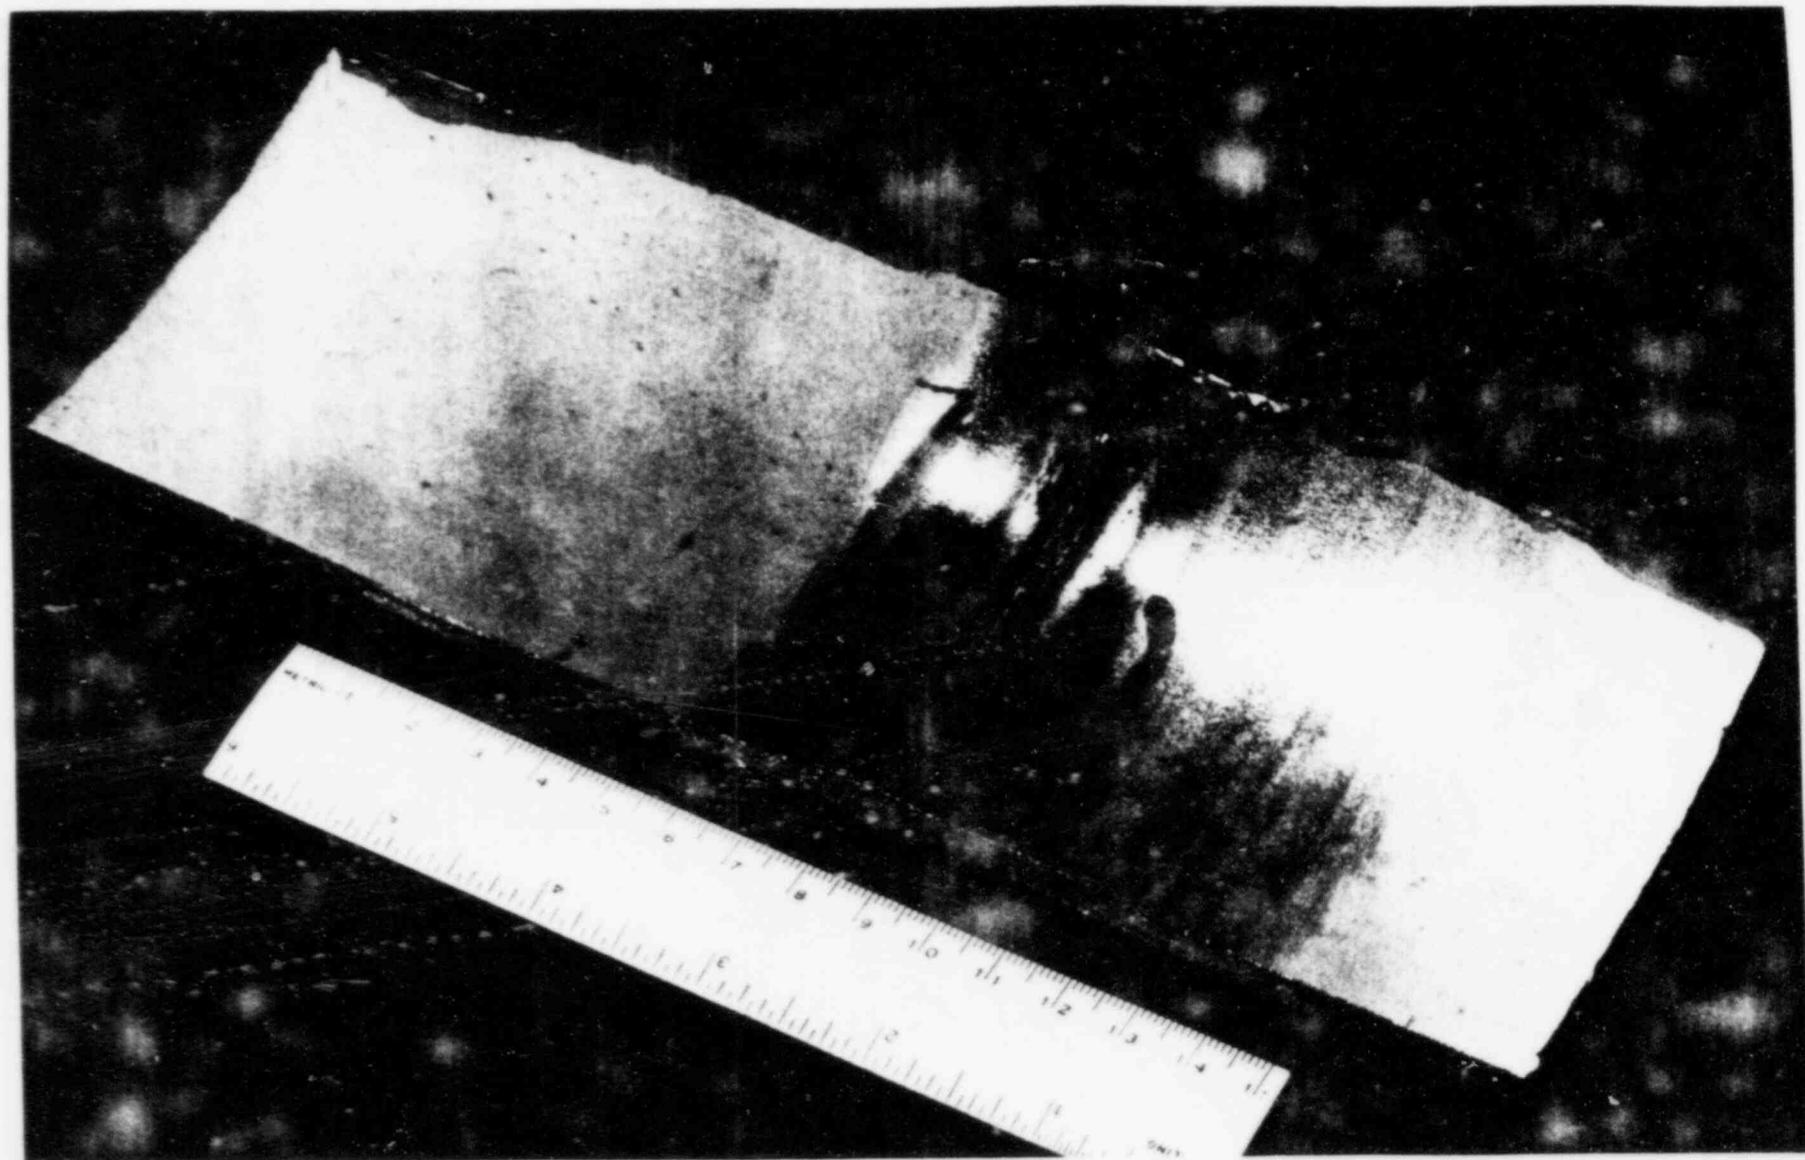
FIGURE 1. APPEARANCE OF INSIDE SURFACE OF THE NONCRACKED PIECE OF SPRAY SYSTEM PIPING AS RECEIVED AT BATTELLE

The appearance of the large noncracked piece is shown in Figures 1 and 2. On the inside of the pipe, the weld and an area about 1/8 inch wide on either side of the weld were covered with a dark brown film. A tarnish film extended outward on either side and to about 1/2 inch away from the center of the weld. Bands of deep blue tarnish were located about 3/8 inch from the center of the weld. On the OD surface, the weld bead was covered with a brown tarnish, the deep blue tarnish bands were \sim 3/8 inch from the center of the weld, and the tarnish extended about 3/4 inch from the center of the weld. Note that the pipe was wire-brushed or ground on either side of the weld, probably as part of the weld preparation.

Note the ground areas on either side of the weld and the bands of tarnish in the heat-affected zone.

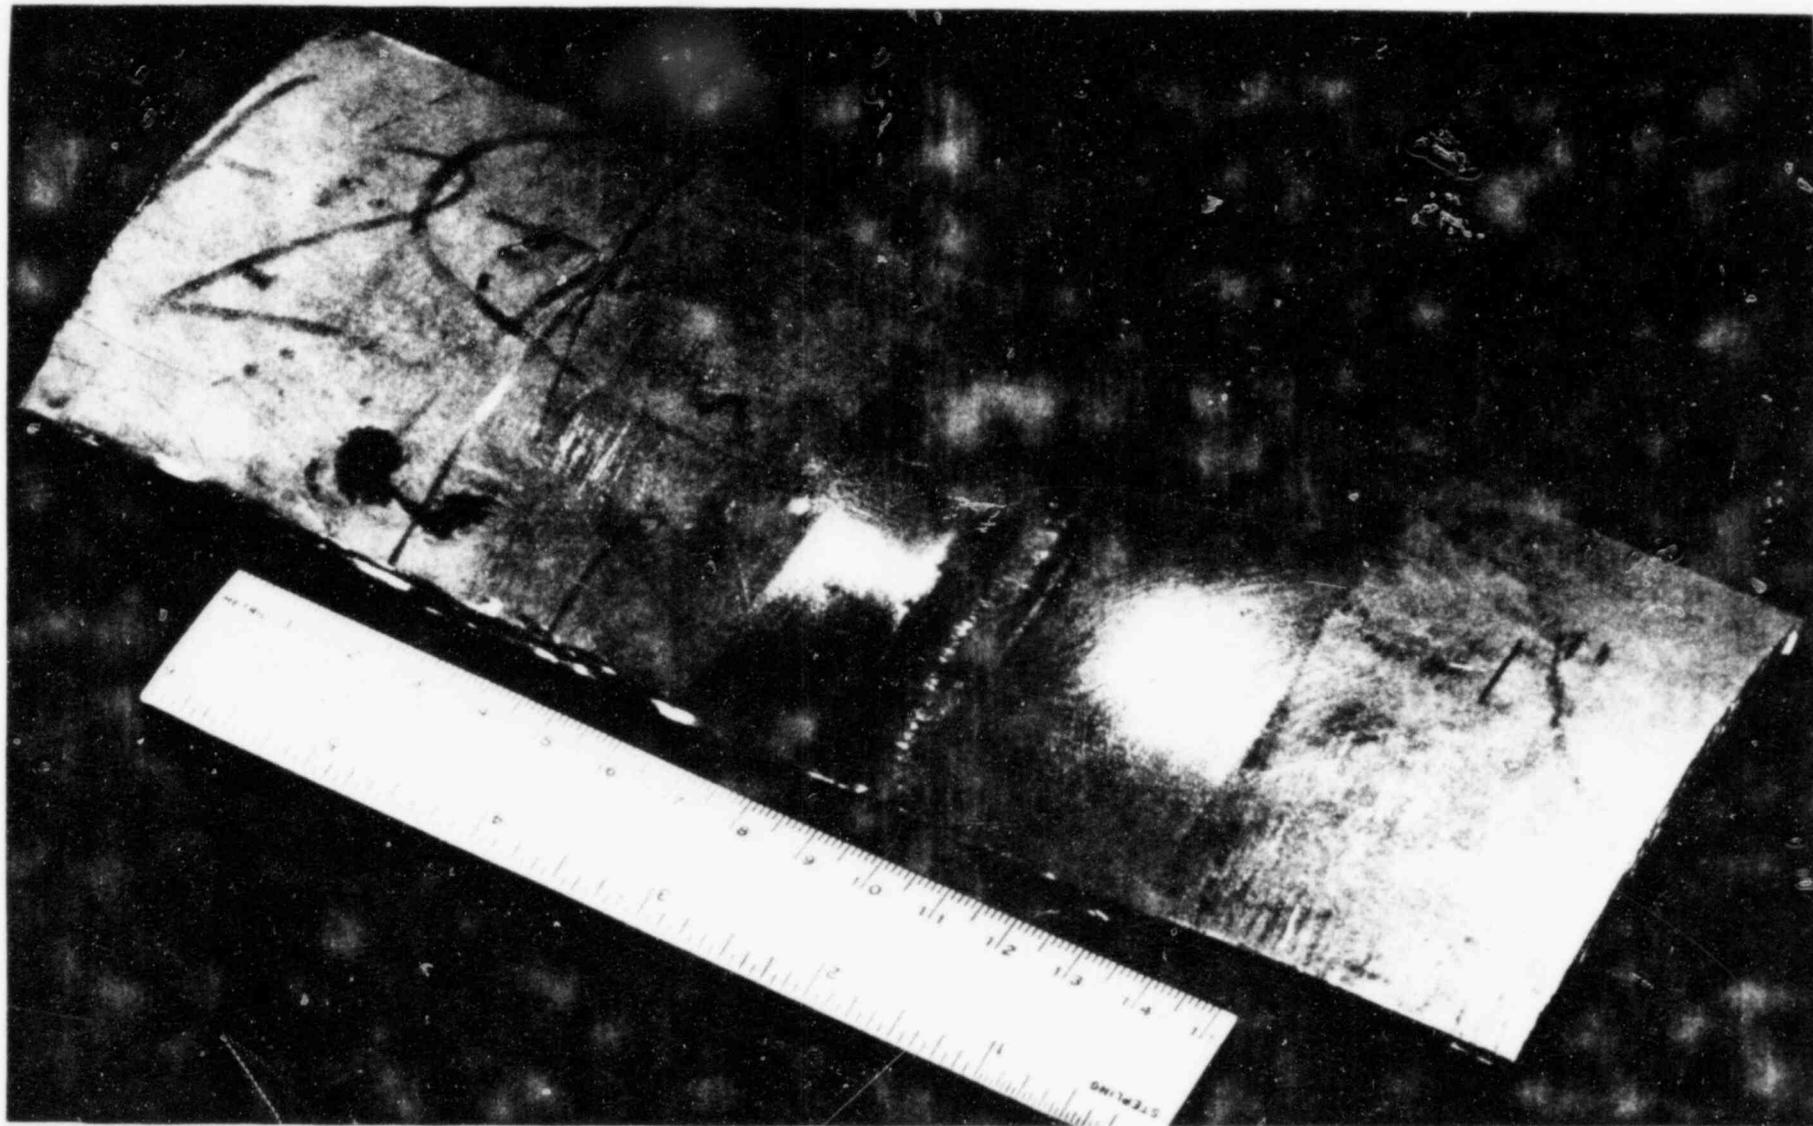
FIGURE 2. APPEARANCE OF OUTSIDE SURFACE OF THE NONCRACKED PIECE OF SPRAY SYSTEM PIPING AS RECEIVED AT BATTELLE

See Figure 1.

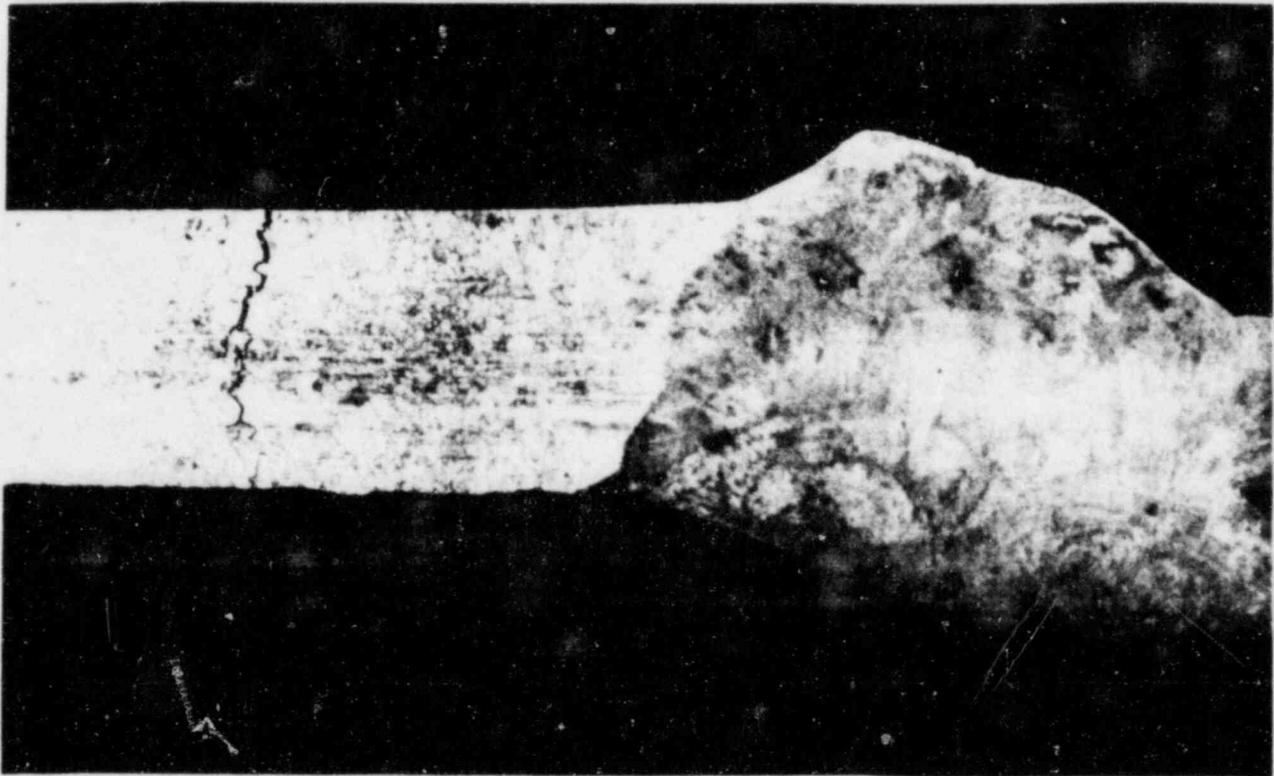
FIGURE 5. PHOTOMACROGRAPH OF ETCHED CROSS SECTION THROUGH CRACK SHOWN IN FIGURE 3

A photomacrograph is shown in Figure 5 of a cross section through the crack shown in Figure 3. The piece was etched electrolytically in 10 percent oxalic acid. If the photograph is examined closely, the sensitized portion (grain-boundary carbides) of the heat-affected zone can be seen. The crack is located near the outer edge of the heat-affected zone away from the weld. Note that the crack is wider at the inner surface and appears to be propagating from the inner surface to the outer surface.

Inside surface of pipe is at top of photograph. Note that crack propagates through the outer edge of the heat-affected zone (where grain-boundary carbides are evident in the microstructure).

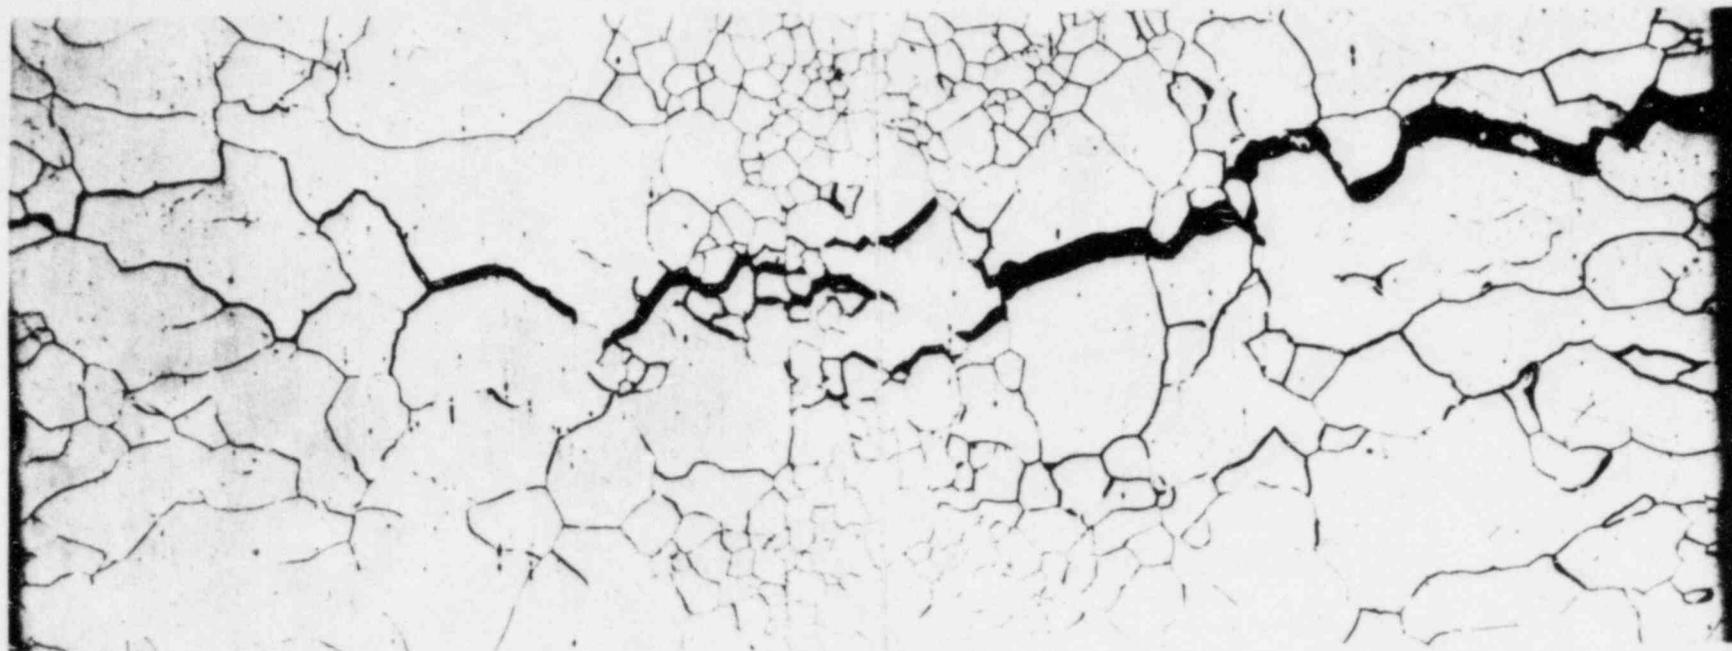
FIGURE 6. PHOTOMICROGRAPH OF CRACK SHOWN IN FIGURES 3 and 5

A photomicrograph showing the crack at higher magnification is presented in Figure 6. Note that the crack propagated at grain boundaries, but was not very branching. Based on the greater width of the crack at the inner surface and the direction of the limited amount of branching, it appears that the crack initiated on the inside surface and propagated toward the outside surface. Also note that the pattern of carbide precipitation produced large sensitized grains at the inner and outer surfaces and small sensitized grains in the center of the cross section. As will be discussed later, the crack is probably a stress-corrosion crack. This type of cracking is an electrochemical phenomenon under these conditions and, thus, large grains at the surface would create a greater tendency to initiate cracking because of the large cathode (grain)-to-anode (grain boundary) ratio.

Inner surface is at right of photograph. Note that the crack propagates intergranularly and appears to have initiated on the inside surface of the pipe. Note also that the grain-boundary carbide precipitation resulted in large sensitized grains on both surfaces and small sensitized grains in the middle of the cross section.

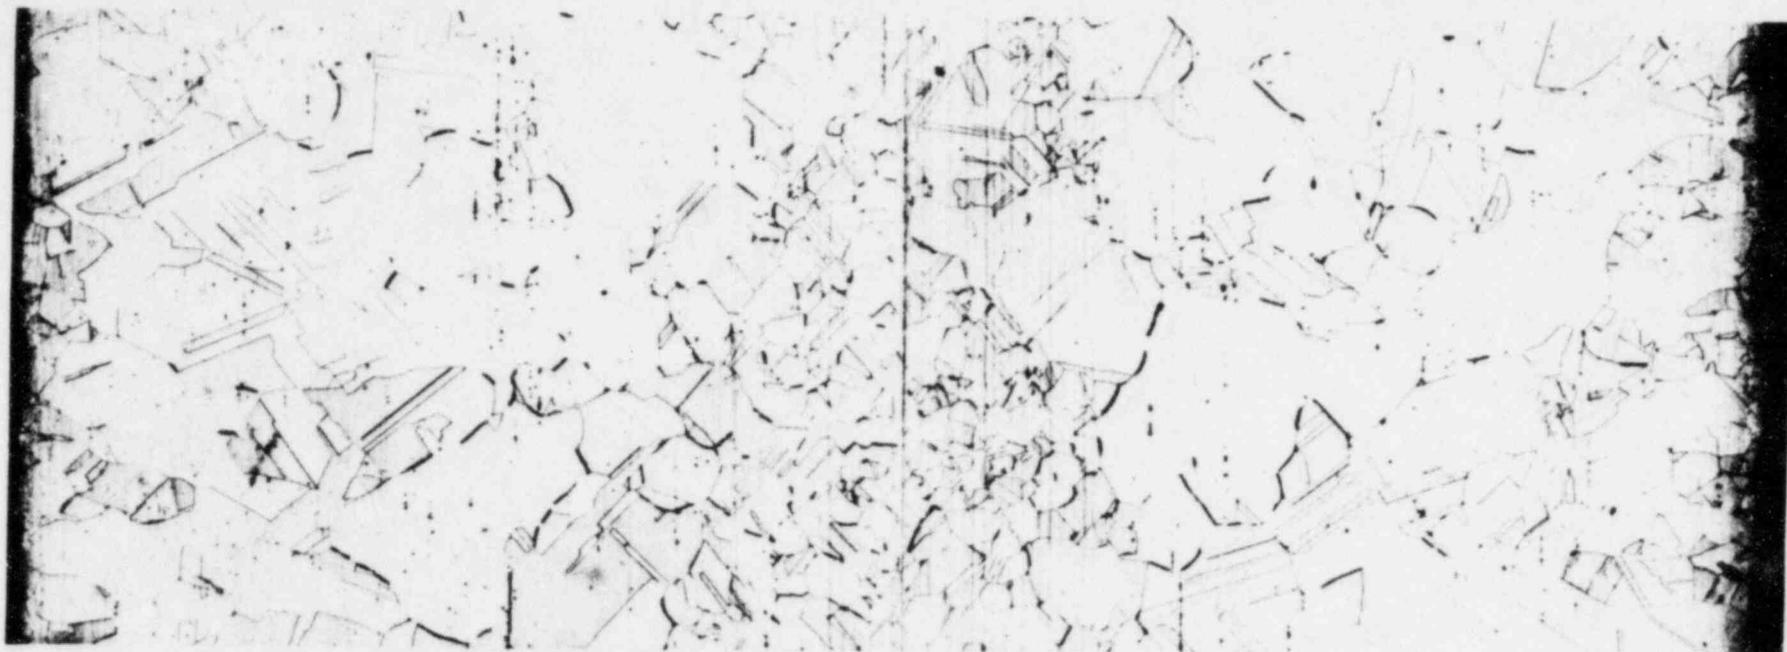
FIGURE 7. APPEARANCE OF REPRESENTATIVE CROSS SECTION OF PIPE WALL AWAY FROM WELD AREA

The microstructure of the pipe was examined in cross section along the entire length (about 5 inches) of the pieces received at Battelle. Partial sensitization (discontinuous carbide precipitation at grain boundaries) was observed in the center of the cross section of the pipe wall along the entire length. In some places, the partial sensitization extended almost to the inner and outer surfaces of the pipe wall. Examples are shown in Figures 7 and 8. Note the partial sensitization, particularly in the center of the cross section

Note partial sensitization is greater at center but also occurs near the surface in isolated areas.

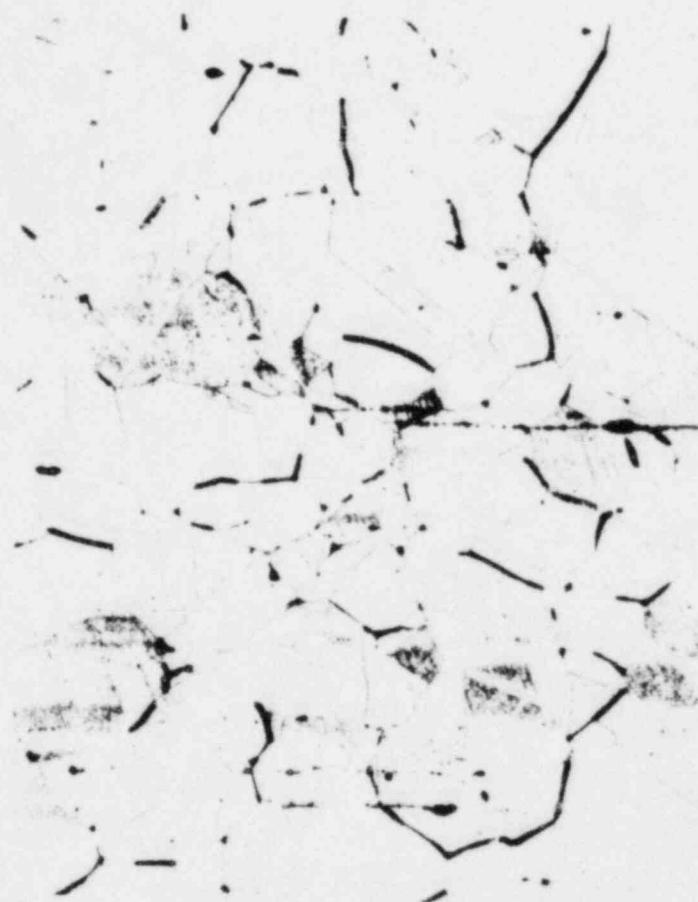
FIGURE 8. PHOTOMICROGRAPH SHOWING ENLARGEMENT OF CENTER PORTION OF TUBE WALL CROSS SECTION AWAY FROM THE WELD

Note the partial sensitization (discontinuous carbide precipitation at grain boundaries). Also see Figure 7.

and the large grains at either surface. This partial sensitization suggests that the pipe was not rapidly quenched after the final anneal at 2000 F or the center of the pipe was not heated to 2000 F. The large grains near either surface might be the result of surface heating of the sheet during the final anneal in the mill. If the sheet were severely cold-worked before the final anneal, the hotter outside surface could have recrystallized more rapidly, which would account for the large grains. Failure to reach the annealing temperature in the center of the sheet would account for the partial sensitization as well as the smaller grain size in the center of the sheet. As a check on this hypothesis, a microhardness traverse was made across the wall of the specimen. The results are summarized below.

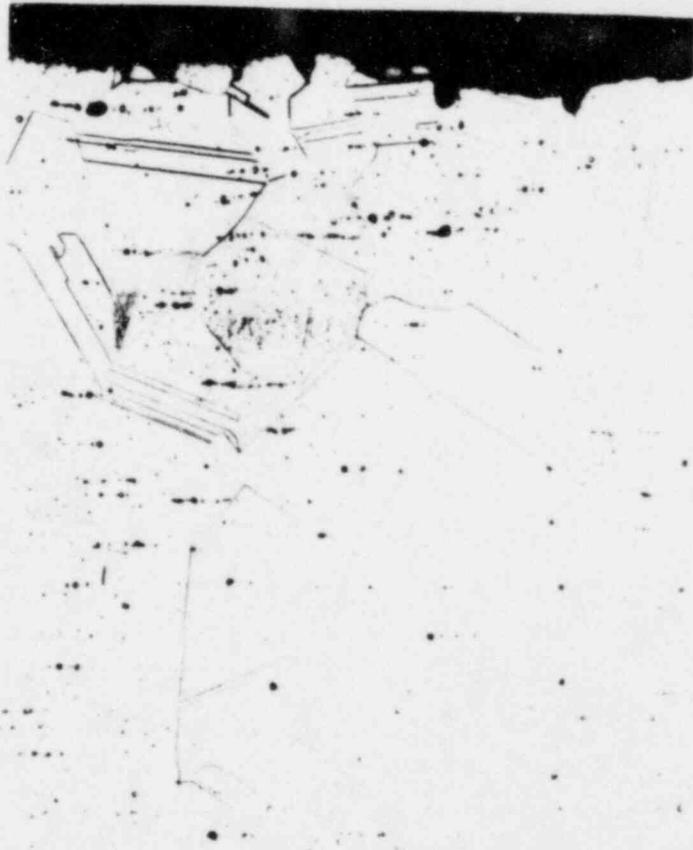
FIGURE 9. CROSS SECTION THROUGH THE INTER-
GRANULAR ATTACK NOTED ON THE
INSIDE AND OUTSIDE SURFACE OF THE
PIPE AWAY FROM THE WELD

The cross sections of the pipe wall away from the weld area also were examined for the nature of the etching attack observed on both the inner and outer surfaces of the pipe. This attack was found to be incipient grain-boundary corrosion ≈ 0.5 mil deep. An example is shown in Figure 9. As mentioned earlier, this attack probably occurred as the result of pickling to remove heat-treating

Note that the attack was only about 0.5 mil
deep and apparently occurred at grain
boundaries.

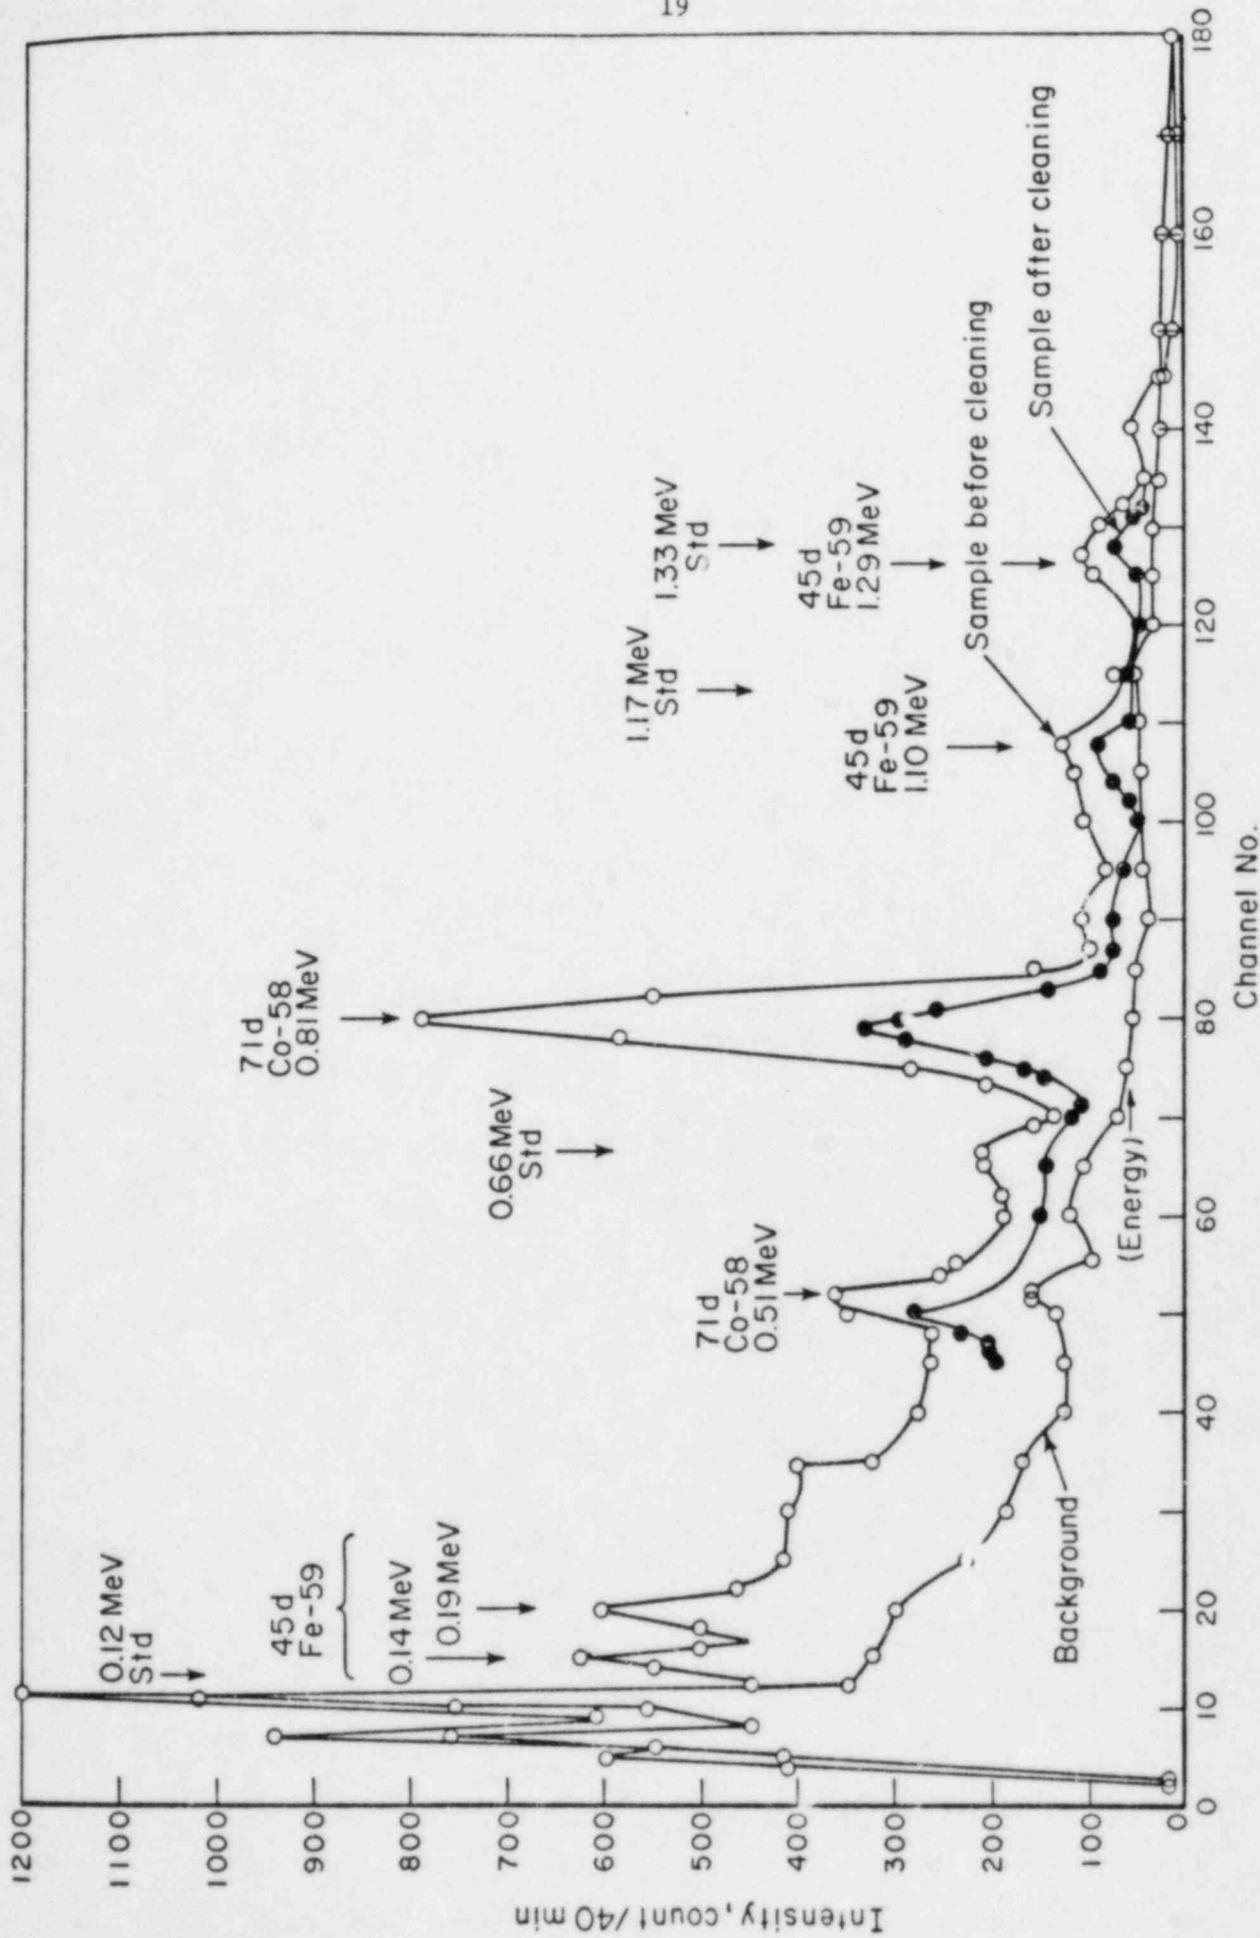
FIGURE 10. GAMMA-RAY SPECTRUM OF INNER SURFACE OF 10-INCH PIPE

Although monitoring the pipe weld sample (304 SS) with a sensitive lab monitor revealed no activity, a long time count (40.0 min) in an efficient 3 x 3-inch NaI(Tl) well crystal revealed six gamma rays as follows (see Figure 10):

There is no doubt that these activities were present when compared with the low background count. Note that no Cr 51 was detected. If the stainless piping had been activated, one would expect to find Cr 51 in the gamma spectrum.

Since no Cr 51 was found on the surface and a large percentage of the activity was removed by scrubbing, it is concluded that these elements were transported from elsewhere in the system and were deposited on the inner surface of the pipe.

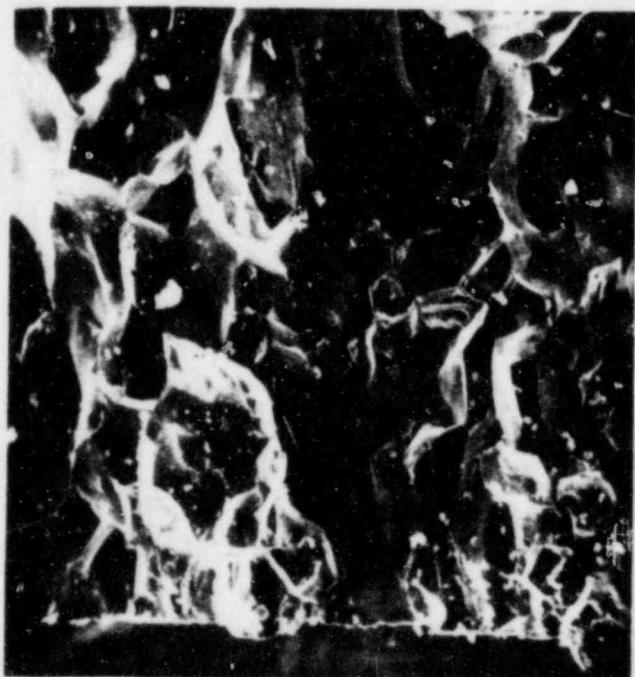
FIGURE 11. SEM PHOTOGRAPHS OF THE FRACTURE SURFACE OF THE CRACK SHOWN IN FIGURES 3, 5, AND 6

The scanning electron microscope (SEM) also was used to examine and analyze the fracture surface. SEM photographs of the fracture surface near the inner and outer surfaces of the pipe wall are shown in Figure 11. Note the "rock-candy" structure that is typical of intergranular cracking. Dispersive X-ray analyses of a spot of "debris" just left of center and at the bottom of Figure 11a (inner surface) revealed appreciable quantities of chlorine, sodium, aluminum, silicon, sulfur, potassium, and calcium as well as iron, chromium, and nickel. Analyses of other areas near the inner surface revealed the same general results except little or no chlorine was detected.

Thus, the SEM results show that the fracture surface near the initiation site (inside surface) was contaminated with chlorine, aluminum, and silicon as well as sodium, calcium, and potassium. These contaminants were largely absent where the crack penetrated the outside surface of the pipe. This distribution would be expected if contamination on the inner surface of the pipe was responsible for crack initiation.

Note the "rock-candy" structure that is typical of intergranular stress-corrosion cracking.
