UNITED STATES OF AMERICA
NUCLEAR REGULATORY COMMISSION

In the Matter of)
LONG ISLAND LIGHTING COMPANY) Docket No. 50-322(OL)
(Shoreham Nuclear Power Station,)
Unit 1))

ADDITIONAL CYLINDER BLOCK TESTIMONY OF
DR. DUANE P. JOHNSON, DR. CHARLES A.
RAU, JR., MILFORD H. SCHUSTER, DR. HARRY F.
WACHOB AND EDWARD J. YOUNGLING ON BEHALF
OF LONG ISLAND LIGHTING COMPANY

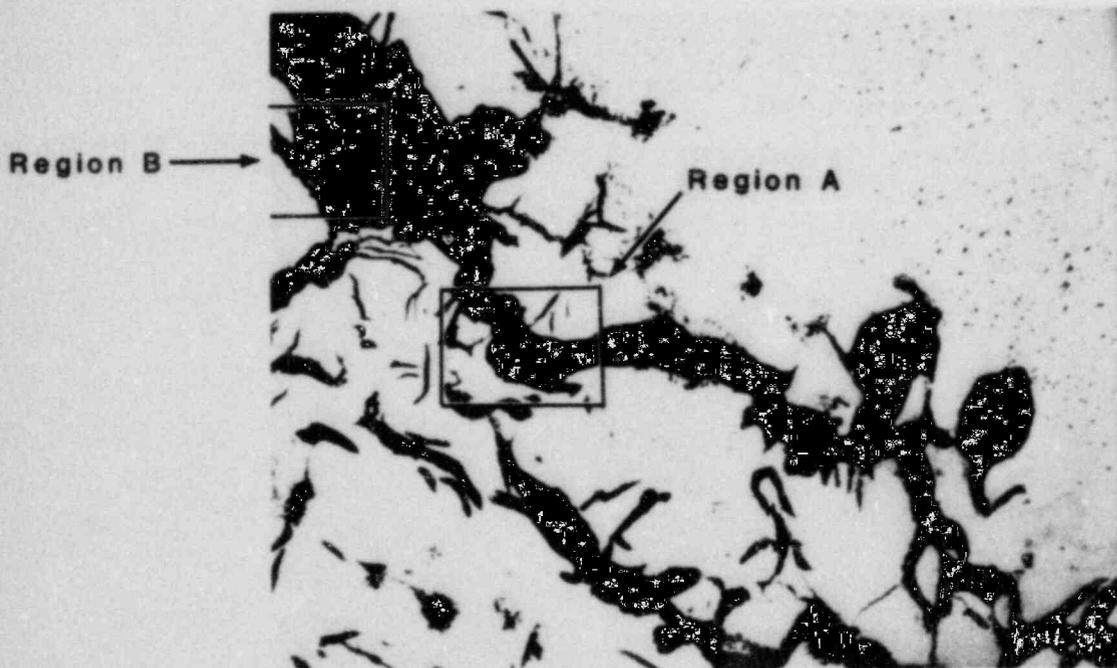
At the meeting of the parties on November 20, 1984, Lilco agreed to take additional photomicrographs of the weld shrinkage crack at 500x magnification. (See Tr. 26990-91). Accordingly, two additional photomicrographs at 550x were taken of representative areas of the weld shrinkage crack in cam gallery bearing support no. 7. These photomicrographs are attached as Exhibit B-65. The locations where these photomicrographs were taken are shown in Lilco Exhibit B-66, which is a marked-up version of County Exhibit S-4.

The 550x photomicrographs confirm what the 100x photomicrograph in County Exhibit S-4 depicted, namely that the weld shrinkage crack surface has a very thin oxide which is markedly different from the uniformly thick (0.2 to 0.5 mils), dark oxide on the contiguous casting shrinkage crack depicted

Photomicrograph of the weld shrinkage crack at face 1 of
cam saddle No. 7 of the original DG103. 100X. Mount I613.
Photo ID #PA07396-DW7-9/4/84.
