LICENSEE EVENT REPORT (LER)

FACILITY NAME (1) Calvert Cliffs Unit 1 DOCKET NUMBER (2) 0500031171 PAGE (3) 1 OF 05

TITLE (4) Failure of #12 MSIV to fully close during surveillance testing

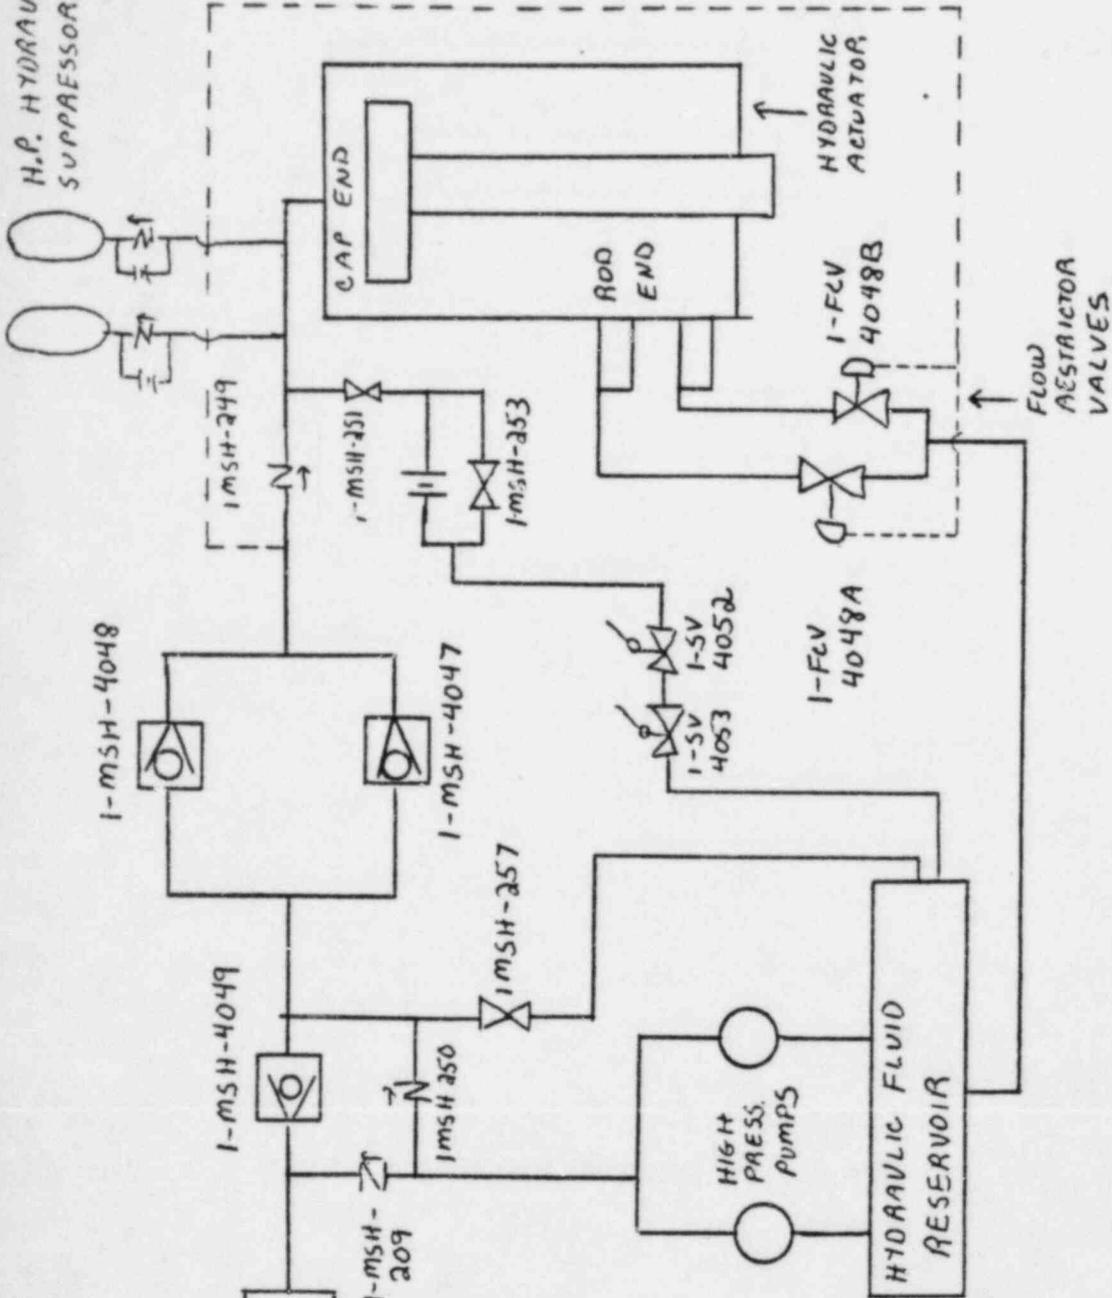
H.P. HYDRAULIC SUPPRESSORS

With the plant in **MODE 3** at 2100 on December 12, 1984, #12 MSIV (SB-ISV) failed to fully close within 3.6 seconds as required by the MSIV quarterly surveillance test and was declared inoperable. Three attempts were made by the Control Room Operator to perform the required timed stroke test of #12 MSIV. In each case, the Operator initiated the attempt by taking #12 MSIV's handswitch (SB-HS) to the CLOSE position. This action should have resulted in the following:

1. The opening of one of the two in parallel solenoid operated pilot check valves (1-MSH-4047) (SB-FSV).
2. Discharge of high pressure hydraulic fluid from an accumulator bank (SB-ACC) which is maintained at a pressure of 4700-5000 psig to the high pressure header and the cap end of the actuator.
3. One of the two in series cap end vent solenoids (1-SV-4052) (SB-FSV) energizing to close, to isolate the cap end of the actuator (SB-84) from the hydraulic reservoir (SB-RVR).
4. The restrictor valves (SB-FSV) opening to a preset position, after sensing the increased high pressure header pressure to control the flow of hydraulic fluid from the rod end of the actuator, thereby controlling the MSIV closing speed. At the completion of the valve stroke rod end fluid pressure should be 0 psig.

personnel inspected the Control Room handswitch for #12 MSIV. The upper contact blocks (Honeywell Model: CMC911AGA031BB, Part: Microswitch Contact: PTCC) were found to cause erratic contact closure across the contacts which open the solenoid operated pilot check valve and shut the cap end vent solenoid. Failure of these components to operate resulted in the failure of the MSIV to close during the first attempt. The failure of the handswitch would not, however, have interfered with the valve closure from a Steam Generator Isolation Signal (SGIS). The bad contact blocks were replaced and at 1930 on December 13, 1984, a fourth timed stroke of #12 MSIV was attempted. The MSIV went full shut in the required time, however, rod end pressure increased to approximately 3000 psig after the stroke and cap end pressure was below the normally expected value of greater than 2400 psig. It was postulated that bad piston seals (SB-SEAL) in the actuator or a malfunction of the restrictor valves could be causing the low cap end pressure and abnormally high rod end pressure.

1. The solenoid valves associated with the solenoid operated pilot actuation check valves were replaced (1-SV-4047 and 1-SV-4048).
2. Two check valves (SB-V) (1-MSH-209 and 1-MSH-250) between the high pressure header and high pressure pump discharge were replaced.
