TMI-1 OTSG REPAIRS

DEPARTMENT/SECTION Engineering & Design
Materials Engrg/Failure Anal.RELEASE DATE 1/11/85 REVISION DATE _____**DOCUMENT TITLE:** Evaluation of Eddy Current Indications Detected
During the 1984 Tech. Spec. Inspection

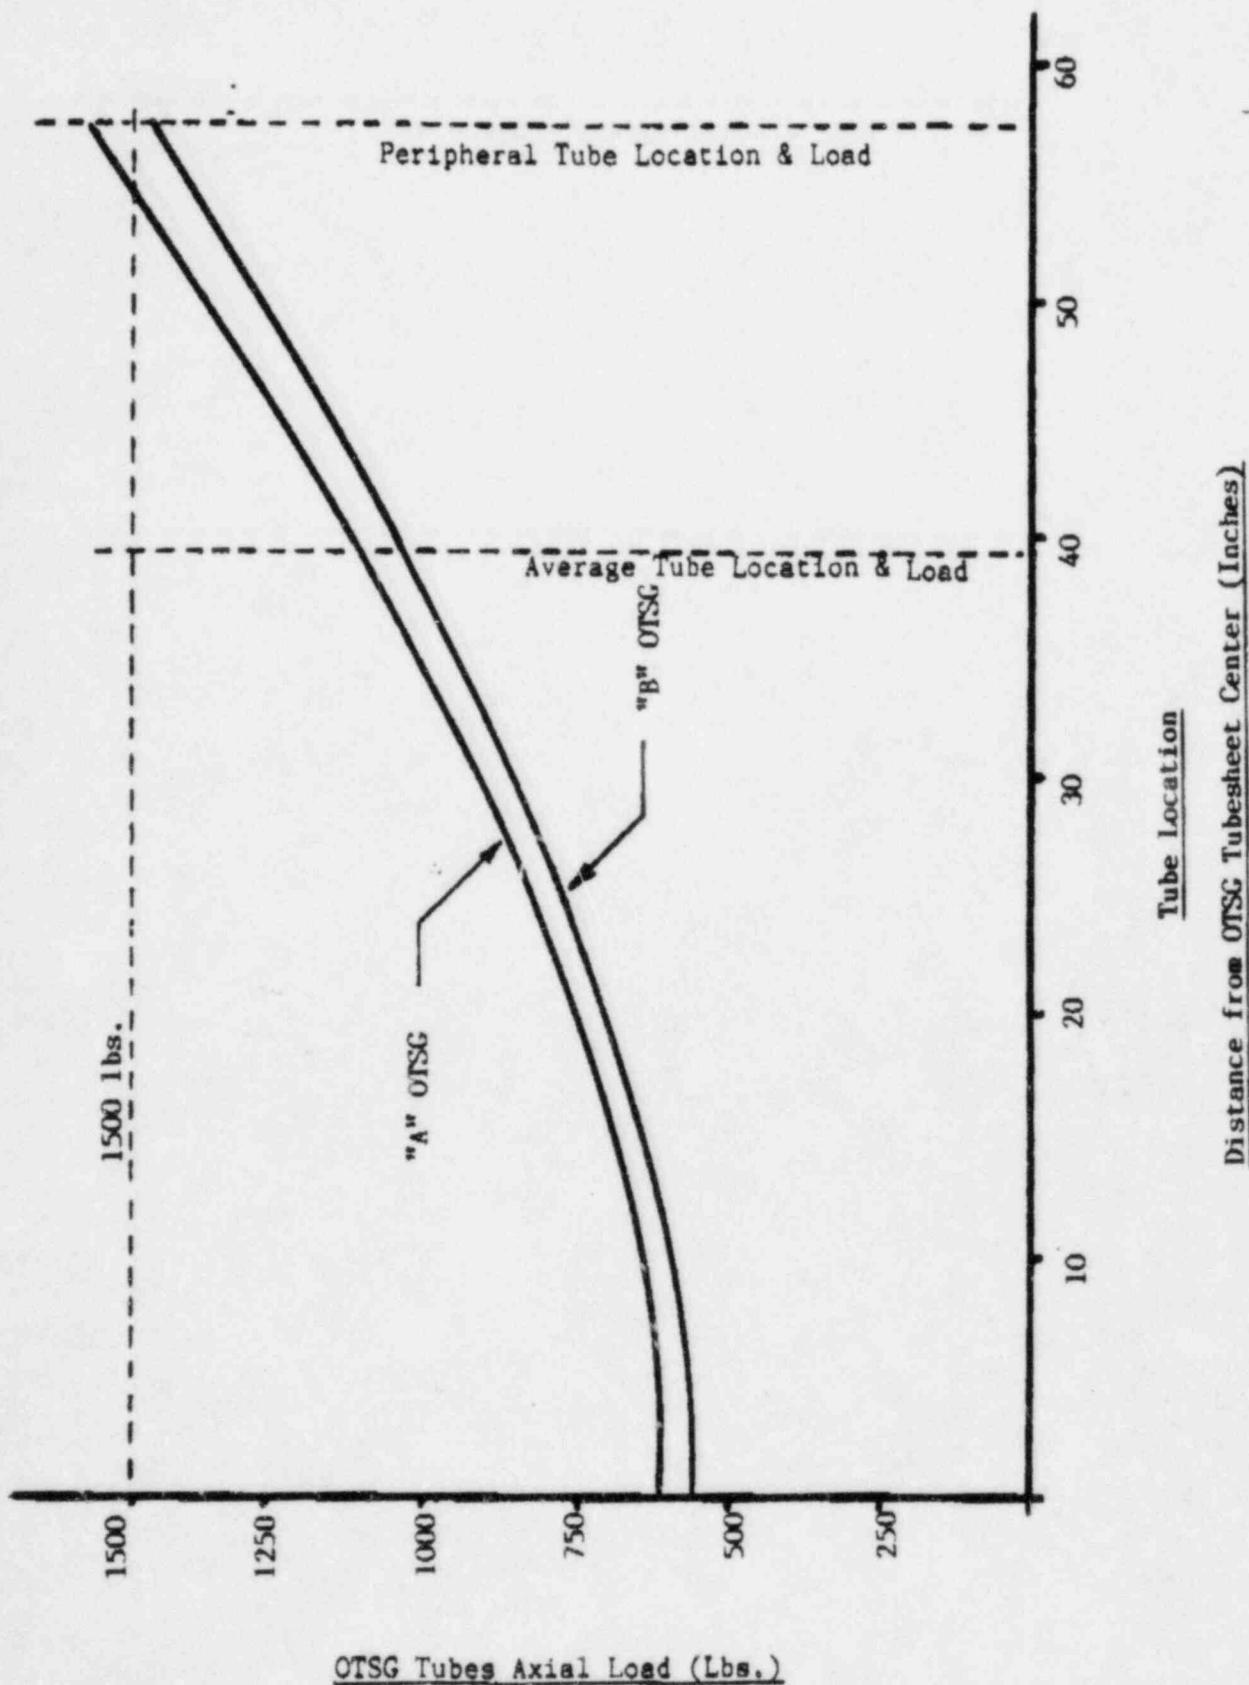
Figure 1 - TMI-1 OTSG Testing 3rd Cooldown (10-2-83)

Two additional pieces of data from Ref. 16 lend support to the mechanical scenario. First, peripheral tubes consistently see higher loads than core tubes. Therefore, in the periphery, the highest stresses would also act on this IGA. Second, the A-OTSG cooled down more quickly than the B unit. The peak load during the most rapid cooldown (Ref. 16) was 200 lb, or higher (12%), in the A-OTSG than in B-OTSG. Figure 1 is a representation of how the A-OTSG would have had significantly more tubes carrying loads high enough to cause IGA to become more detectable.

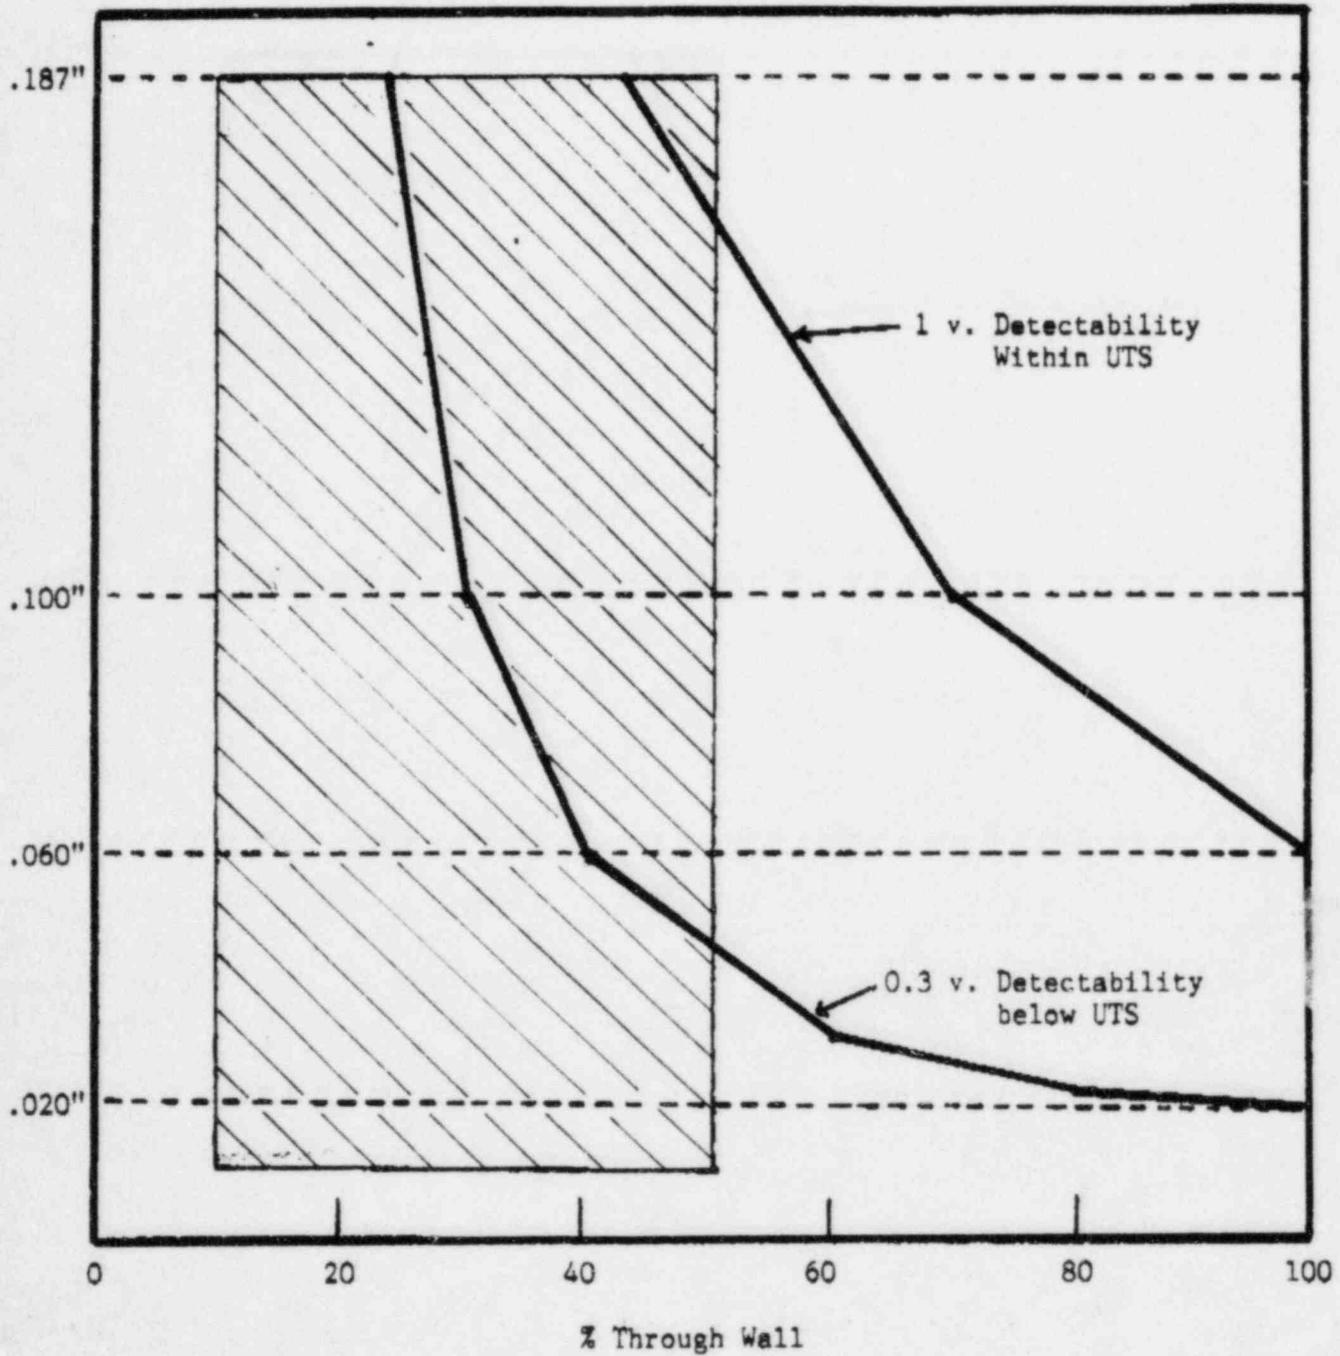
Figure 2 - 1984 Eddy Current Data

Figure 2 (Figure 2 from Reference 2) shows the measured sensitivity of the .540" S.D. technique in the range of short circumferentially oriented defects. The shaded region in Fig. 2 identifies the area in which 90% of the 1984 indications fall. It can be seen that the eddy current calls span the 0.3 volt detectability limit. Thus only slight changes in indication geometry could cause a particular indication to become detectable.

90% of 1984 Indications
Lie Within This Area

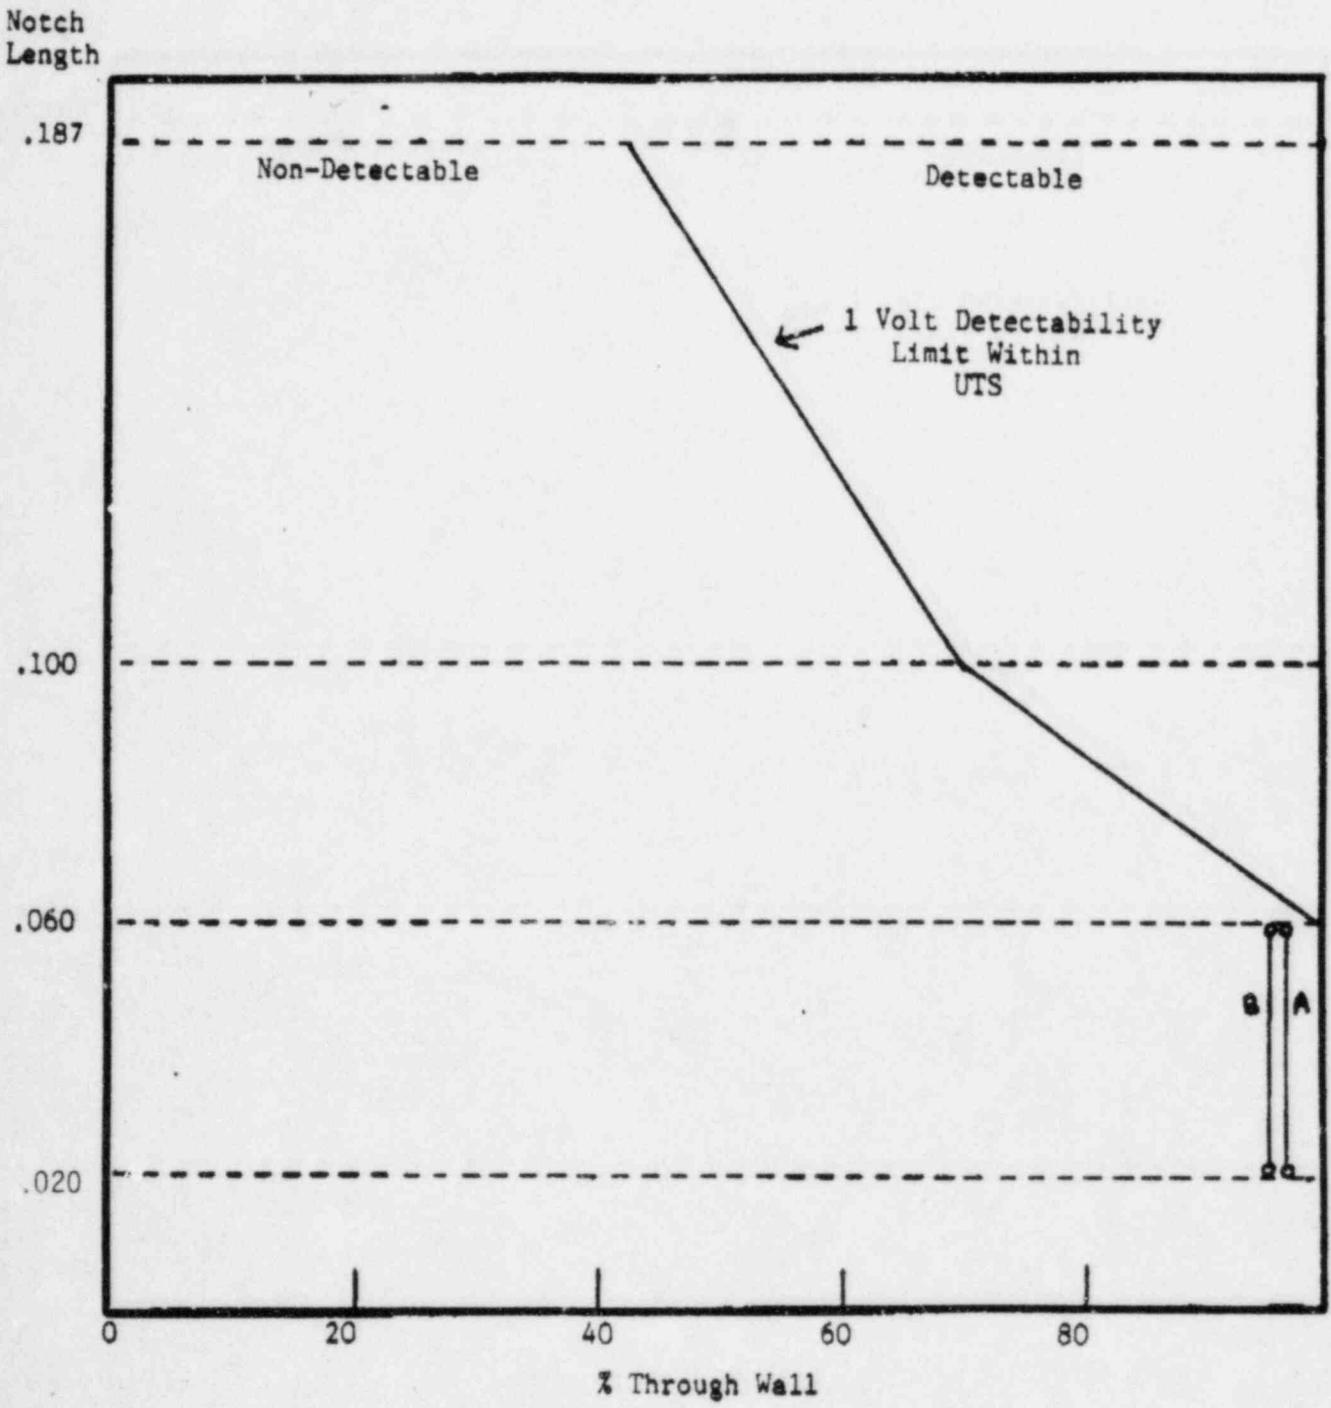
Figure 3a - Within - Tubesheet
Fiberscope Indications
Compared to Detectability Limit

In Figure 3a and 3b, we have taken the eddy current data and visual observations from the fibroscope inspection (shown in Table 6) and indicated where the indications would be in relationship to the calibration curves. The tubes for fibroscope inspection were chosen to be representative of the types of indications being found in 1984. All of the below-UTS indications (Figure 3b) are close to the 0.3 v detectability limits; the within-UTS indications (Figure 3a) do not fall into the detectable range. Therefore, it is reasonable that before mechanical loading these indications may not have been detectable. Mechanical loading, as discussed in the previous section, can alter IGA geometry.
