SUBJECT: REVIEW OF PRELIMINARY ACCIDENT SEQUENCE PRECURSOR ANALYSIS OF 1995 OPERATIONAL EVENT AT WATERFORD STEAM ELECTRIC STATION, UNIT 3 (WATERFORD 3)

Event Description: Reactor trip, breaker failure and fire, degraded offsite power, and degraded shutdown cooling

Fig. 1 Dominant core damage sequences for LER No. 382/95-002.

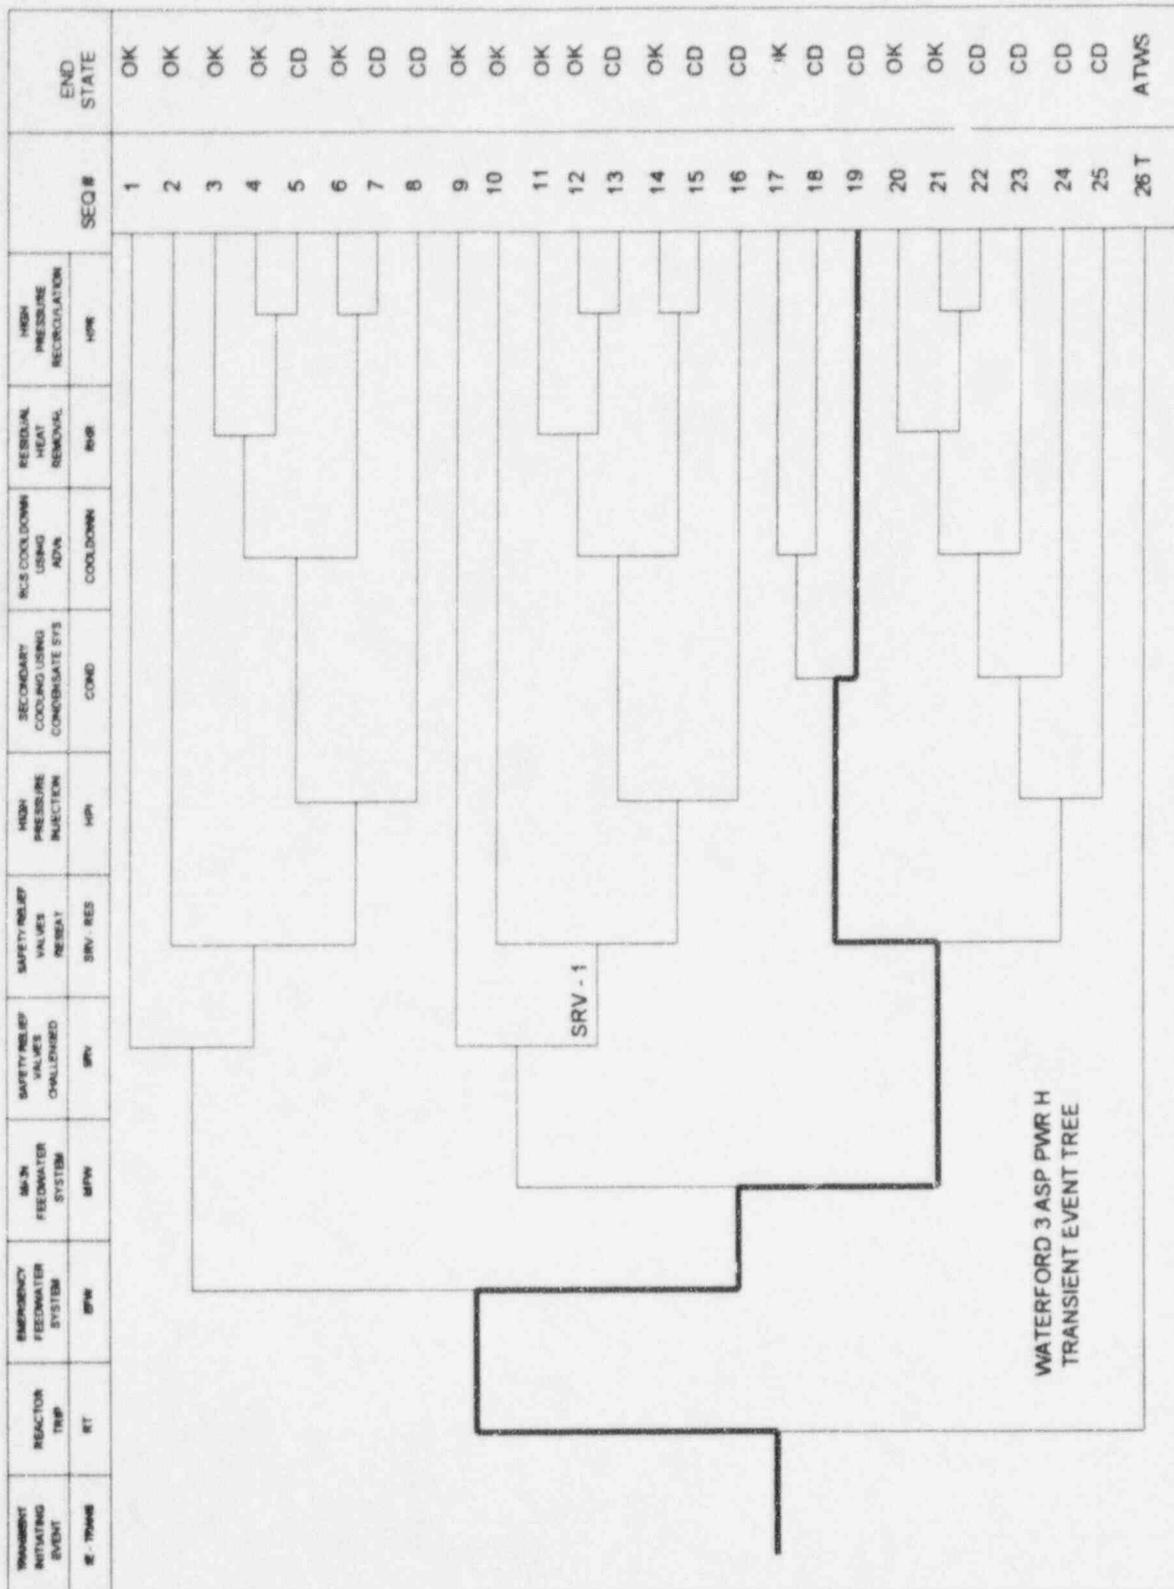
The conditional core damage probability estimated for trip, fire and resulting loss of offsite power to train A, loss of feedwater, and unavailability of the SDC isolation valves is  $2.5 \times 10^{-5}$ . The dominant sequence, highlighted on the event tree in Fig. 1, contributes about 83% to the conditional probability estimate for the initiating event and involves failure of EFW (including the AFW pump) to provide secondary-side cooling,

and failure of the condensate system as an alternate source of cooling water. The dominant cut sets involve failure to provide an alternate source of water to the EFW pumps following depletion of the condensate storage pool, and failure of the condensate system to provide flow to the steam generators (failure to initiate and equipment failure both contribute).
