U.S. NUCLEAR REGULATORY COMMISSION
REGION I

Report No. 50-293/84-44

Facility Name: Pilgrim Nuclear Power Station

Inspection Summary: Inspection on December 18-19, 1984 (Report No. 50-293/84-44)

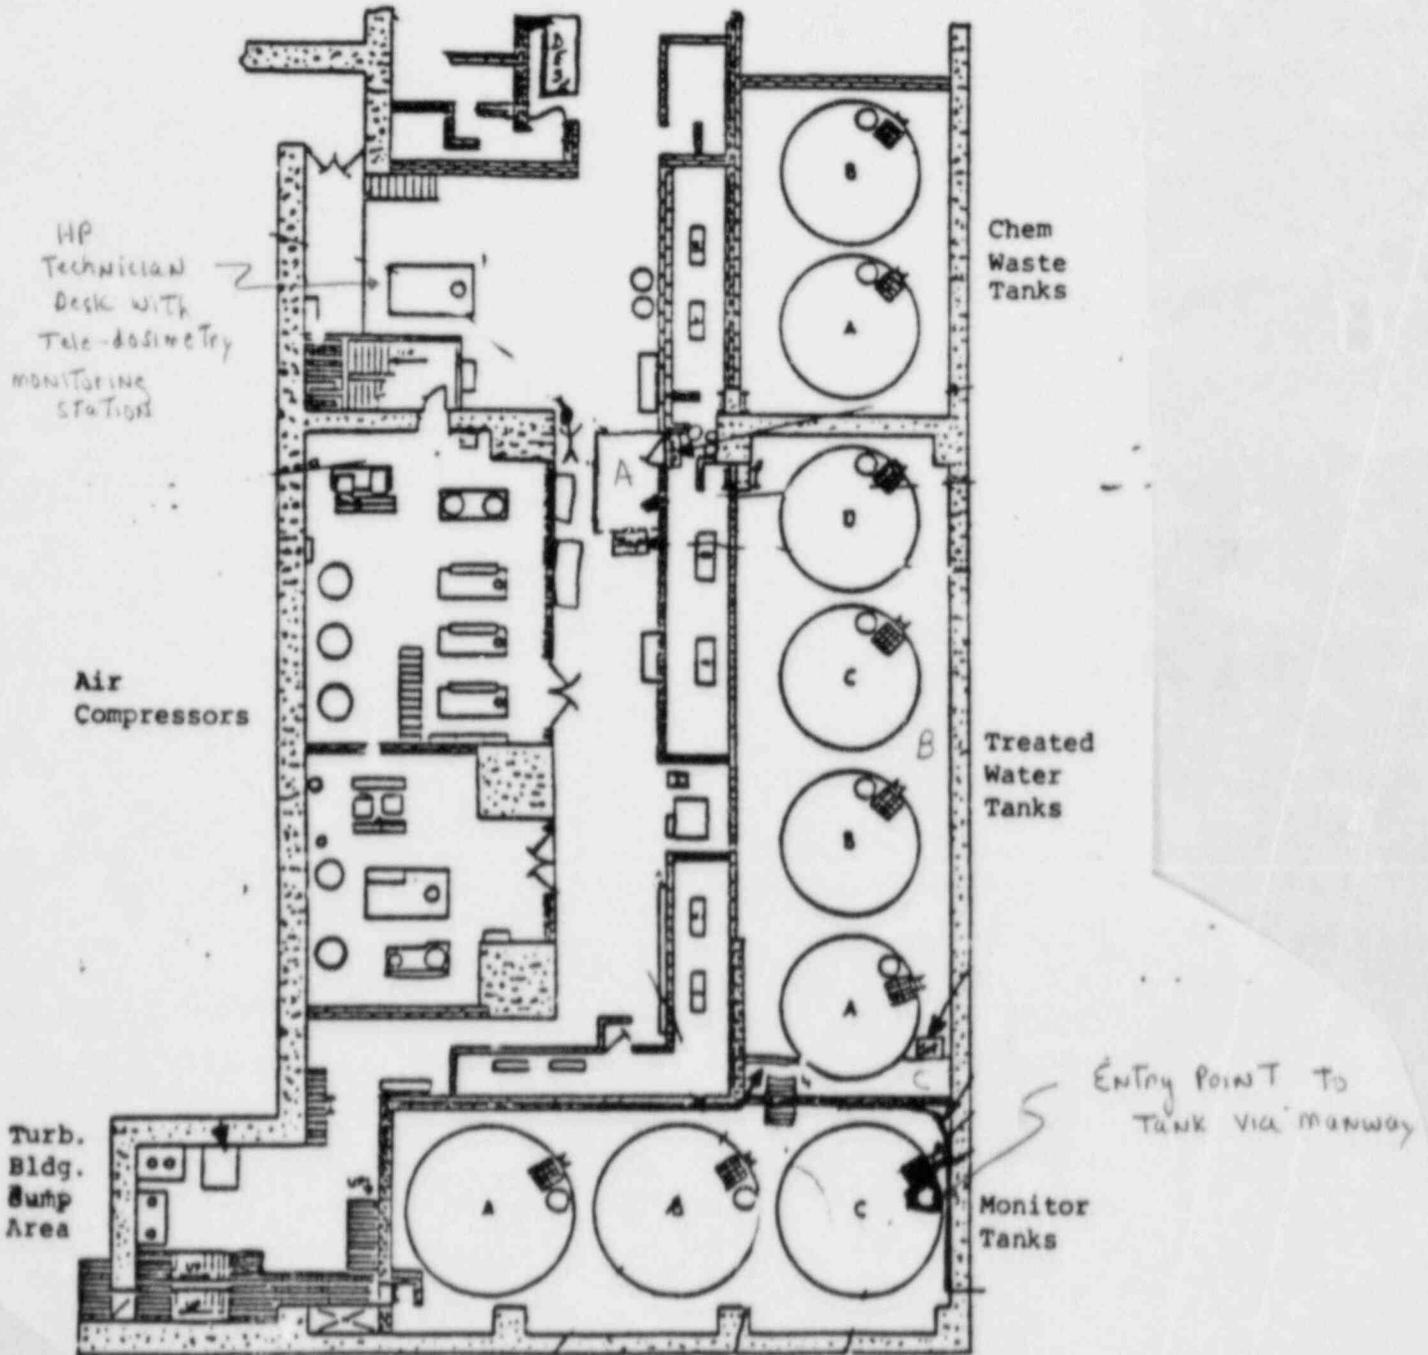
Figure 1 (attached) depicts the general work area.

The inspector review found the means of entry to the area, as routinely used by personnel, to be an undesirable route. The inspector noted that personnel (fully suited in several layers of protective clothing and respiratory protective equipment) were required to: climb about a 15 foot high wall, walk about 15 to 20 feet along a narrow walkway on top of the wall, drop down onto various valves and piping and walk on the narrow piping, and reach out over a 15 foot drop and grab a ladder on the side of the tank to ascend to the man-way. The inspector noted the piping appeared to exhibit an oily-residue making it slippery to walk on with rubber boots. Inspector discussions with licensee personnel indicated this route was selected in order to minimize personnel exposure.
